Incident Summary #II-1665852-2024 (#43817) (FINAL)

SUPPORTING INFORMATION	Incident Date	January 21, 2024	
	Location	Aldergrove, BC	
	Regulated industry sector	Electrical - Low voltage electrical system (30 to 1000V)	
	Impact	Qty injuries	0
		Injury description	N/A
	Damage	Injury rating	None
		Damage description	A 2000kVA unit substation transformer was damaged beyond repair after a phase to ground fault in the secondary low voltage compartment.
		Damage rating	Major
Incident rating	Major		
Incident overview	The outdoor unit substation feeding a community centre was damaged beyond repair after a conductor installed with improper bend radius suffered abrasion from expected vibrational friction against a sharp surface on the interior of the secondary compartment resulting in exposed wire and a phase to ground short.		
INVESTIGATION CONCLUSIONS	Site, system and components	<p>The 2000kVA unit substation that supplied power to a city community centre consisted of the following components (as per engineering report):</p> <ul style="list-style-type: none"> • A 25kV incoming power supply • A 25kV load break switch (ABB NAL-24-6) complete with 65E fuses. • A FR3 oil-filled 2000kVA transform

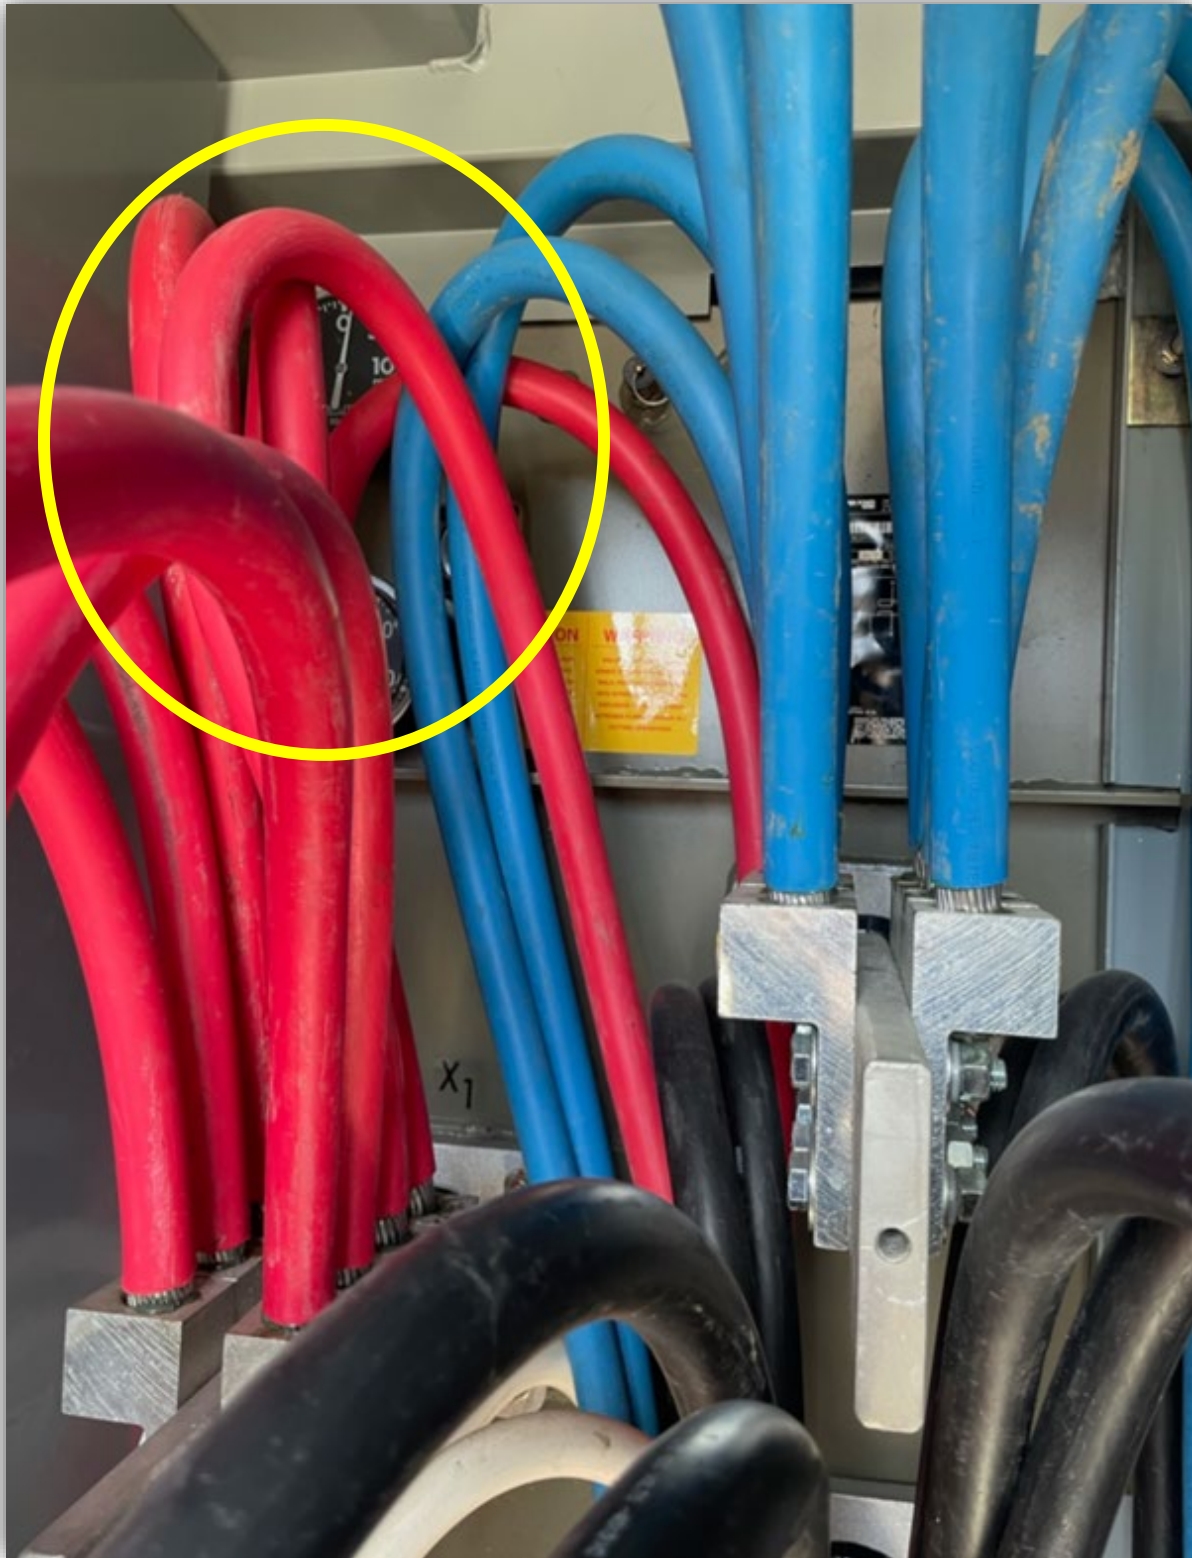
<p>Causes and contributing factors</p>	<p>Conductors were in direct contact with sharp surfaces of an enclosure's secondary compartment which is typically prevented with installation techniques and adequate bend radius where conductors are more isolated from edges.</p> <p>It is likely through normal operation, the common vibration of the transforming equipment combined with improper installation created conditions where the conductors either had or were prone to physical stress and abrasion, creating enough friction that it cut through and broke down the insulation of the conductor causing an exposed wire and phase to ground fault with a subsequent catastrophic failure of the equipment and outage to the facility.</p>

Image 1 - Sharp bend radius of conductors causing them to be pressed against enclosure wall.

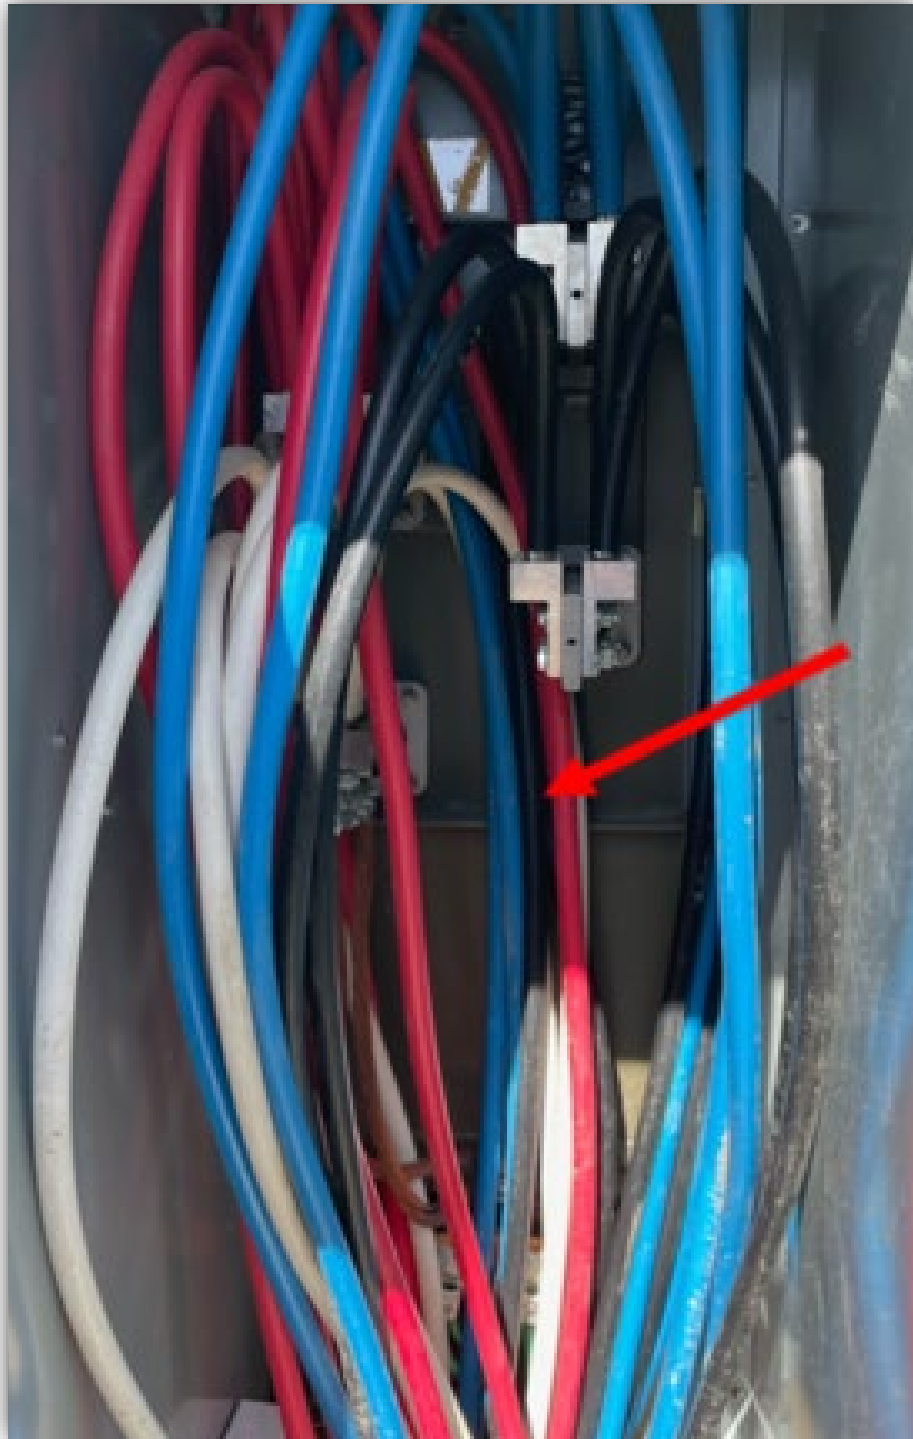
Image 2 - The route taken to install the two red phase conductors that were in close proximity to where the fault occurred (Provided by FSR).

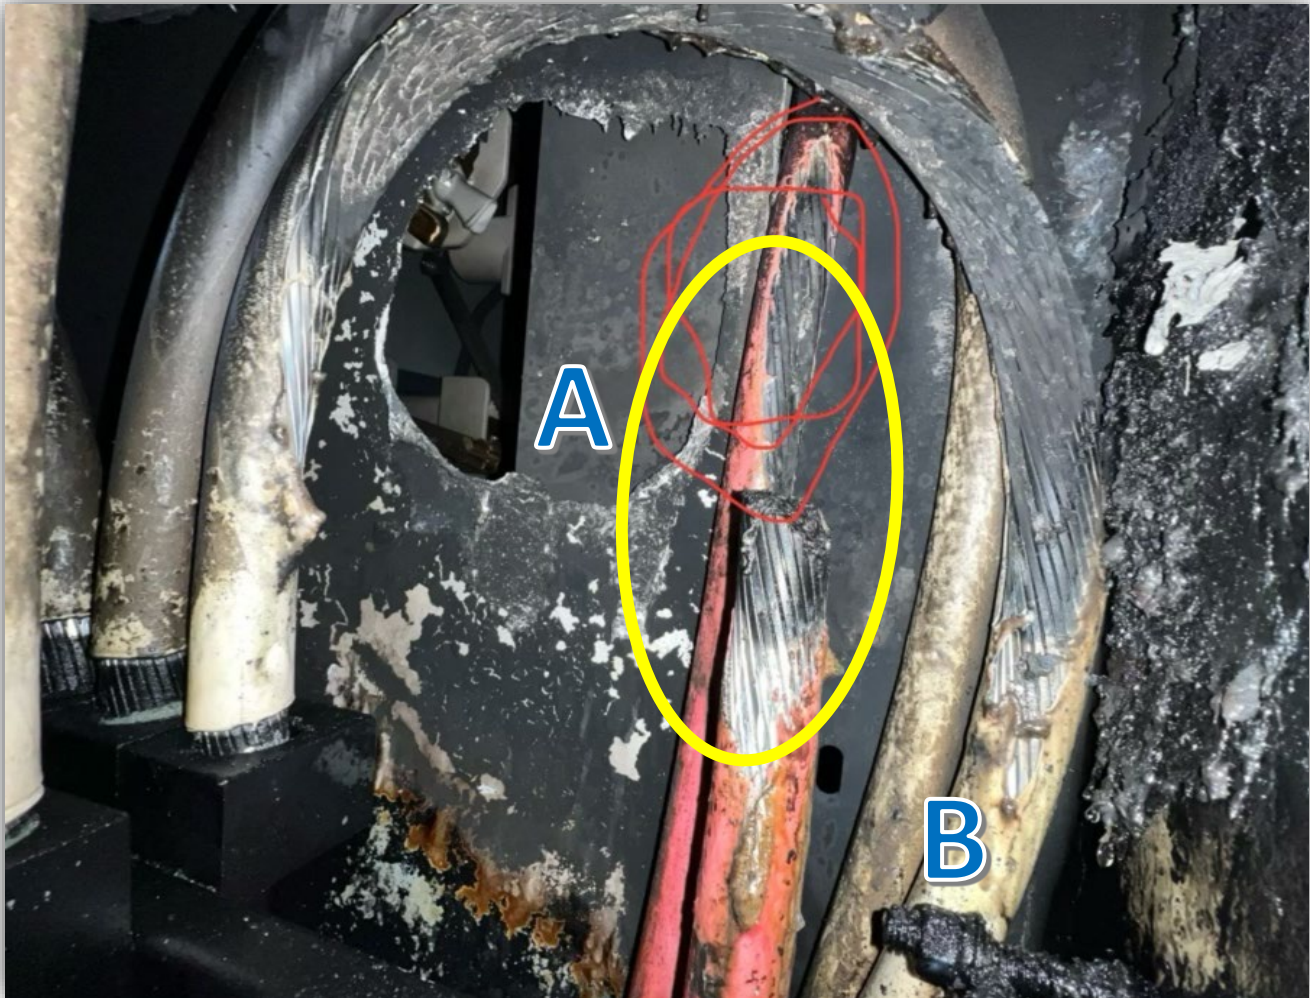
Failure scenario(s)	<p>During regular transformer operation, vibrations are generated from the equipment and over time, the constant friction, compounded by the stress from the excessive bend radius, progressively damaged the insulation around the conductor.</p> <p>The exposed conductor ultimately led to insulation failure, creating an electrical arc to the transformer casing resulting in a phase-to-ground fault. The initial fault caused significant damage and triggered cascading faults across all phases, compounding the damage to the unit substation and its components.</p> <p>The fuses did eventually operate. however, high voltage fuses do not function quite the same way as a circuit breaker in a house. They are not as sensitive to in rush currents from large loads and line surges. Although we know the type of fuse used (65E) we do not know the speed rating. Depending on the selected speed rating when purchased, 65E fuses can take up to 300 seconds to operate during an overcurrent condition.</p>

Image 3 – Shows conductor damage after rubbing on sharp surface (Provided by FSR).

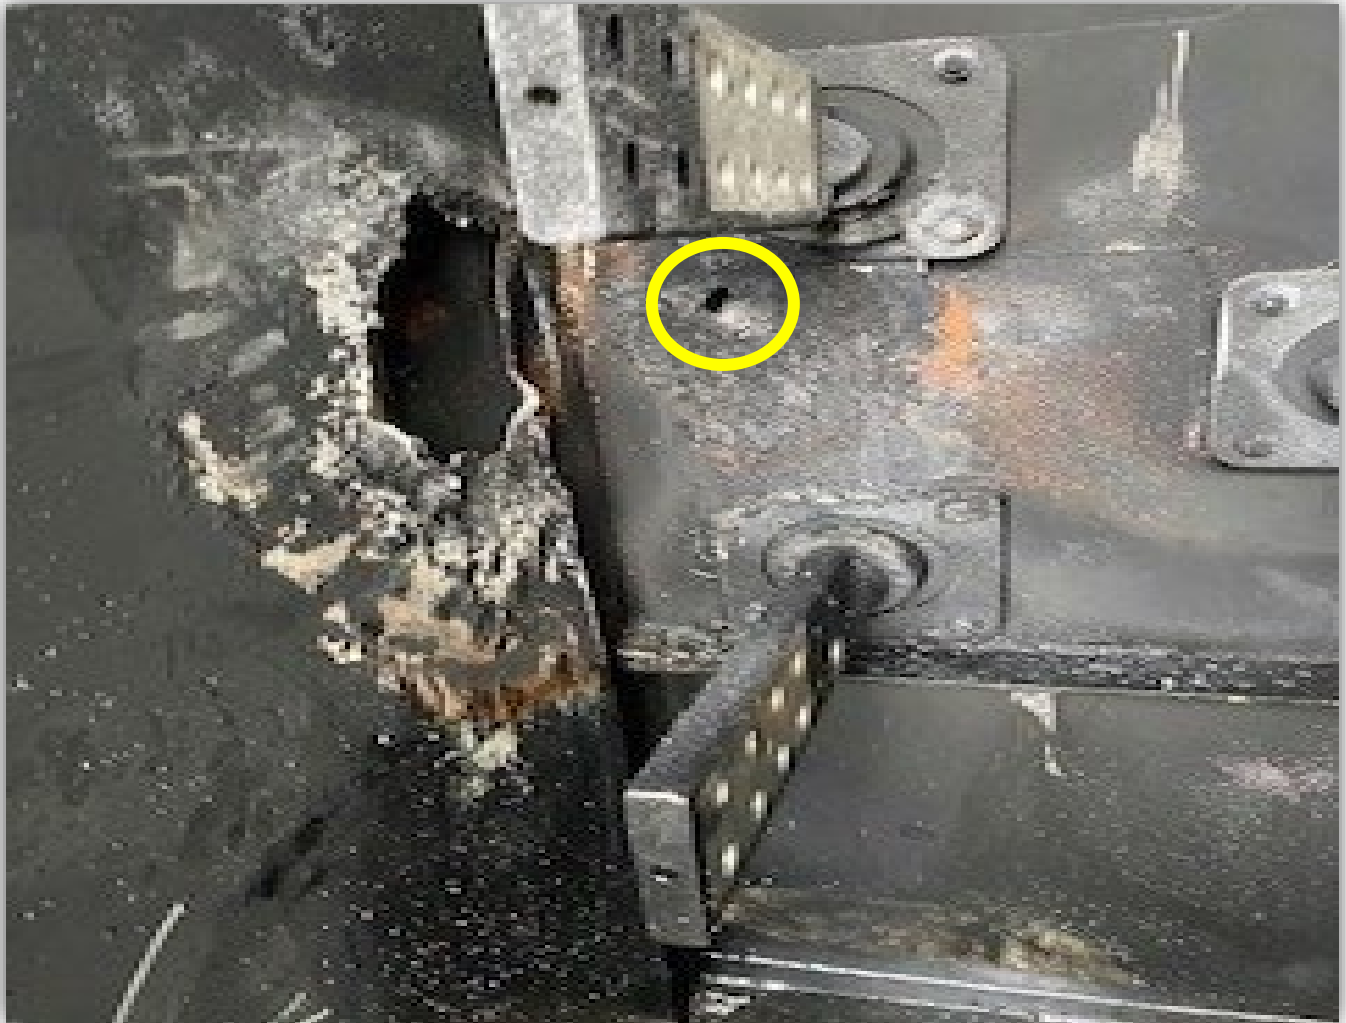
Image 4 - Possible initial fault location just past the “A” phase terminal block insulator and directly below where the bottom left bolt would have been if it had not melted off.

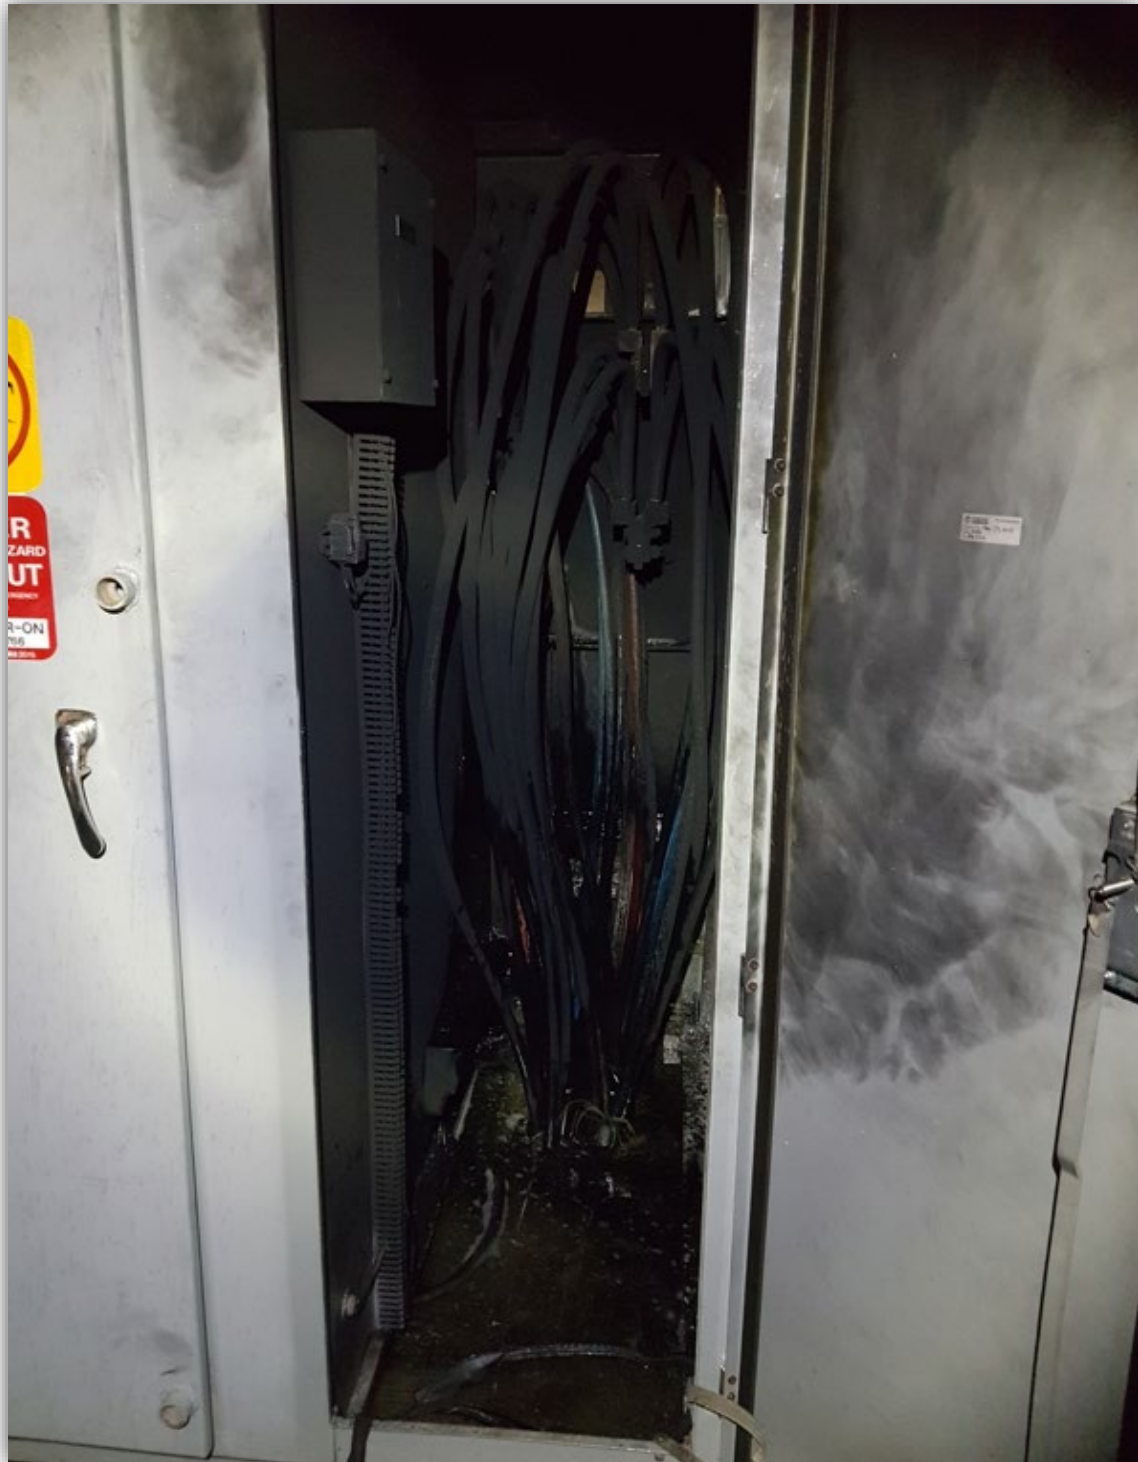
Image 5 - Secondary compartment at time of incident. Shows soot and damage from outside looking into transformers.

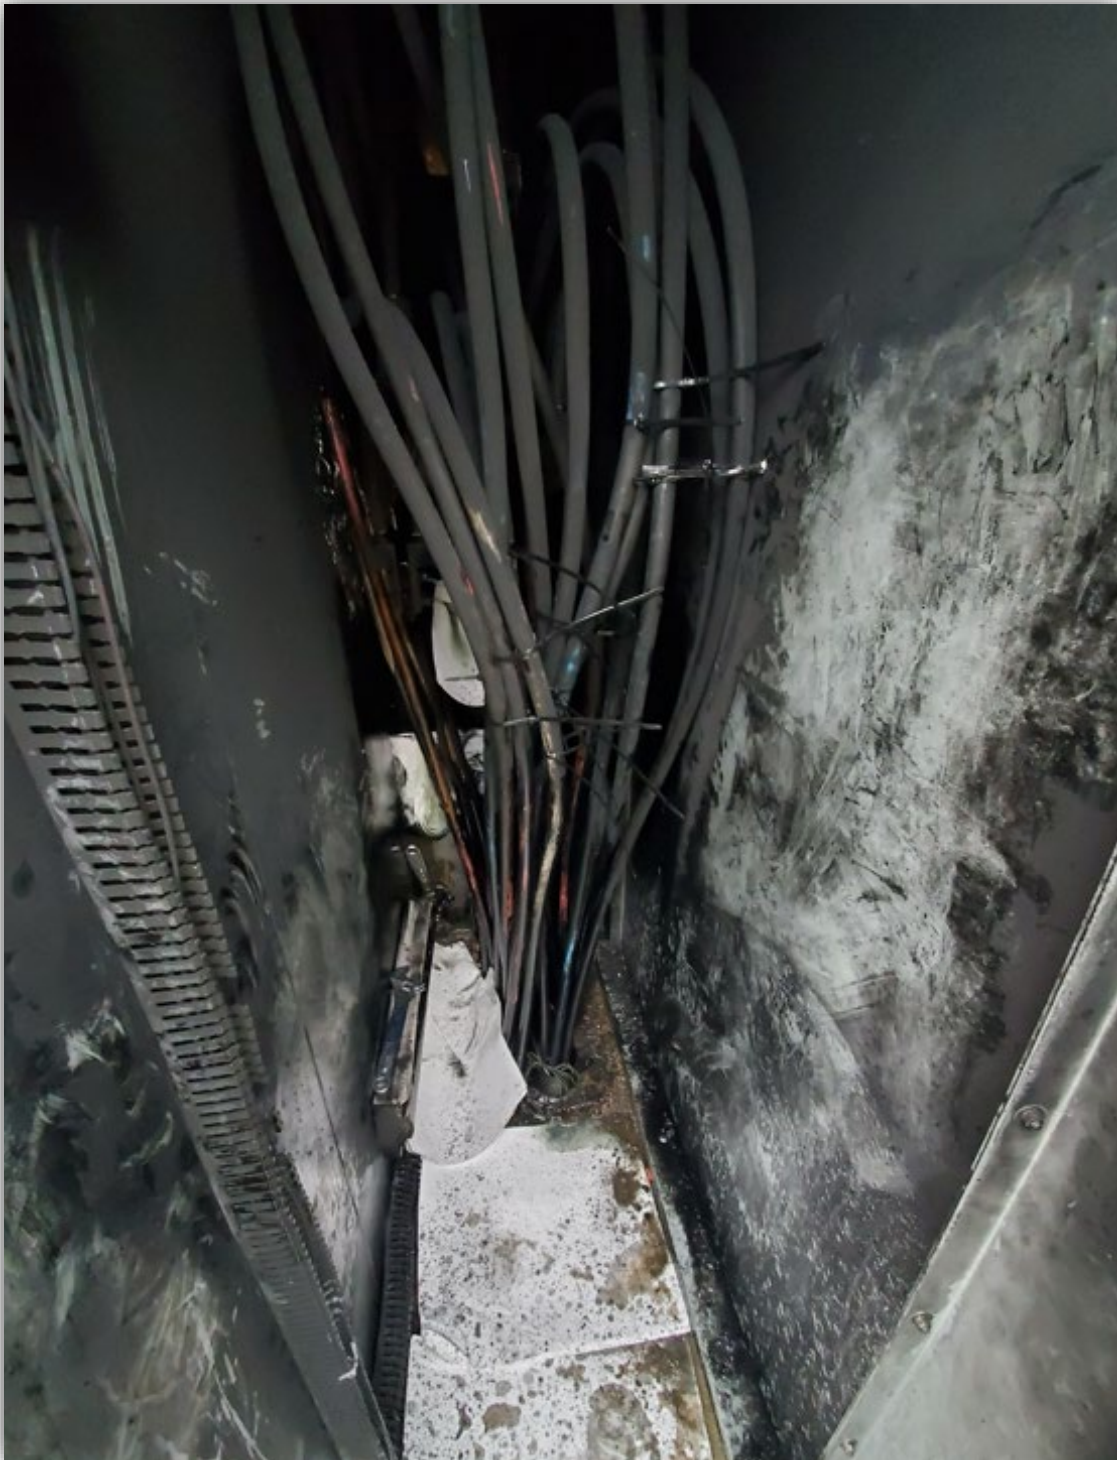
Image 6 – Interior of secondary compartment at time of incident.
