Incident Summary #II-1224484-2021 (#22816) (FINAL)

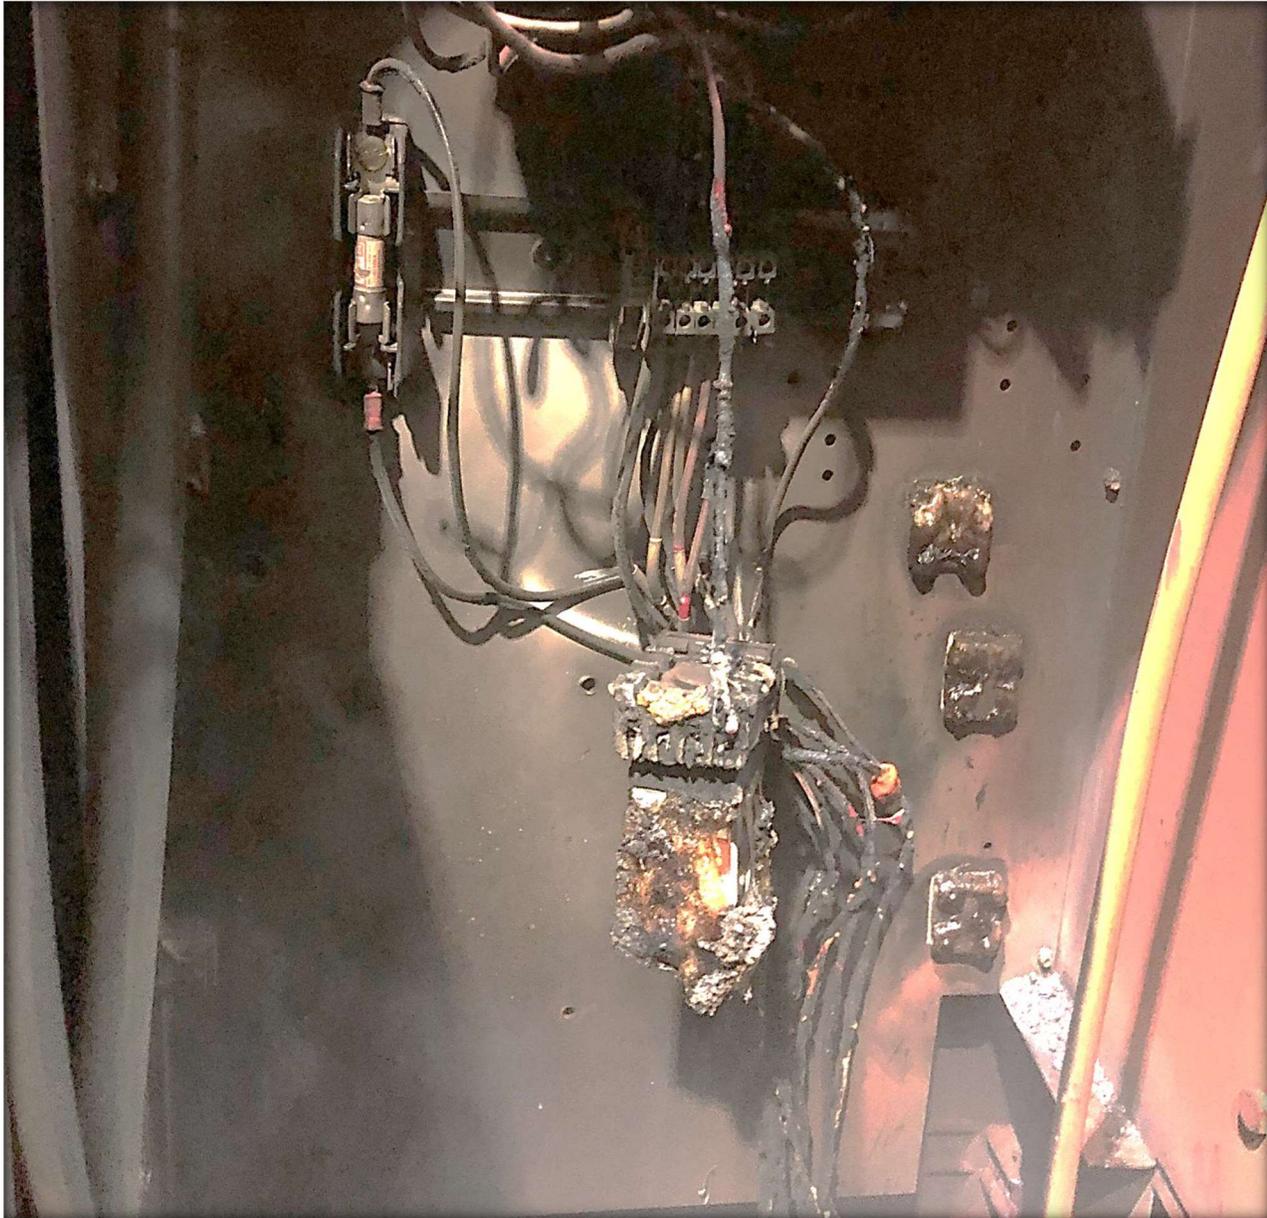
It highly probable that manually bumping the magnetic starter coil created an uneven force to be applied across the contacts, allowing a misalignment of the connections creating an arc and a fire to develop.

Figure: 1 – Internal components, floating relay, and damage.

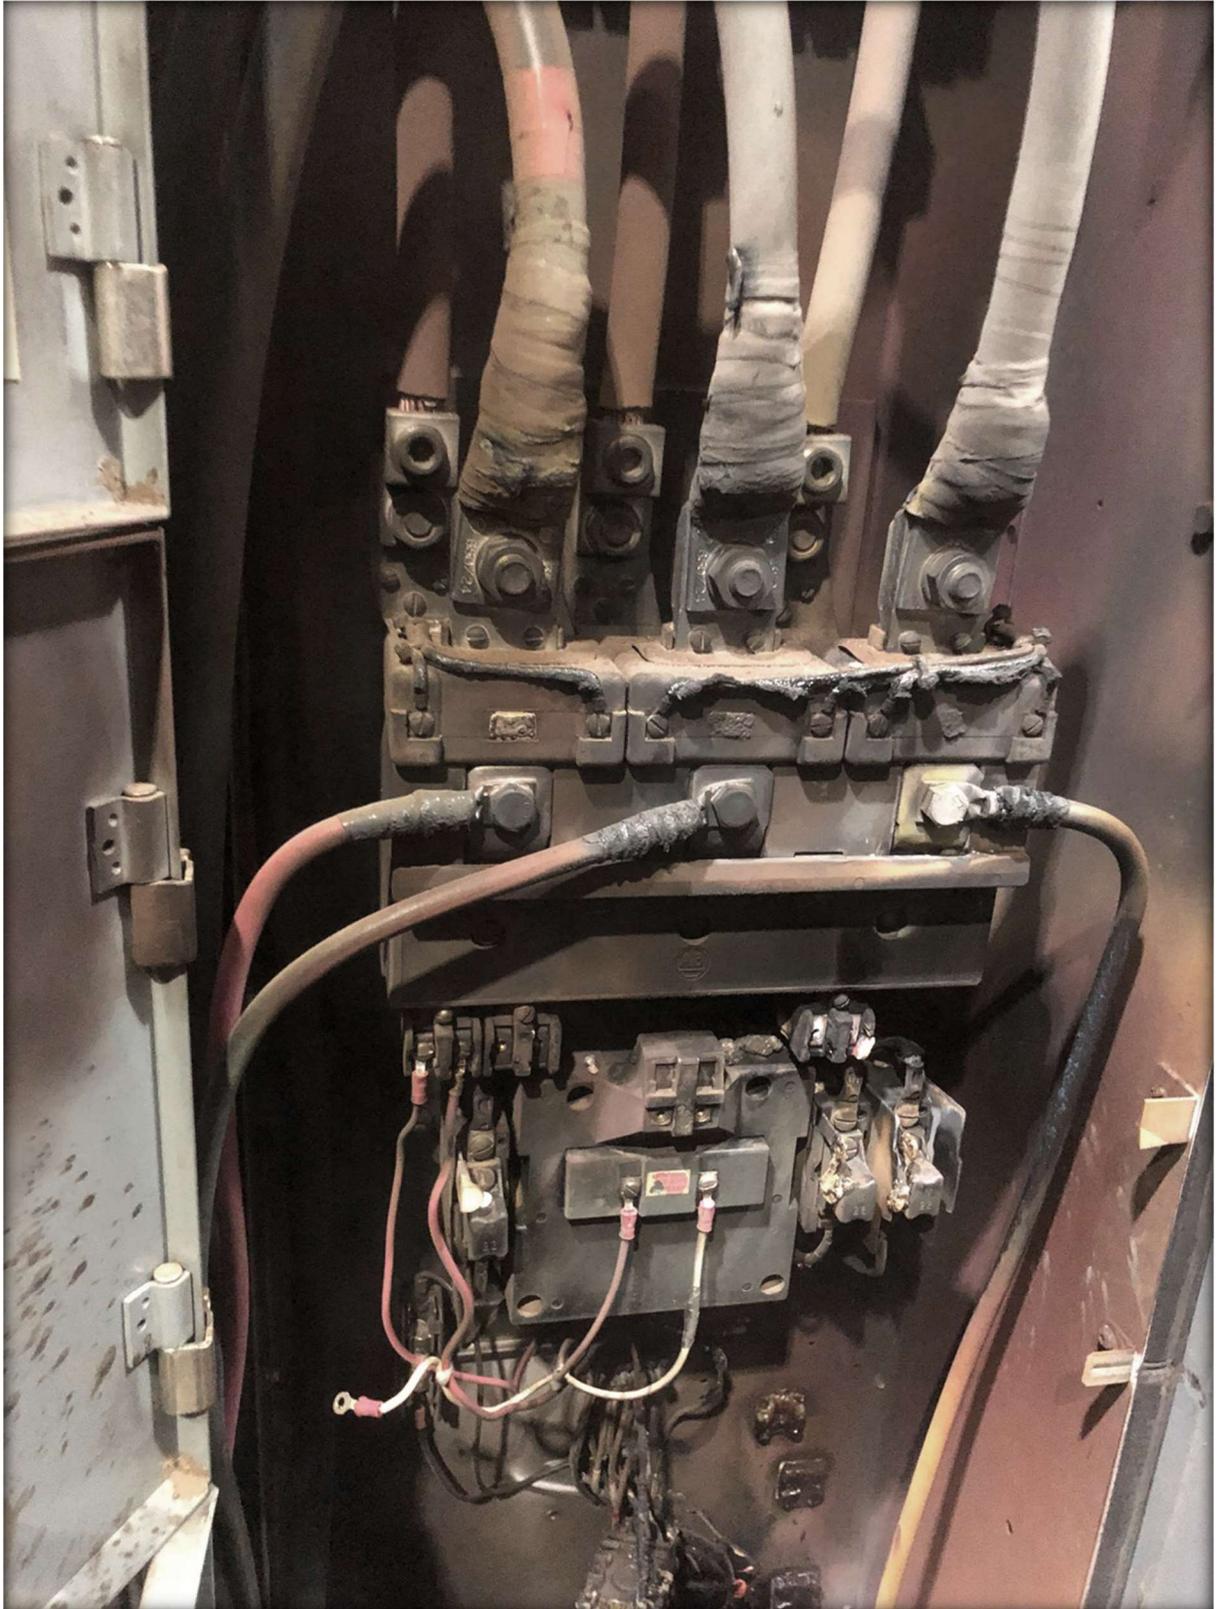
Figure: 2 – Internal damage.

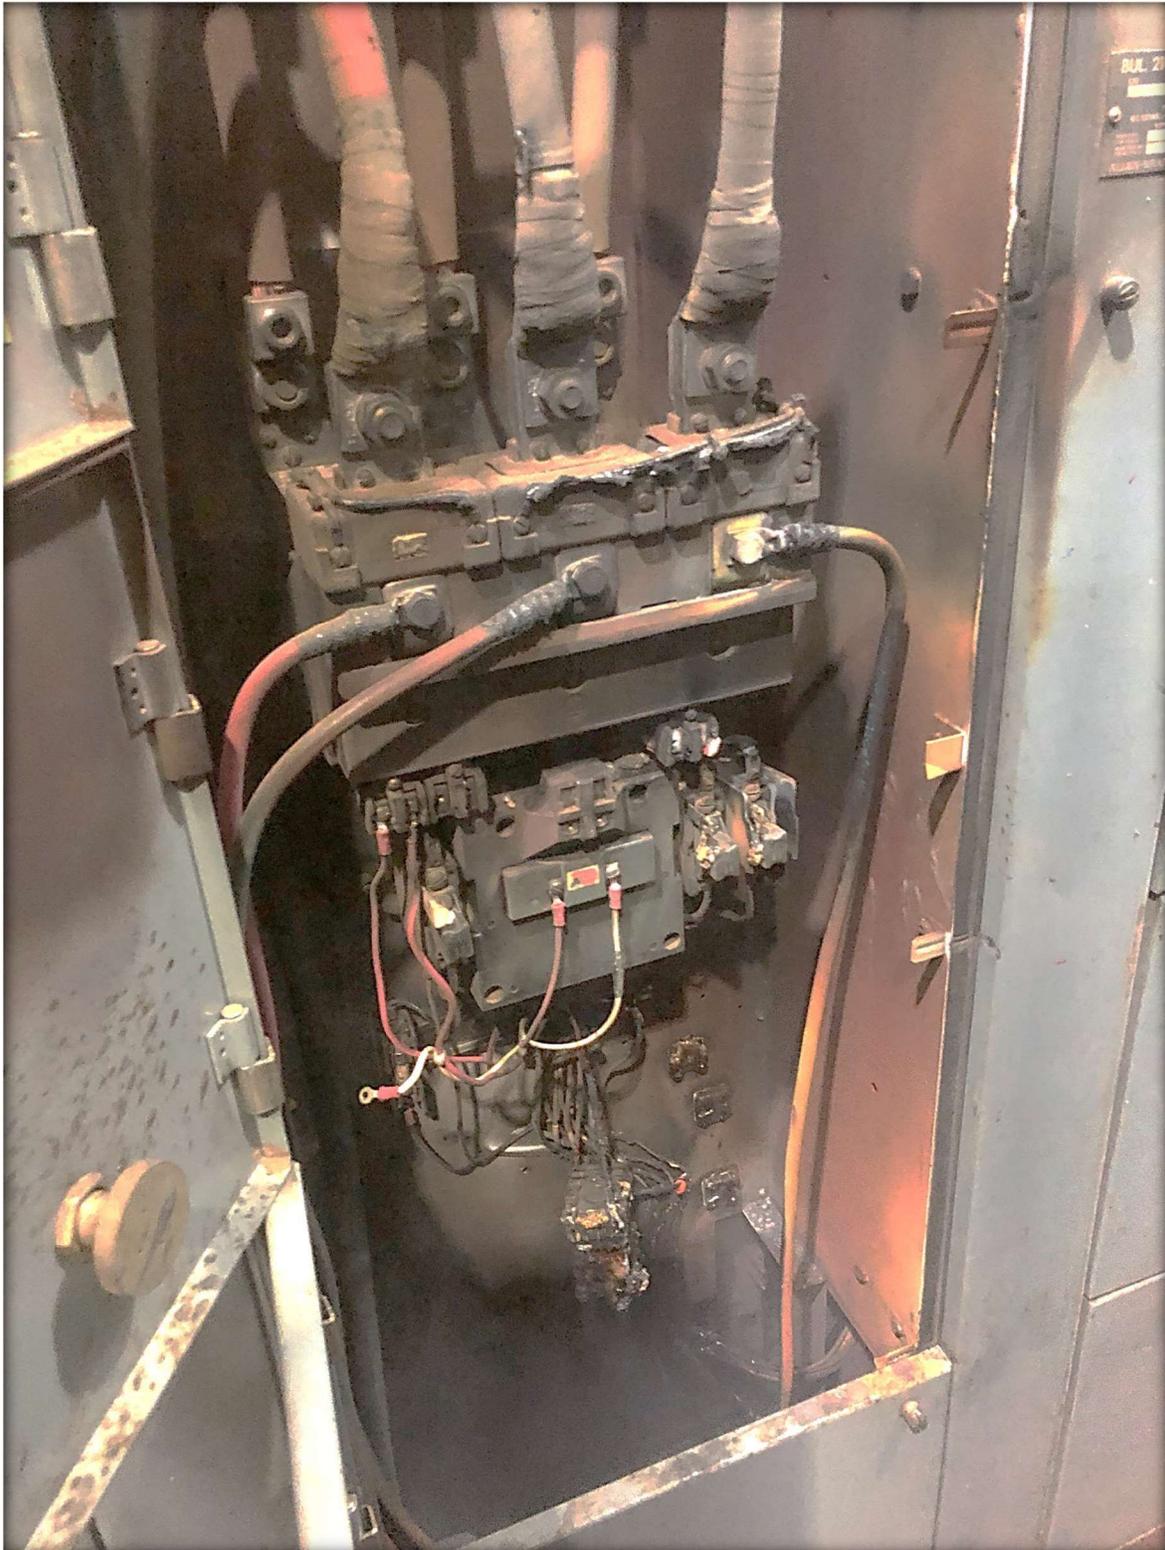
Figure: 3 - Internal components, connections, and damage.

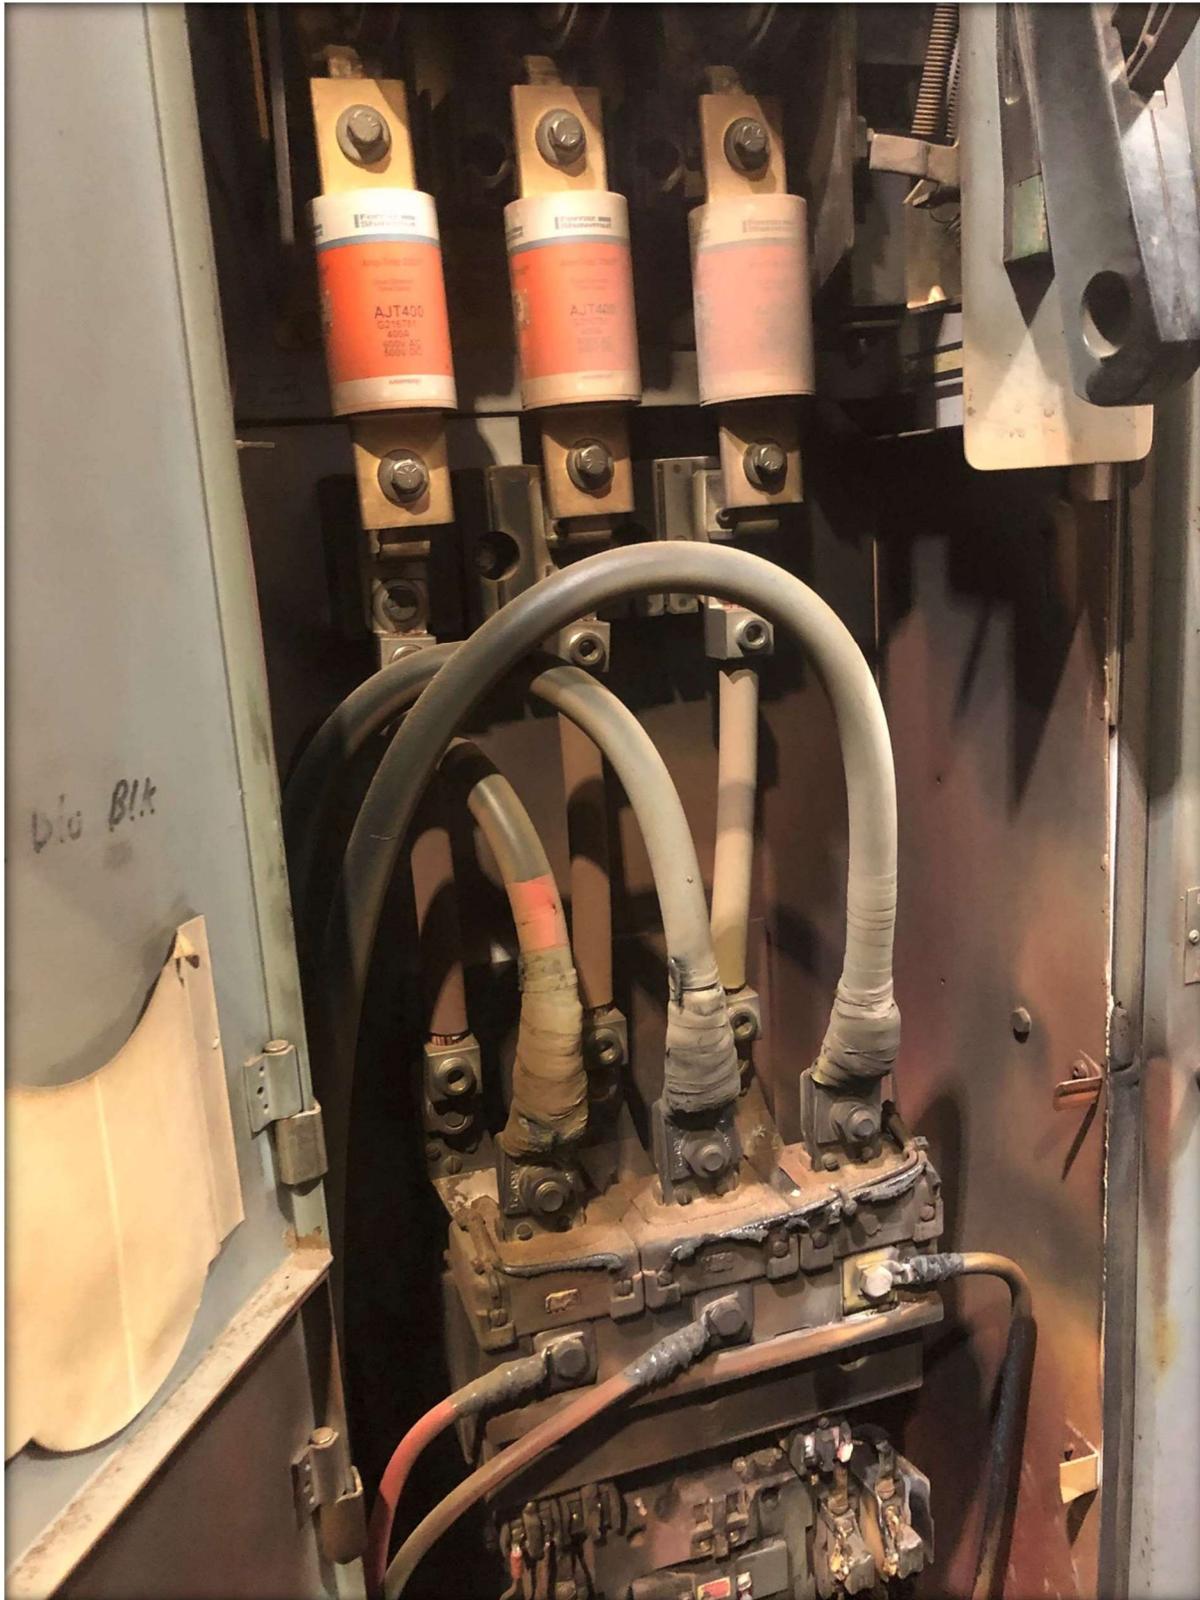
Figure: 4 - Internal fuses, connections, and damage.
