Incident Summary #II-1000791-2020 (#16966) (FINAL)

Incident overview	A boiler located in the mechanical room of an apartment building went into an over temperature/pressure condition and a release of hot to boiling water occurred through the safety relief valve.		
INVESTIGATION CONCLUSIONS	Site, system and components	<p>The boiler is a means of providing heat to the apartment building by generating hot water that is pumped through piping to radiators.</p> <p>A transformer powers the low voltage safety circuit. The circuit consists of multiple safety components wired in series. The safety components are designed to trip and open the electrical circuit when the boiler reaches certain operating conditions that could become unsafe. In the event of such operating conditions, the burners of the boiler will then safely shut off. The components in this circuit consist of a low water cut-off switch, a water flow switch, an operating temperature switch, and a high temperature limit switch. The low water cut-off switch and the high temperature limit switch are both required to be manually reset when tripped to allow the boiler to operate again.</p> <p>There is a second transformer, separate

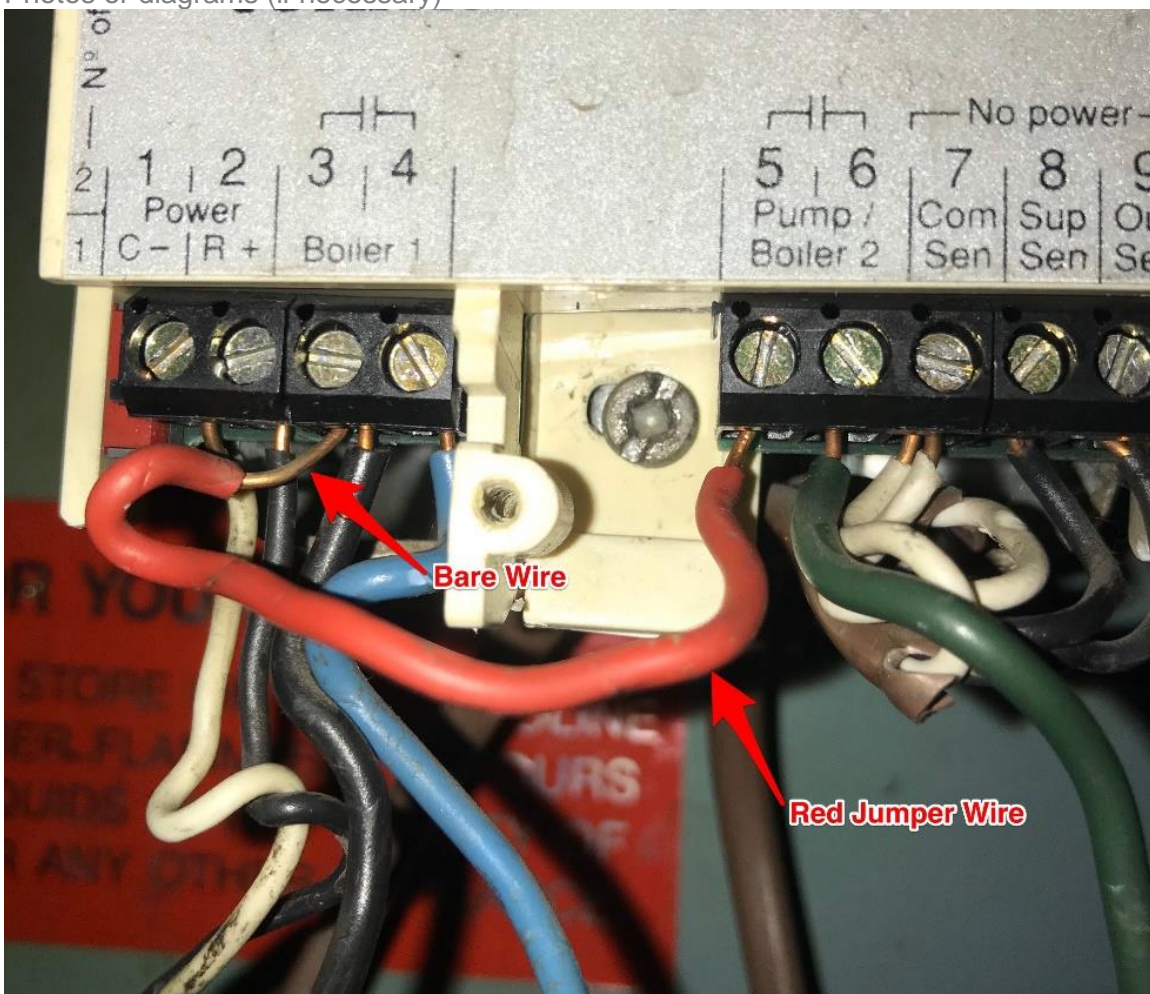
<p>Failure scenario(s)</p>	<p>A jumper wire was installed in the digital controller from terminal #3 to terminal #5. This was to power both the high and the low circuits of the two stage gas valve. The insulation of the jumper wire had been stripped back and exposed an excessive amount of bare wire past the terminal connection point on terminal #3. (See Image 1) The bare portion of the wire came into contact with the energized wire connected to the adjacent terminal (terminal #2). This created a separate circuit that powered the gas valve, and allowed the safety circuit to be bypassed and the boiler to operate continuously until the power was manually shut off to the boiler. (See Wiring Diagram in Images) The continuous operation of the boiler caused it to go into an over temperature/pressure condition. The safety relief valve released hot to boiling water and excessive internal temperatures damaged the boiler and components. (See Images 2 to 7)</p>

The probable cause of the incident was that the jumper wire was installed with the insulation of the wire stripped back far enough to expose an excessive amount of bare wire. The bare wire made contact with an adjacent terminal that was receiving constant power. With that contact, an unintentional circuit, powering the gas valve and bypassing the redundant safety features, was created.

Image 1: Controller Wires, including Jumper Wire and bare portion (Note: Photo taken after jumper wire having been manipulated by maintenance contractor. Wire was disconnected to ensure the connection was broken and unsafe situation could not be re-created.)

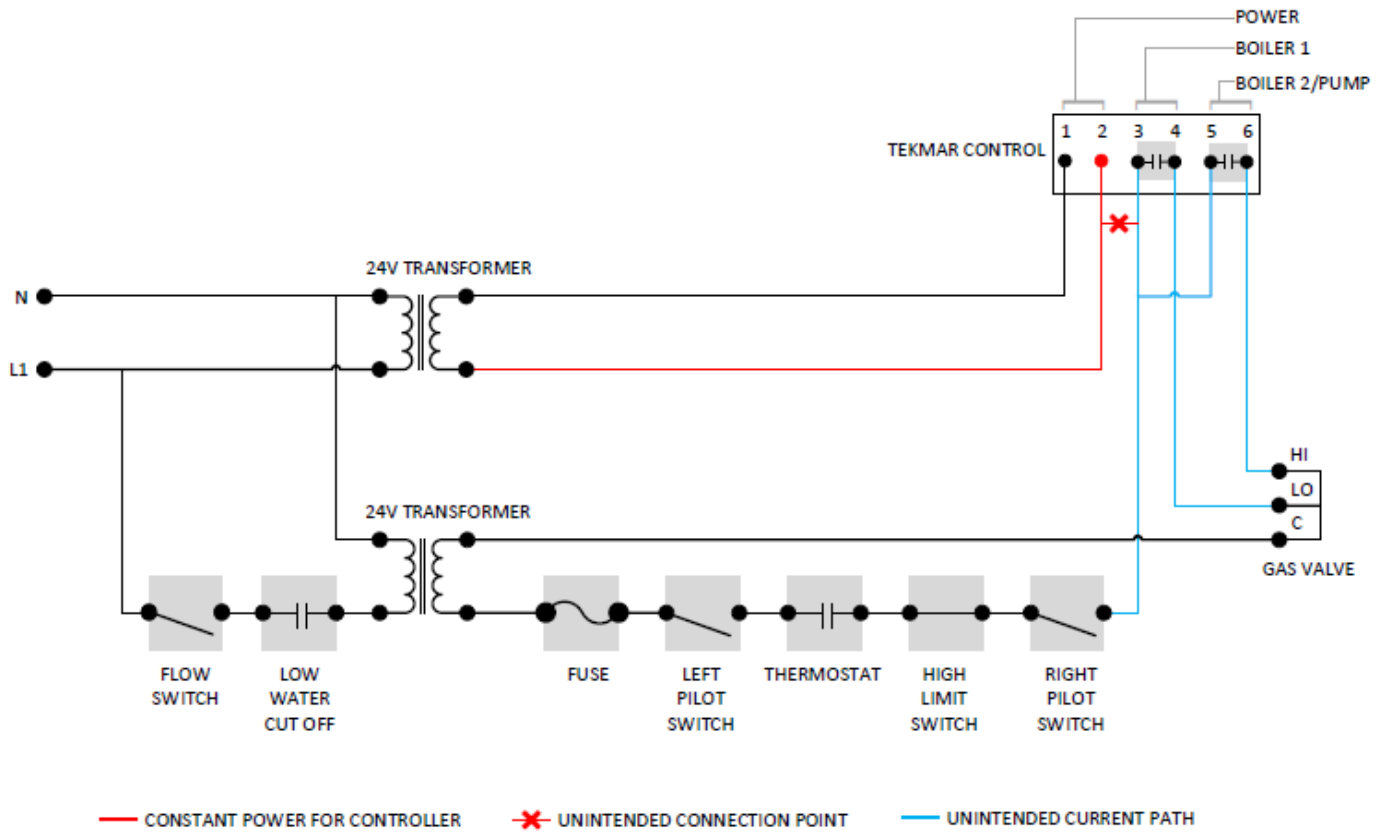
Wiring Diagram: Shows the wiring layout of the boiler and power potential, including the unintended current path.

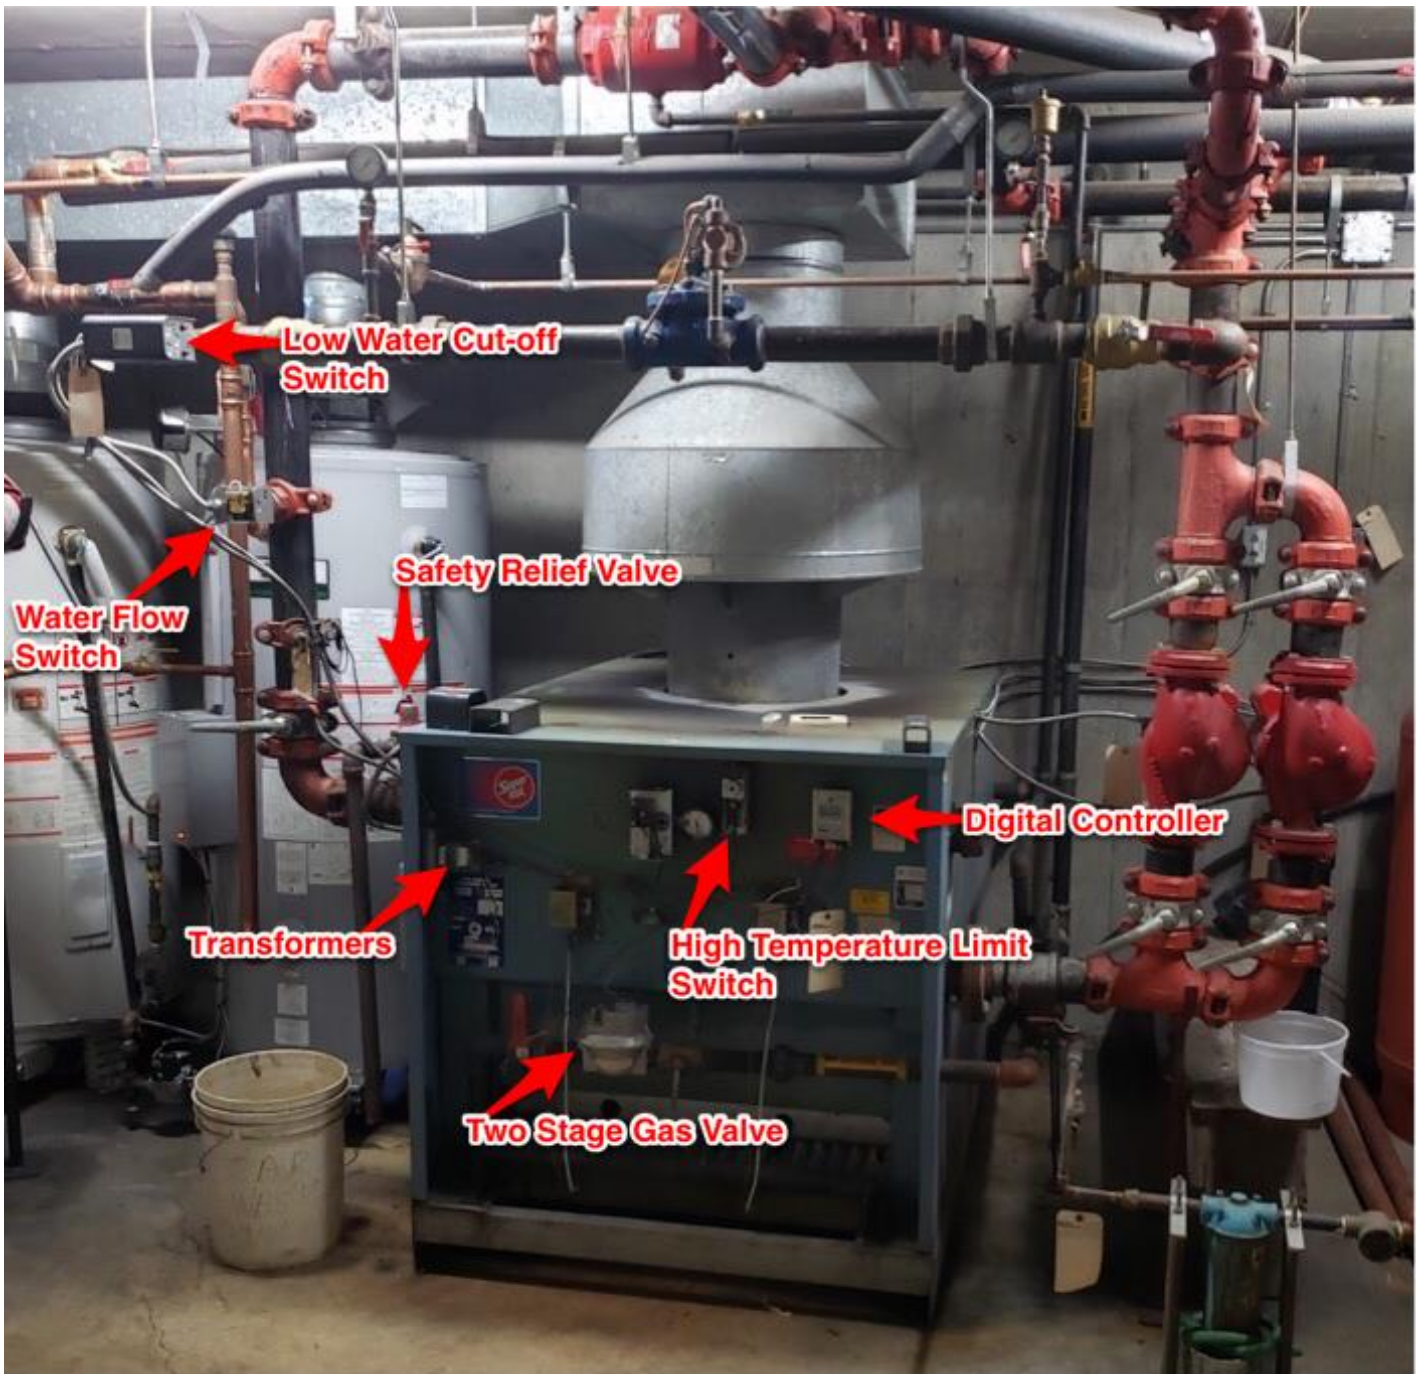
Image 2: Overall View of Boiler and Locations of Components

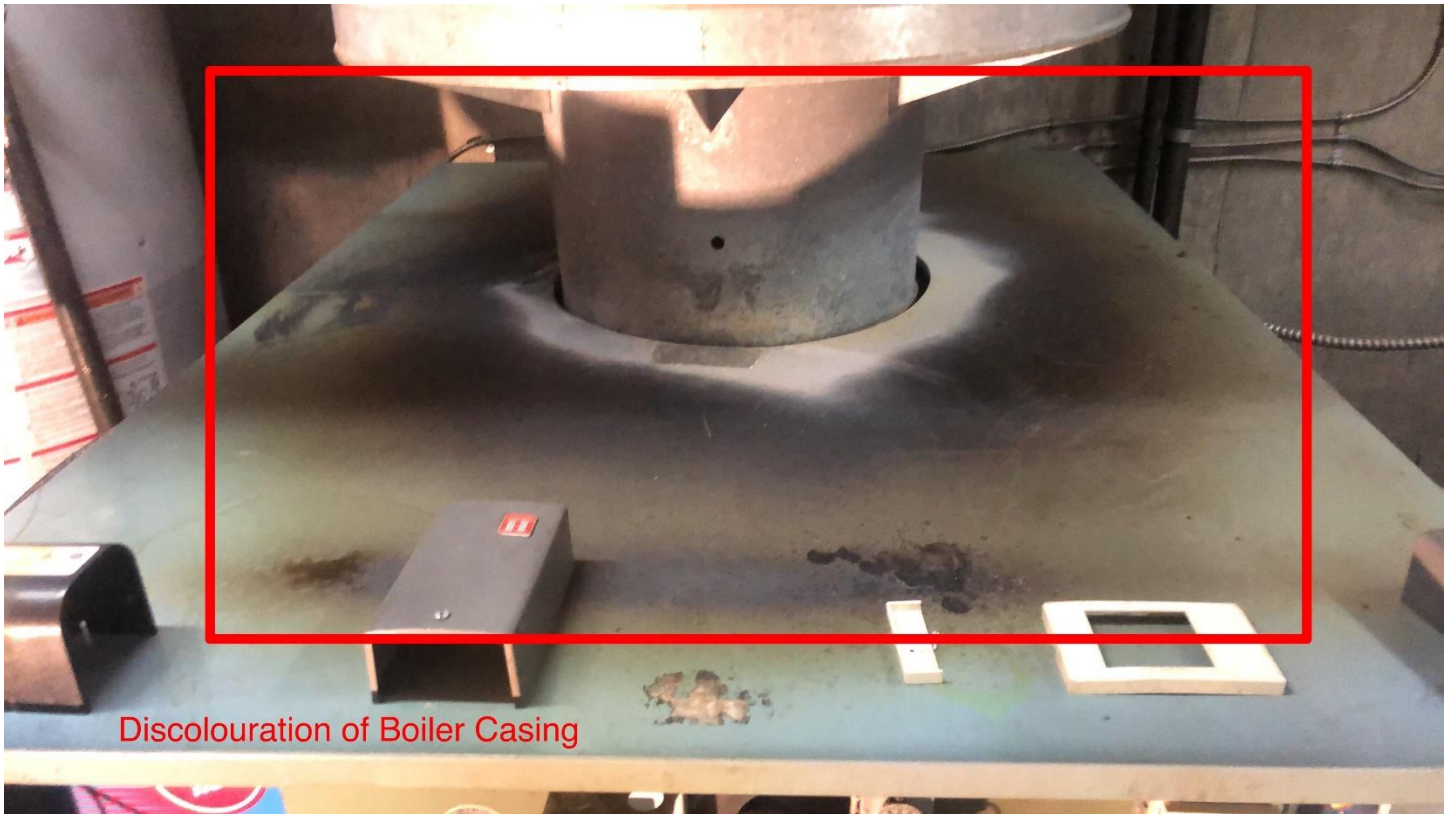
Image 3: Discoloration of Boiler Casing

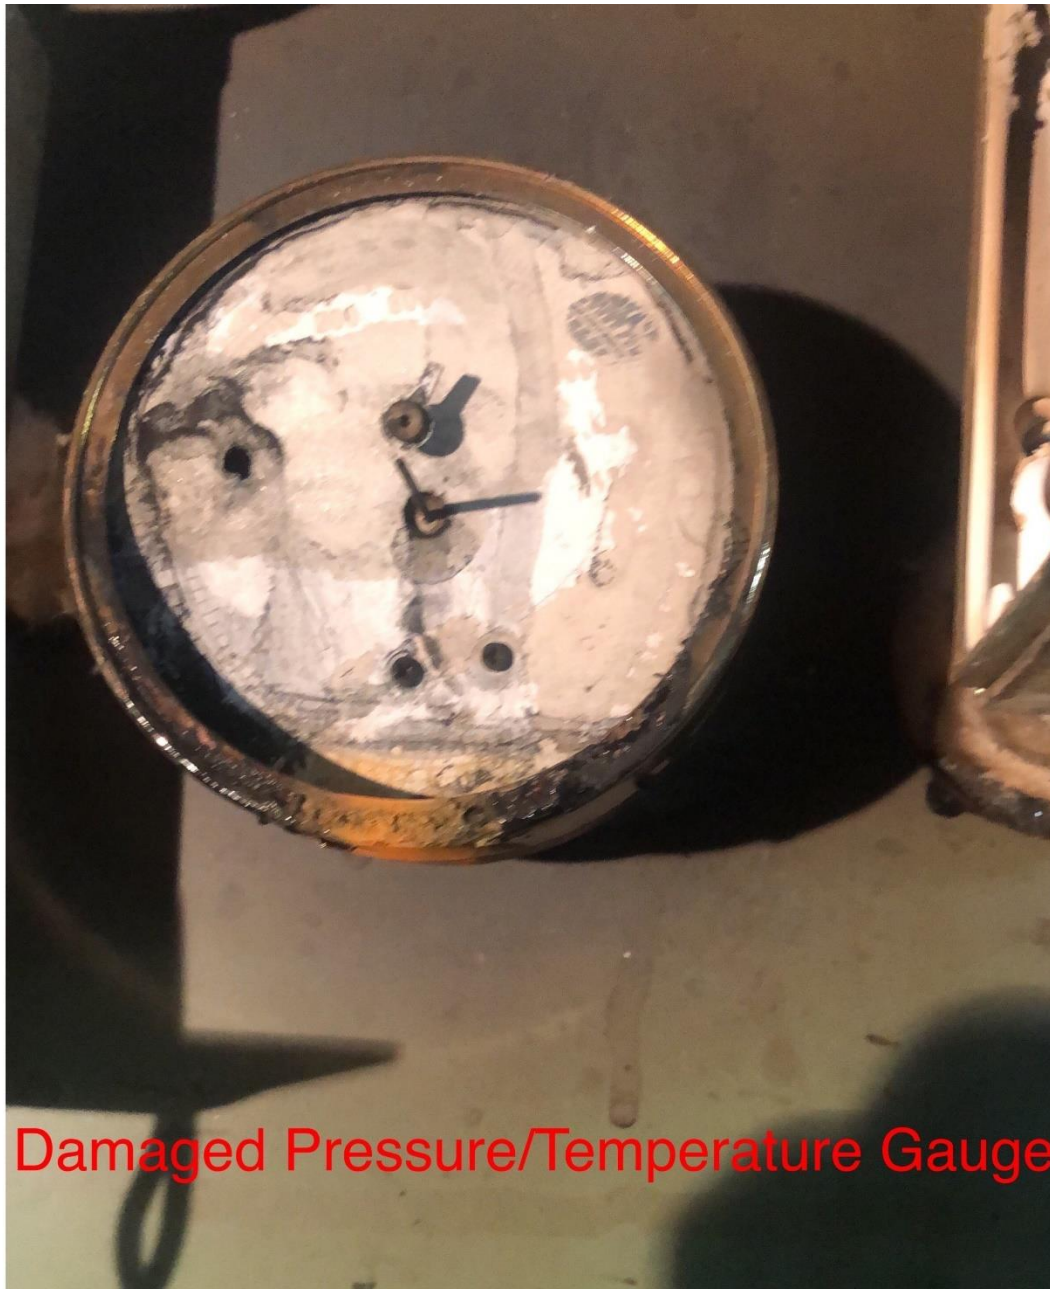
Image 4: Damaged Pressure Gauge

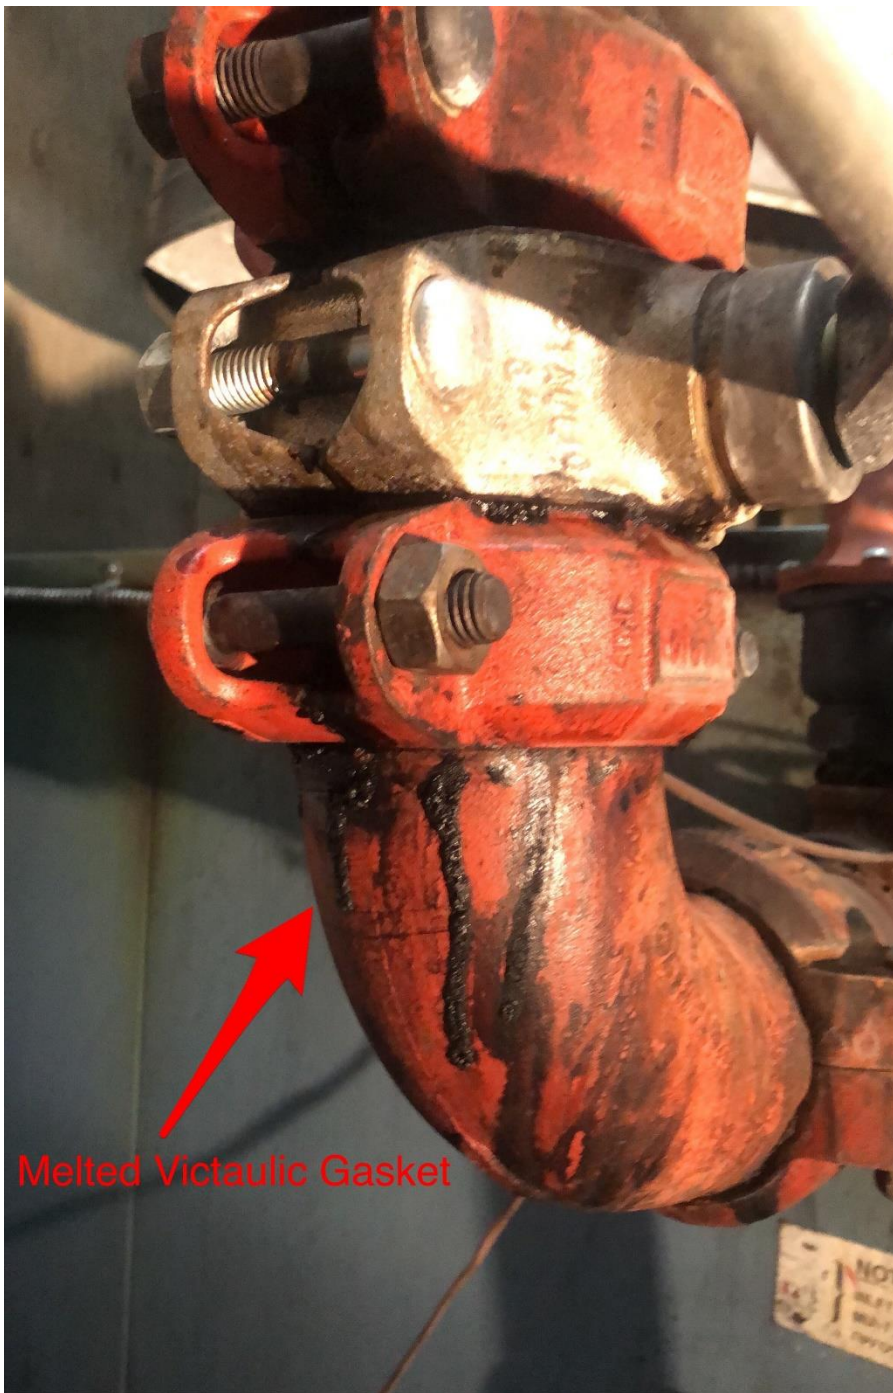
Image 5: Melted Victaulic Gasket on Boiler Outlet Piping

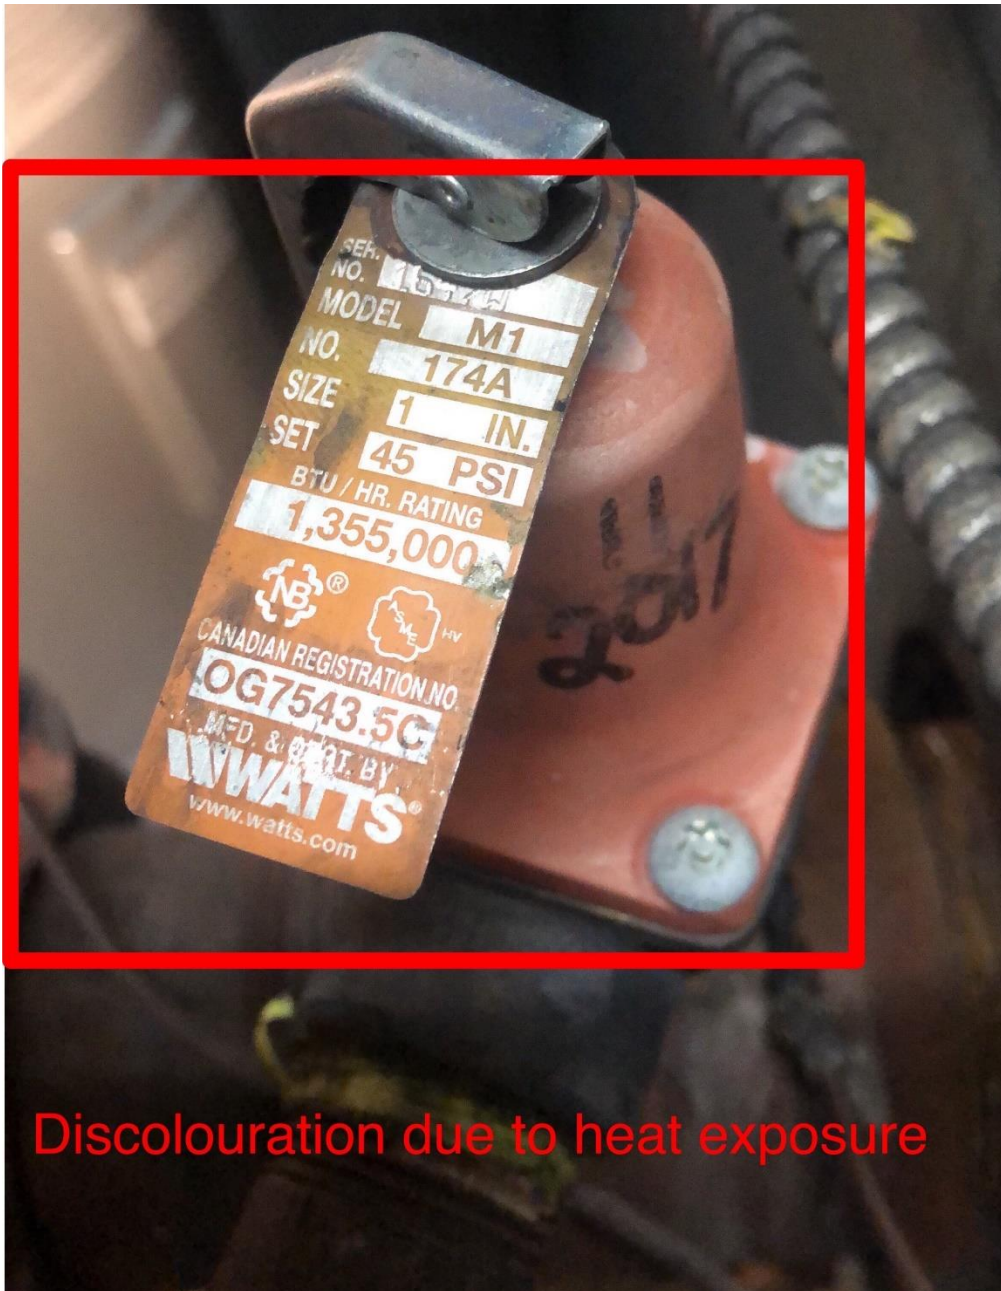
Image 6: Damaged Safety Relief Valve

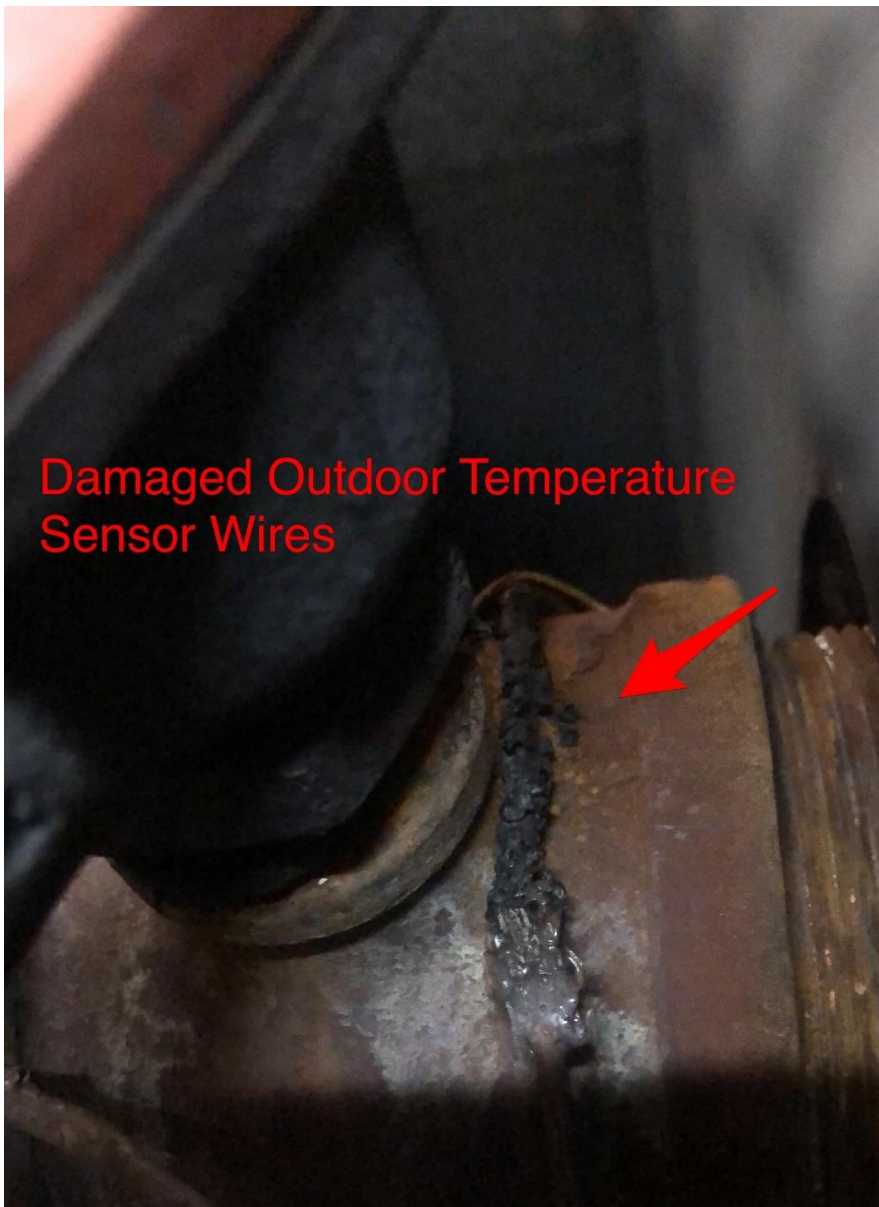
Image 7: Damaged Outdoor Temperature Wires at base of Safety Relief Valve
