Incident Summary #II-882435-2019 (#14204) (FINAL)

SUPPORTING INFORMATION	Incident Date	July 10, 2019	
	Location	Richmond	
	Regulated industry sector	Gas - Natural gas system	
	Impact	Qty injuries	0
		Injury description	None
	Damage	Injury rating	None
		Damage description	Damage to multiple suites in an apartment building due to an explosion, fire and fire suppression activities.
		Damage rating	Major
	Incident rating	Major	
Incident overview	Work performed during a natural gas fireplace retrofit created a gas leak within a four story apartment building resulting in an explosion and fire. The building was evacuated and the fire department extinguished the fire.		
INVESTIGATION CONCLUSIONS	Site, system and components	<p>A four story apartment building that has natural gas fireplaces in each suite. The building gas supply was distributed through a gas pipeline in the parkade level providing gas at 2 PSI pressure. The gas line branched to a number of vertical gas pipes (“risers”) in the parkade.</p> <p>Each riser incorporated a line pressure regulator that reduced pressure to under ½ PSI. Each vertical riser provided gas to the 1st, 2nd, 3rd and 4th floor suite fireplaces. The gas sup

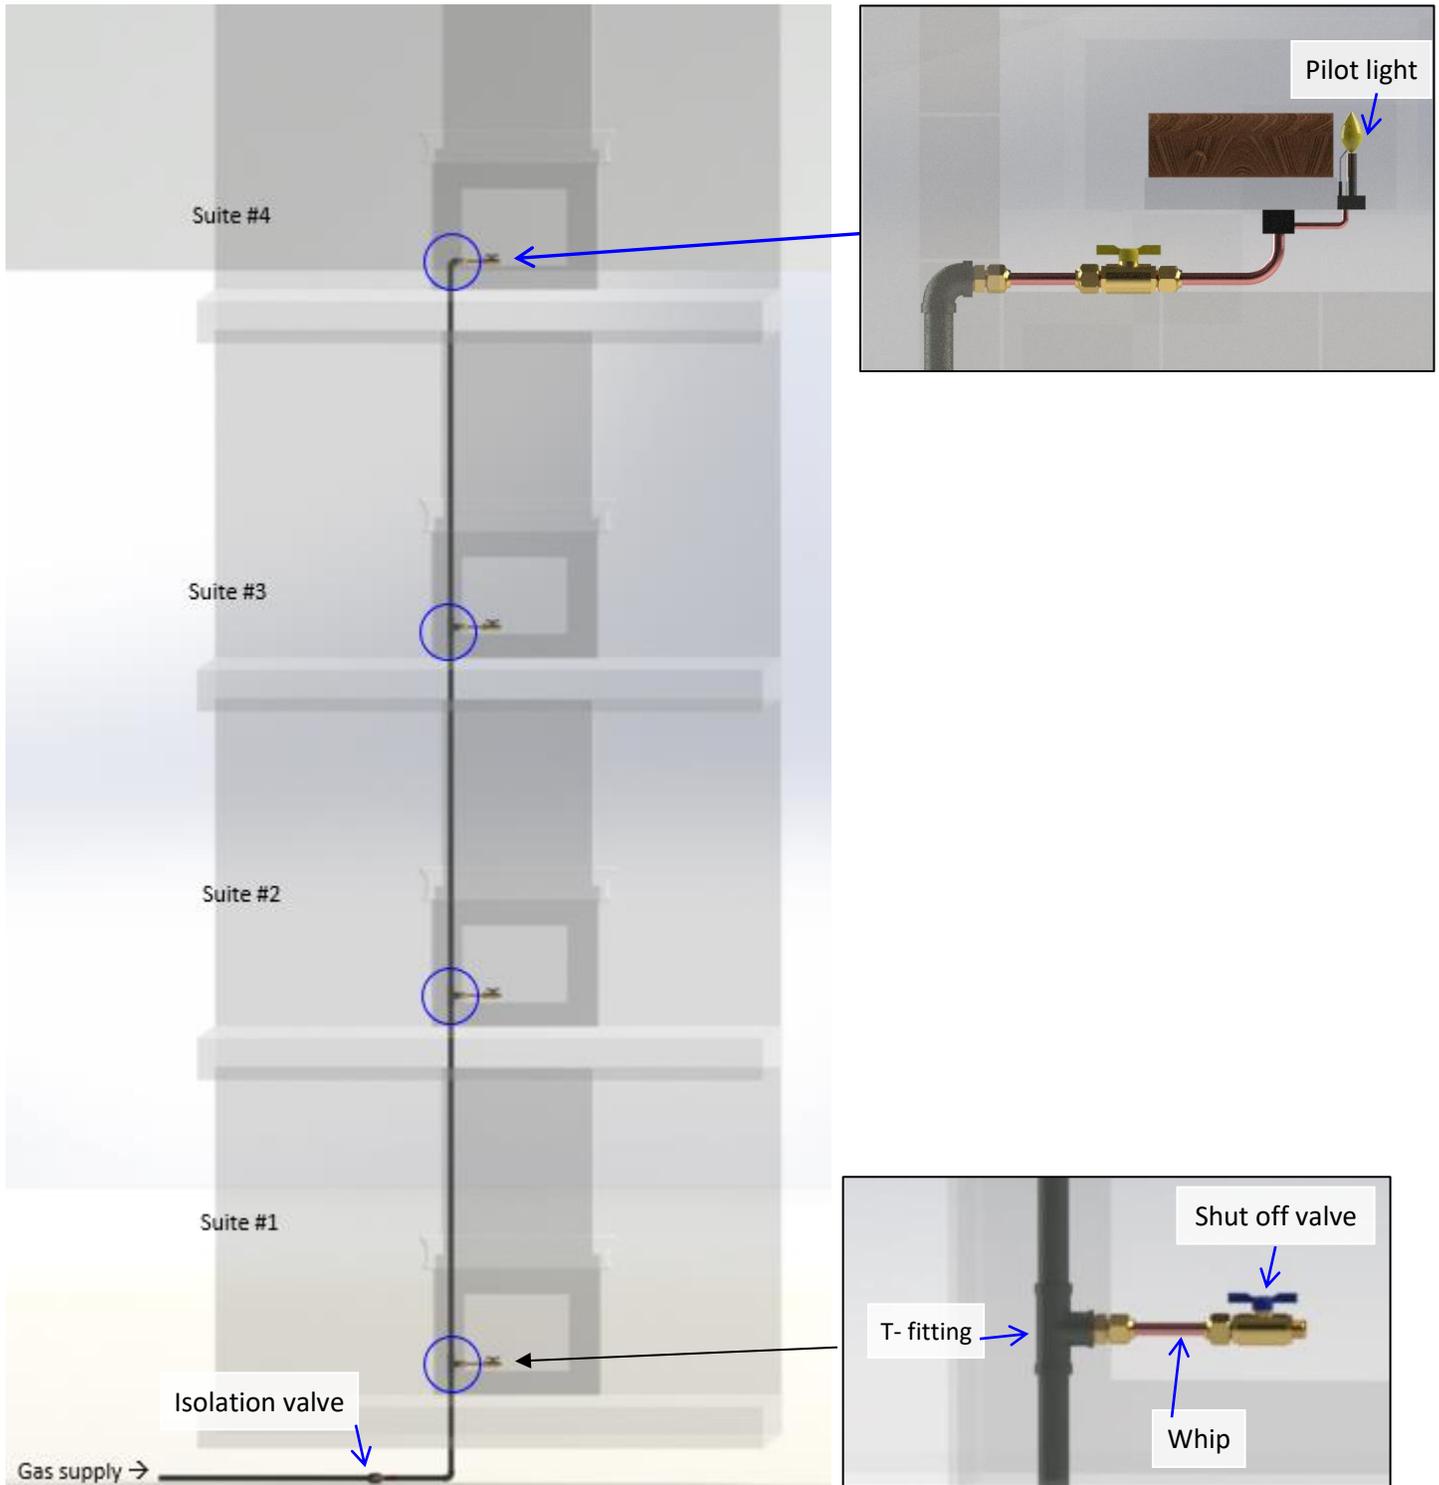
Figure 1: Schematic diagram of the gas piping system. Horizontal gas pipe in parkade connects to vertical gas riser that extends to all four floors. A T-fitting (blue circle) in the riser at each floor connects to a copper whip that supplies gas to the fireplaces.

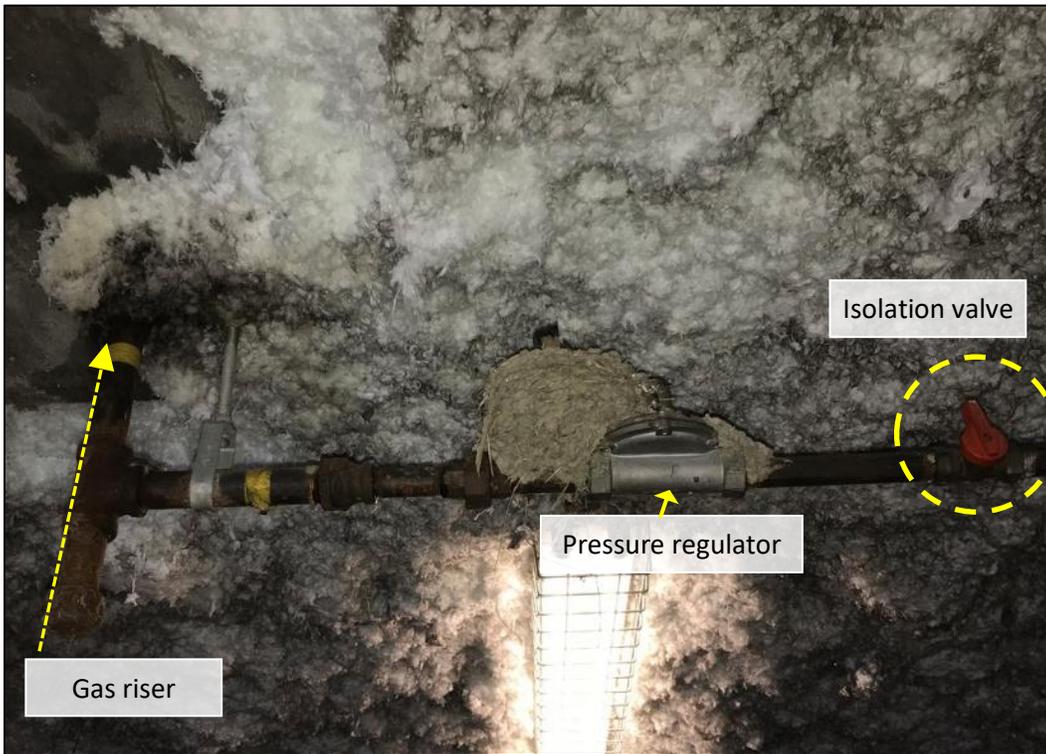
The gas utility technician arrived on site shortly after the incident and turned off the main gas supply to the building. The technician reported to have found the gas riser isolation valve in the “on” position, that supplies gas to the four incident suites. The utility technician then turned the gas riser isolation valve off. CCTV security video confirmed that the valve for the gas riser in the parkade had not been turned off prior to the incident.

Photo 1: Gas line components located in the parkade: gas riser, pressure regulator and isolation valve which was turned “off” after the incident (as shown in photo).

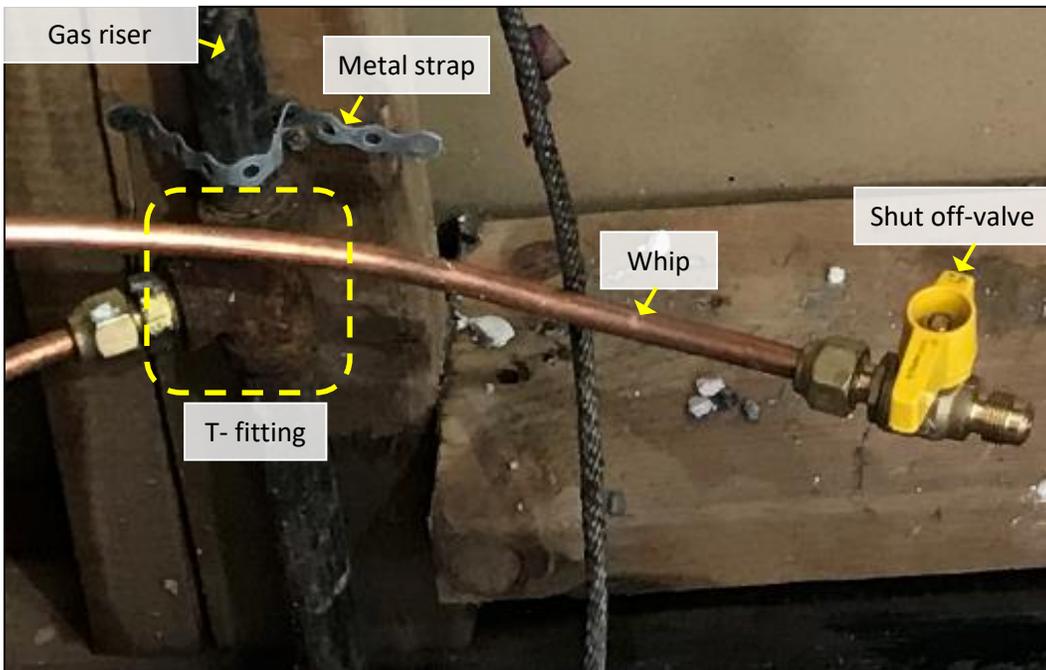
Photo 2: Gas riser pipe, T-fitting, copper whip and shut off valve in suite #2.

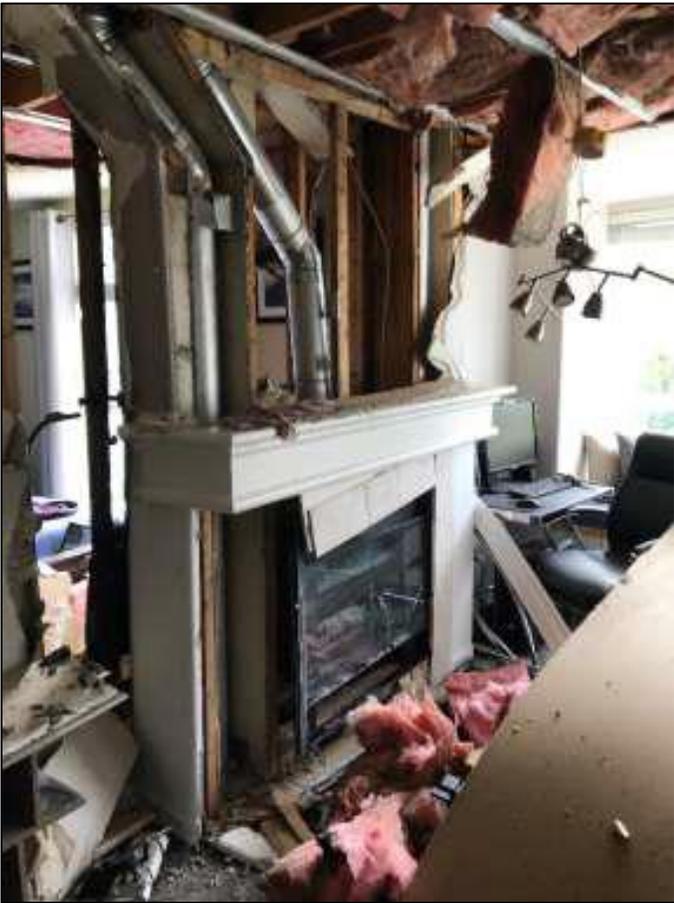
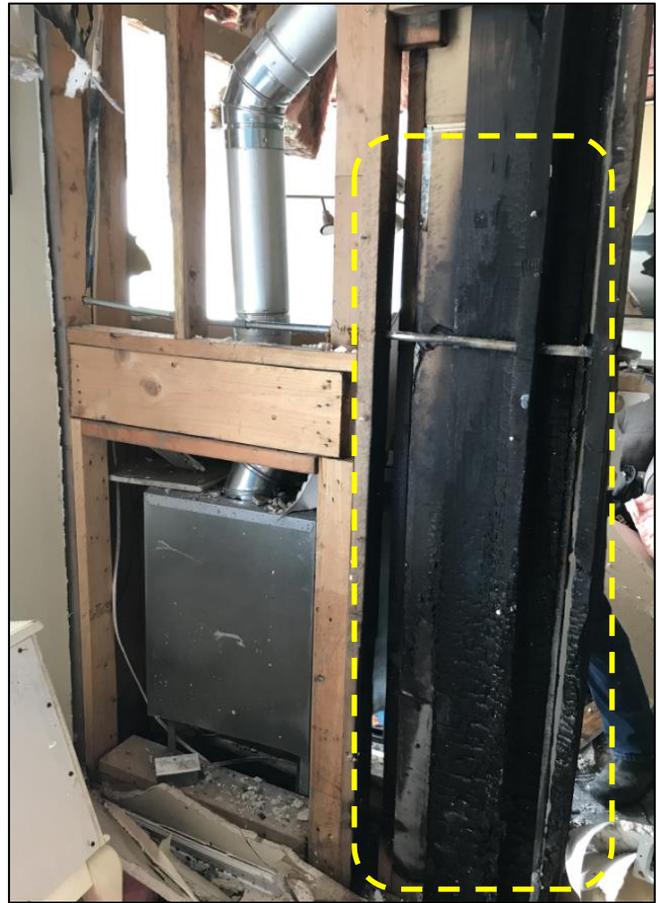
Damage analysis inside the apartment suites determined that the explosion occurred in the 3rd and 4th floor suites. It was apparent that gas leaking in the fireplace hearth of these suites had fueled the explosion. The fireplaces in these suites were found to be dislodged out of the wall as a result of the explosion. The fire investigators reported that burn patterns in the 3rd floor suite indicated that natural gas from

the broken copper whip sustained the fire until the main gas supply was turned off, (Photo 3).

Photo 3 (a & b): (a) Fireplace in suite #3 partially blown out of wall. (b) Fire damage due to gas burning from broken whip.

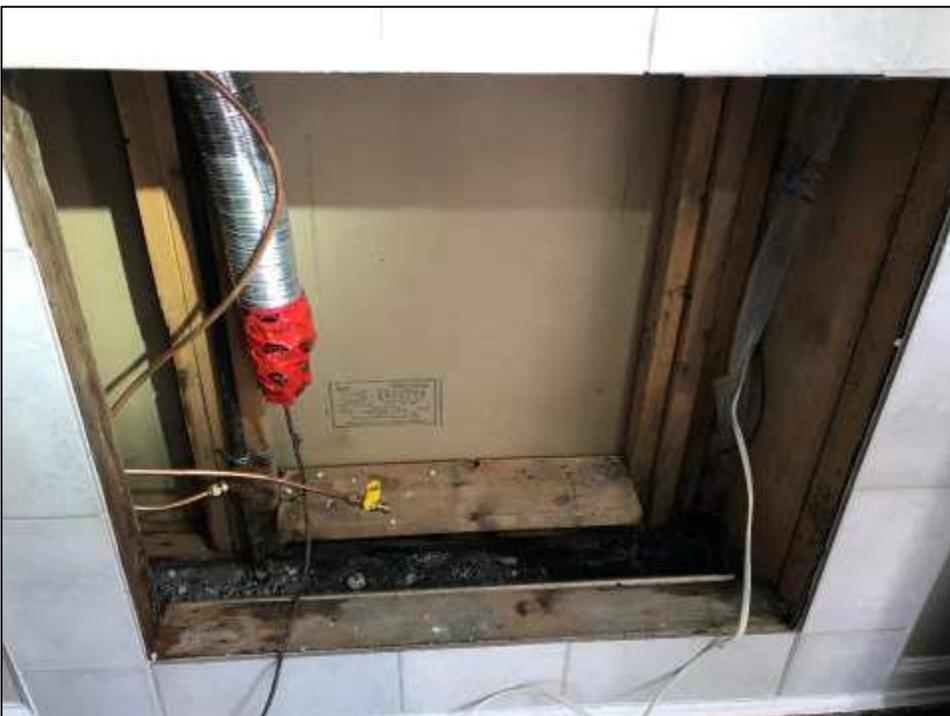
The gasfitter stated that the location of the gas riser T-fitting blocked installation of the new fireplace (the new fireplace was larger than the original fireplace). Gasfitter #1 stated that they moved the gas riser out of the way and strapped it to an adjacent 2x4 stud. The gas riser was connected to fireplaces in four suites so moving the gas riser in one suite can affect another component in the system, as was the case in this incident where two other whips were damaged. Given that the whip in suite #2 was thought to be brittle then the other three whips may have been brittle as well and subject to damage by moving the gas riser. The effect of moving the gas riser in suite #2 on the rest of the system (e.g. whips in suites #1, #3 & #4) was not verified by the gas fitter.

Photo 4: Gas fitting work completed to replace fireplace in suite #2 with a new whip and T-fitting moved left.

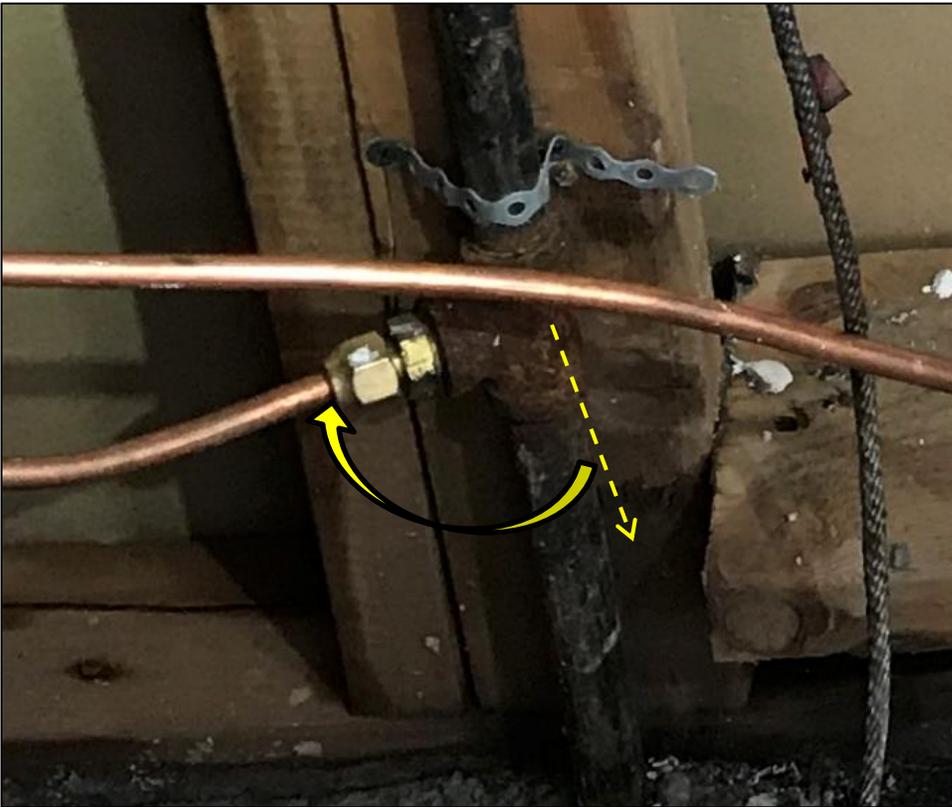
The T-fitting in suite #1 was found pointing towards the fireplace. In suite #2, the T-fitting was found pointing away from the fireplace. In suites #3 and #4, the T-fittings were also found pointing away from the fireplace. Examination of similar suites in the building that were not involved in the incident found the T-fittings pointed towards the fireplace in all cases. This indicates that the final positions of the T-fittings found in suites #2, #3 and #4 had changed from their original positions, likely due to manipulation of the riser by gas fitters during installation of the new fireplace. Fire investigators reported finding tool marks on the T-fitting and riser pipe in suite #2.

Photo 5: Gas riser T-fitting found moved and rotated in suite #2, as shown with new whip attached. The metal strap had been added by the gas fitter to restrain the riser pipe in its new position.

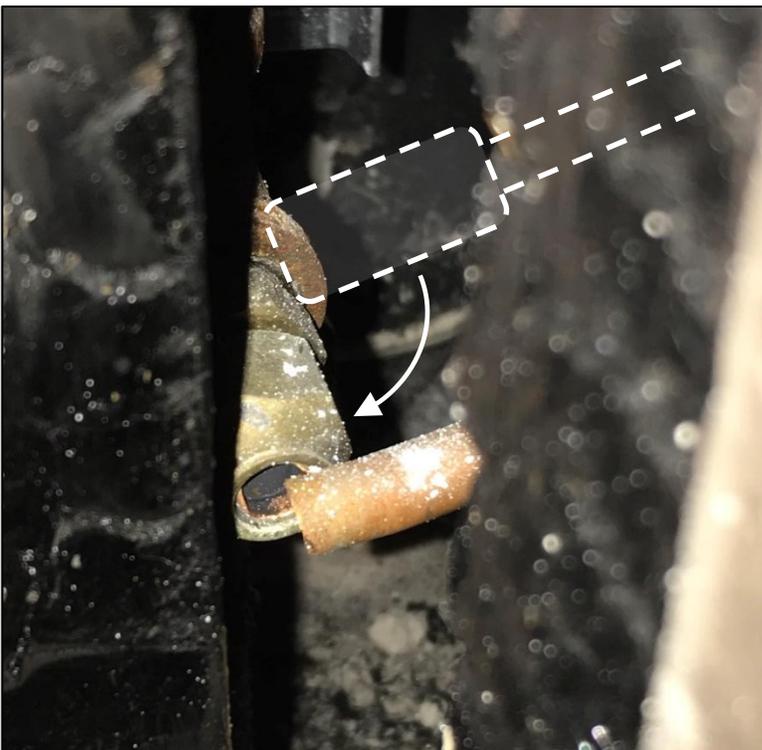
The copper whip in suite #1 was found cracked. In suite #3, it was found completely fractured (Photo 6) and in suite #4 the whip was found partially fractured, (Photo 7). In all cases the fractures occurred where the copper whip was connected to the gas riser T-fitting.

Metallurgical analysis of whips #3 and #4 indicated that both whips had been exposed to a severe bending load that exceeded the mechanical strength of the copper tube resulting in complete separation of whip #3 and partial separation of whip #4.

Analysis of the copper whip in suite #3 determined that it had fractured before the explosion, rather than as a result of the explosion. The copper whip in suite #4 had also partially fractured before the explosion allowing a small amount of gas to maintain the pilot light burning until the explosion. The force of the explosion further opened the fracture in whip #4.

Photo 6: Copper gas whip in suite #3 was bent ~90 degrees and completely fractured. The leaking gas ignited, burning the wood structure. The original position of the T-fitting is estimated by the white dashed line in the photo.

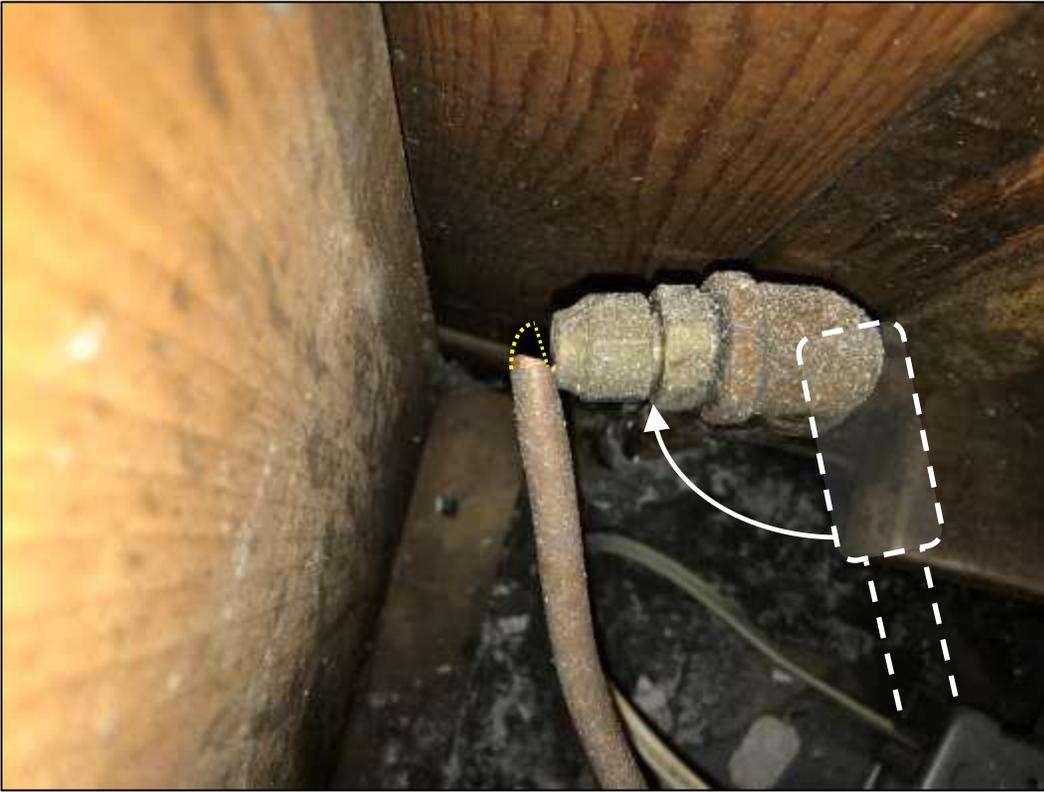
Photo 7: Copper gas whip in suite #4 was bent ~90 degrees and partially fractured (yellow line) then fully fractured due to the explosion, as shown above. The original position of the elbow fitting is estimated by the white dashed line.

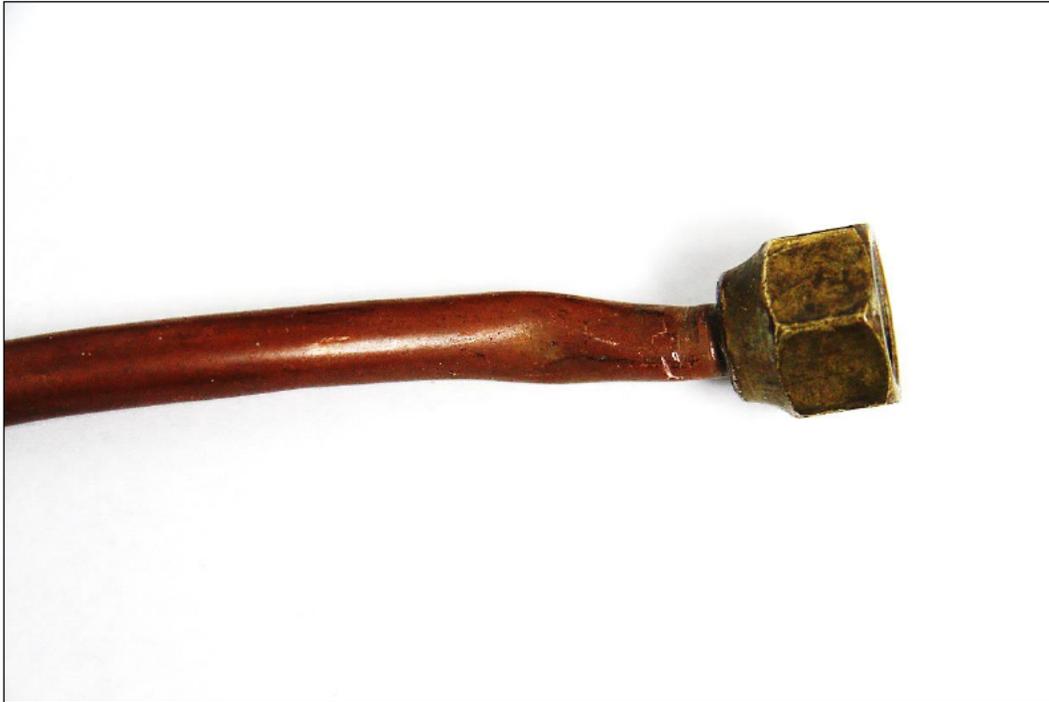
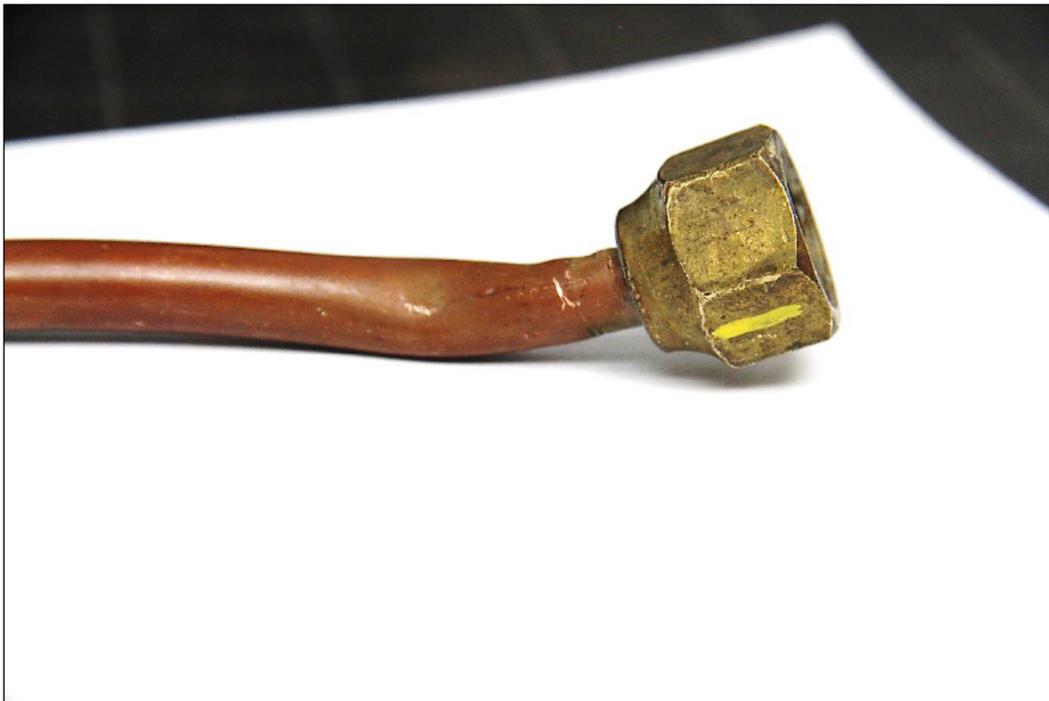
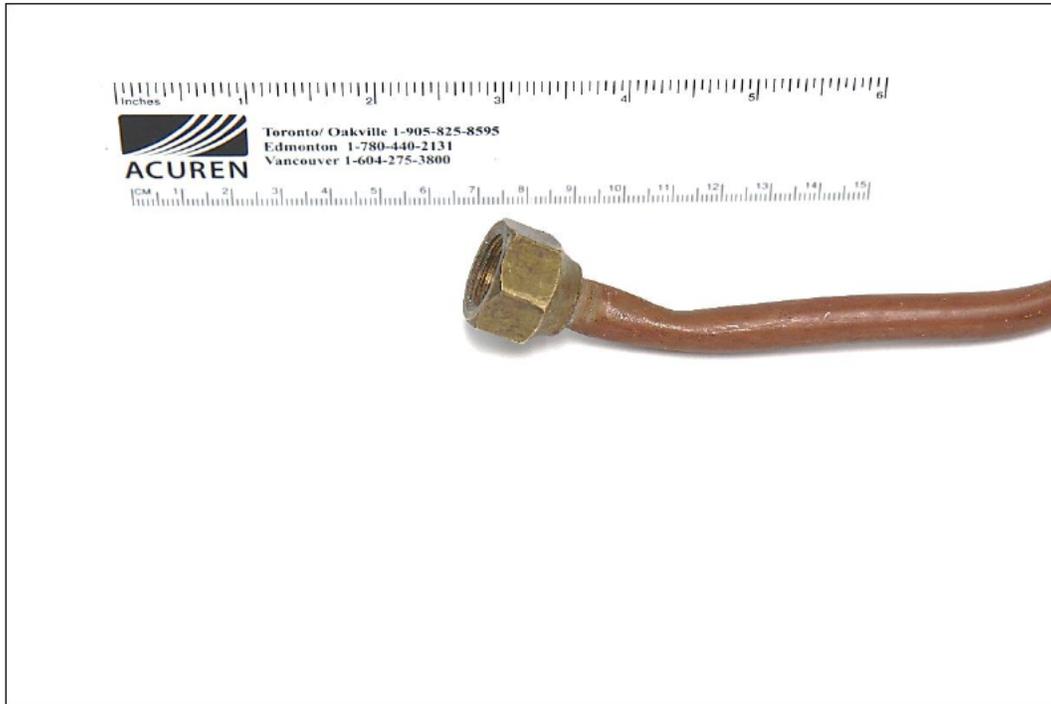
The riser side of whip #128 was not straight. The position of the copper pipe at this location was likely exposed to bending or torsional stresses. In addition to flaring marks, a fresh surface scratch was also noted (Figure 5 to Figure 7).

Figure 5 The riser side of whip #128 was bent.

Figure 6 Whip #128 was bent at the riser side.

Figure 7 Whip #128 was bent at the riser side.

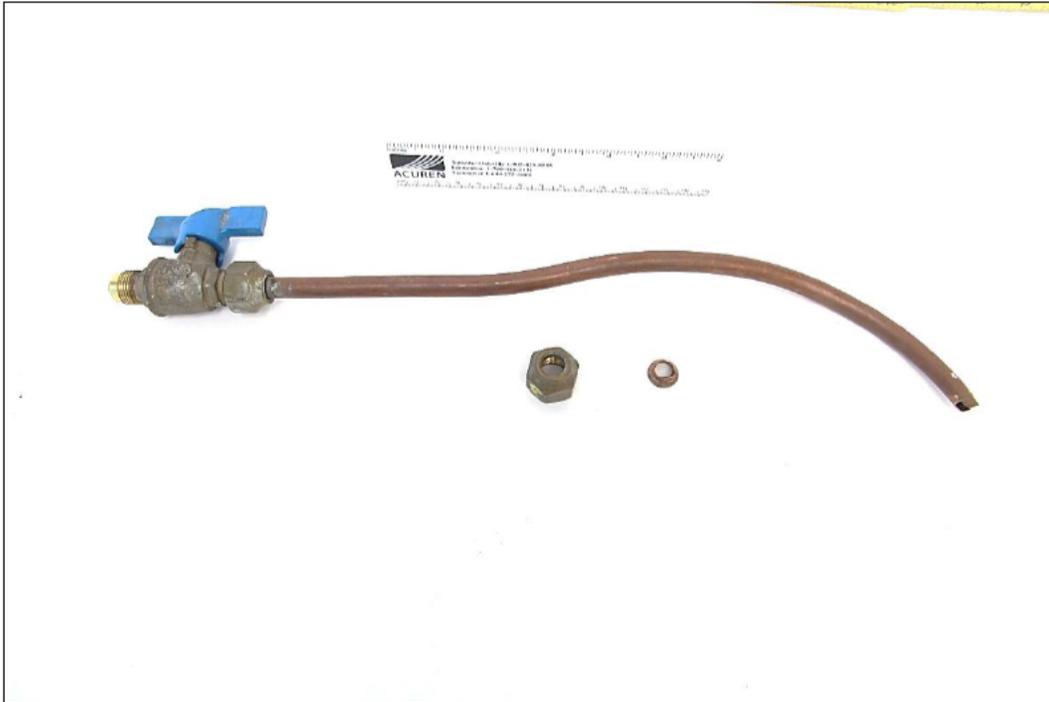
Figure 15 and Figure 16 show the condition of the riser side of whip #328. The copper pipe at this location was fractured adjacent to the flared area. The pipe was straight near the fracture location. The fracture profile indicated that flared end had been bent off the copper pipe.

Figure 11 General condition of whip #328 as received. The riser side was fractured. The fracture fragments are shown.

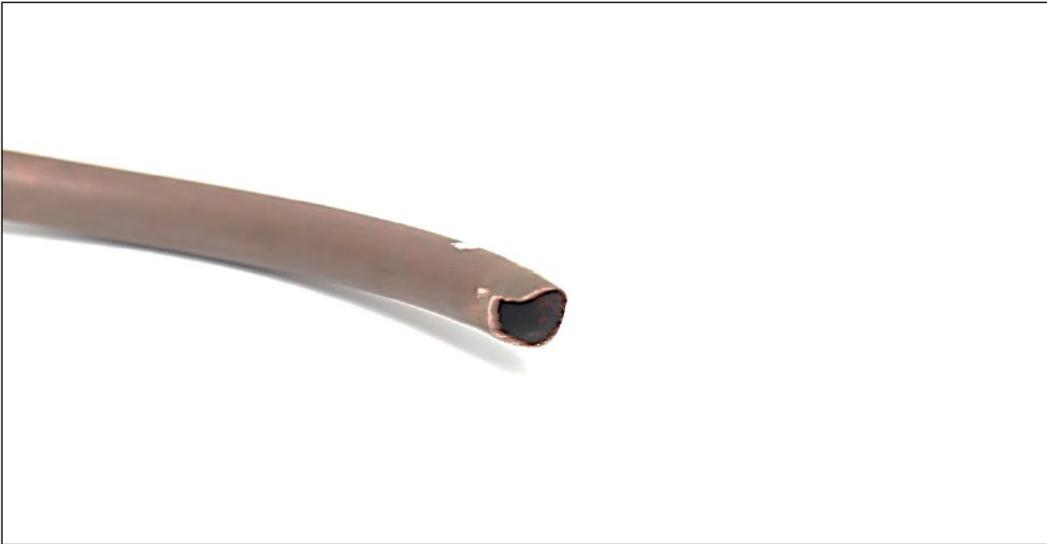
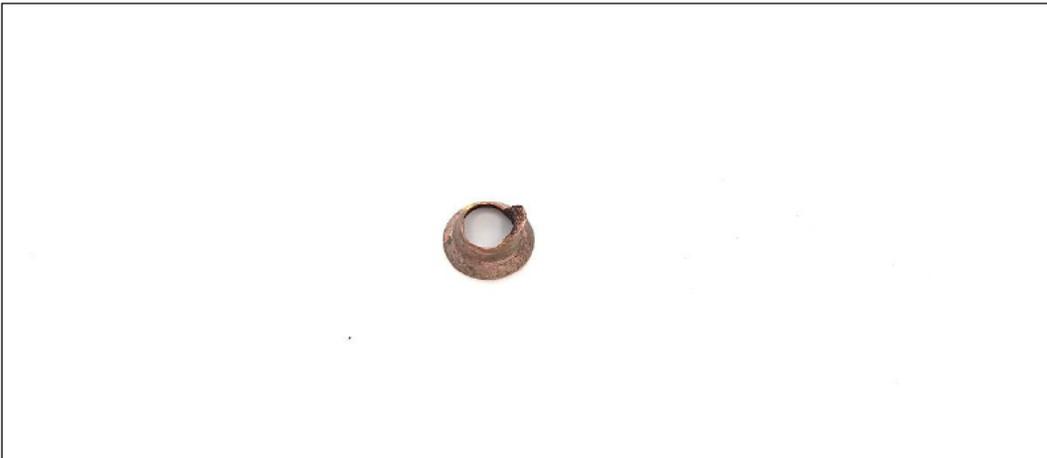
Figure 15 The fracture surface of the rise side of whip #328.

Figure 16 The fracture surface of the rise side of whip #328.

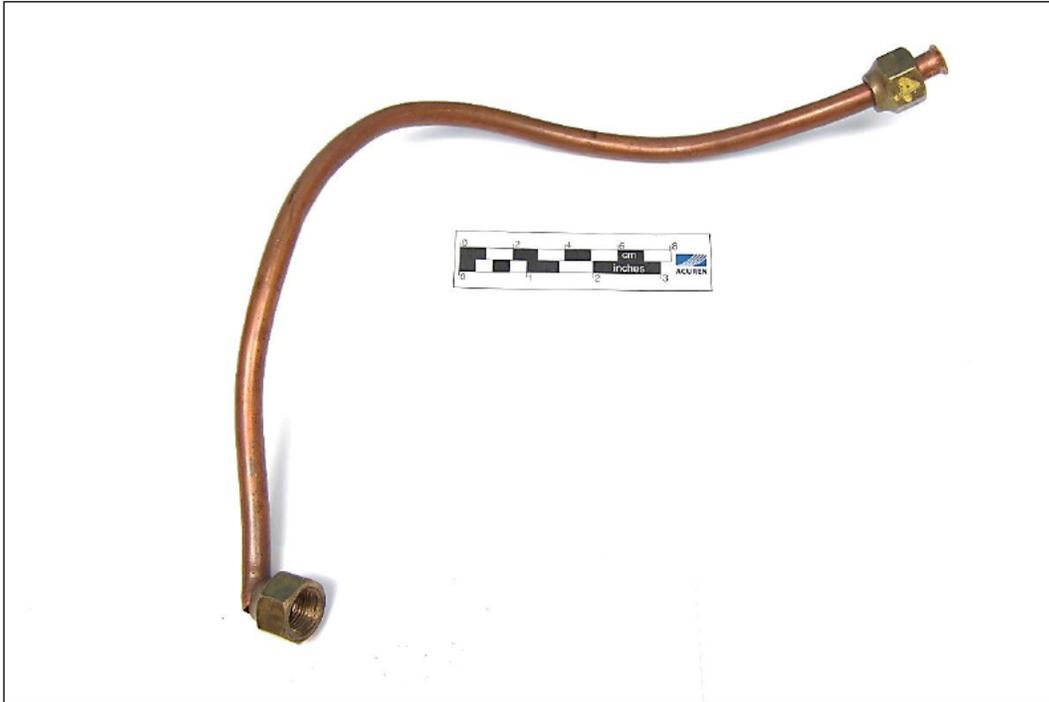
Figure 17 General view of whip #428 as received. The valve side is intact, and the riser side is fractured.

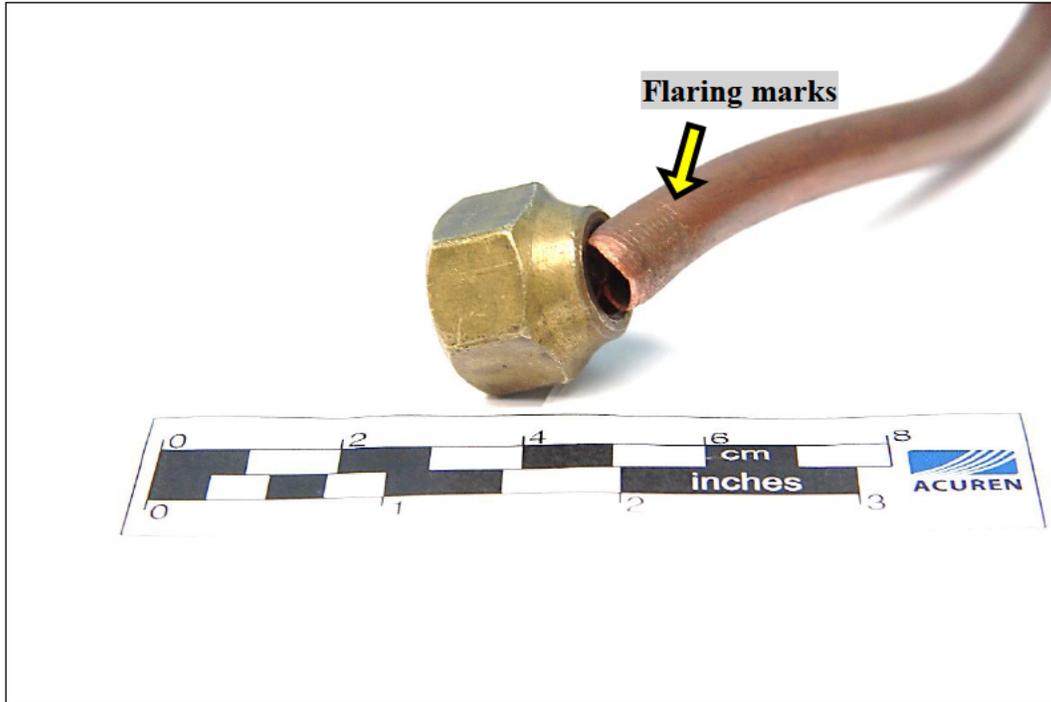
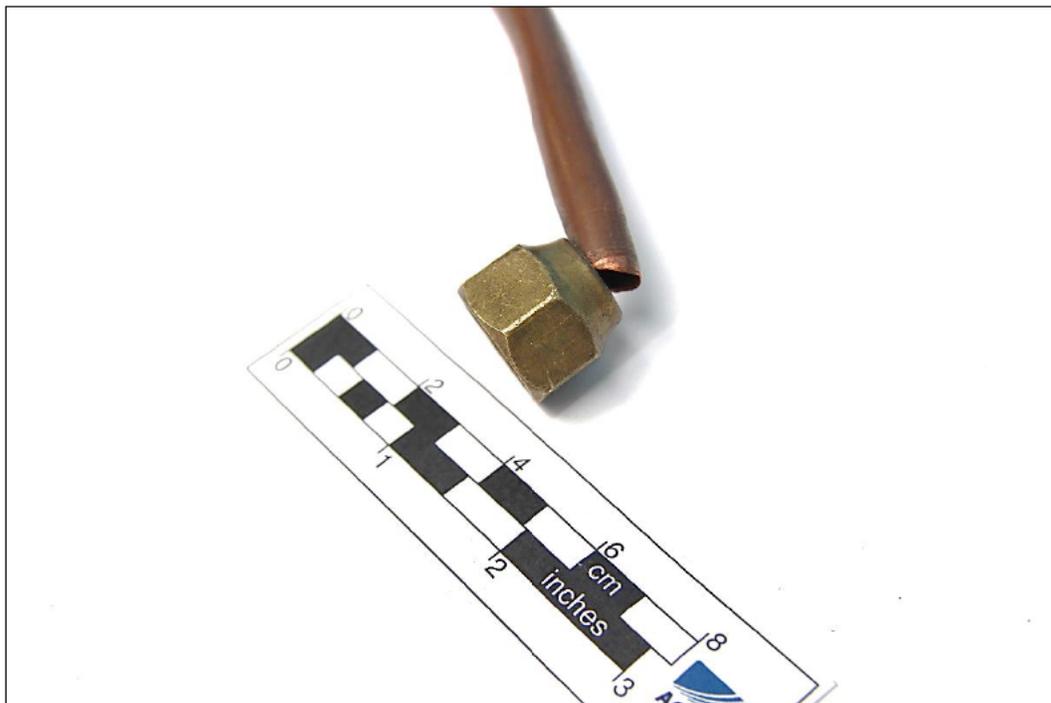
The images of the riser side of whip #428 are presented in Figure 19 and Figure 20. The copper pipe at this location was fractured adjacent to the flared end. The fractured portion, however, was attached to the pipe. The fracture profile of the whip was similar to that of whip #328 and verified that the intense bending loads exerted to the riser side of the whip caused the fracture.

Figure 19 The position of the fitting indicated that bending forces were applied to the riser side of whip #428.

Figure 20 The position of the fitting indicated that bending loads were applied to the riser side of whip #428.

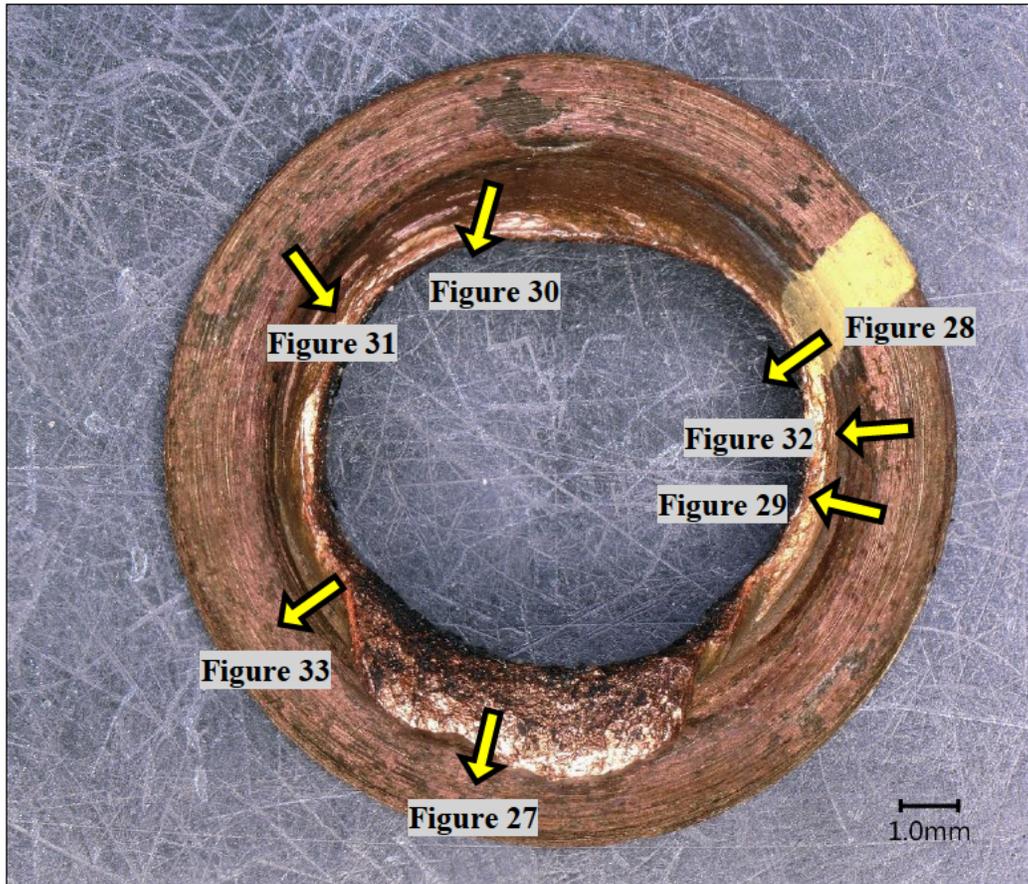
Micrograph of whip#328 fracture surface is presented in Figure 21. The fracture surface configuration indicated that the final fracture zone was at about the 6 o'clock position, and the fracture origin was between the 12 and 2 o'clock position.

Figure 21 Fracture surface of the riser side of whip #328. Arrows show the fracture propagation direction.

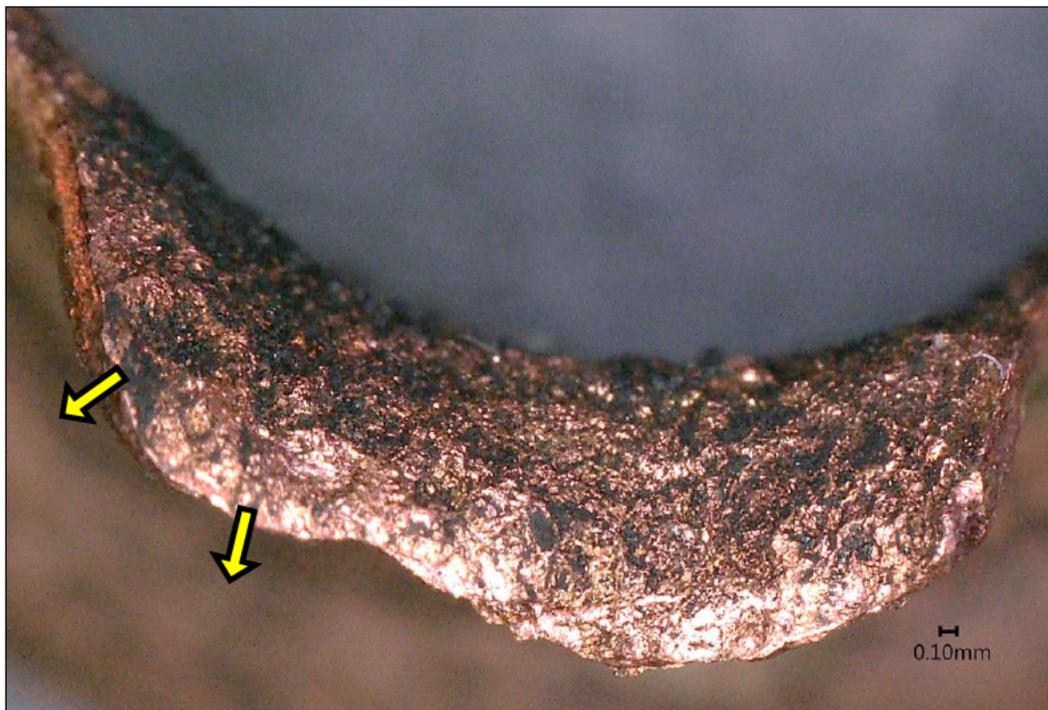
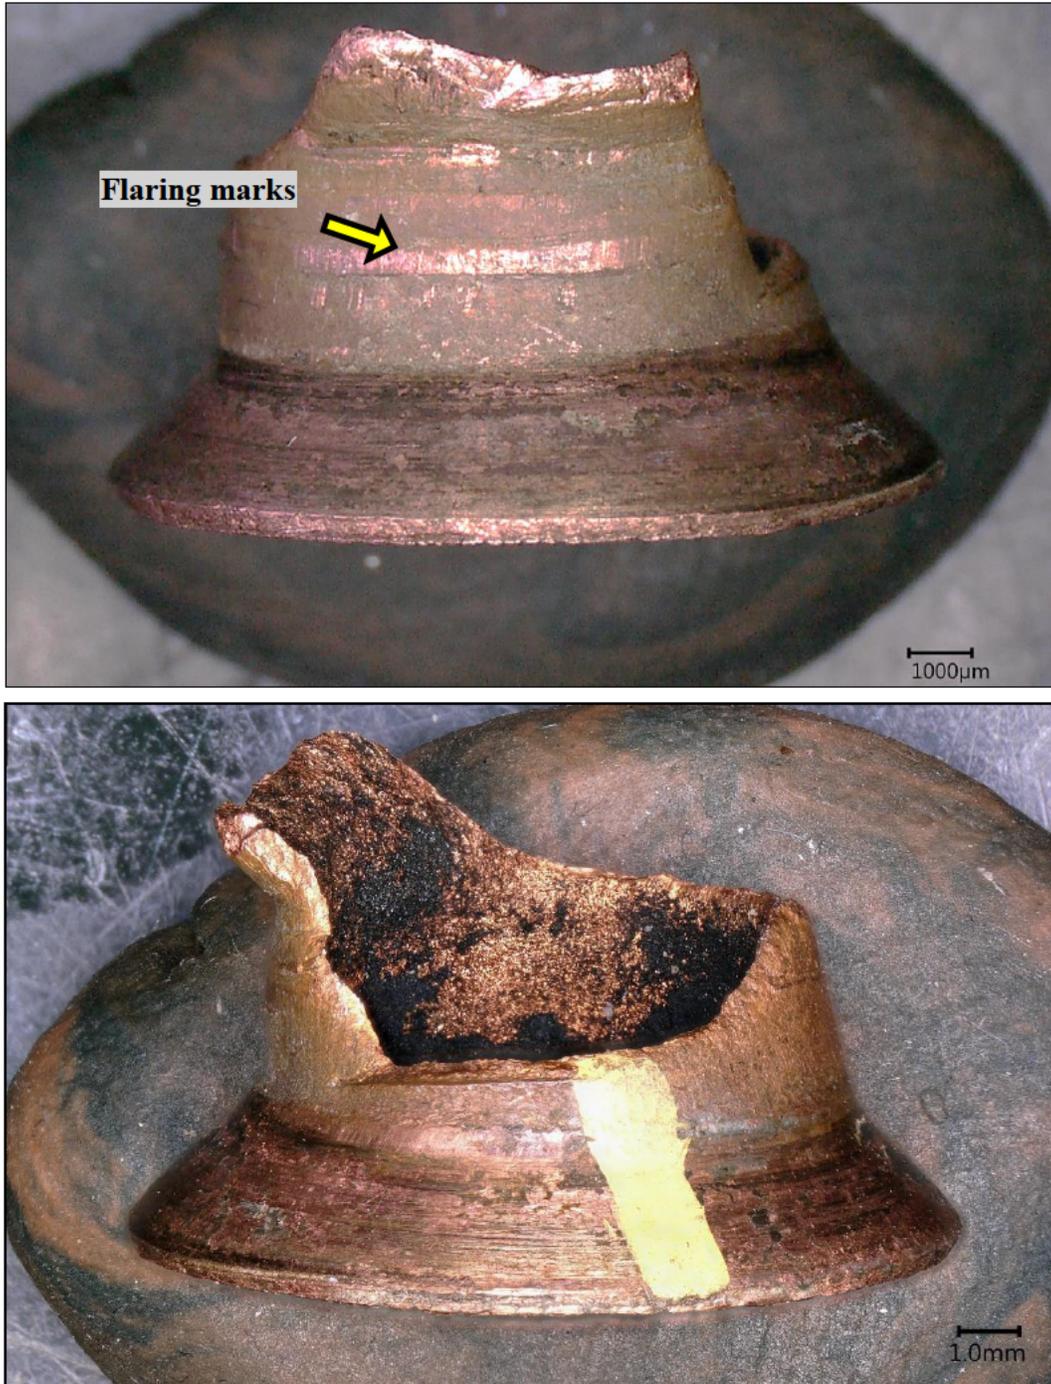
The final fracture surface in Figure 22 and Figure 23 indicated that the copper pipe had been fractured under bending stresses. The fracture origin is presented in Figure 24. The wall of the copper pipe near the fracture origin exhibited necking typical of ductile fracture.

Figure 22 Final fracture zone of whip #328.

Figure 23 The fracture profile of the copper pipe indicated that the pipe was bent.

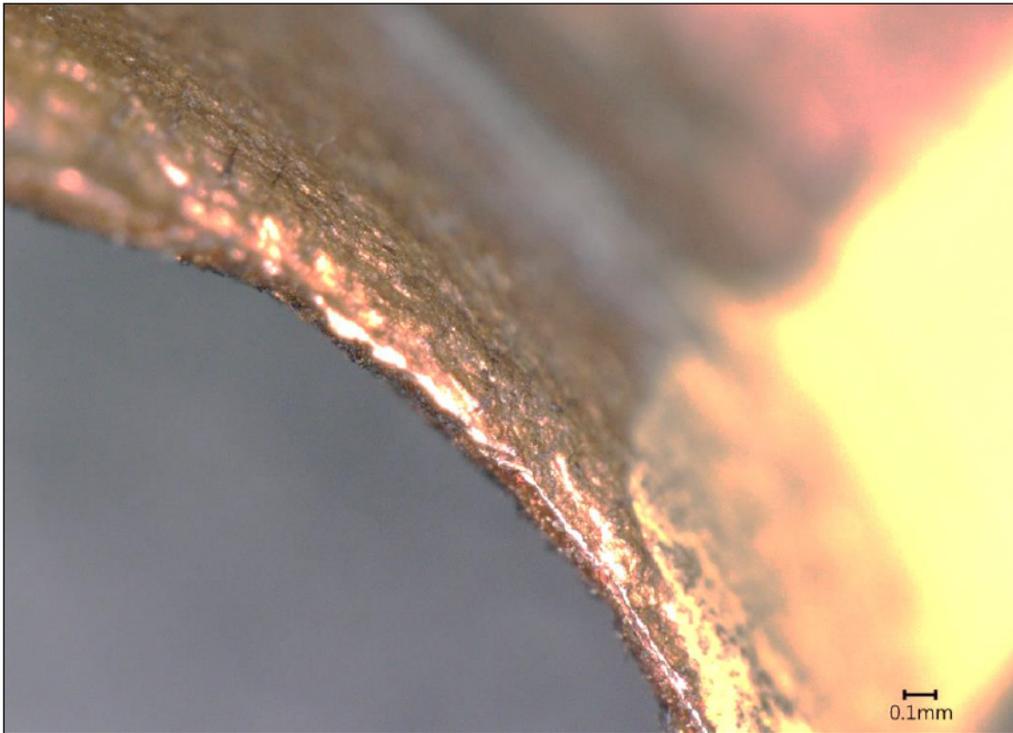
Figure 24 The fracture origin of the whip #328 fracture surface. The wall of the pipe exhibited necking.

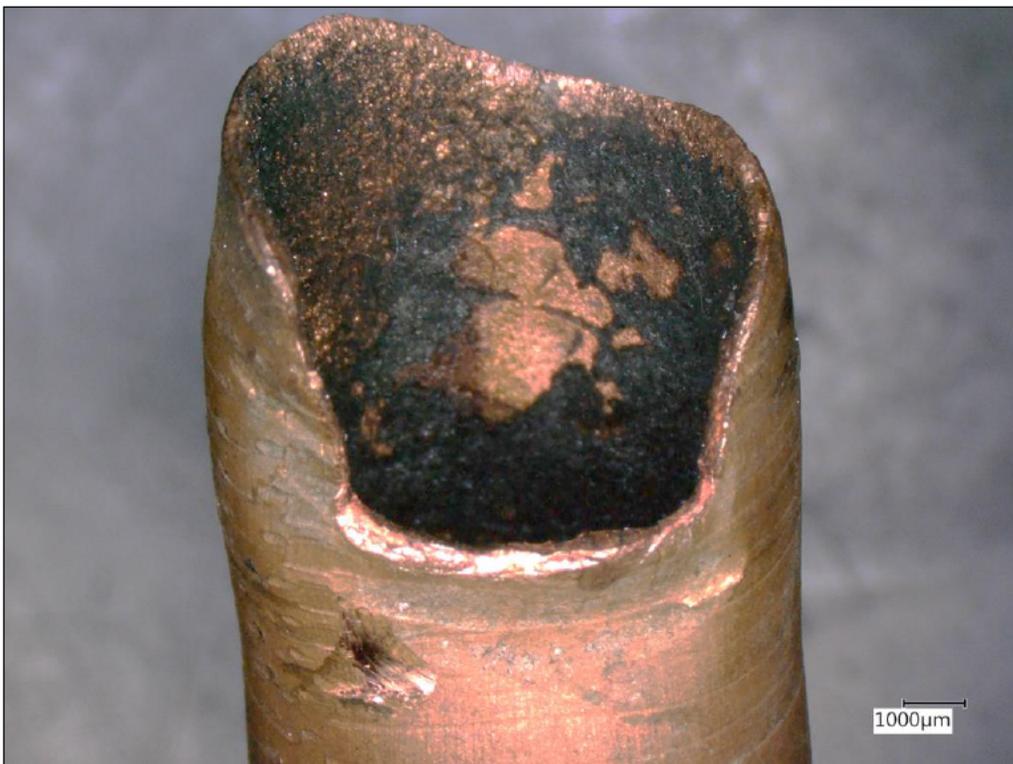
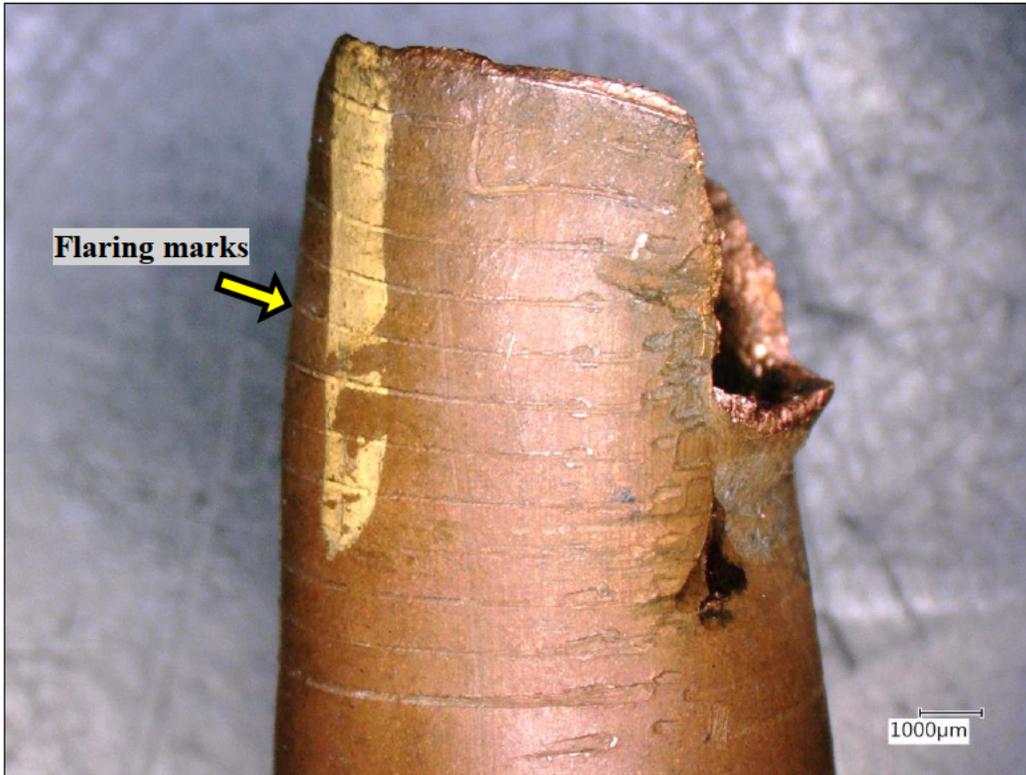
Figure 25 Matching fracture surface of whip #328 fracture surface. Black deposits were noted on the pipe ID. The copper pipe was bent toward the final fracture zone.

Figure 26 Matching fracture surface of whip #328 fracture surface. The pipe profile shows that it was under bending stress.
