Incident Summary #II-882435-2019 (#14204) (FINAL)

SUPPORTING INFORMATION	Incident Date	July 10, 2019	
	Location	Richmond	
	Regulated industry sector	Gas - Natural gas system	
	Impact	Qty injuries	0
		Injury description	None
	Damage	Injury rating	None
		Damage description	Damage to multiple suites in an apartment building due to an explosion, fire and fire suppression activities.
		Damage rating	Major
	Incident rating	Major	
Incident overview	Work performed during a natural gas fireplace retrofit created a gas leak within a four story apartment building resulting in an explosion and fire. The building was evacuated and the fire department extinguished the fire.		
INVESTIGATION CONCLUSIONS	Site, system and components	<p>A four story apartment building that has natural gas fireplaces in each suite. The building gas supply was distributed through a gas pipeline in the parkade level providing gas at 2 PSI pressure. The gas line branched to a number of vertical gas pipes (“risers”) in the parkade.</p> <p>Each riser incorporated a line pressure regulator that reduced pressure to under ½ PSI. Each vertical riser provided gas to the 1st, 2nd, 3rd and 4th floor suite fireplaces. The gas sup

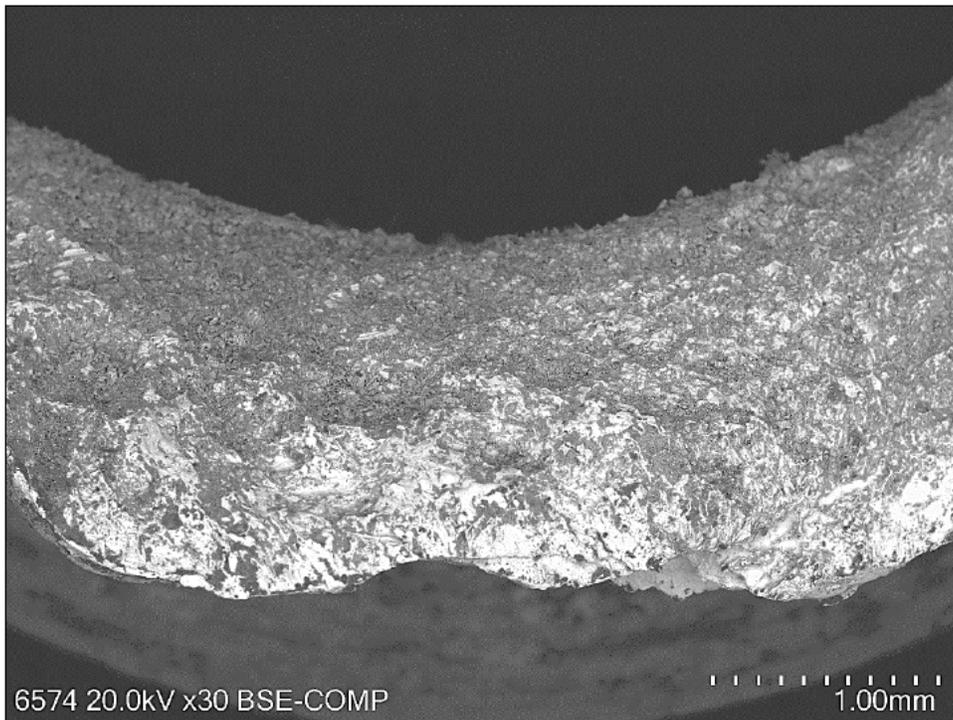
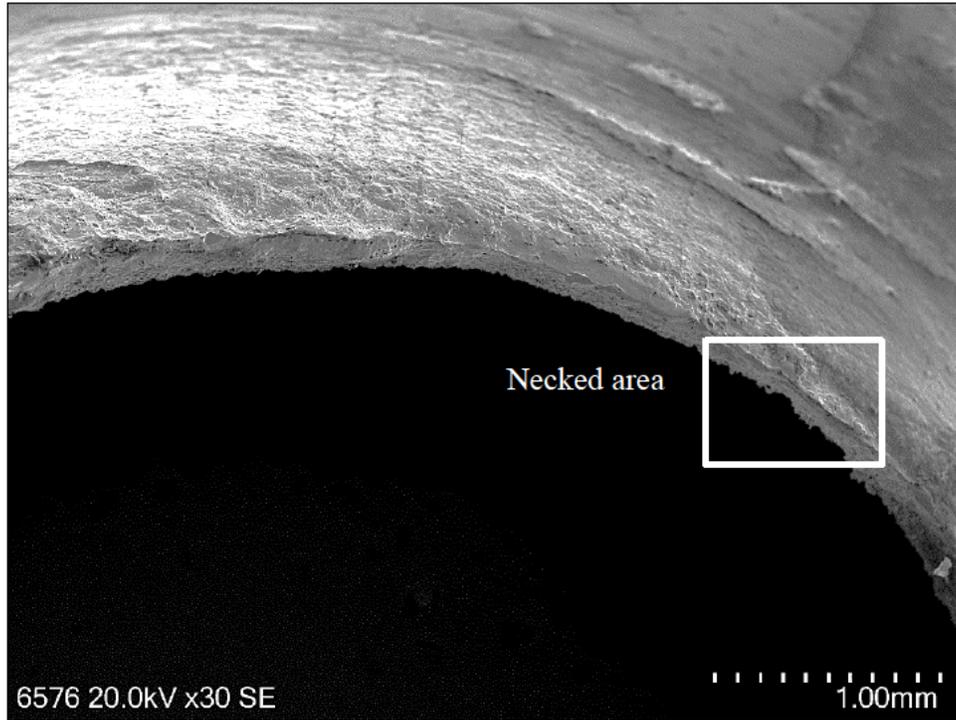
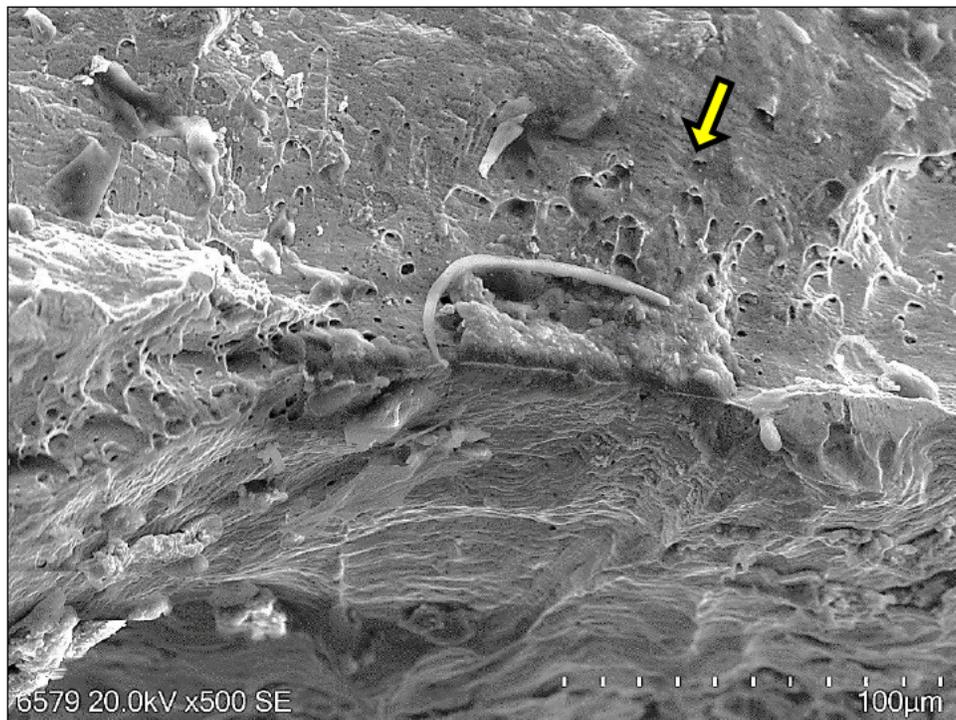
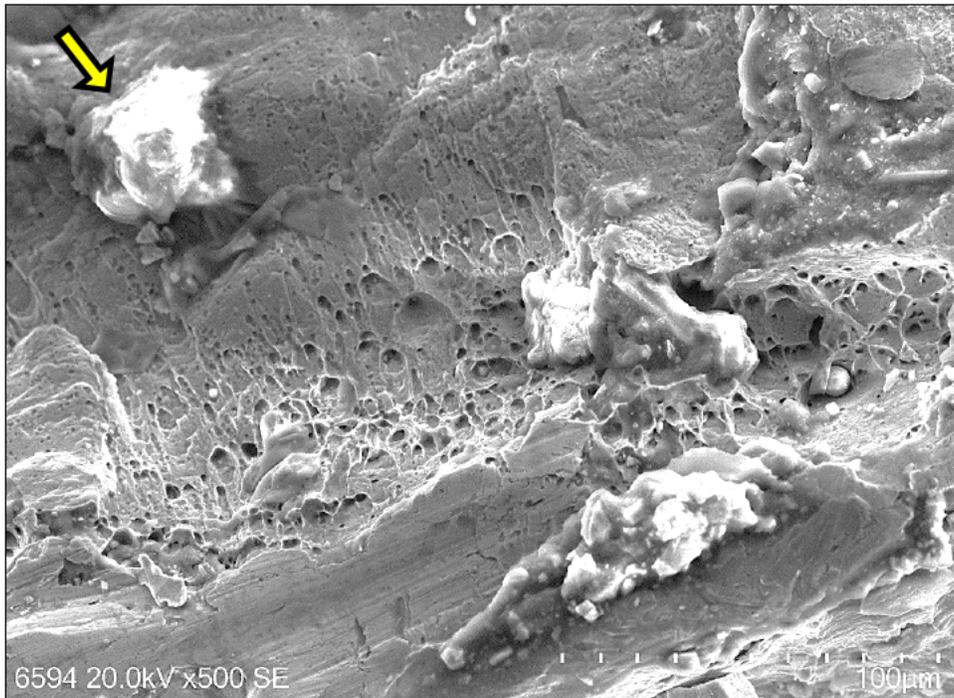
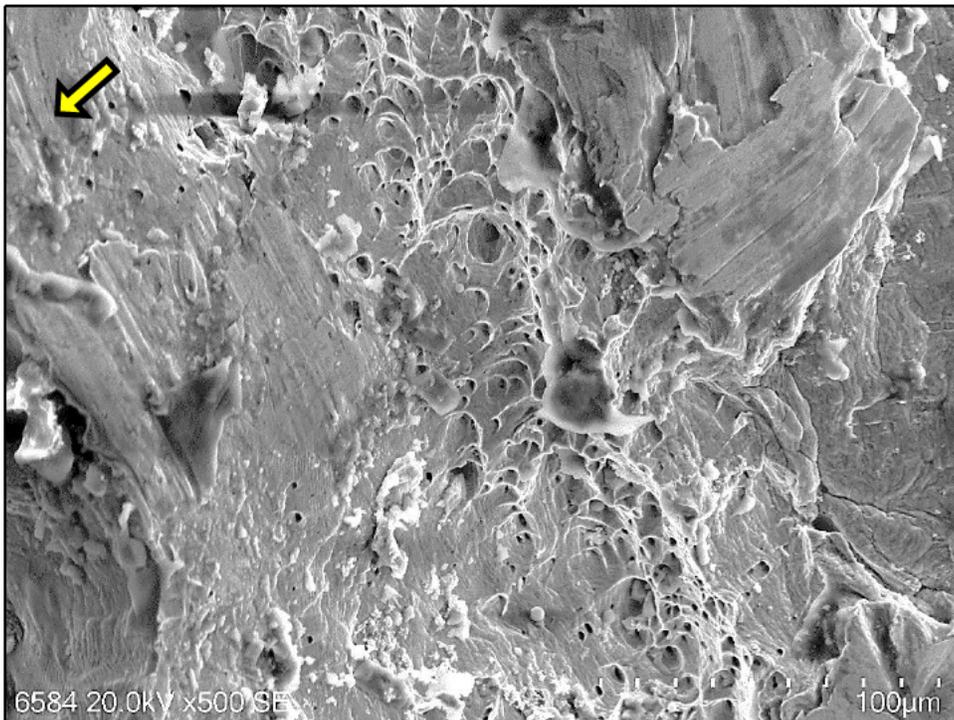
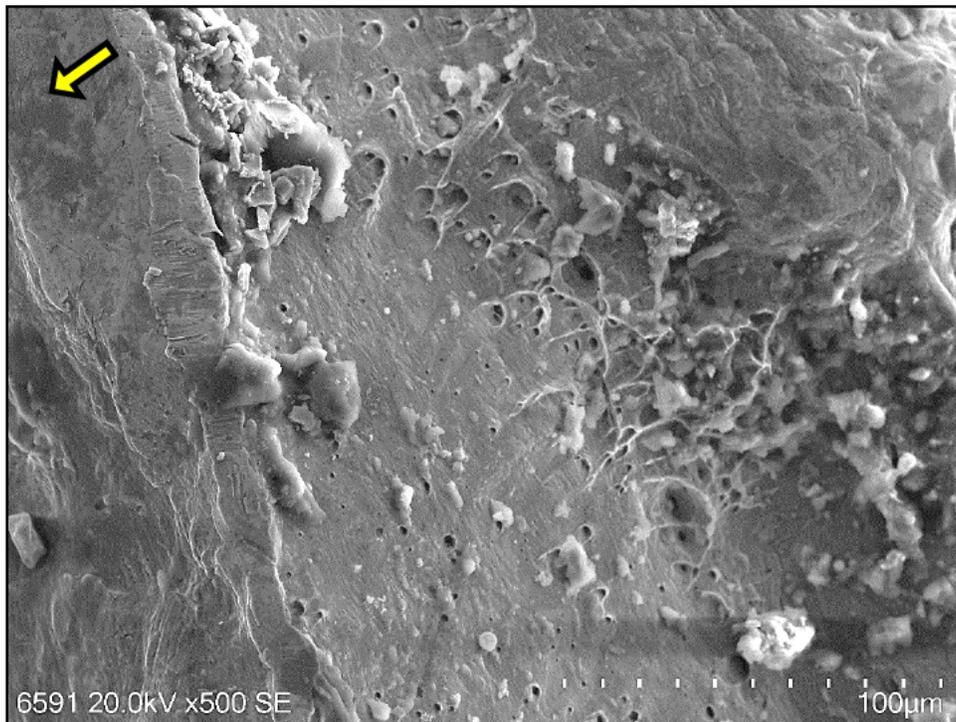
SEM images of the fracture surface of whip #328 at the locations indicated in Figure 21 are shown in Figure 27 to Figure 32. The fracture features along the tube were elongated dimples typical of ductile failure.

The fracture surface around the pipe wall of whip #328 consisted of slightly elongated dimples indicating the whole failure occurred in ductile mode. It is concluded that the copper pipe of whip #328 was overloaded by bending stress and ruptured accordingly.

Figure 27 SEM image of the fracture surface, as indicated in Figure 21.

Figure 28 SEM image of the fracture surface, as indicated in Figure 21. Pipe wall experienced necking.

Figure 29 SEM image of the fracture surface, as indicated in Figure 21. Elongated dimples indicating ductile fracture are notable. The arrow shows the fracture propagation direction.

Figure 30 SEM image of the fracture surface, as indicated in Figure 21. Elongated dimples indicating ductile fracture are notable. The arrow shows the fracture propagation direction.

Figure 31 SEM image of the fracture surface, as indicated in Figure 21. Elongated dimples indicating ductile fracture are notable. The arrow shows the fracture propagation direction.

Figure 32 SEM image of the fracture surface, as indicated in Figure 21. Elongated dimples indicating ductile fracture are notable. The arrow shows the fracture propagation direction.
