Incident Summary #II-1257048-2021 (#24091) (FINAL)

SUPPORTING INFORMATION	Incident Date	September 3, 2021	
	Location	Armstrong	
	Regulated industry sector	Electrical - Low voltage electrical system (30V to 750V)	
	Impact	Qty injuries	0
		Injury description	N/A
		Injury rating	None
	Damage	Damage description	Transient voltage suppression unit caught fire.
		Damage rating	Minor
	Incident rating	Minor	
Incident overview	Transient voltage suppression unit overheated and caught fire, no known damage to electrical system noted at time of incident.		
INVESTIGATION CONCLUSIONS	Site, system and components	<p>A power bar model C2005, Interact by Recoton is rated for 15amps 125volt, 330Vpk/ ULc Certified Transient Voltage Surge Suppressor 'TVSS' was used.</p> <p>A transient voltage surge suppressor is used to suppress temporary power surges on the electrical system and helps regulate the voltage for a constant voltage output during normal operating conditions with normal power issues occurring.</p>

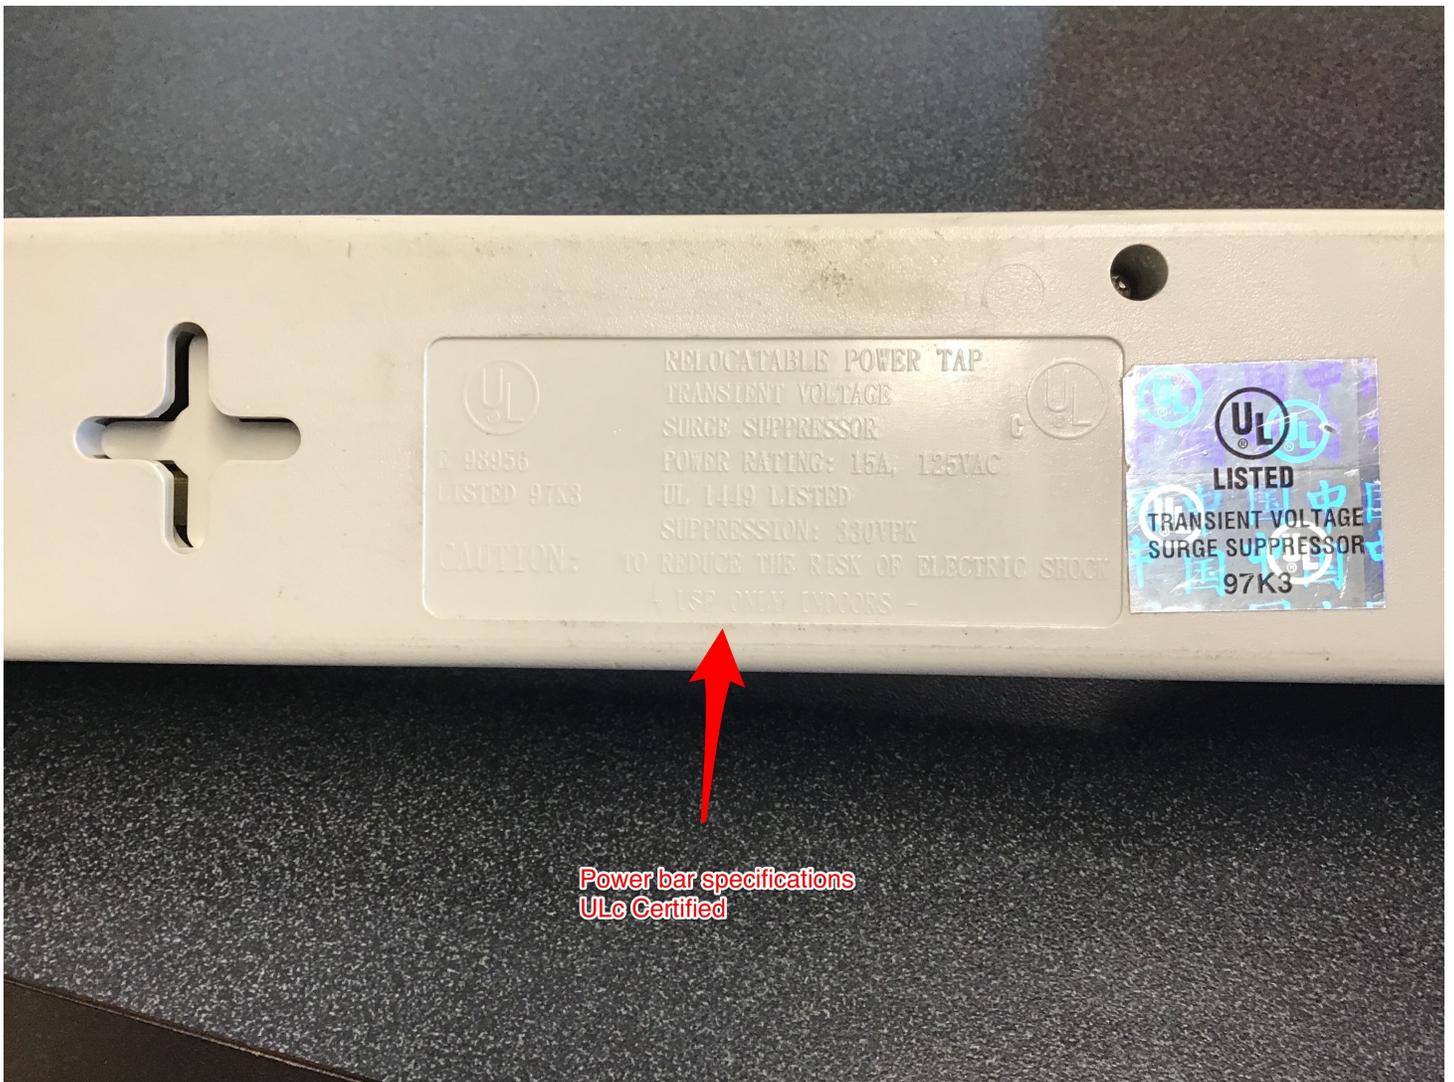
Power bar specifications
ULc Certified

Image 1 - Transient Voltage Surge Suppressor ratings

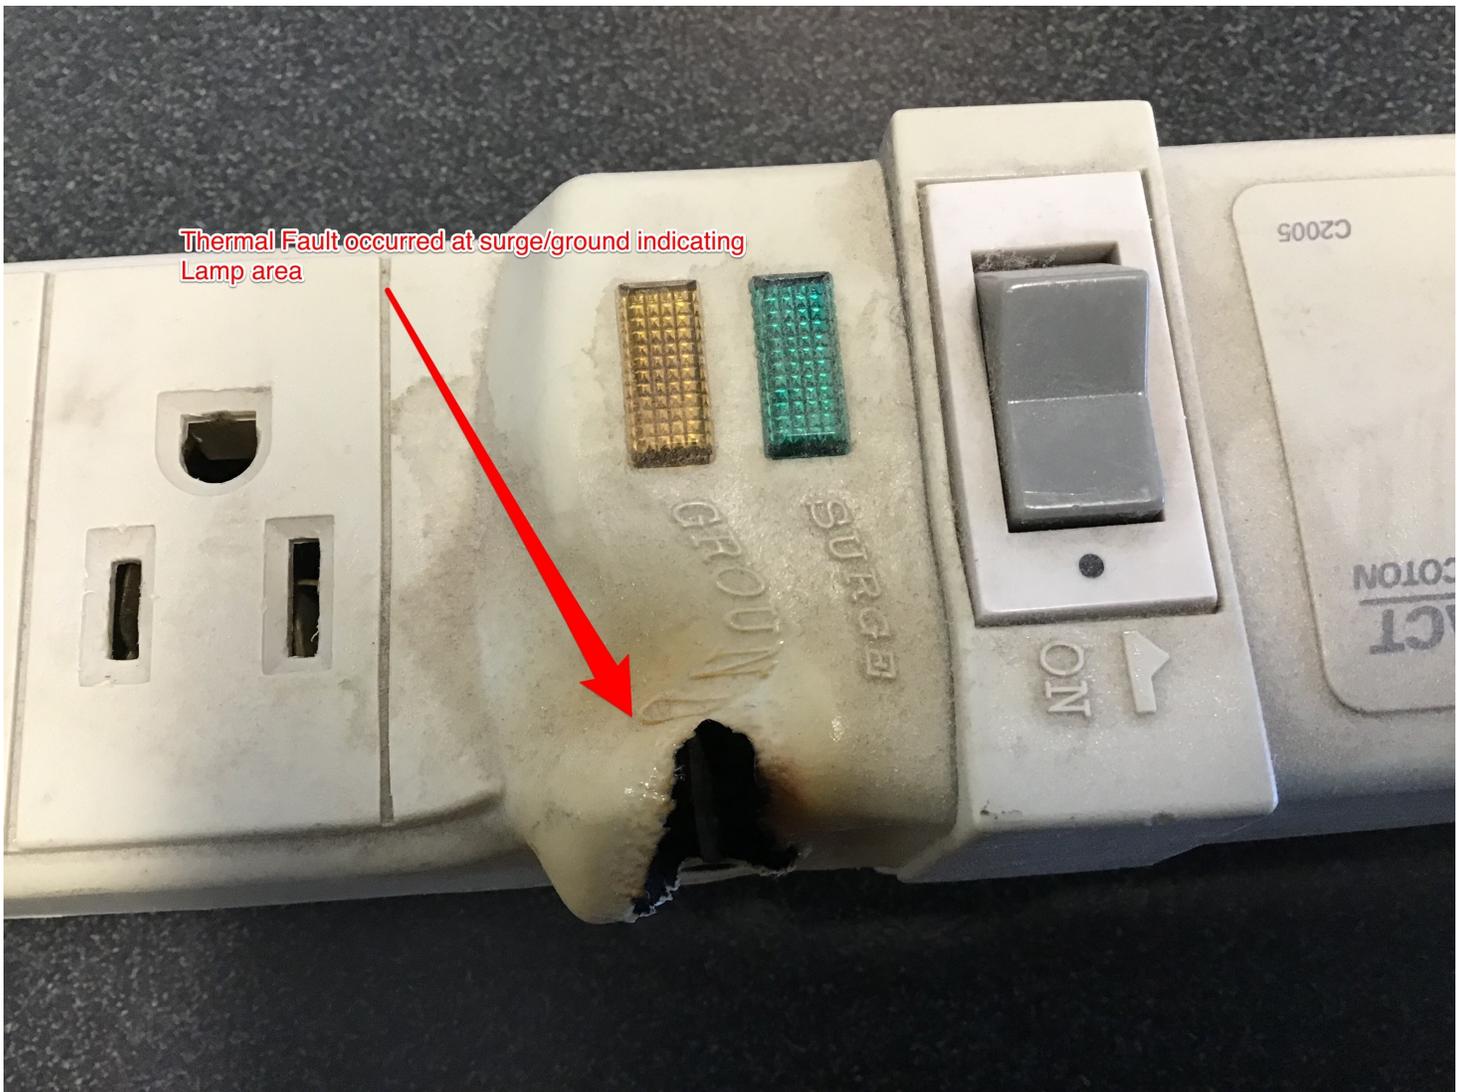
Image 2 - Specific heat damage- equipment rated

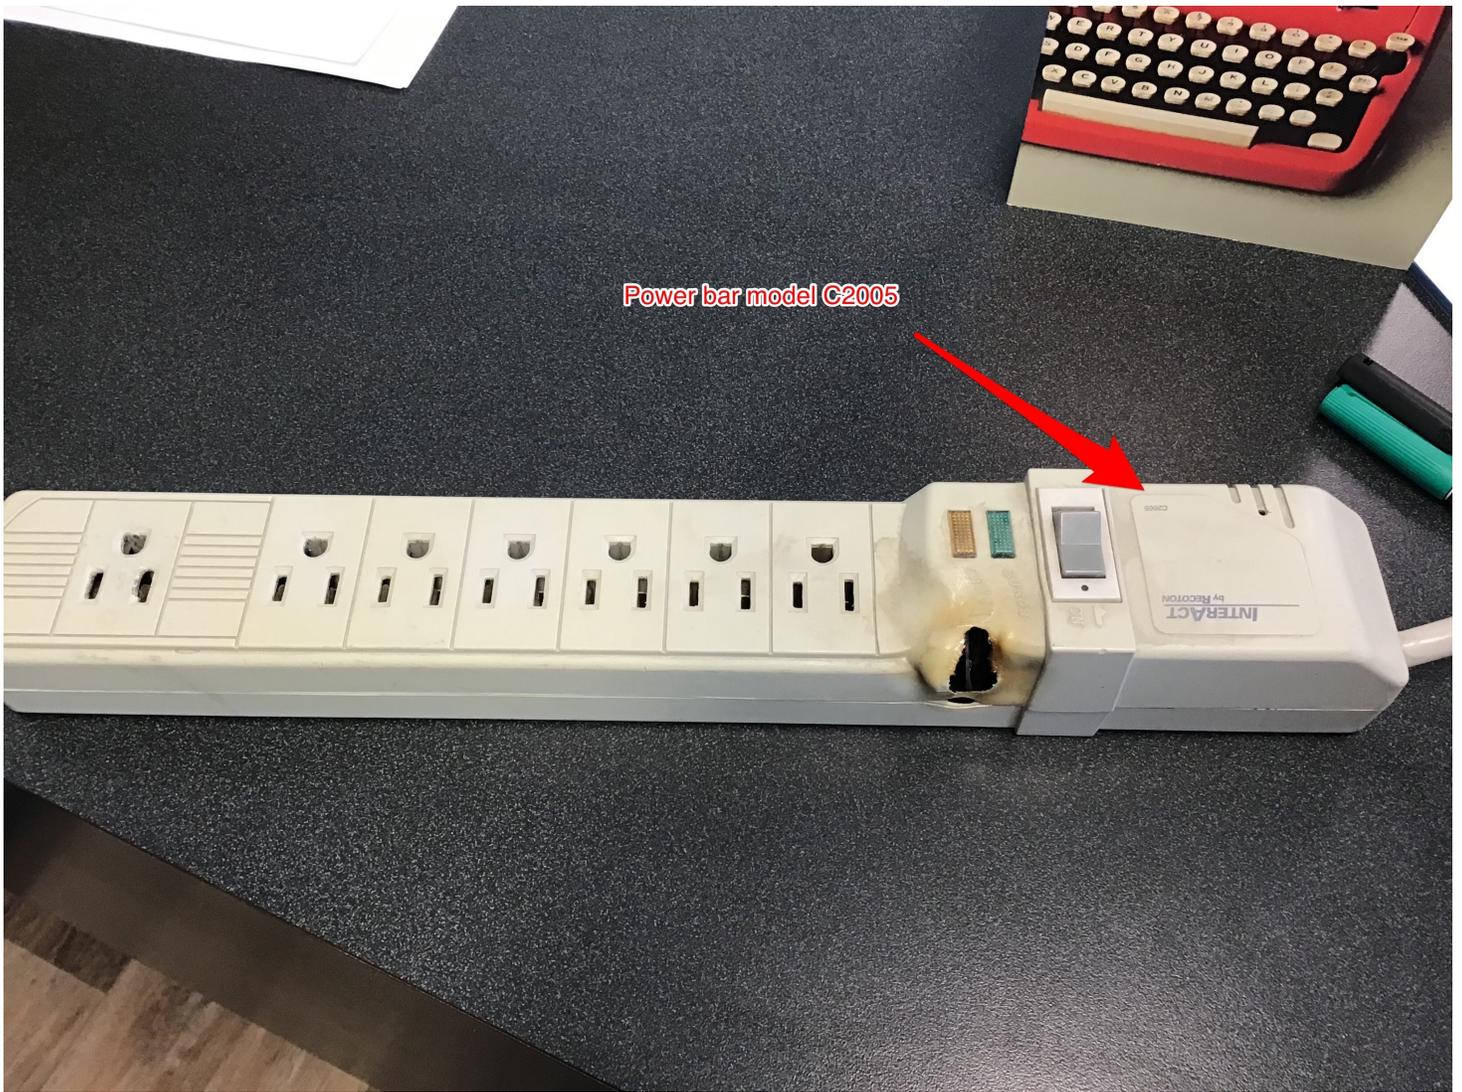
Causes and contributing factors	It is likely the loose main conductor in the electrical panel caused a continuous over-voltage which resulted in the power bar melting with a small fire and smoke.

Image 3 - View of damaged TVSS unit

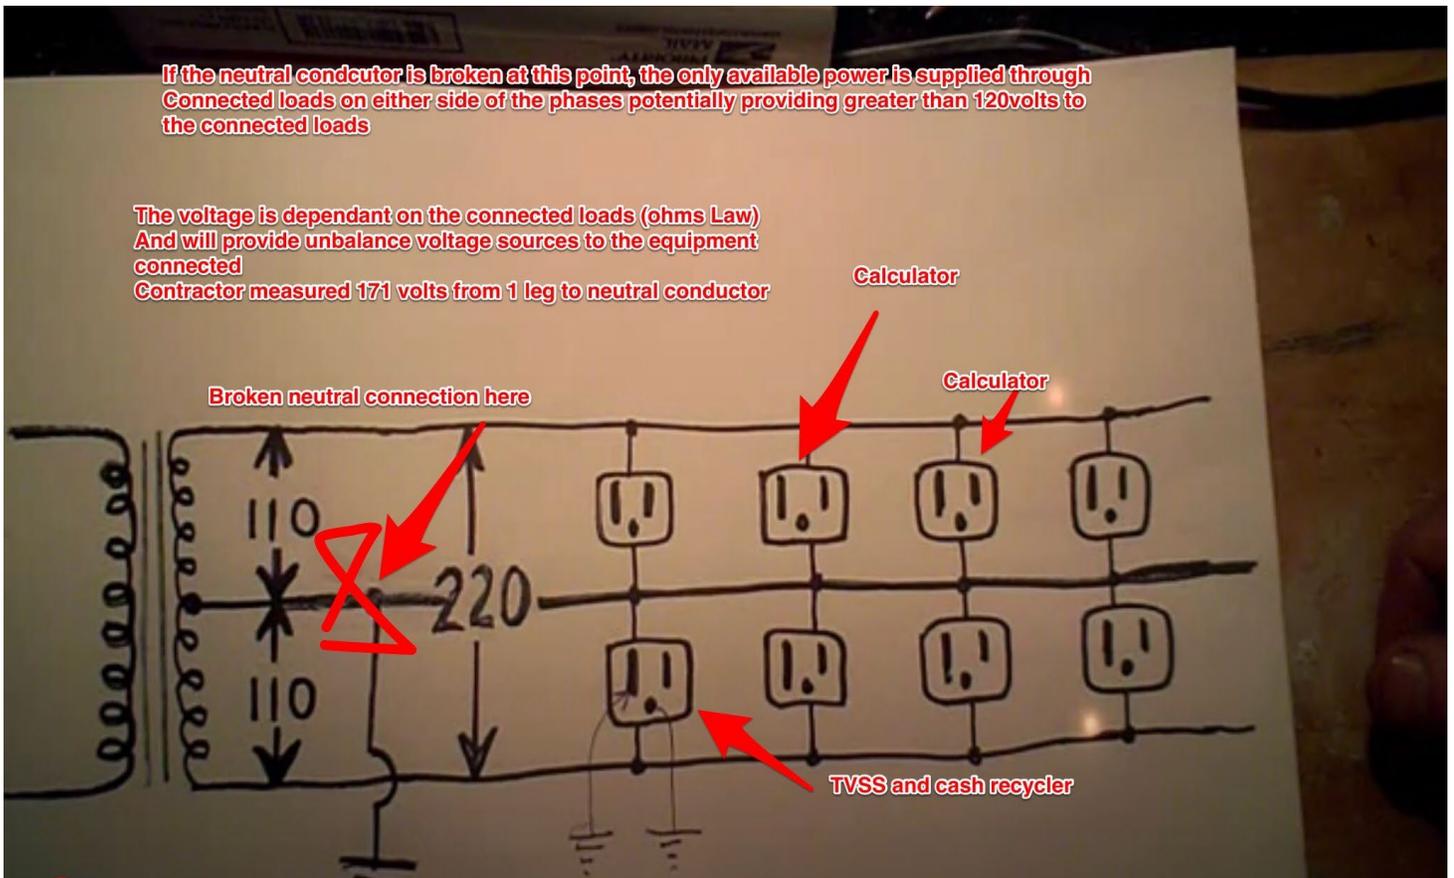
Failure scenario(s)	<p>A power issue created by a loose main identified conductor in the electrical panel G-1 electrically disconnected the identified grounded neutral conductor from the connected circuits in panels G1 and G2. This provided the only operational electrical path to operate from the line-line ungrounded conductors through connected equipment. This caused an overvoltage of 171-volts to the 120-volt receptacles. The overvoltage caused the Transient Voltage Surge Suppressor voltage regulator in the power bar to overheat due to a constant over-voltage (171-volts) and fail causing the equipment to melt with a small fire/smoke.</p>	
	Facts and evidence	<p>Witness statements</p> <ul style="list-style-type: none"> • Prior to the initial power bar fault, it was noted lights in the entry area were found flickering and various power outlets noted not working. • The power bar during operation became overheated and faulted within the indicating light area and melted, no damaged was noted to carpet or furniture. • The fire department was called and arrived at scene; no fire was noted. • Prior to the TVSS power bar failing, an UPS power supply shut down and all alarms within the room triggered. • All the calculators were found damaged and inoperable.

Image 4 - Diagram of wiring when the identified conductor is damaged and disconnected from the electrical system. The power still creates a circuit through the 240volt conductors through connected loads, each load will have different resistances and will distribute power unevenly and this can damage the equipment.
