## Incident Summary II-903654-2019 #15155 (FINAL)

SUPPORTING INFORMATION	Incident Date	September 5, 2019	
	Location	Interior	
	Regulated industry sector	Passenger ropeways - Above surface ropeway	
	Impact	Qty injuries	0
		Injury description	Not Applicable
	Damage	Injury rating	None
		Damage description	Visible friction wear on the haul rope and 33 carriers were damaged. This includes bent safety bars and arm rests, abrasion to the fixed and moveable jaws.
		Damage rating	Major
	Incident rating	Major	
Incident overview	Maintenance personnel were performing tower line work from the use of a maintenance carrier. While moving between towers in reverse operation a carrier conveyance belt came off a pulley in the return station. This blocked carrier movement through the station resulting in multiple carrier collisions and pile-up.		
INVESTIGATION CONCLUSIONS	Site, system and components	High speed chairlifts detach each carrier from the haul rope when they are at drive and return stations. This allows for easier, safe and efficient loading and unloading of passengers. The grip is the device on the carrier (chair) that attaches to the haul rope. A detachable grip is designed to be opened

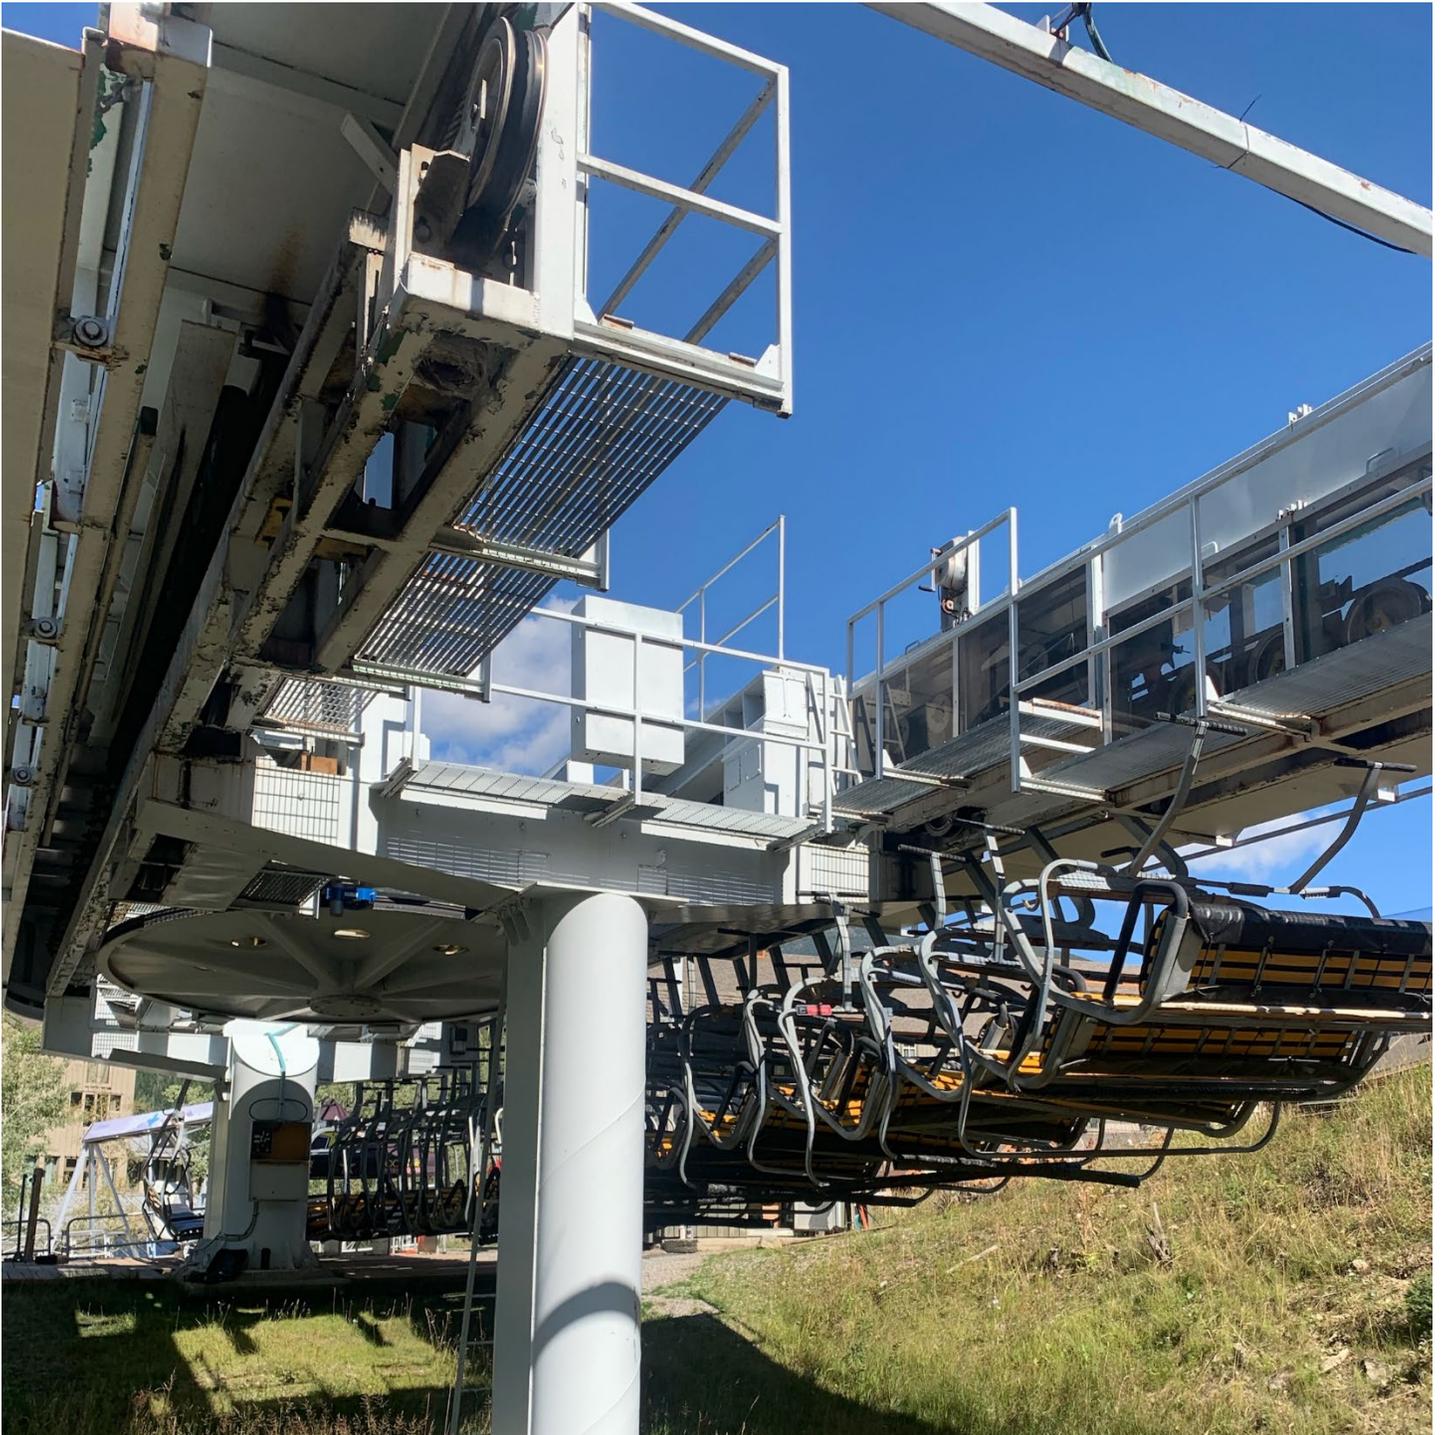
Failure scenario(s)	The unmanned return station of a detachable chairlift had a belt for the carrier conveyance system come off a pulley. Carrier transport through the return station was interrupted at the location where the belt was removed. The adjacent carriers collided and stacked up in the return station as the ropeway continued reverse operation.	
	Facts and evidence	Regulatory requirements: <ul style="list-style-type: none"> <li>CSA Z98-14 clause 13.5.4 – when ropeway operating for maintenance purposes only one operator required.</li> <li>CSA Z98-14 clause 12.3.2.4 – operator shall be in attendance at the drive station while personnel working on the line</li> </ul> Manufacturer Service and Maintenance manual: <ul style="list-style-type: none"> <li>Refer to applicable codes when operating work carrier for maintenance</li> </ul> Ropeway Station monitoring safety system: <ul style="list-style-type: none"> <li>Does not function in reverse operation</li> </ul>

## Piled-up Chairs in Return Station

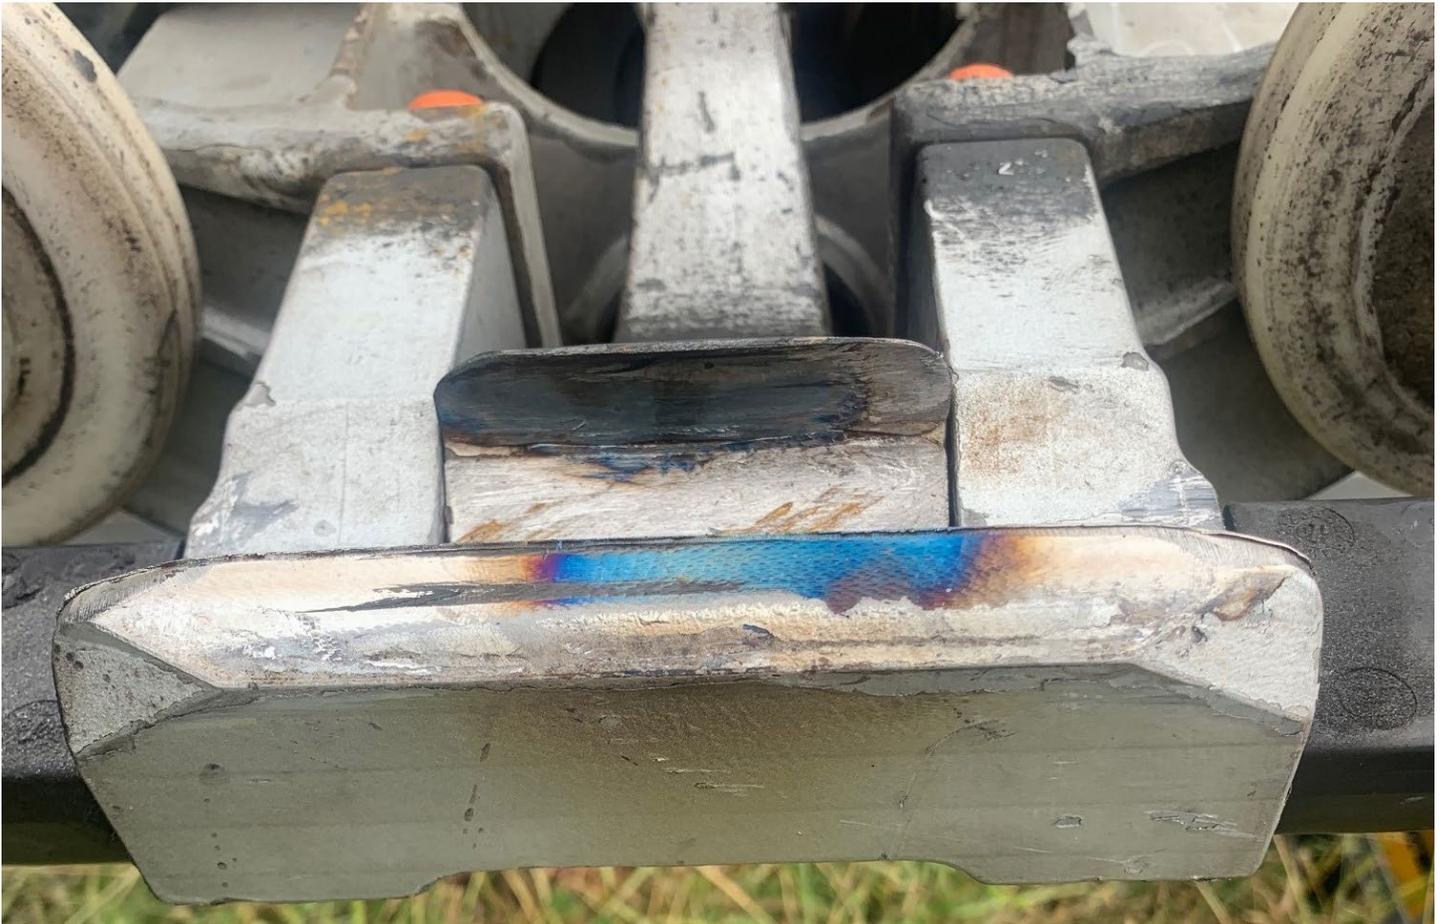
Grip Jaw Wear

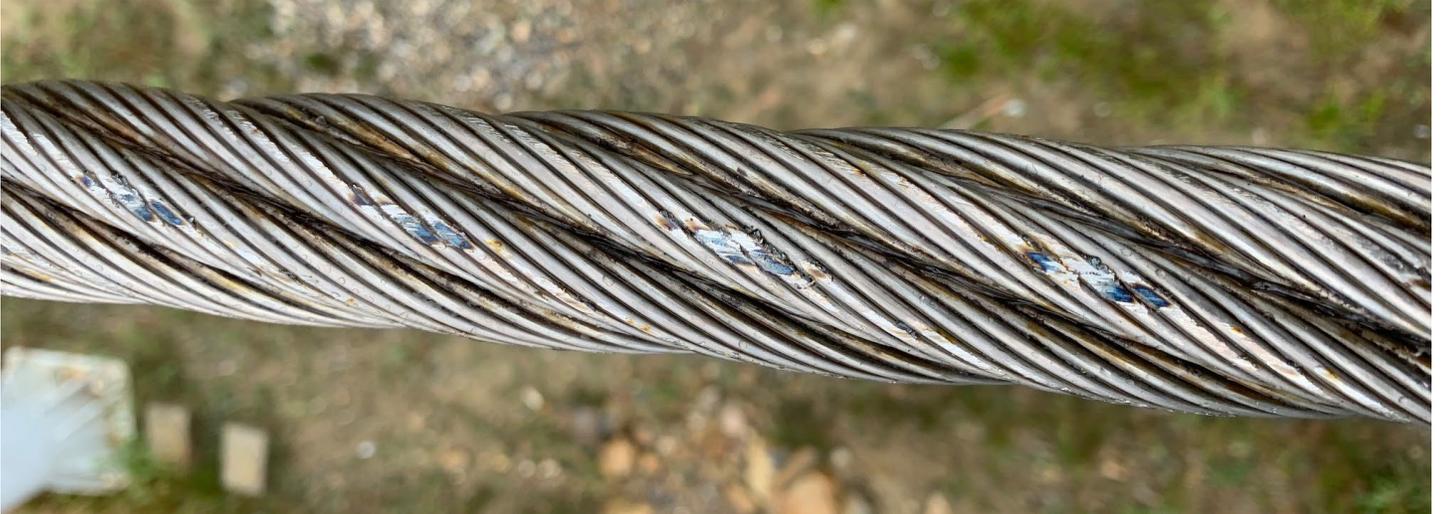
<p>Causes and contributing factors</p>	<p>It is very likely a belt failure in the station conveyance system for the chairs caused damage to the haul rope and a variety of components of multiple chairs.</p> <p>It is likely that contributing factors were that in reverse operation the carrier monitoring safety system will not function and operating without an operator in attendance at return station.</p>

## Haul Rope Abrasion
