Incident Summary #II-1216438-2021 (#22636) (FINAL)

SUPPORTING INFORMATION	Incident Date	June 27, 2021		
	Location	Vancouver		
	Regulated industry sector	Gas - Natural gas system		
	Impact	Qty injuries	0	
		Injury	Injury description	N/A
			Injury rating	None
	Damage	Damage description	Release of a significant quantity of compressed natural gas (CNG) into multiple parkade levels and an adjacent building's HVAC system	
		Damage rating	Moderate	
	Incident rating	Moderate		
Incident overview	A pressurized bank of compressed natural gas (CNG) cylinders were subject to high ambient temperature during a heat wave, causing an increase in pressure and subsequent relief valve discharge of natural gas into the atmosphere and an adjacent building's HVAC system.			
INVESTIGATION CONCLUSIONS	Site, system and components	<p>The site in question is an abandoned CNG filling station that was used to fill CNG vehicles. The station consists of a natural gas supply provided by the utility that is compressed to a high pressure via a 3-stage compression system. The gas is compressed into three storage banks, low, medium, and high. Each bank consists of two cylinders connected to a common relief valve. Eac

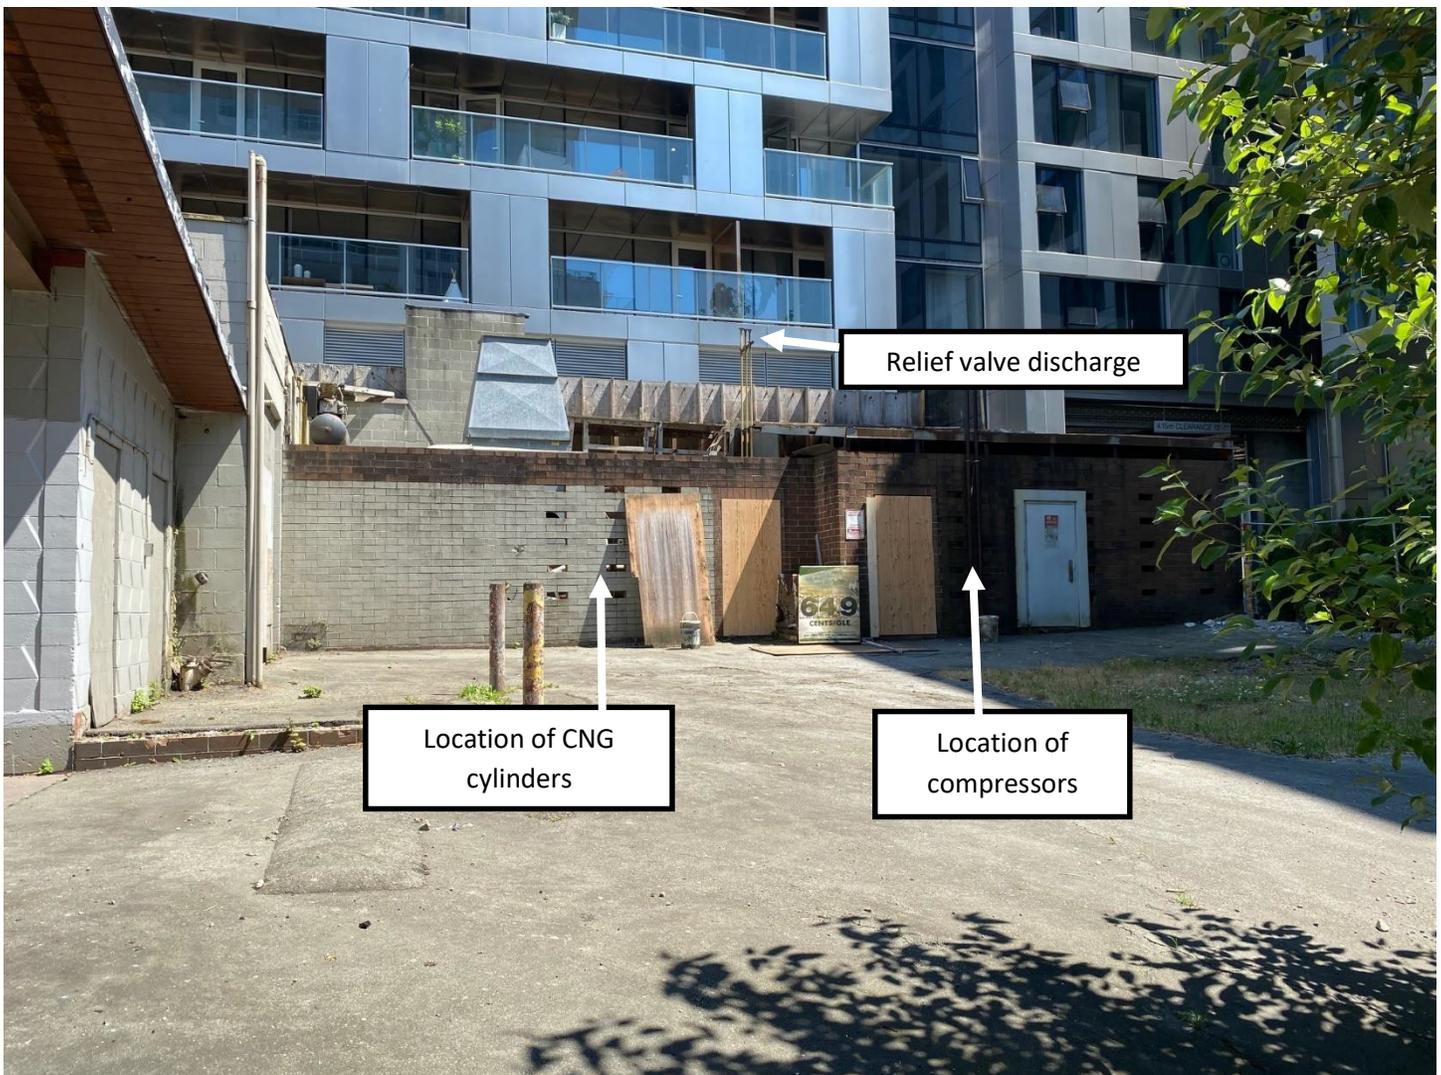
Image 1 - Site overview showing the location of the CNG cylinders

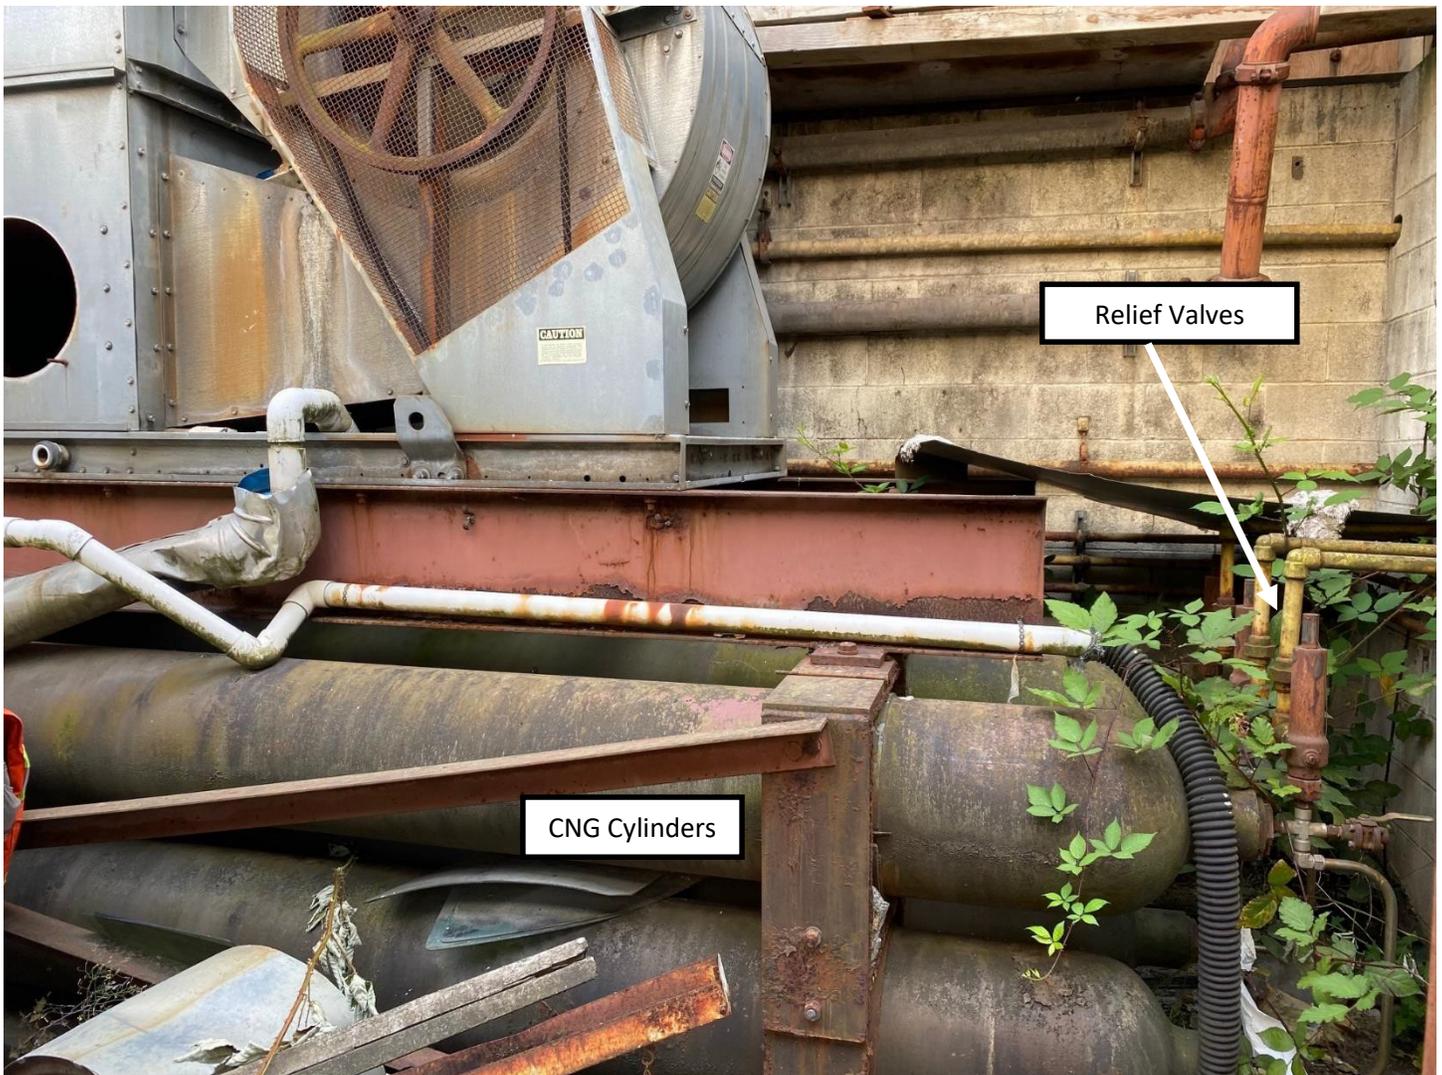
Failure scenario(s)	The CNG station was decommissioned in 2015. The electrical and gas supply to the station was removed and the compressors and cooling system were decommissioned. The CNG cylinders were disconnected from the piping system but still connected to the relief valves. 4 of the 6 cylinders were not emptied during the decommissioning.

Image 2 - CNG Cylinders. Two cylinders are connected to a common relief valve

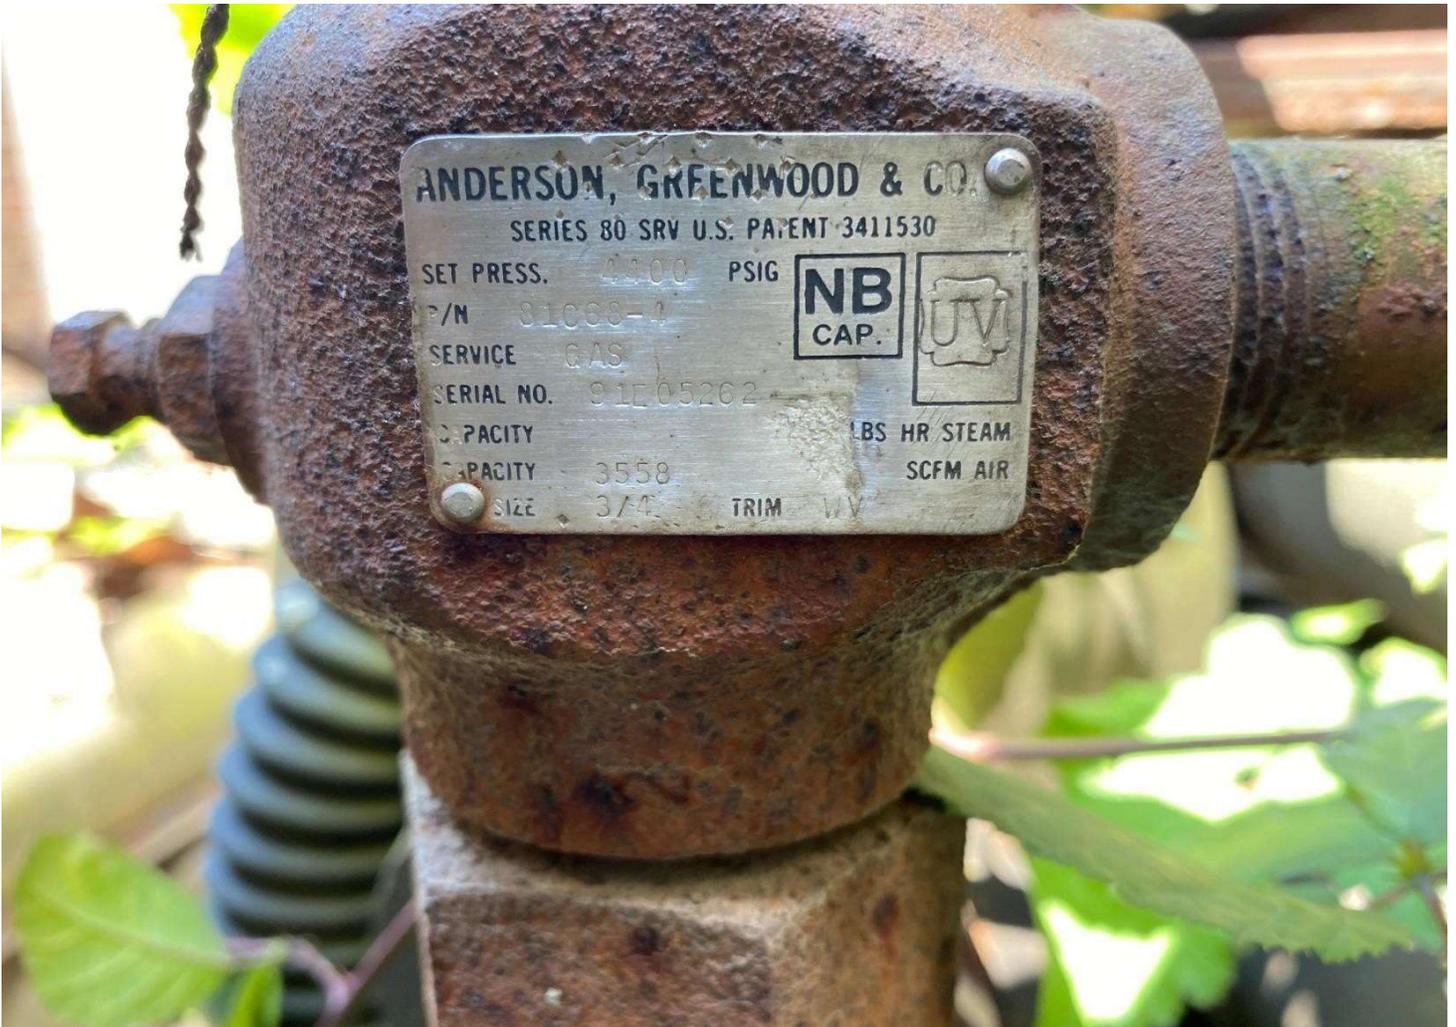
It is likely that persistent, high ambient temperatures contributed to an increase in pressure inside the CNG cylinders, exceeding the relief valve trip point. The relief valves relieved under an overpressure condition and released a large quantity of natural gas into the atmosphere and adjacent building.

Record setting high seasonal temperatures exposed the cylinders to pressures greater than the relief valve setting.

Image 3 - Relief Valve set at 4400 PSI

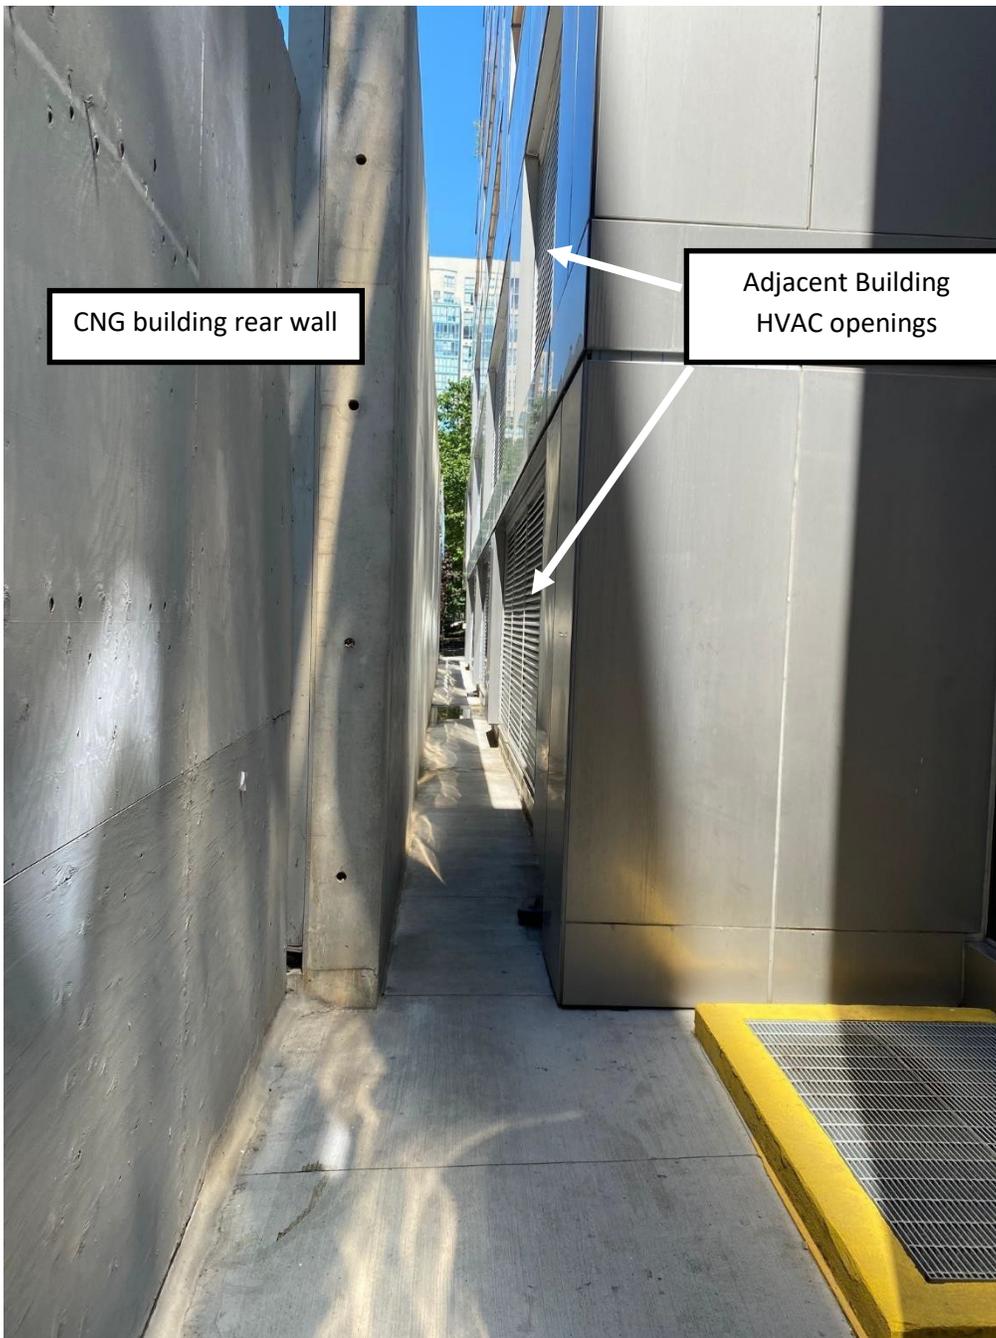
<p>A high-rise tower was recently constructed next to the cylinder building and relief valve discharge (the distance between the rear cylinder building and high-rise tower is approximately 3 feet). As a result, the relief valve discharge pipes terminated near the adjacent building's HVAC air intake (Image 4 and 6).</p> <p>On the week leading up to the natural gas release the area was experiencing a record high heatwave with temperatures above 40 degrees Celsius. Stored outdoors, the CNG cylinders were subject to high ambient temperature and radiant heat from the sun. This increase in temperature caused an increase in gas pressure, most likely exceeding the relief valve setting of 4400 PSI. The relief valve discharged near the adjacent building, releasing a large volume of gas that was drawn into the building's HVAC air intake. Gas was found on parkade levels P1,P2 and P3.</p>
<p>Facts and evidence</p>	<ul style="list-style-type: none"> -On June 27 the Fire Department responded to reports of an explosion from a nearby tenant. It should be noted that the reported explosion was not actually an explosion, but the sound of the relief device operating as intended to maintain safe pressures within the vessel. -The first responders found a heavy smell of gas around the cylinders as well as in the parkade of an adjacent building. -The likely cause of the reported explosion was the triggering of the relief valve(s) serving the CNG tanks which may be extremely loud when relieving at a pressure of 4400 PSI. -Subsequent investigation found that two of the cylinder banks (4 cylinders) were under pressure with natural gas. The first bank was found to have a pressure of 3600 PSI and the second, a pressure of 2200 PSI. The third bank of cylinders was found to be empty. -The large amount of natural gas detected in proximity to the cylinders by the fire department suggest the cylinders were the source of the gas release. -The proximity of the relief valve vent lines to the adjacent building indicates they were likely the source of gas that infiltrated the parkade. -The reported explosion coincides with the anticipated sound of a high-pressure relief valve discharge. -Utility gas supply had been removed from the site, making the CNG cylinders the only potential source of gas -4 of the 6 cylinders were found to be under high gas pressure. -The high ambient temperatures correlate with an increase of gas pressure in the cylinders. (Gay-Lussac's Law states that the pressure of a given mass of gas varies directly with the temperature of the gas, when the volume is kept constant) -The dilapidated site conditions suggest that the cylinders and associated relief valves had not been inspected or serviced for an extended period

Image 4 – location of adjacent building's HVAC openings

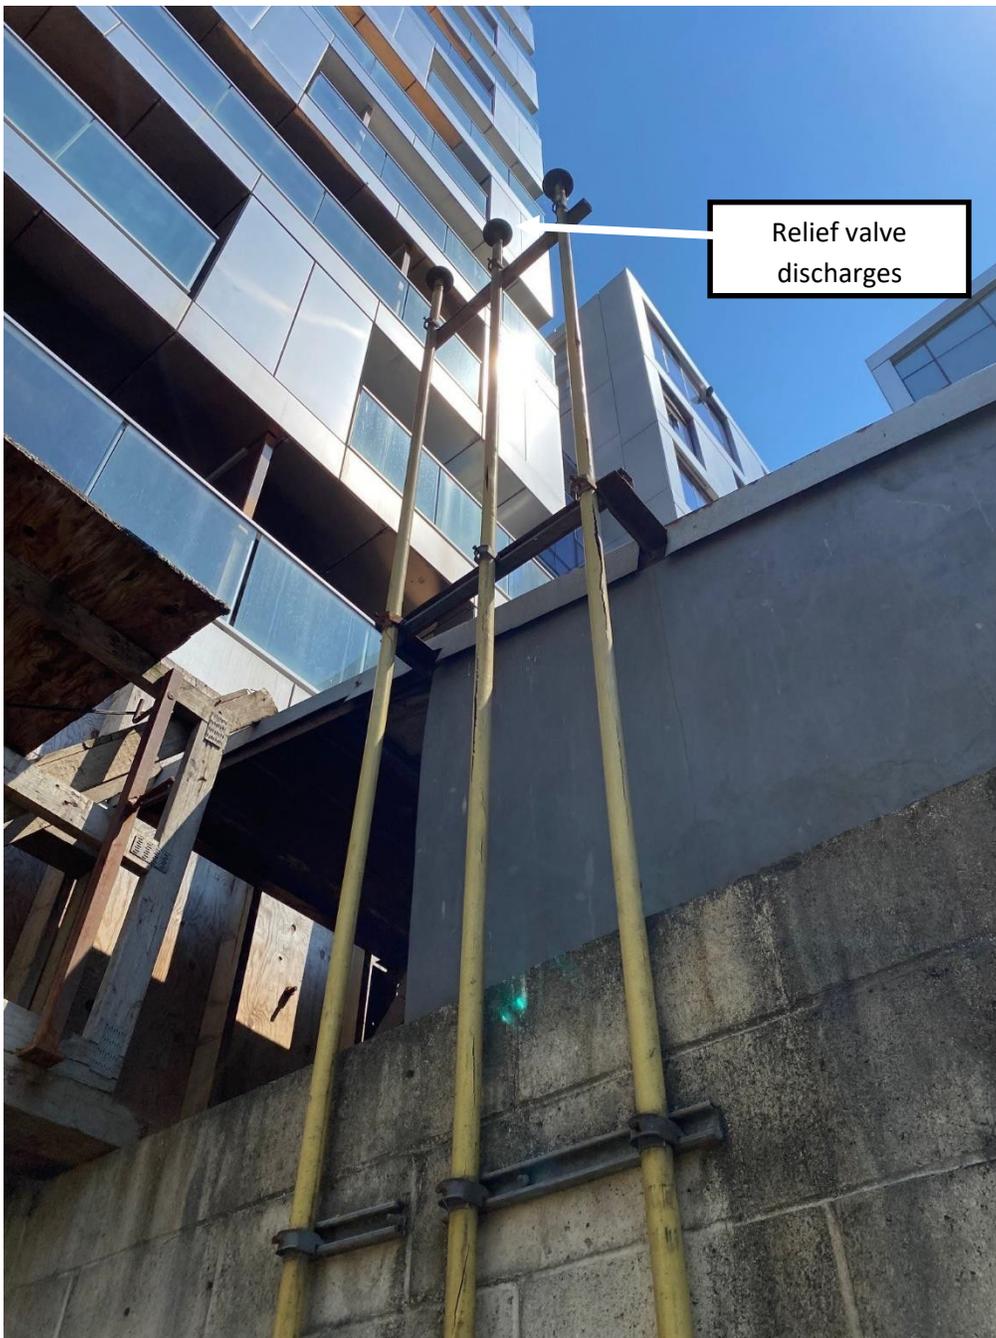
Image 5 – cylinder relief valve discharge

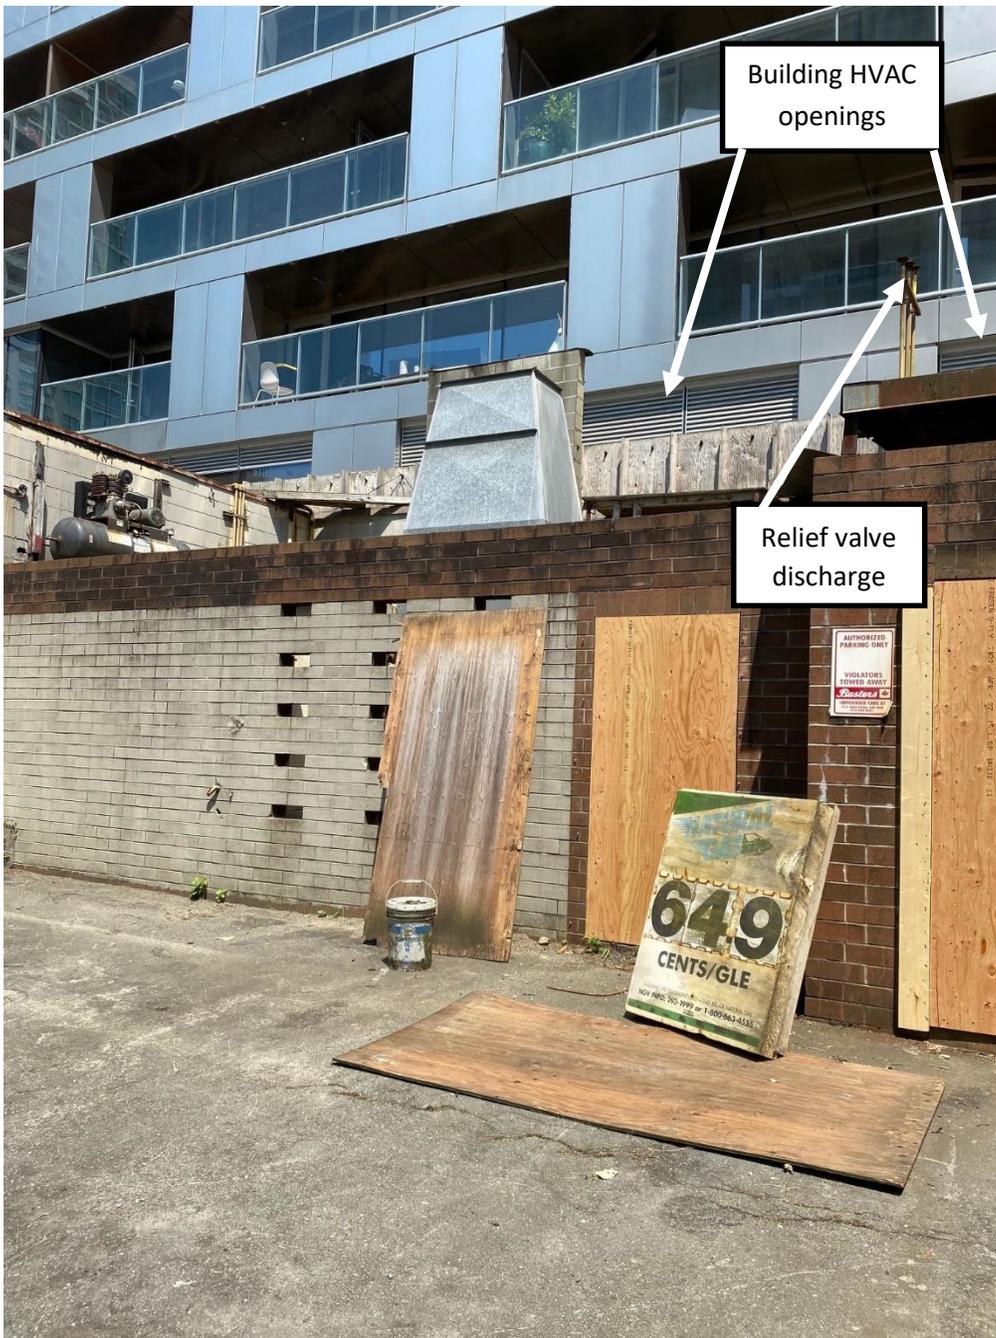
Image 6 – CNG cylinder building and relief valve location

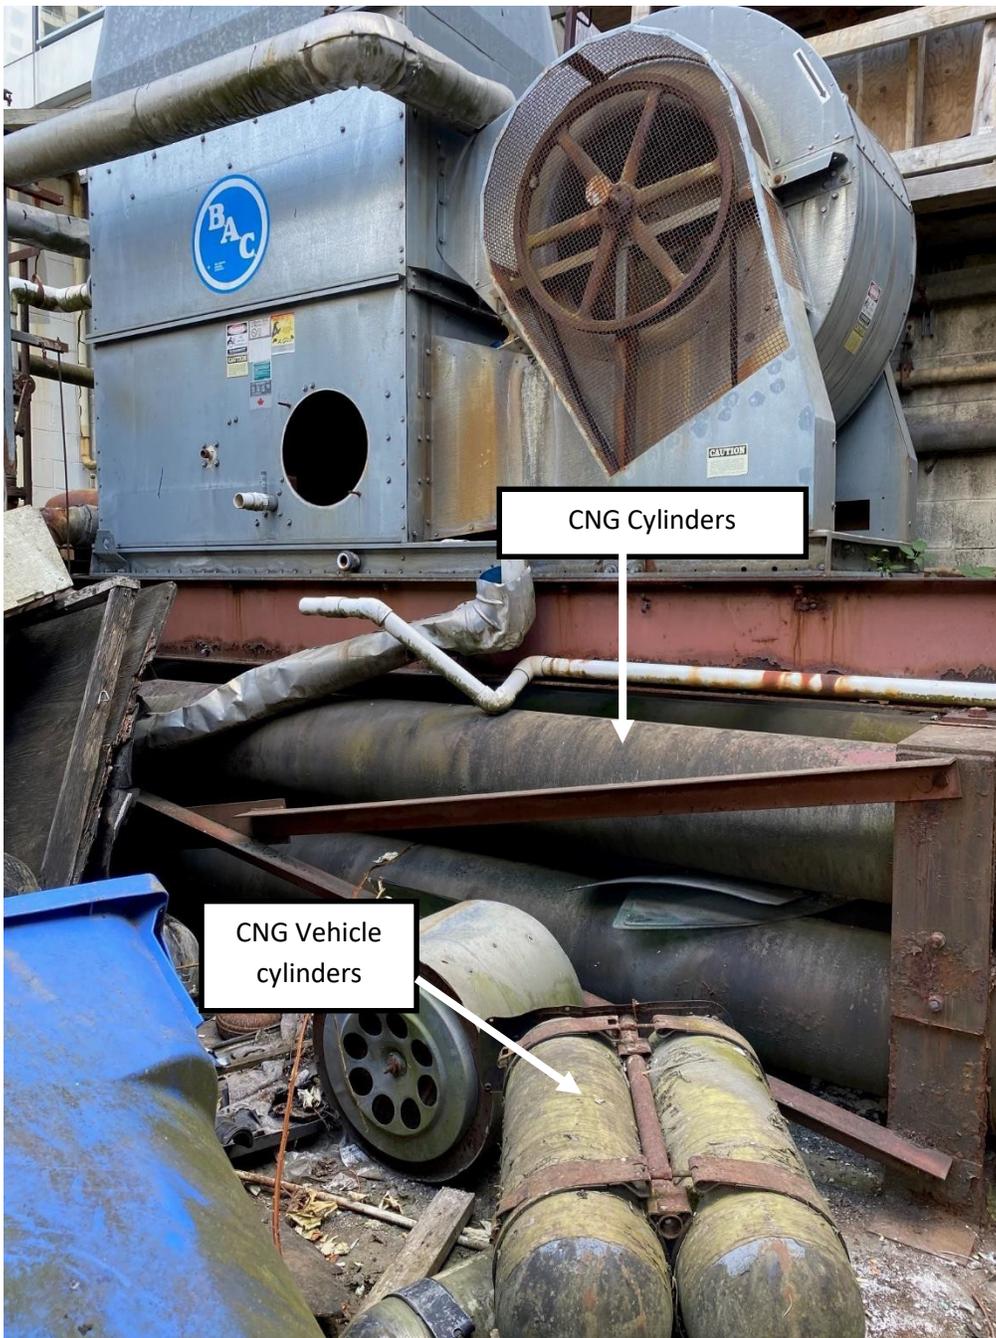
Image 7 – Cylinder location
