Engineering Analysis
Fernie Memorial Arena Investigation
Cold Dynamics Ltd.

Fernie Memorial Arena Investigation

REPORT FOR TECHNICAL SAFETY BC
FERNIE MEMORIAL ARENA

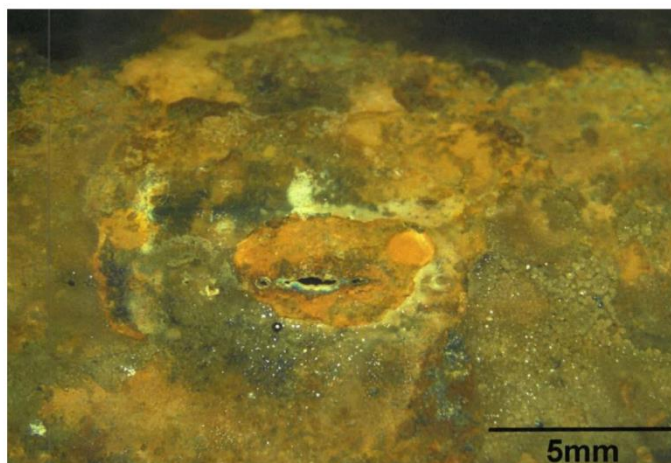
One tube was found leaking in the chiller. There was one elliptical opening approximately 2.2 mm x 0.2 mm in size and several smaller openings in the same vicinity on the same tube, see Figure 2. The leak occurred due to pitting corrosion along the electrical resistance welding (ERW) weld line. This tube was located in the second row from the top of the chiller and is indicated on Figure 3.

Figure 2: Leak on chiller tube with pitting corrosion along ERW line.

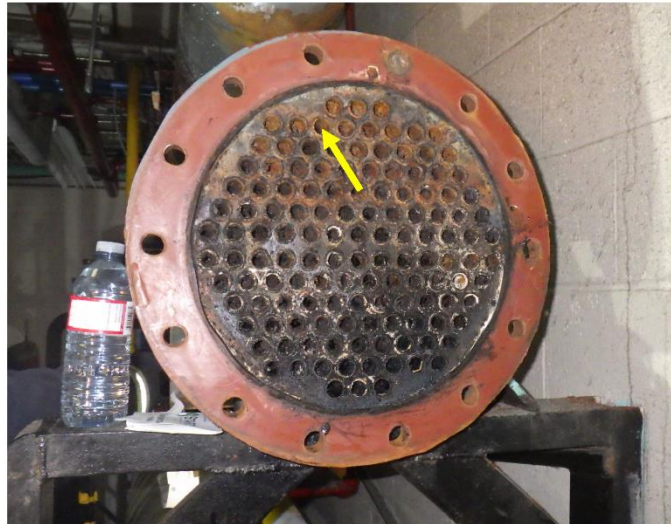
Figure 3: Return head of chiller showing clear tubes on upper half of the tube sheet and arrow indicating tube with leak

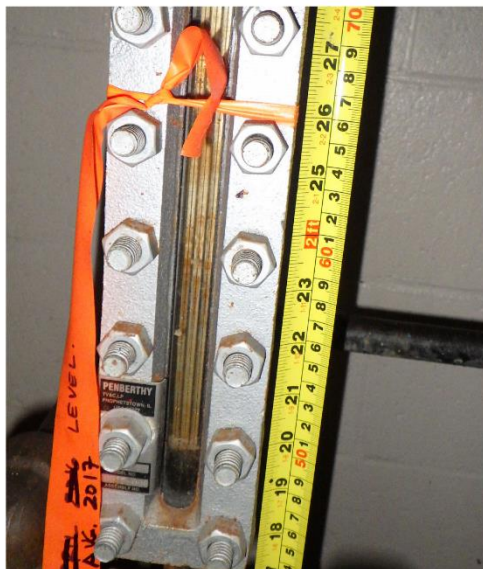
Figure 4: Indication of August 2017 receiver ammonia level.

The total refrigerant inventory estimated using the conditions at the arena during the August 2017 start-up, is 885 lb [402 kg].¹

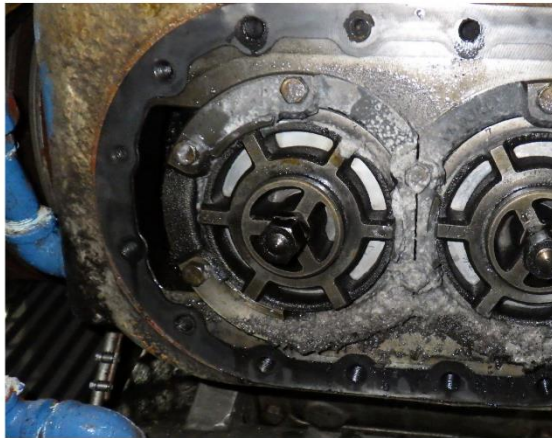
CaCl₂ brine had the opportunity to leak into the ammonia refrigeration system up from the time the leak developed until the system was pumped down in May 2017 and again after the curling brine system was started in October 2017. Evidence of CaCl₂ was found in the refrigeration system in both the arena chiller and the compressor oil and cylinders; an example is shown in Figure 5 below. CaCl₂ present in the refrigeration system can cause increased corrosion and damage.

Figure 5: CaCl₂ Evidence in Compressor Cylinder Heads

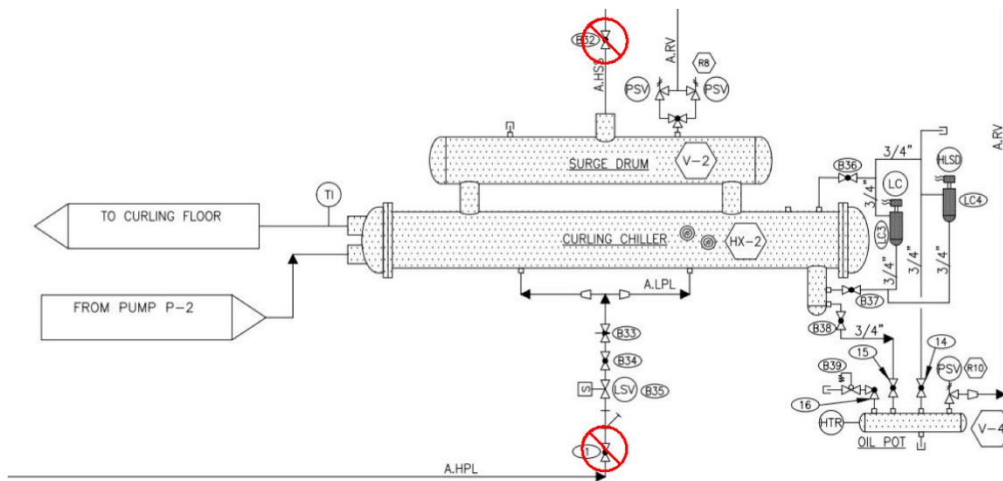
The as-found valve positions indicate that the refrigerant side of the curling chiller was isolated. Both the liquid (inlet) and the suction (outlet) isolation valve were closed by the operators responding to the ammonia alarm, see Figure 6 below. The firefighters and refrigeration plant operators that responded to the alarm were not in the room long enough to perform a pump down procedure to remove the ammonia from the chiller and no such procedure was described by any of the firefighters during their interviews. Since it was not pumped down, the curling chiller would have had approximately 90 lb [41 kg] of ammonia remaining when it was isolated. For additional details regarding the ammonia quantity, refer to the Ammonia Inventory section of this report.

Figure 6: Cut out from Technical Safety BC Report Appendix B showing the valves that isolated the ammonia in the curling chiller.

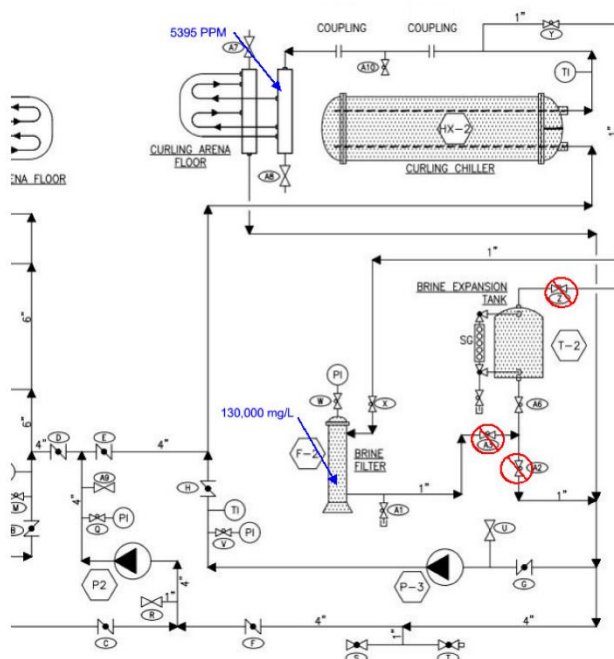
The brine system was also isolated and the brine pump electrical was turned to off during the response. Following the incident, a brine sample was taken that indicated an ammonia concentration in the brine filter of 130,000 mg/L [113,400 ppm]. An additional brine sample was taken from the curling header that indicated there was an ammonia concentration of 5395 ppm [6435 mg/L] throughout the system. Figure 7 below shows the location of the two brine samples and the normally open valves that were effectively closed, isolating the brine system from atmosphere.

Figure 7: Cut out from Technical Safety BC Appendix B Diagram. The red cross-outs indicate the valves that isolated the brine system from the atmosphere and the blue arrows indicate the location of the brine sample measurements. Valve Z was found with the handle 10° open but was assumed to be effectively closed because of debris in the valve and piping.

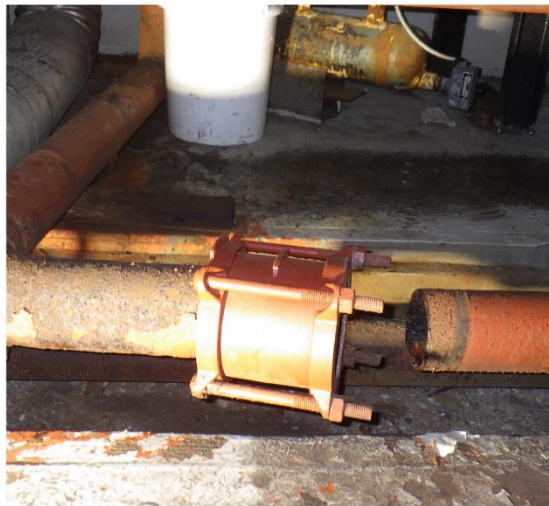
Figure 9: Separated brine coupling on 4" brine piping

Approximately 5 hours after the initial emergency response that isolated the curling chiller and brine system, a 4-inch coupling installed on the brine supply line suddenly separated spraying a mixture of ammonia and CaCl_2 brine into the room; the coupling can be seen in Figure 9 above. When the coupling separated there would have been a rapid depressurization of the brine system. When this occurred, a portion of the ammonia in the ammonia saturated brine, located near the tube leak and in the upper tubes and heads of the chiller, would have expanded from liquid to vapour rapidly; the brine and ammonia contents from the top half of the chiller and the section of the brine piping between the chiller and the separated coupling would have been pushed rapidly by the expanding ammonia into the mechanical room. Figure 10 shows a graphical representation of the approximate volume of the release. The visual evidence of the spray from the coupling indicated that all of the flow was in the direction from the chiller into the room and not from the curling header and underfloor brine piping which corroborates that a high ammonia concentration was in the chiller and not in all of the brine piping.

An exemplar coupling was tested, which revealed that, installed with no support, this coupling could have failed at a pressure as low as 30 psig [207 kPag]. For details regarding this testing, see the Technical Safety BC Investigation Report. The installed coupling was better supported than the test rig, so it would have likely failed

at a higher pressure. In normal operation, the installed coupling would have been subject to pressures of approximately 30 psig [207 kPag].

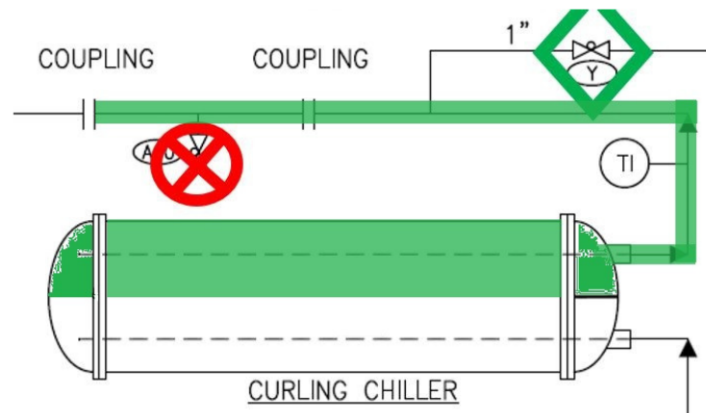
Figure 10 The green highlighted areas represent the approximate volume of ammonia- CaCl_2 brine solution that was released into the mechanical room

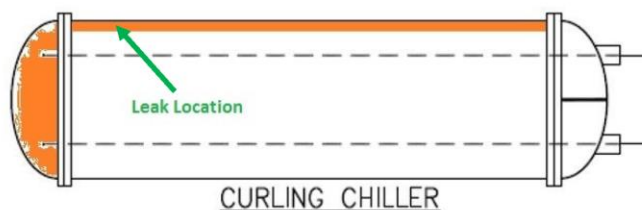
Figure 11: Representation of the areas that were considered near saturation for the release scenario (the drawing is not to scale). The arrow indicates the approximate location of the tube leak.

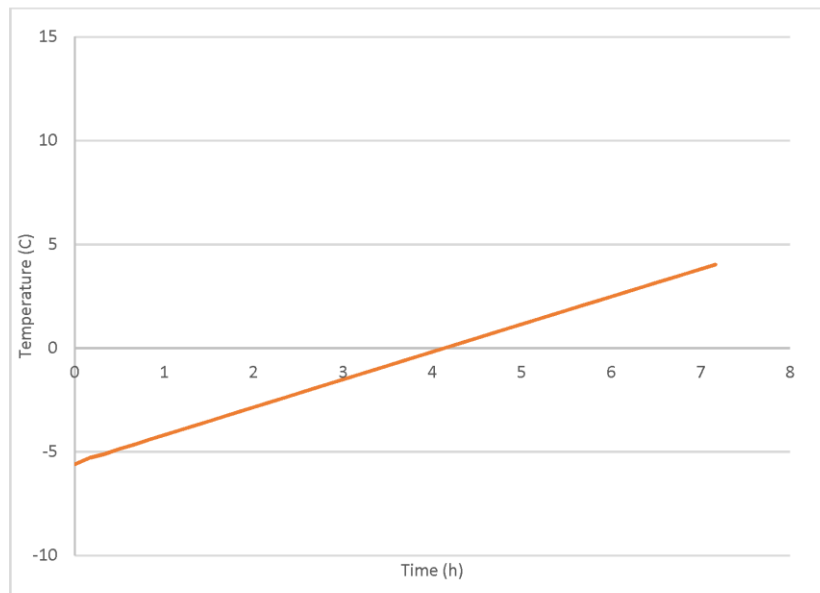
Figure 12: Temperature rise of the chiller over time based on the heat of solution from 2.3 kg of ammonia and a 12.2°C mechanical room.

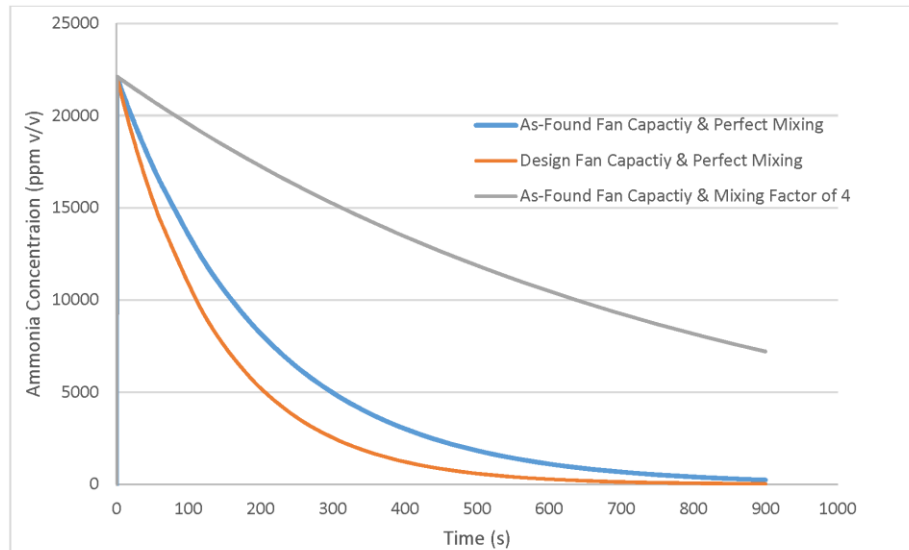
Figure 14: The dilution rate of the ammonia in the machine room for a 4 kg instantaneous release of ammonia, assuming a volume averaged concentration.

It is important to note that the calculations used to obtain the curves in Figure 14 assume a single volume concentration in the room. It is possible that some highly concentrated air and ammonia vapour was initially captured by the exhaust in the time immediately after the leak occurred. Based on the airflow patterns observed in the room during the smoke test, it is not likely this condition would have existed for a long period of time.

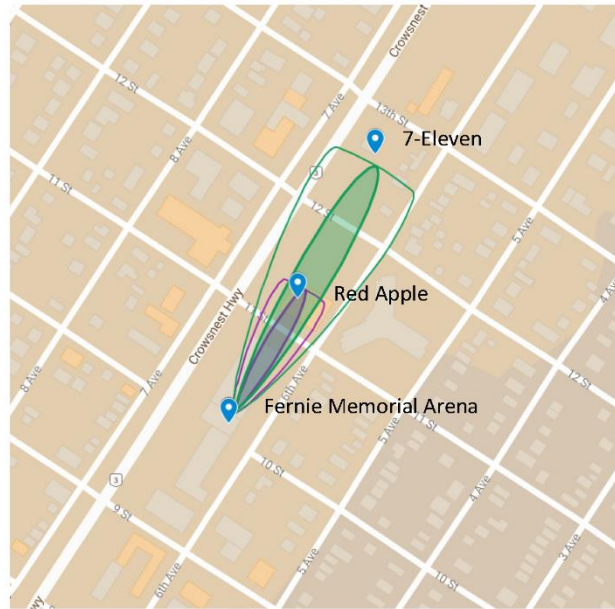
Figure 15: Dispersion modeled at the odour threshold of 5 ppm for a 4 kg (purple) and 8 kg (green) release, using Aloha (EPA/NOAA)

Witnesses at two locations, 7-Eleven and Red Apple (noted in Figure 15) reported the smell of ammonia. Because this is a relatively simple model, it is certainly possible that a pocket of ammonia traveled far enough to be detected at the 7-Eleven in either release scenario. Additionally, as previously discussed, it is also possible that the initial concentration of the ammonia in the exhaust air was higher than predicted.

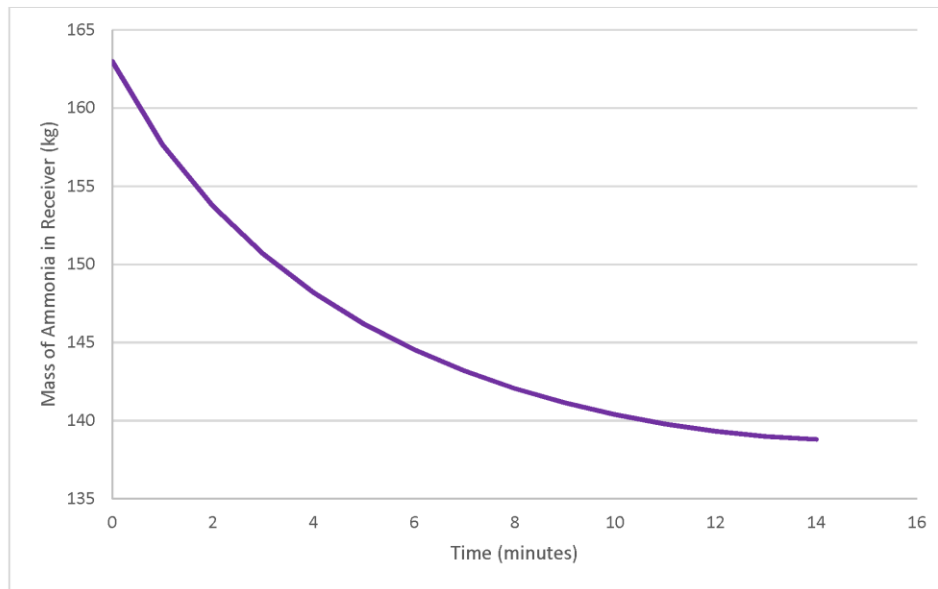
Based solely on the high side components, the initial release rate through the emergency discharge valve would have been approximately 11.7 lb/min [5.3 kg/min]. As the liquid ammonia in the high-pressure receiver boiled, it removed heat from the surrounding liquid and reduced its temperature. This reduction in temperature would have caused a corresponding reduction in pressure and less mass flow out the emergency discharge line. This is often described as a self-arresting leak situation. After 8 minutes, the release rate would have likely decreased to below 2.2 lb/min [1 kg/min]. Figure 17 illustrates the approximate mass change in the receiver as the refrigerant was released. Approximately 55 lb [25 kg] would have been released over 15 minutes until the vessel reached the saturation temperature corresponding with ambient pressure, the remaining 305 lb [139 kg] would have evaporated slowly over several hours and days as heat transferred to the refrigerant in the vessel.

Figure 17: Mass of ammonia in high pressure receiver as a result of the opening of the emergency discharge valve.

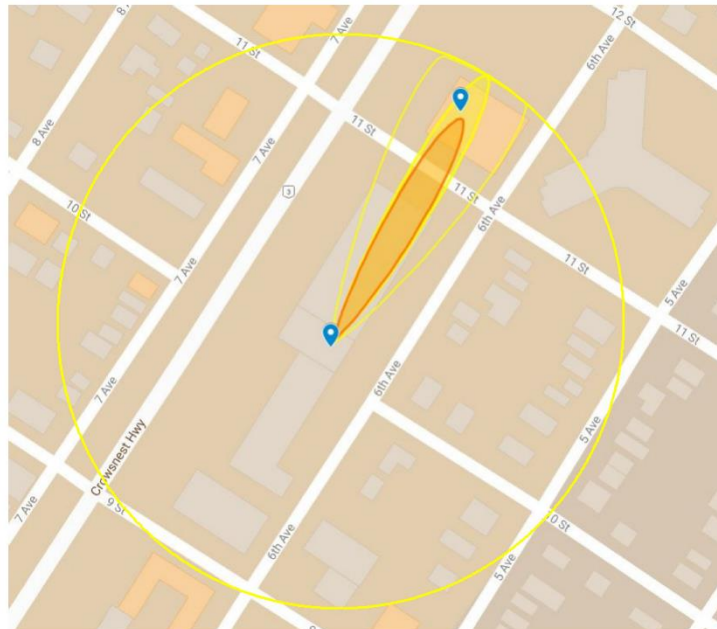
Aloha software was also used to model the vessel release and to verify the previously mentioned calculations(EPA;NOAA). Figure 18 represents the areas that could have reached 25 ppm (yellow) and 35 ppm (orange) based on this release rate. Note that of the 55 lb [25kg] of ammonia that would have been released in the first 15 minutes after opening the emergency discharge valve, more than 80% would have been released in the first 6 minutes.

Figure 18: Approximate 25 ppm and 35 ppm dispersion when the emergency relief valve was opened.
