## Incident Summary (Reference #5577396) (Final)

SUPPORTING INFORMATION	Incident Date		February 14, 2016	
	Location		Near Pink Mountain	
	Regulated industry sector		Boiler and Pressure Vessel System	
	Impact	Injury	Qty Injuries	0
			Injury description	No injuries
			Injury rating	None
	Damage		Damage description	Front and rear doors, control panel and gas piping damaged.
			Damage rating	Major
	Incident rating		Major	
	Incident overview		A high pressure diesel fired steam boiler combustion chamber explosion occurred. The burner management system may have failed resulting in an explosive mixture of diesel and combustion air upon ignition.	
INVESTIGATION CONCLUSIONS	Site, system and components		The incident occurred at a remote drilling rig north of Fort St. John. The burner management flame monitor is a microprocessor based control system designed to provide the proper burner sequencing, ignition, and flame monitoring protection on automatically ignited oil, gas and combination fuel burners. In conjunction with limit and operating controls, it programs the burner/blower motor, ignition and fuel valves to provide for proper and safe burner operation.

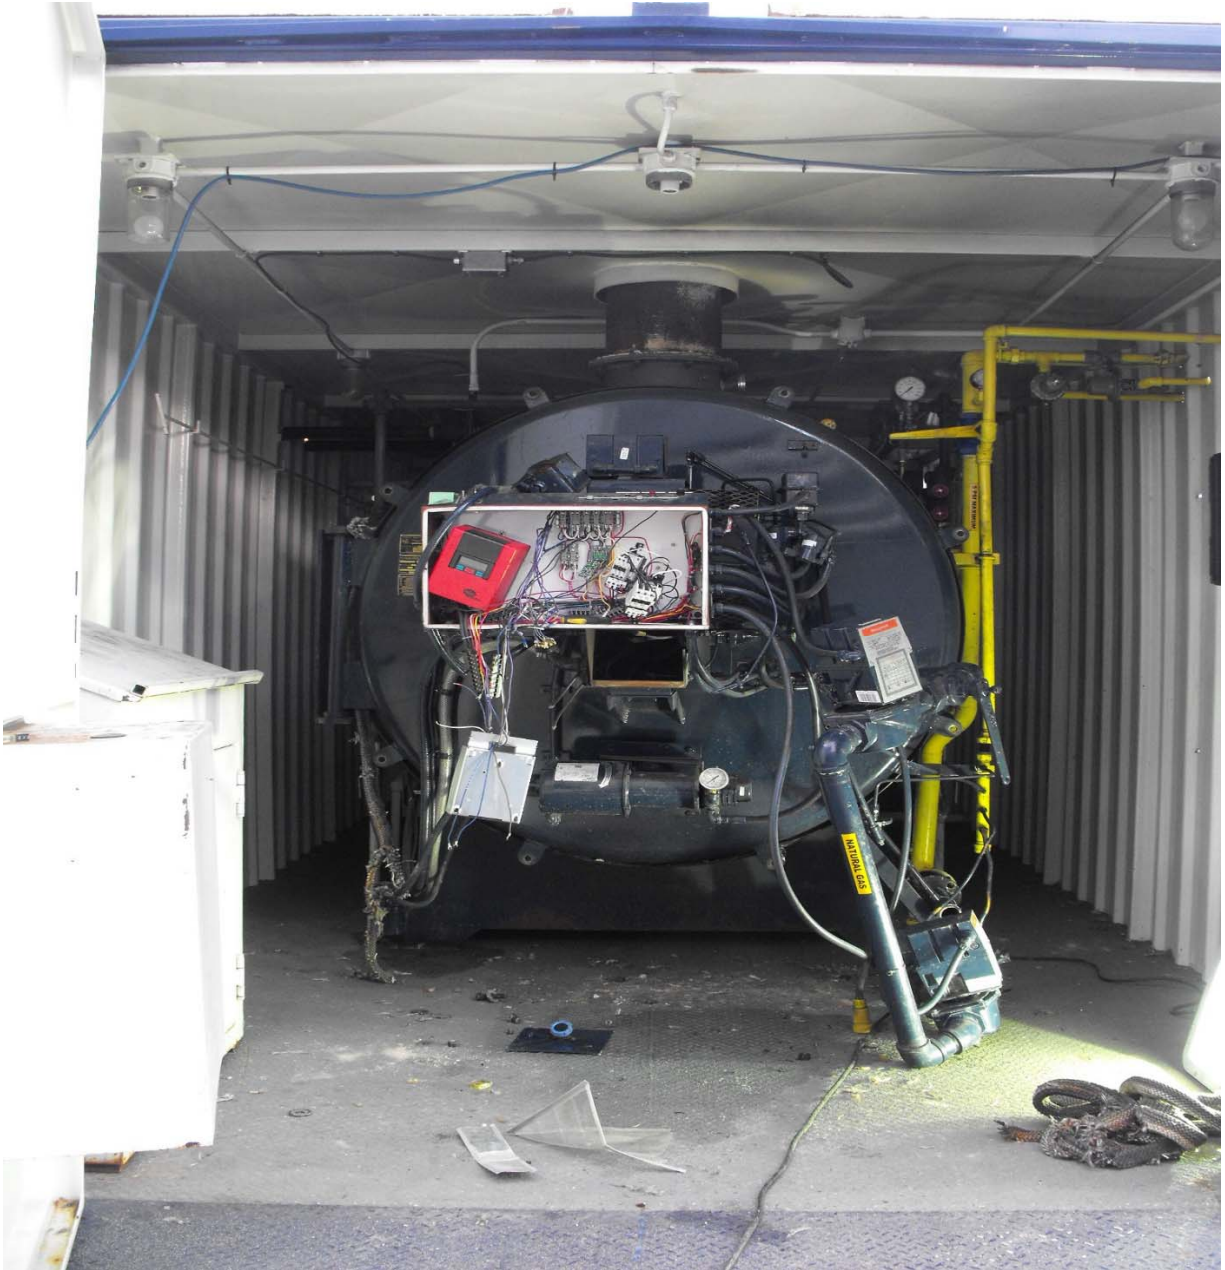
Front of Boiler

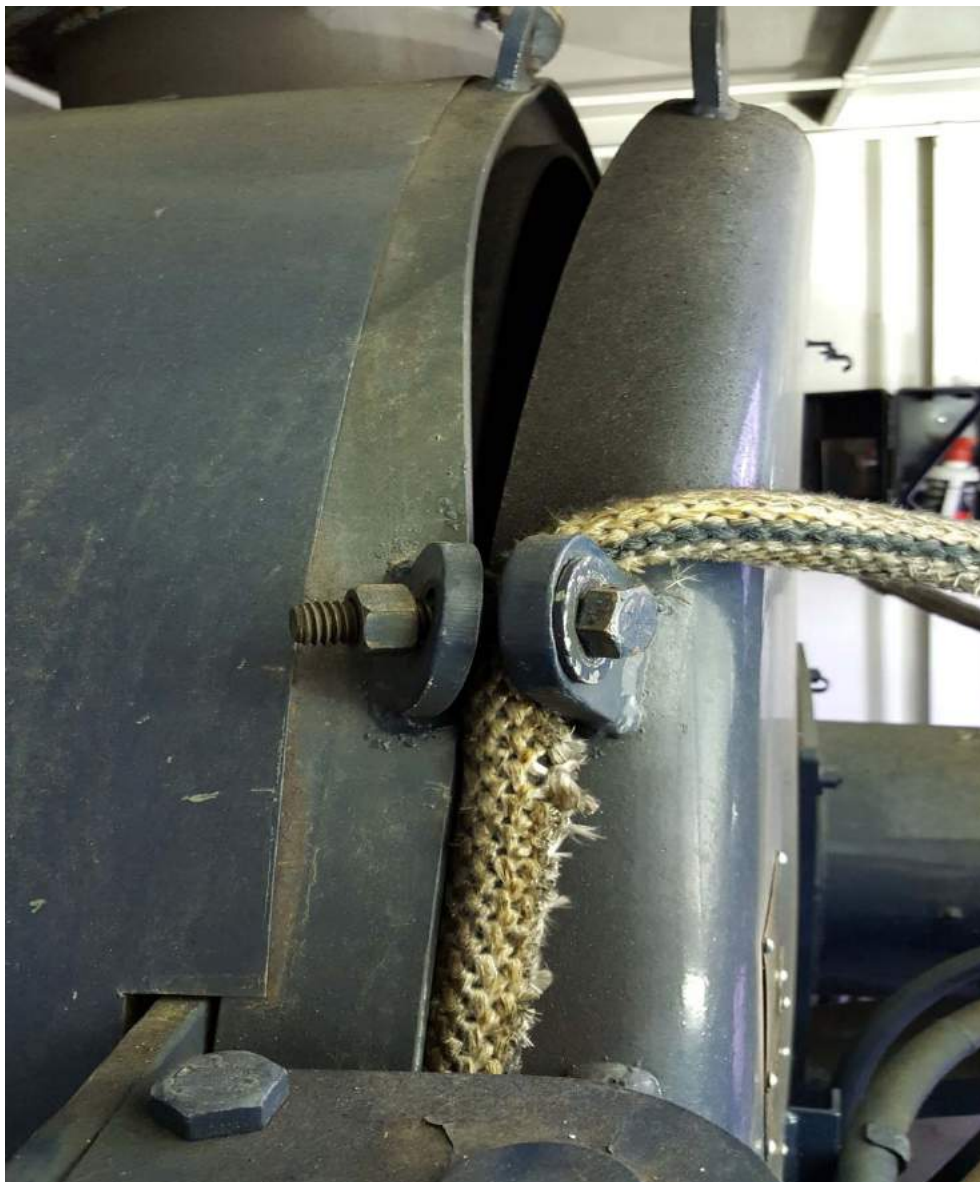
Front door damage

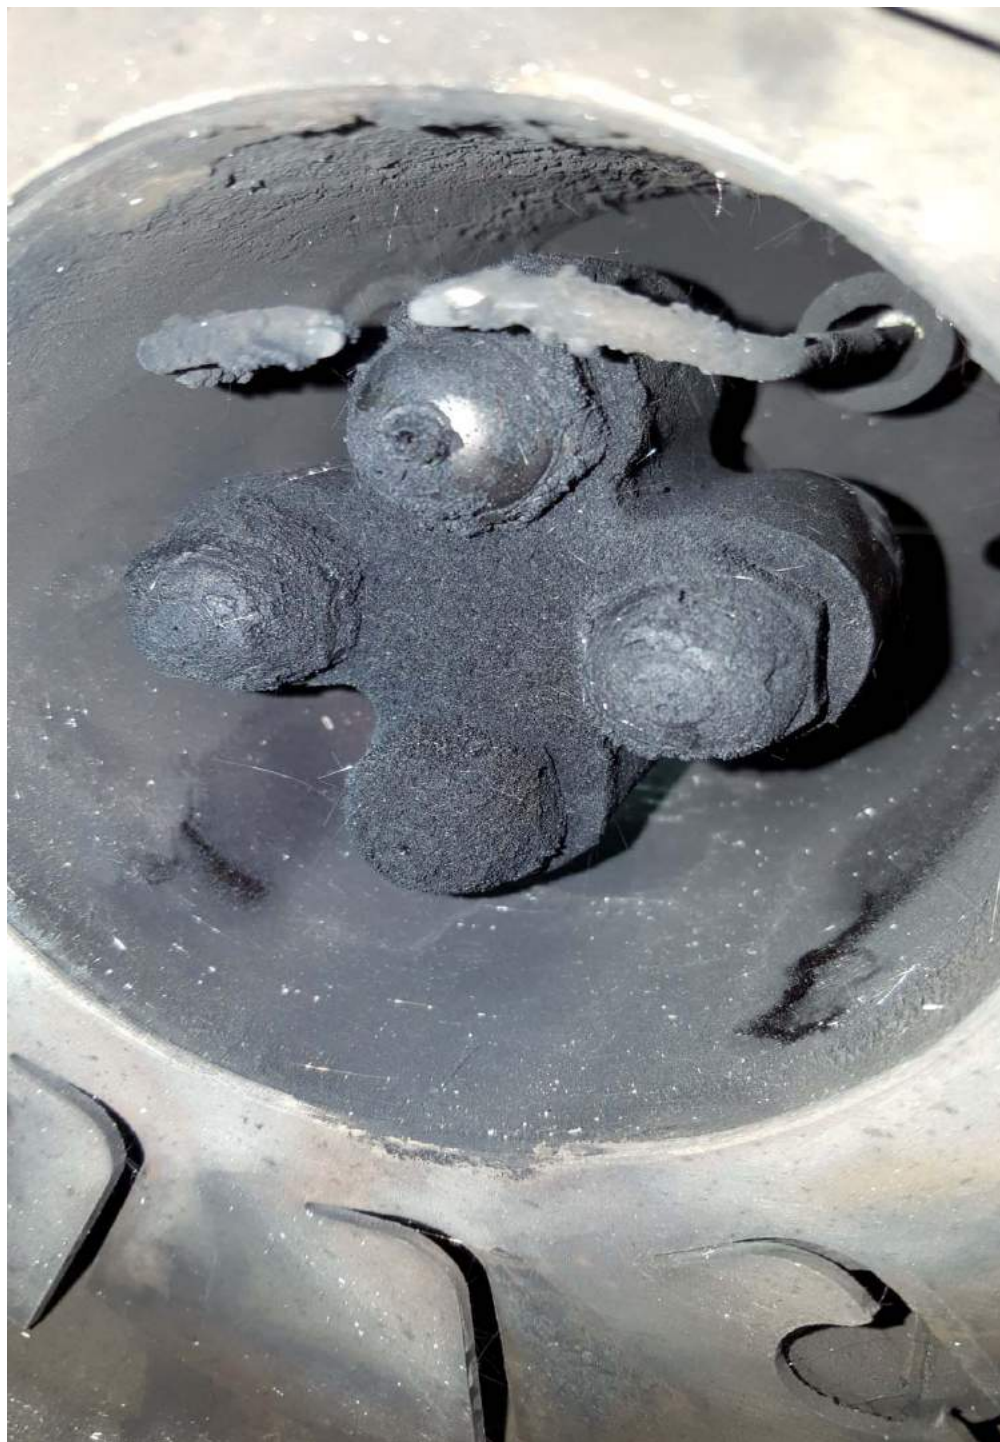
Burner nozzles
