Incident Summary #II-894392-2019 (#14873) (FINAL)

SUPPORTING INFORMATION	Incident Date	August 19, 2019	
	Location	Penticton	
	Regulated industry sector	Electrical - Low voltage electrical system (30V to 750V)	
	Impact	Qty injuries	0
		Injury description	None
		Injury rating	None
	Damage	Damage description	Damaged outer jacket of cable and inner insulation of conductor.
		Damage rating	Insignificant
	Incident rating	Insignificant	
	Incident overview	Direct buried electrical conductors shorted out when a homeowner hit them with a shovel while they were gardening.	
INVESTIGATION CONCLUSIONS	Site, system and components	A direct buried electrical wire normally is to be covered by 18" of soil in areas not accessible to vehicles. This wire additionally should have marking tape installed halfway between the conductors and the finished grade level. When the wire is buried to an acceptable depth as well as marking tape provided the personnel digging would hit the marking tape indicating a live electrical wire below. This allows persons to be aware of the hazard and continue with caution to avoid damaging the installation. Electrical installation permits allow for oversight of installations

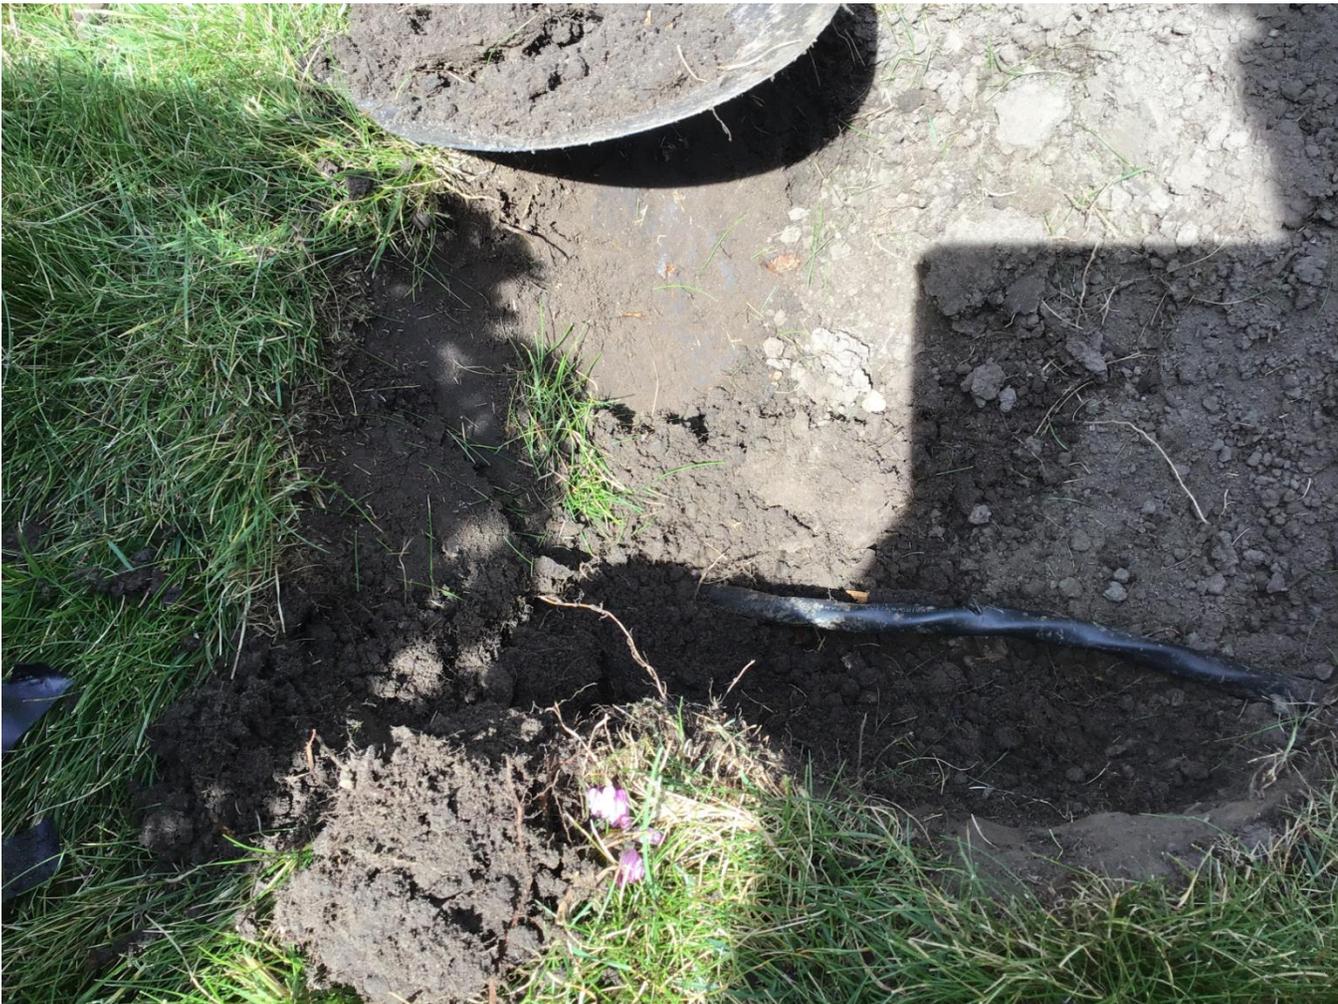
It is Highly Probable that the wiring was hit and damaged due to a lack of compliance with the electrical code during its installation with regards to the depth of burial and lack of marking tape installation. If the wiring had been buried and marked as per the requirements then the homeowner would have been able to dig a minimum of 9" before contacting the marking tape and the incident likely would have never happened.

Direct buried wire at shallow depth

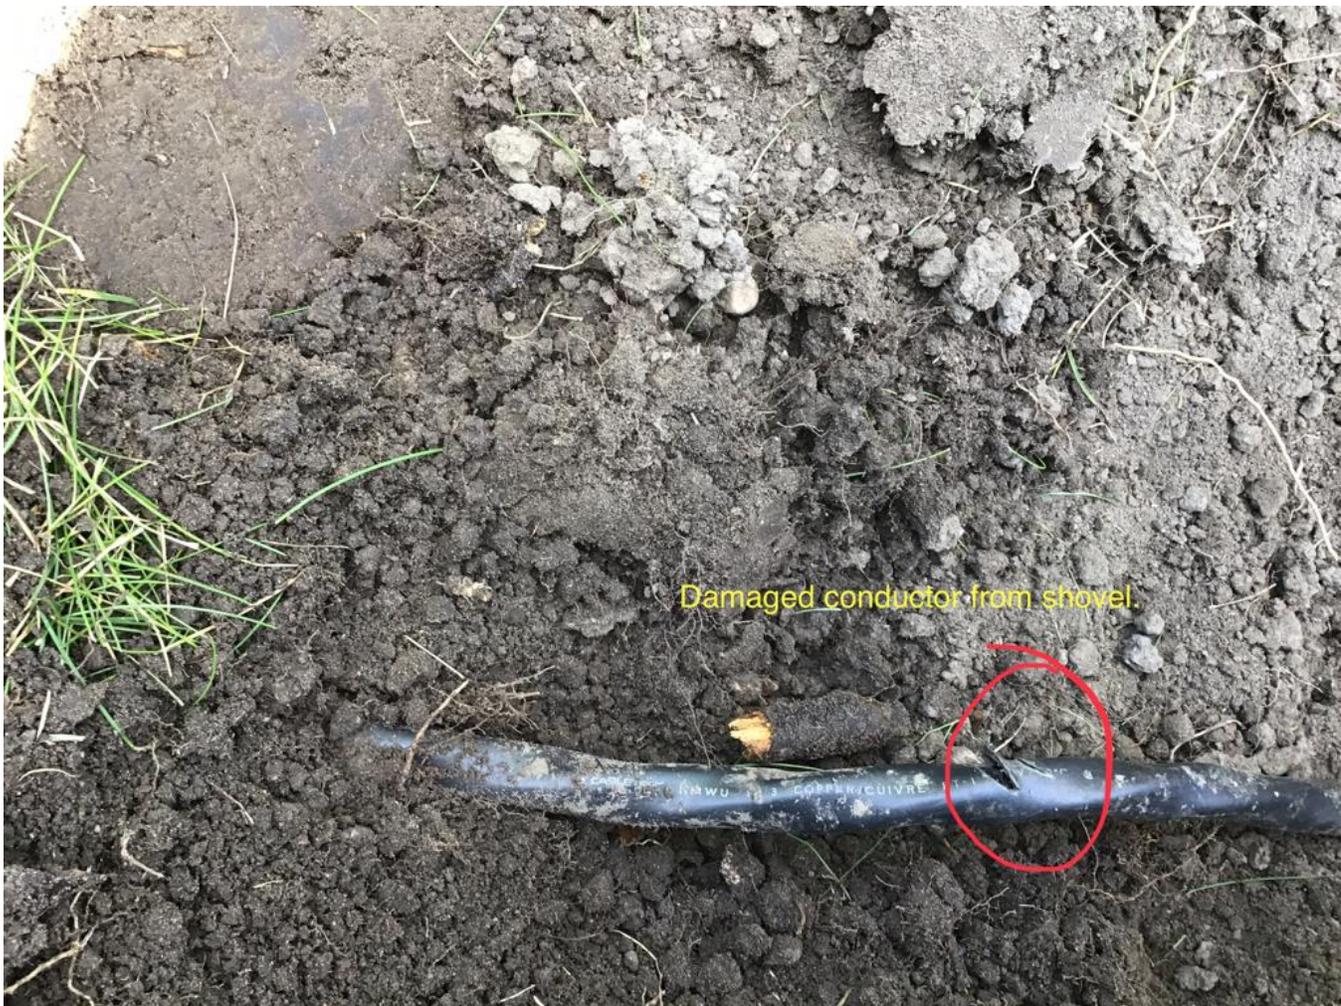
Failure scenario(s)	The homeowner used their shovel to dig a hole for installation of the new flowers. He had recently dug holes in his yard to have the irrigation fixed in the immediate vicinity so he ruled out any possible hazards with buried wiring in the immediate area. When the shovel was pushed into the ground at a depth of approximately 5" he felt the wiring and heard the breaker trip. The short happened quickly and concealed underground limiting the exposure to the homeowner. The breaker tripped as intended but the wire was damaged beyond repair and will need to be replaced.	
	Facts and evidence	<p>Pictures identify</p> <ul style="list-style-type: none"> • Wire buried at a depth of approximately 5" from the finished grade level. • No marking tape was provided above the wiring • Visible cut mark on outer jacket of cable. • Cut mark visible on inner insulation exposing copper <p>The homeowner stated they recently purchased the home and had no knowledge of installation of the wiring.</p> <p>No permit was able to be found for the installation of the buried wiring</p>

Damage to Direct Buried wire from shovel head
