Incident Summary #II-1508412-2023 (#31811) (FINAL)

SUPPORTING INFORMATION	Incident Date	February 10, 2023	
	Location	Langley	
	Regulated industry sector	Boilers, PV & refrigeration - Refrigeration system	
	Impact	Qty injuries	0
		Injury description	None
		Injury rating	None
	Damage	Damage description	Over 1000 pounds of ammonia leaked from the refrigeration system and an extensive amount of refrigerated food product was lost.
		Damage rating	Major
	Incident rating	Major	
	Incident overview	A forklift struck a liquid ammonia refrigeration line at an industrial food processing facility causing an uncontrolled leak. The leak released over 1000 pounds of toxic ammonia into the building and resulted in the evacuation of the facility.	
INVESTIGATION CONCLUSIONS	Site, system and components	<p>The building is a 110,000 square foot industrial food processing facility built in the year 2000. The facility employs approximately 430 workers and consists of warehouses, food processing areas and office spaces. The facility has multiple areas for refrigerating or freezing food products and has a large refrigeration system that contains a charge of approximately 8000 pounds of ammonia.</p> <p>The

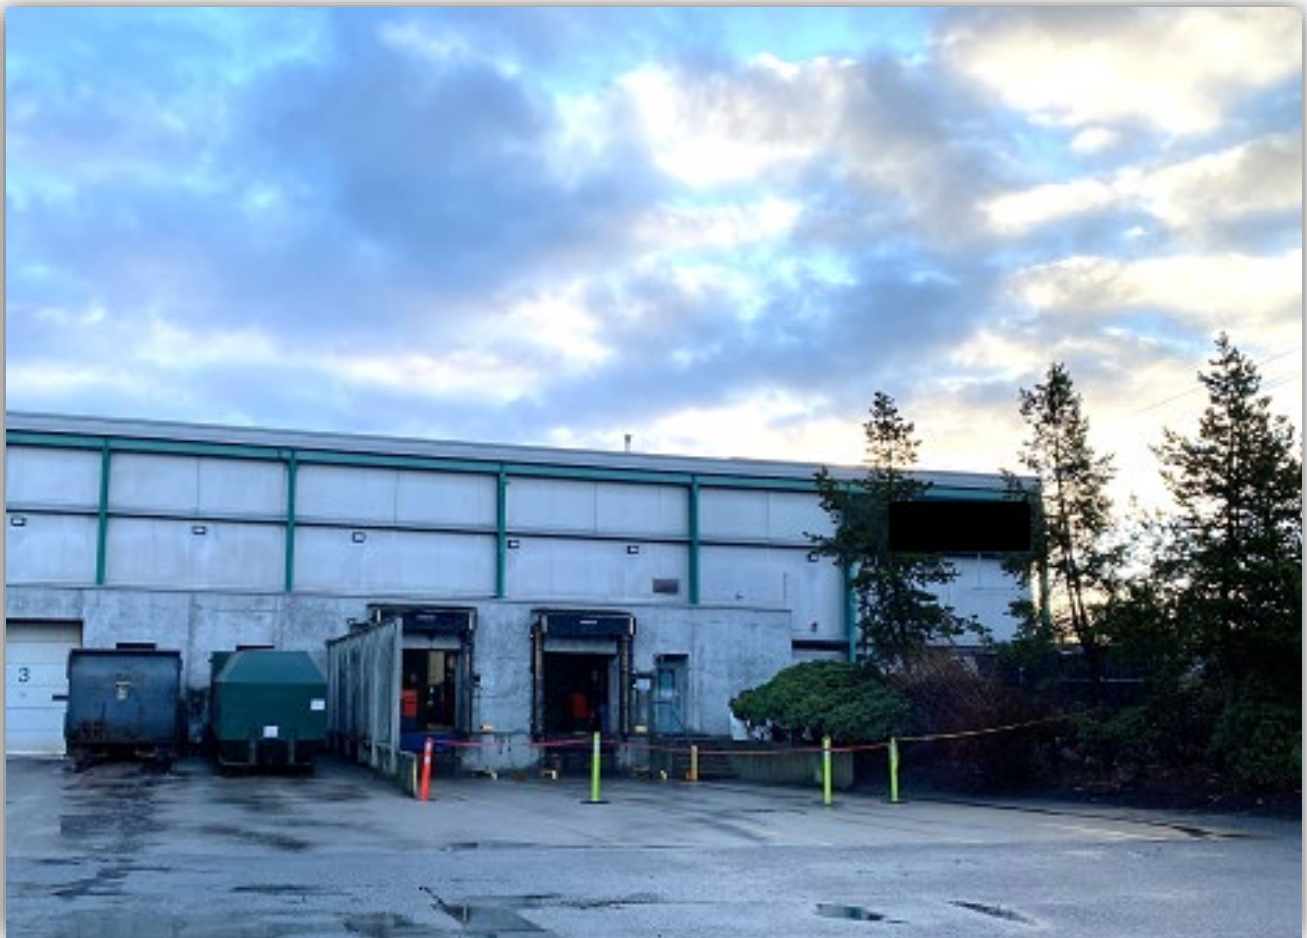
Photo 1 – Exterior of building's receiving area with two open bay doors for ammonia ventilation following the leak.

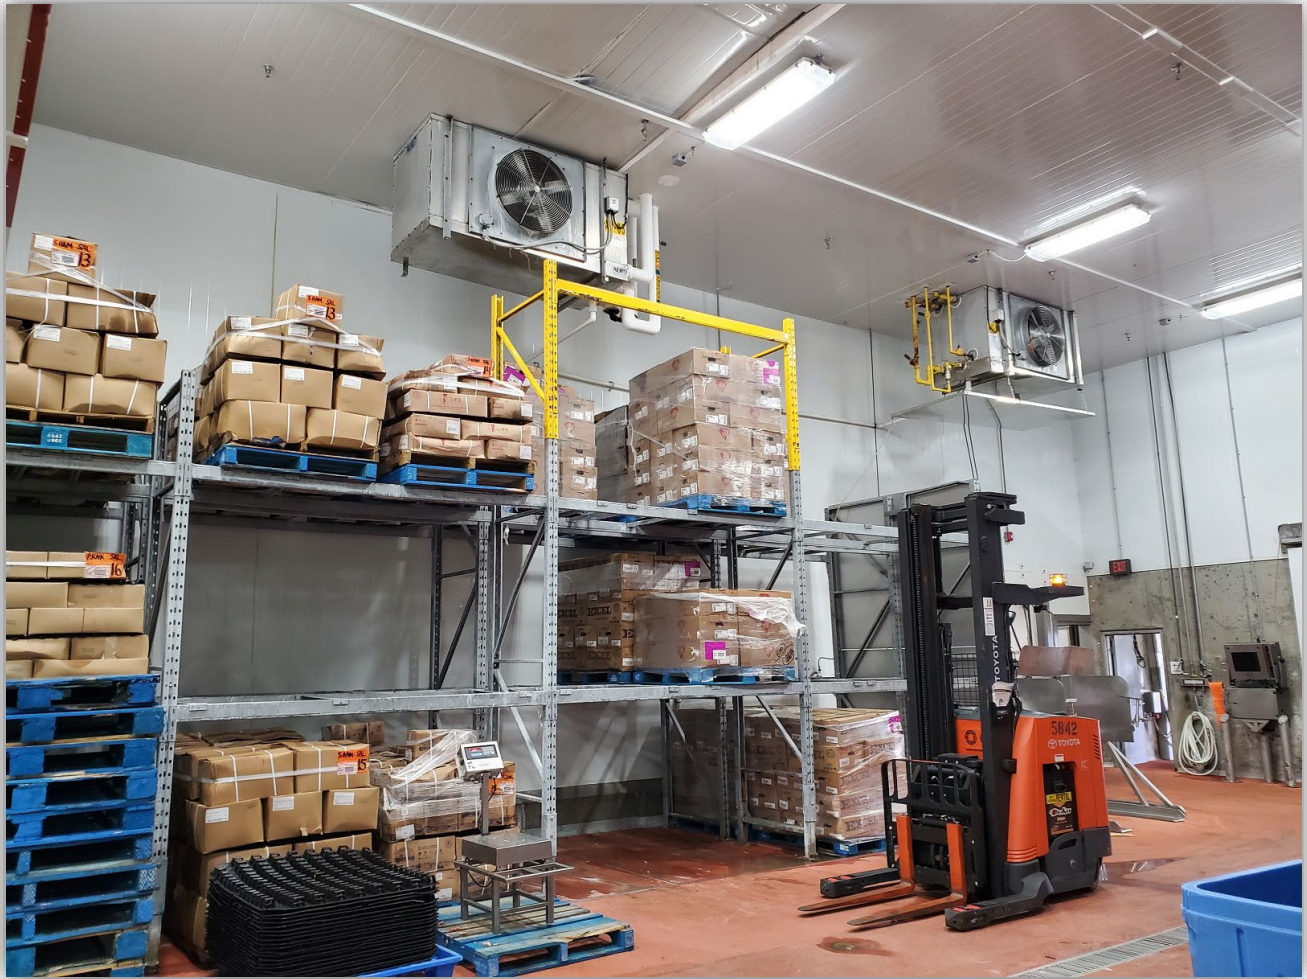
Photo 2 – Refrigerated food receiving area with racks of stacked food pallets, refrigeration condensers, and forklift.

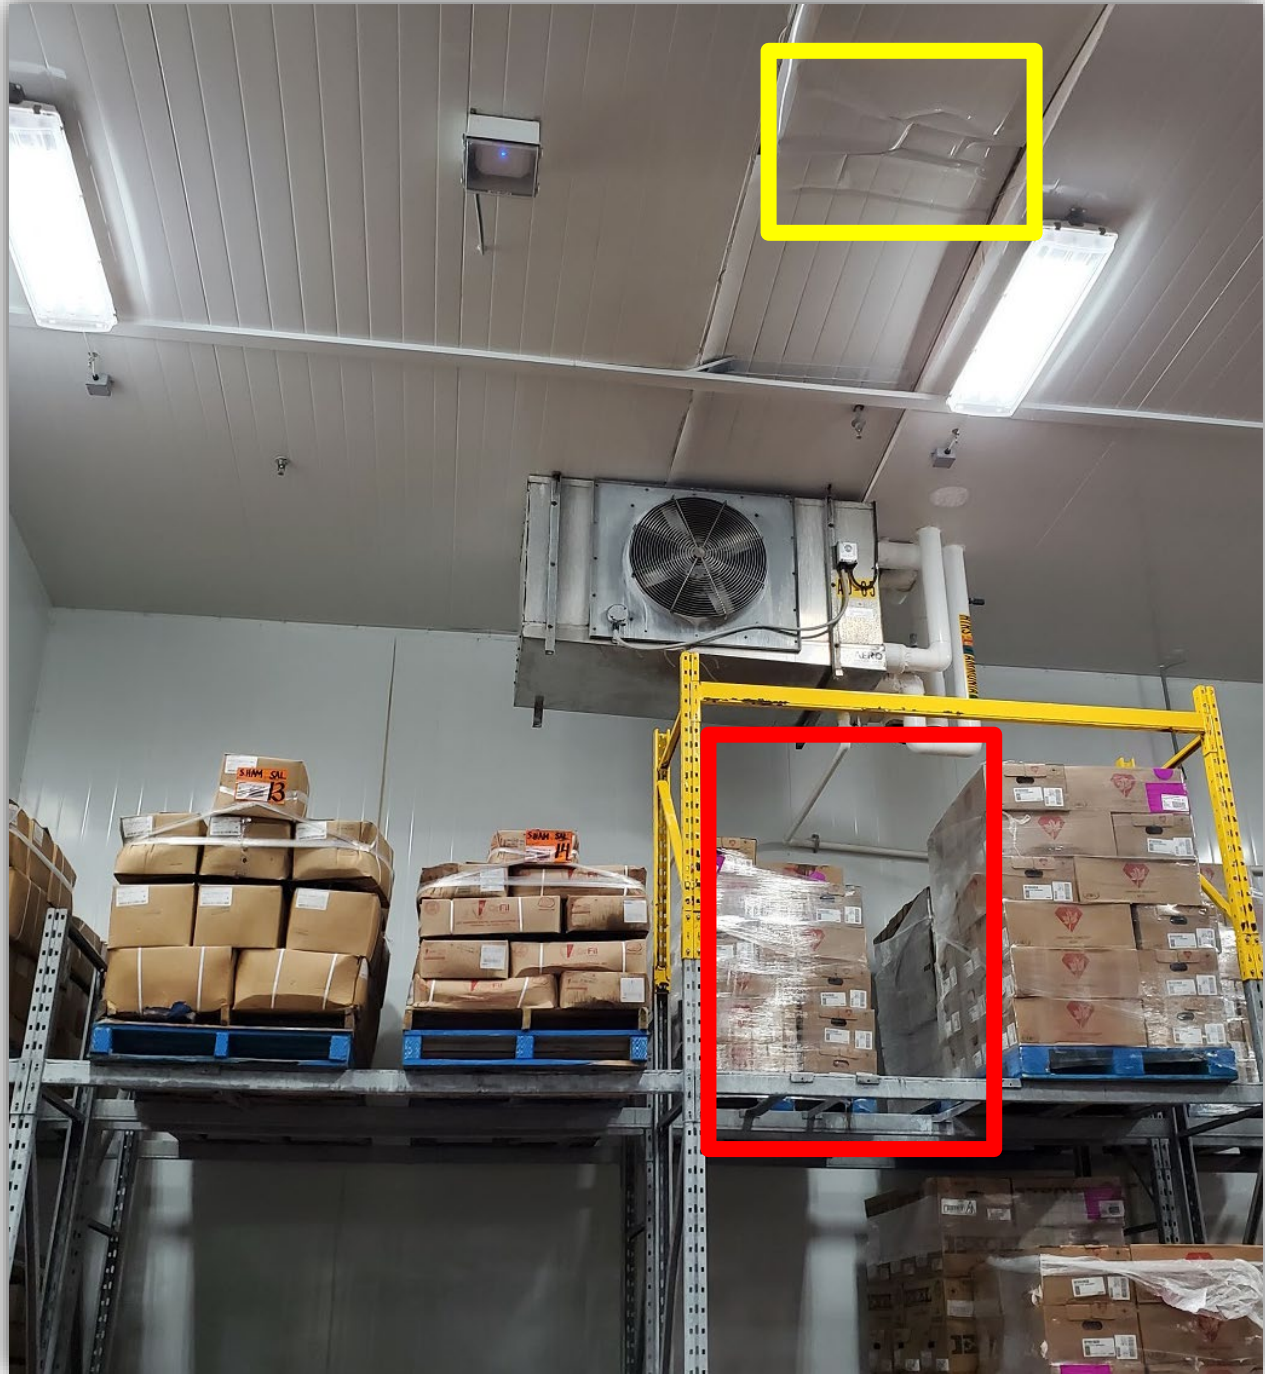
Photo 3 – [RED] Area food pallet was moved from.
[YELLOW] Area forklift contacted ceiling.

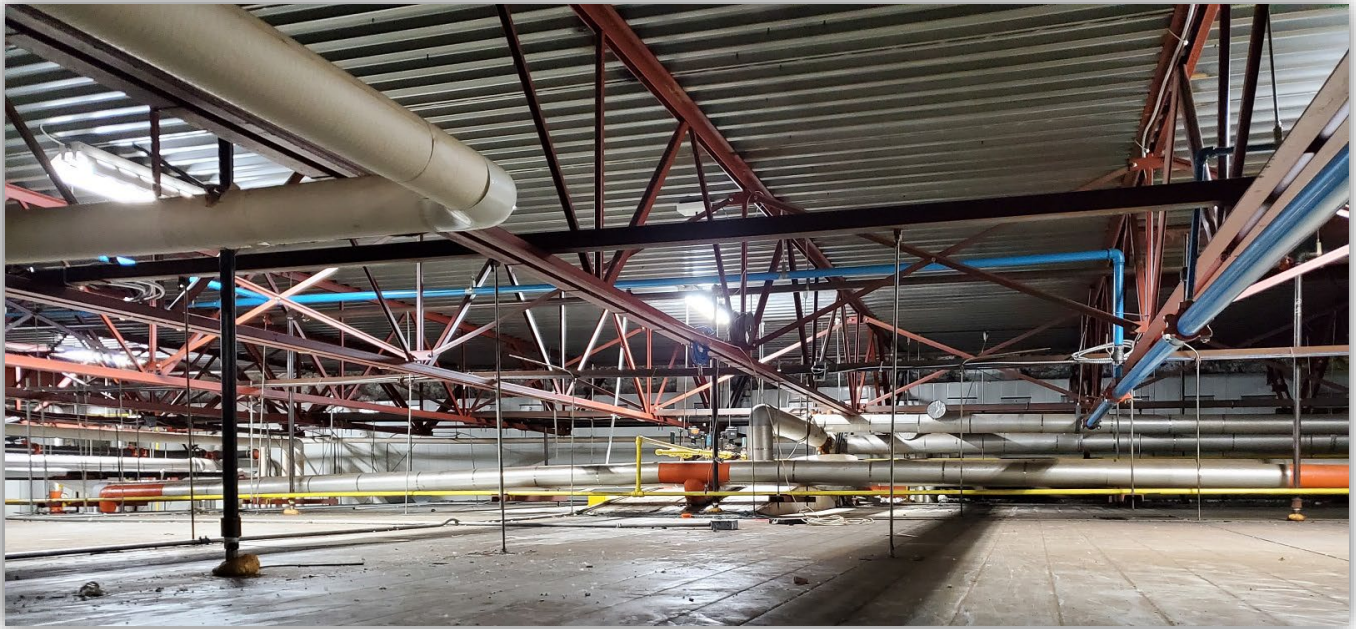
<p>Failure scenario(s)</p>	<p>When the refrigeration system was installed in the mezzanine above the insulated panels of the refrigerated receiving area, the refrigeration lines were suspended from the metal ceiling structure and maintained a clearance to the insulated panels (Photo 4). A 1/2-inch liquid ammonia line was routed underneath the other lines with only approximately 1-inch clearance between the insulated pipe and the ceiling panels (Photo 5). There was no identification of the location of the ammonia piping from the area below.</p> <p>An employee was moving a pallet of food product from an upper storage rack, with an electric forklift in the refrigerated receiving area. The employee lifted the forklift forks too high and contacted the roofing panel at the location of the ammonia line with reduced clearance. The roofing panel was pushed up bending the ammonia line. The force physically strained a two-bolt flange connection and caused liquid ammonia to escape past the sealing gaskets of the flange. The refrigeration system was shut down and the building was evacuated.</p> <p>Ammonia concentrations were measured inside the building up to 4000 parts per million (ppm) from personal sensors in the area of the piping damage from emergency response personnel. The system leaked approximately 1100 pounds of ammonia indoors and into the atmosphere before the ammonia line was able to be isolated and the leak stopped.</p>

Photo 4 – Mezzanine area above refrigerated food receiving area showing refrigeration piping suspended above insulated panels.

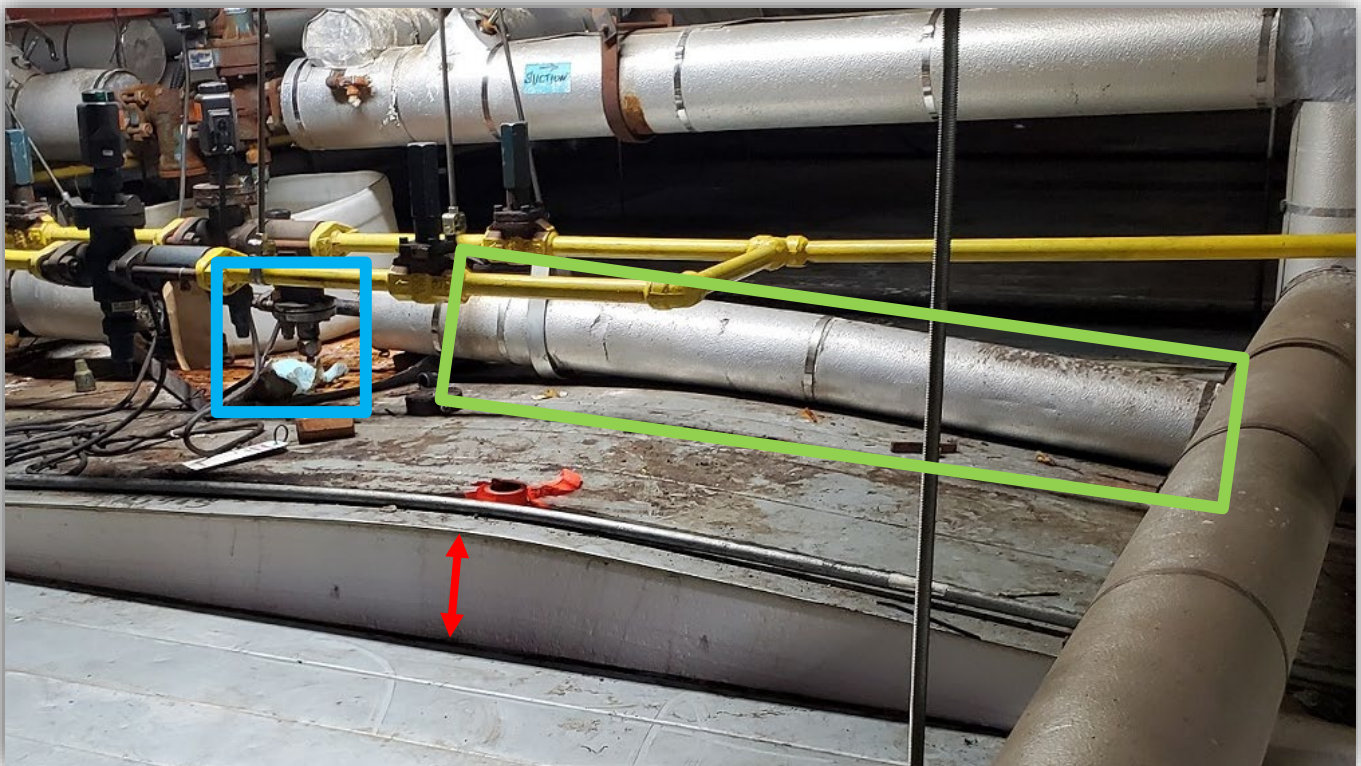
Photo 5 – Mezzanine area.

The cause of the incident was physical contact between the mobile forklift equipment and the ammonia line.

- The 1/2-inch ammonia line being installed without sufficient clearance or protection from the material handling equipment below.
- No identification of the location of the ammonia lines from the work area below.
- The reliance on the forklift operator's actions to not raise the forks high enough in the work area to contact the ceiling panels under the refrigeration lines.

[GREEN] Insulated ammonia line contacted by insulation panel.

[ARROW] The distance the insulated panel was pushed up by the forklift.

[BLUE] Area of ammonia leak from a flange connection.

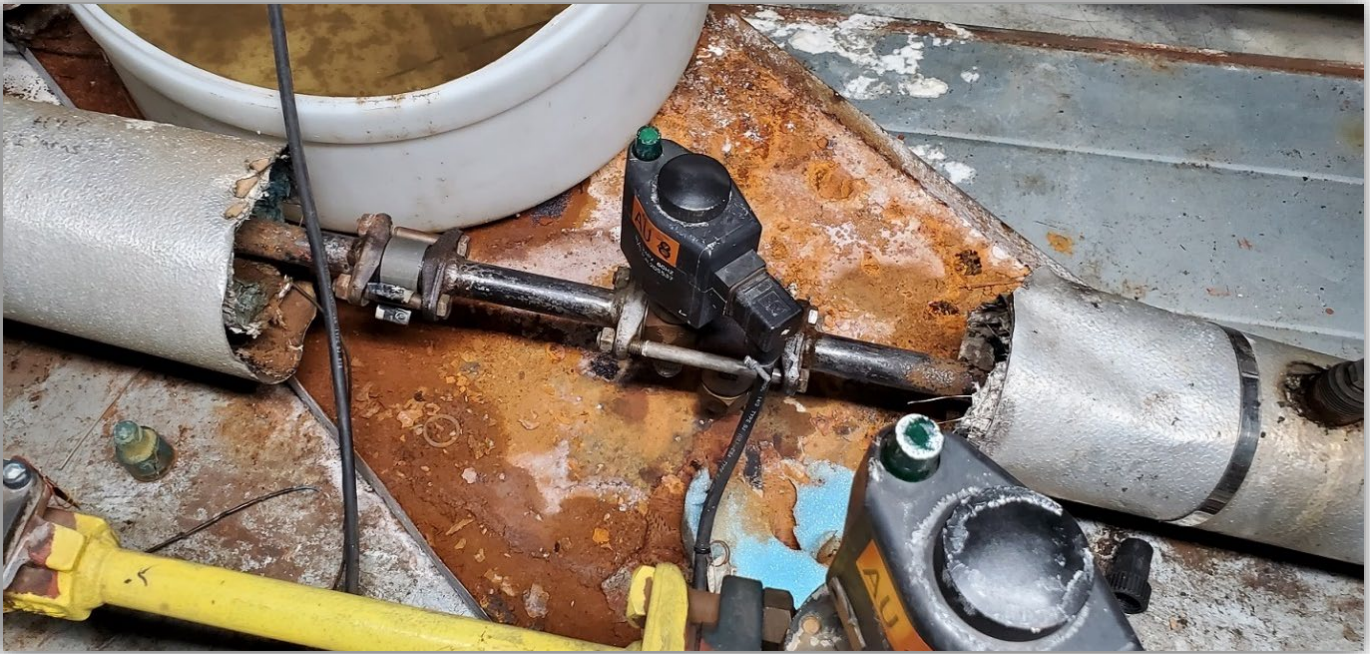
Photo 6 – Closeup of ammonia lines at the location on the leak. Ammonia line with two-bolt flanged connections with sealing gaskets.

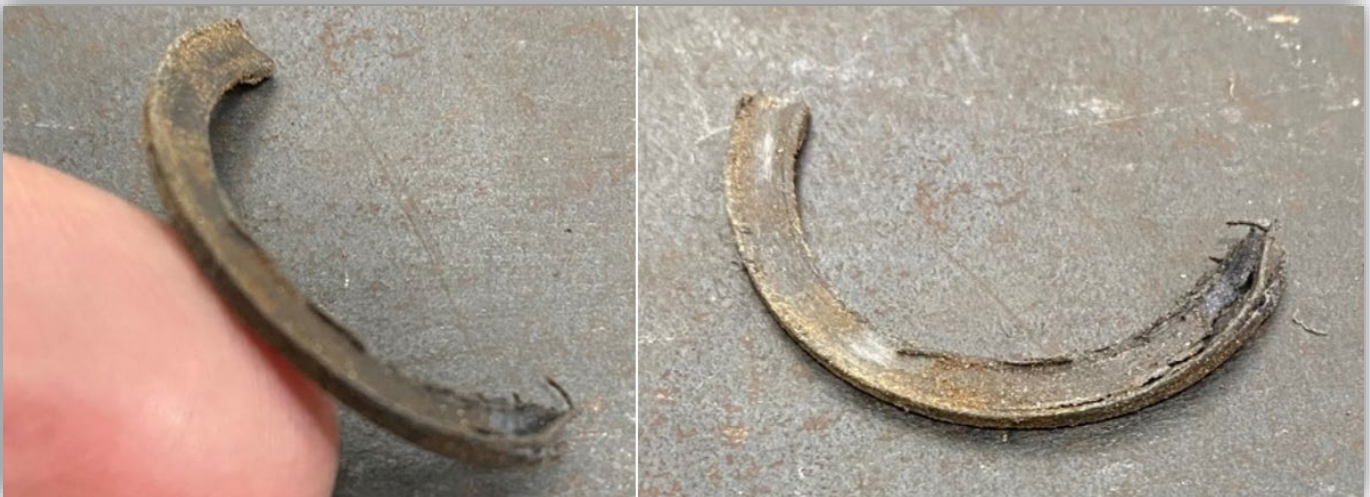
Photo 7 - Two pieces of the damaged flange gasket from the location of the leak.
