Incident Summary #II-1516573-2023 (#32891) (FINAL)

SUPPORTING INFORMATION	Incident Date	March 2, 2023	
	Location	Osoyoos	
	Regulated industry sector	Electrical - Low voltage electrical system (30V to 750V)	
	Impact	Qty injuries	0
		Injury description	N/A
		Injury rating	None
	Damage	Damage description	Electrical bus bars melted and burned where the fault occurred. Circuit breakers were wetted.
		Damage rating	Moderate
	Incident rating	Moderate	
	Incident overview	Pressure washing above dry type electrical panels results in water entering live electrical equipment causing a fault to occur.	
INVESTIGATION CONCLUSIONS	Site, system and components	<ul style="list-style-type: none"> • Electrical panels and equipment are available with different ratings depending on the environment they are installed in and if those locations are dry/wet/damp/dusty. • Electrical wiring methods and devices used to connect the electrical equipment are designed for use in various designated locations. • Qualified individuals select and install electrical equipment based on the area designation. • Designation type 1 electrical equipment is designed for a standard indoor dry location. • Designation type 3R el

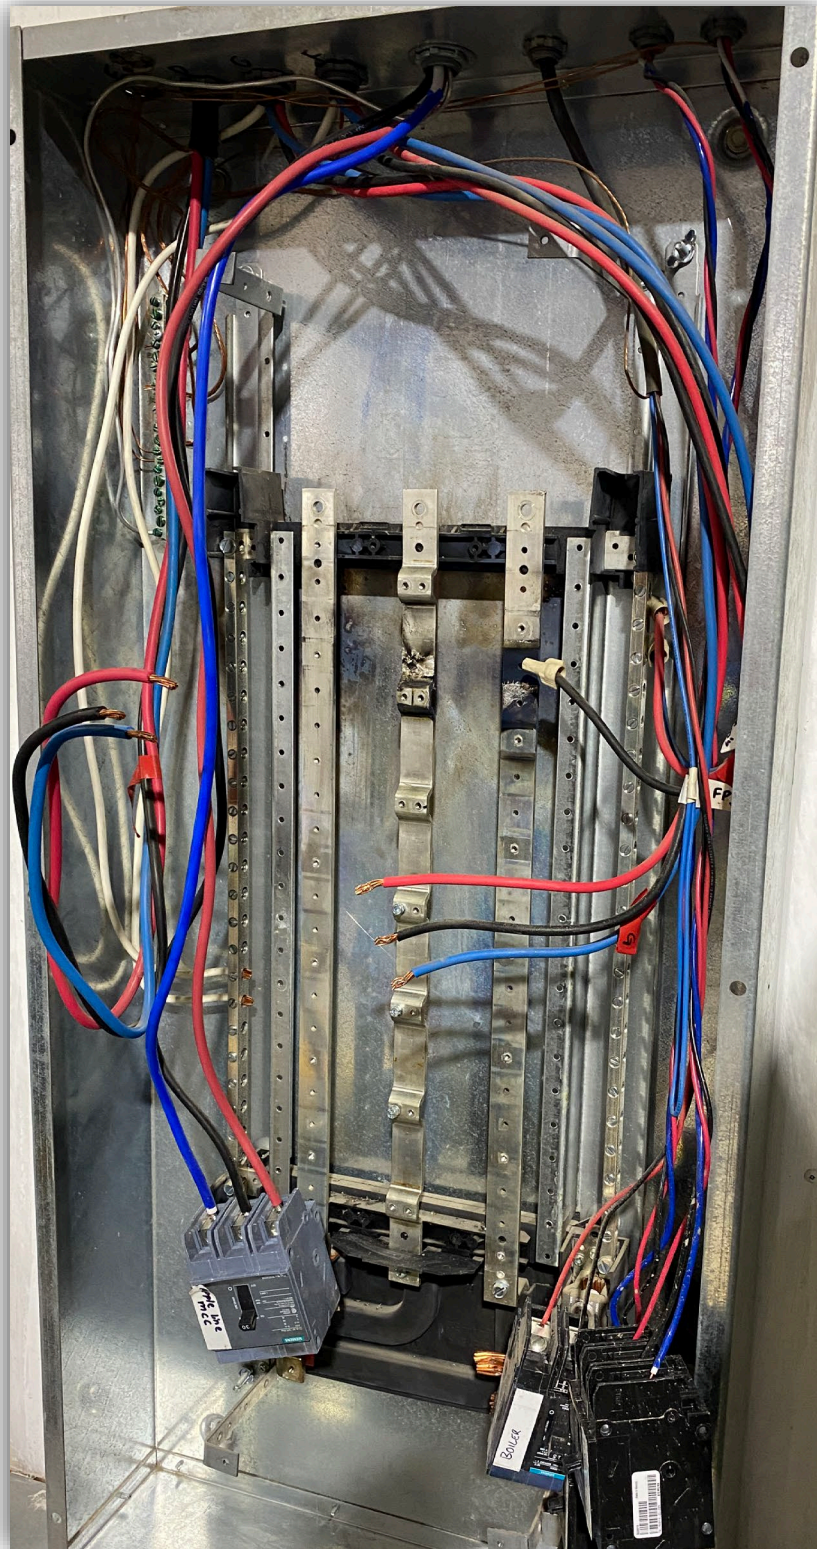
Image 1 - Electrical panel where fault occurred with all components removed.

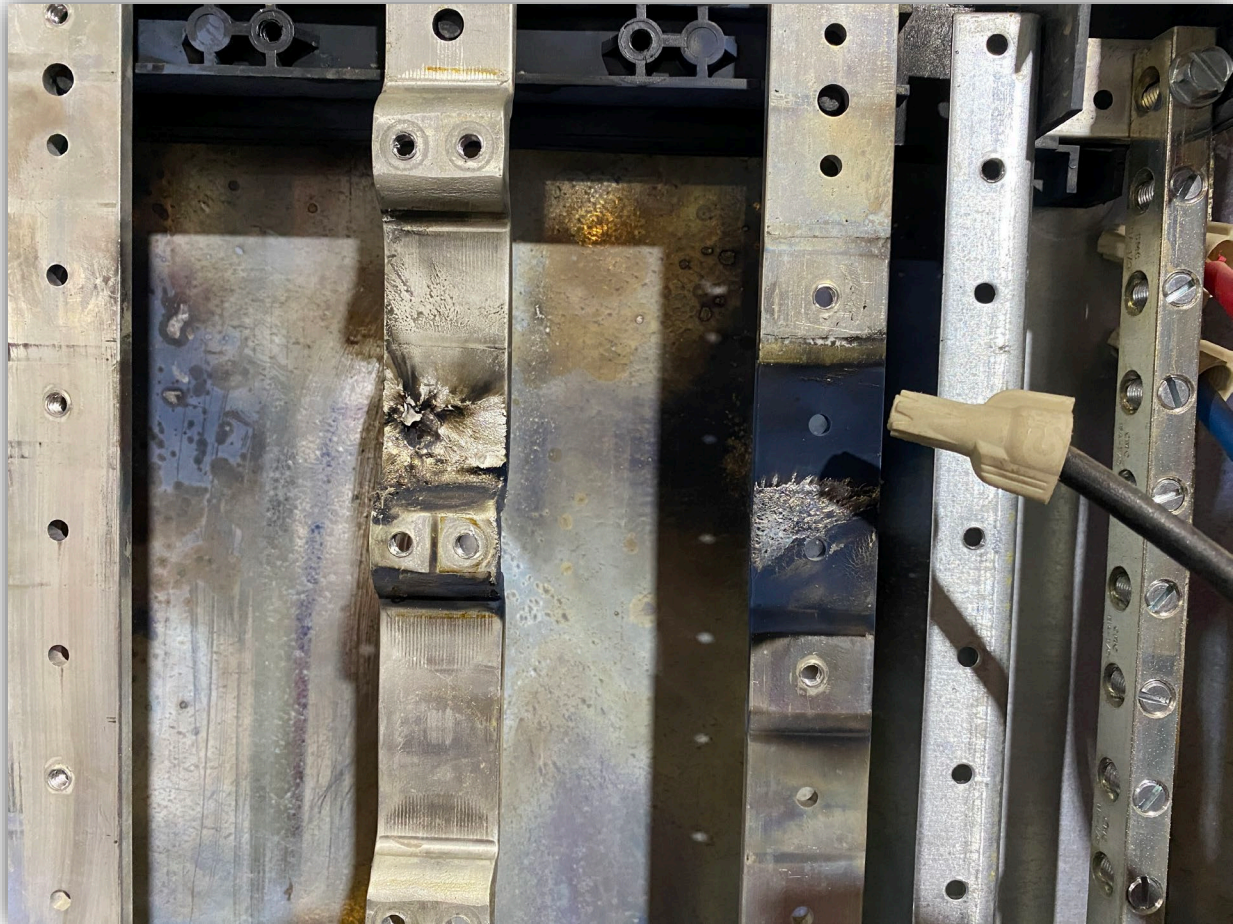
Image 2 - Bus bars of electrical panel showing charring and melting of electrical bus.

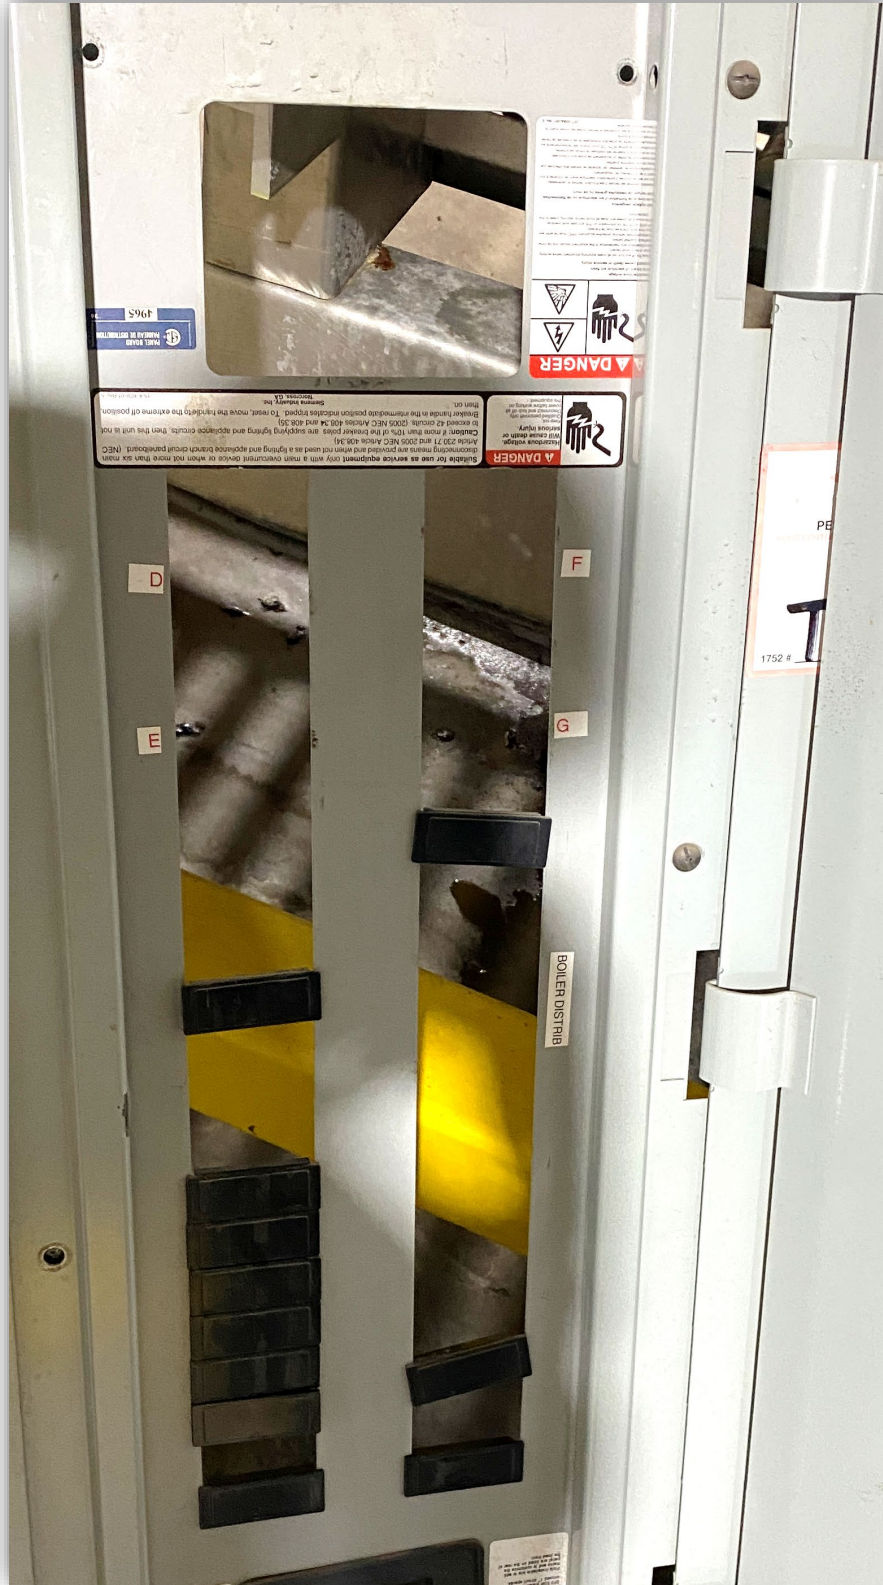
Image 3 - Cover of electrical panel showing signs of charring on panel at location of the fault.

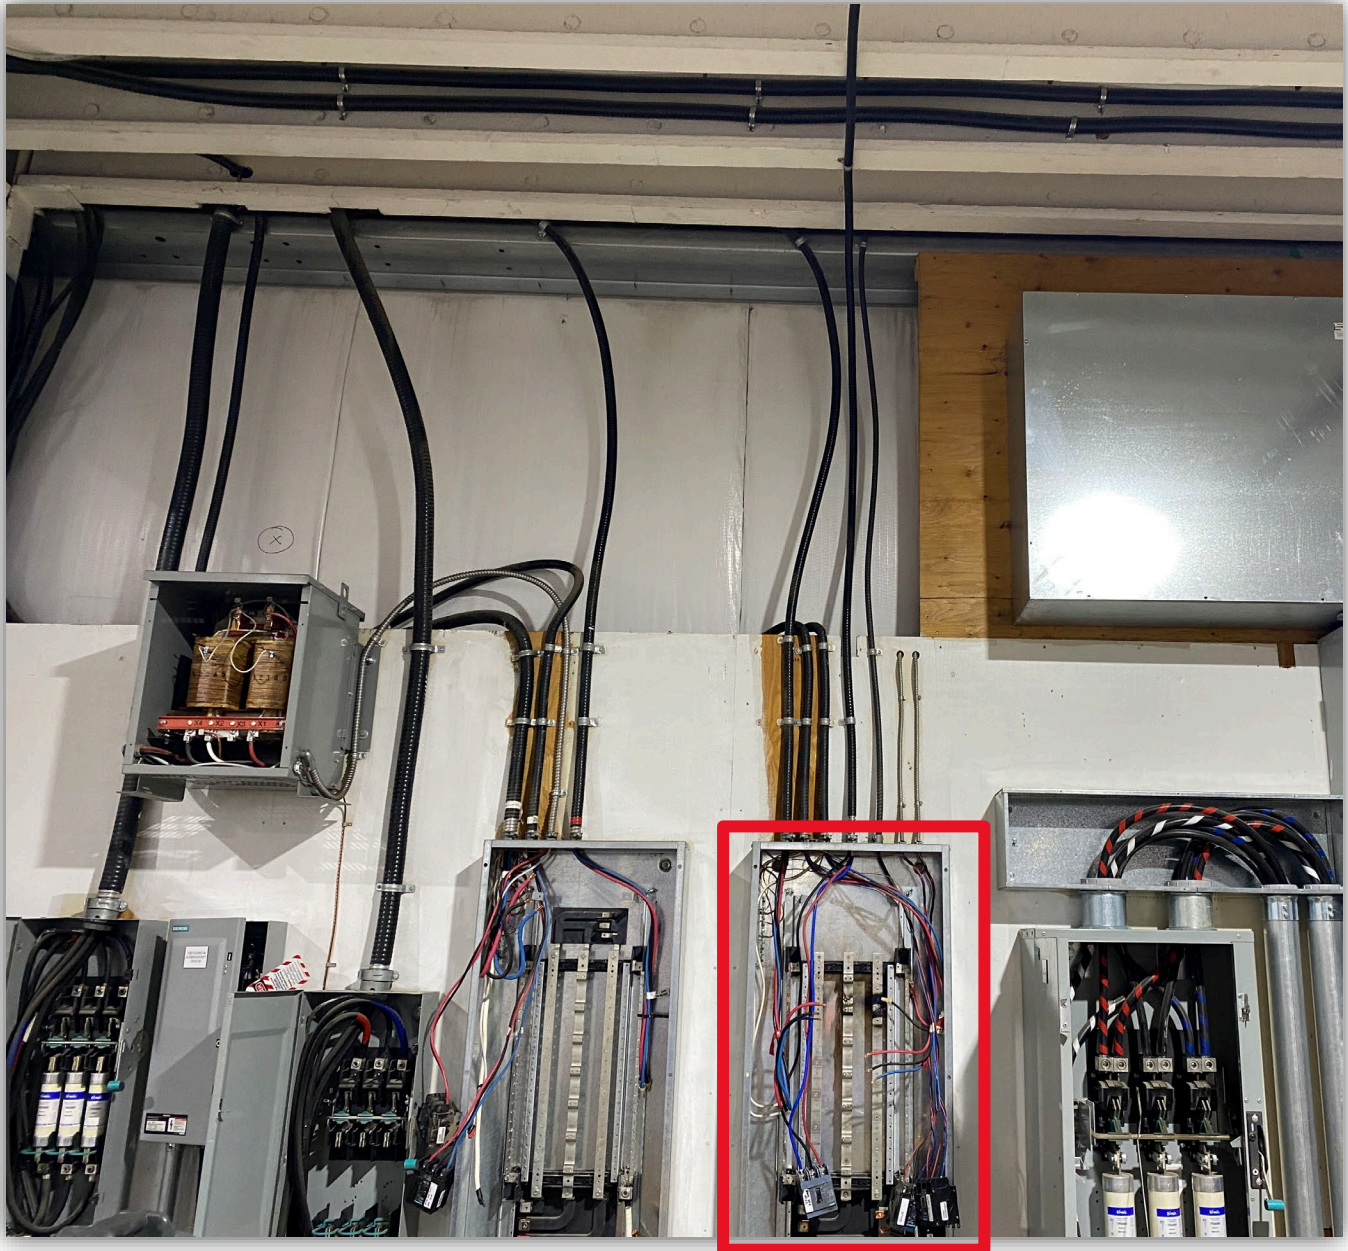
Image 4 - Electrical equipment and wetted ceiling area that was being washed. 600-volt electrical panel effected. All covers removed to allow for visual inspection of the electrical equipment after the incident occurred. In some panels circuit breakers were removed and replaced due to being wetted.

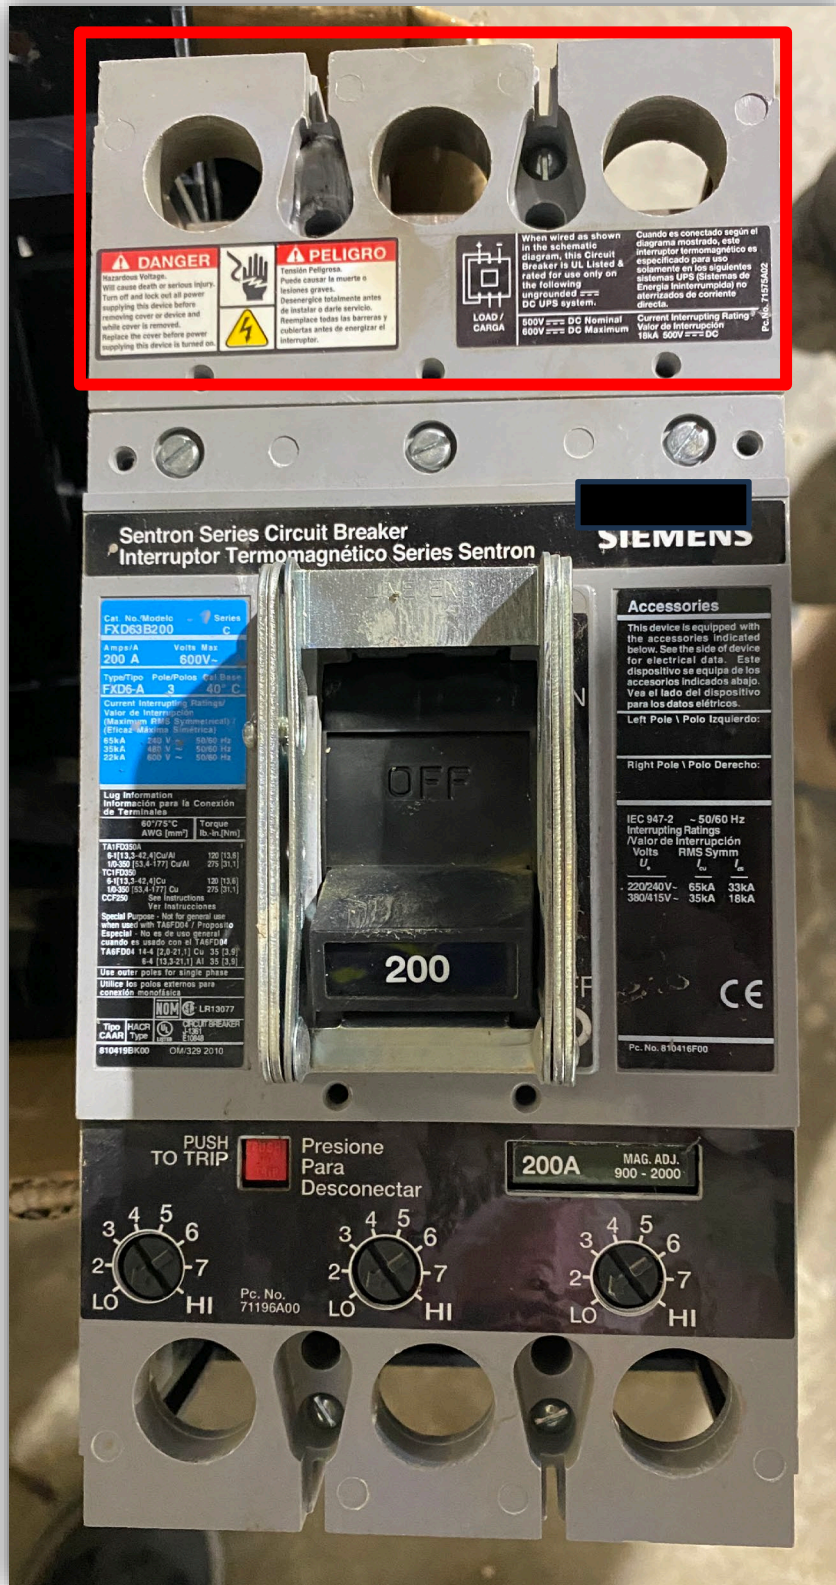
Image 5 - Main breaker that was previously installed in the electrical panel where the fault occurred. A light brown colour can be seen in this area where the fault occurred.
