Incident Summary #II-1499917-2023 (#31030) (FINAL)

SUPPORTING INFORMATION	Incident Date	January 17, 2023	
	Location	Armstrong	
	Regulated industry sector	Electrical - Low voltage electrical system (30V to 750V)	
	Impact	Qty injuries	2
		Injury description	Two people were treated for smoke inhalation attempting to personally douse the fire.
		Injury rating	Moderate
	Damage	Damage description	A single-family dwelling fire occurred that structurally destroyed a large portion of the home and damaged the remaining home with heat and smoke, additionally water from fire-fighting and possible other water ingress flooded the basement and made it inaccessible.
		Damage rating	Severe
	Incident rating	Severe	
	Incident overview	<p>The use of portable electric heaters utilized throughout home were plugged into various outlets throughout, the home had a very limited number of outlets installed due to the age of the structure. There were no notable alterations and viewed as original wiring.</p> <p>The location of fire origin in the bedroom had only 1 or 2 outlets that were operational in the room which had a portable electric heater, TV and gaming console utilized and plugged into a flexible ext

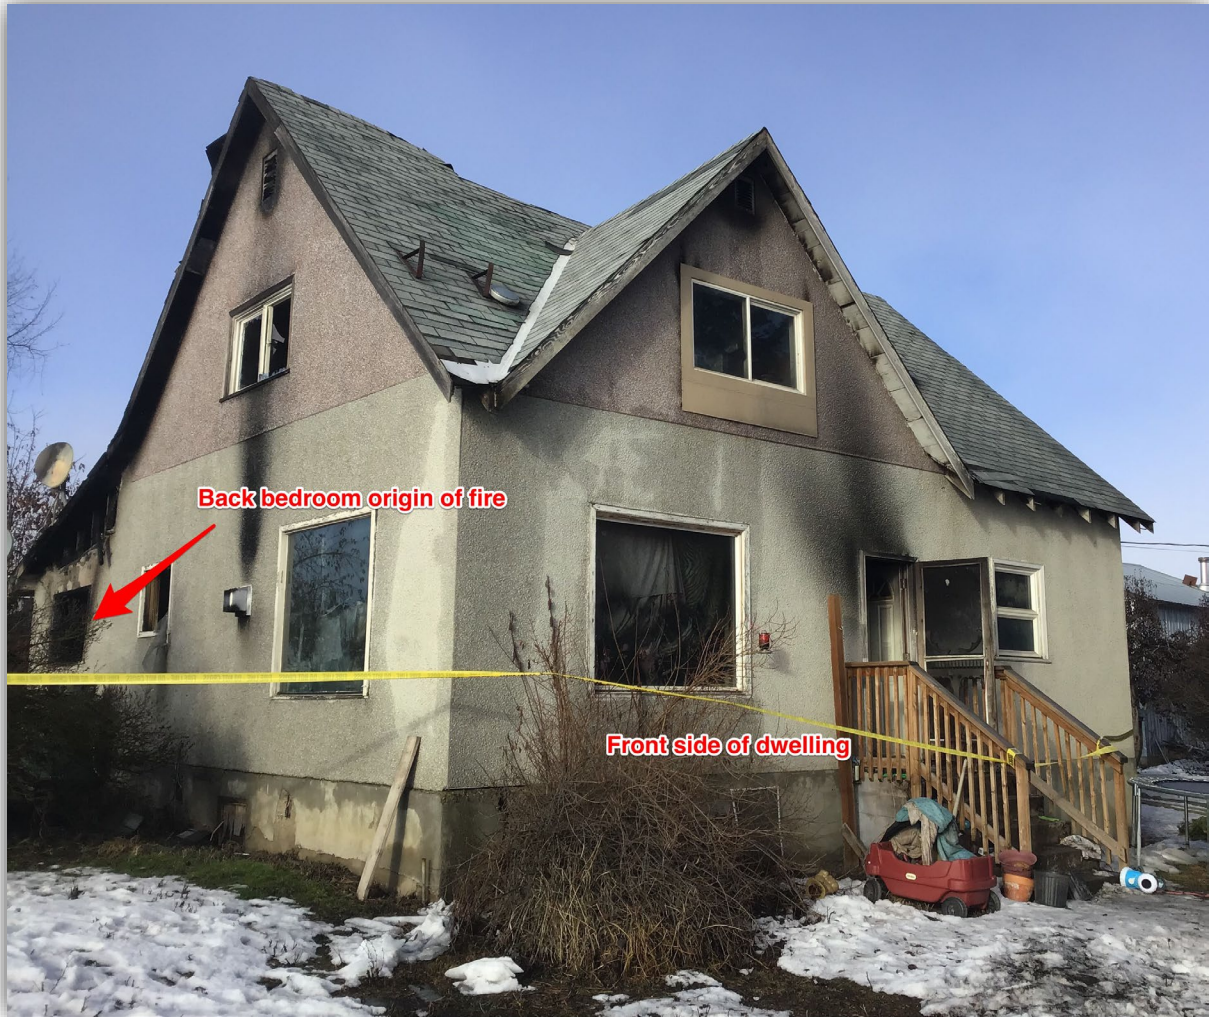
Photo 1 - Front side of dwelling from Southeast direction showing smoke only damage at front with windows intact.

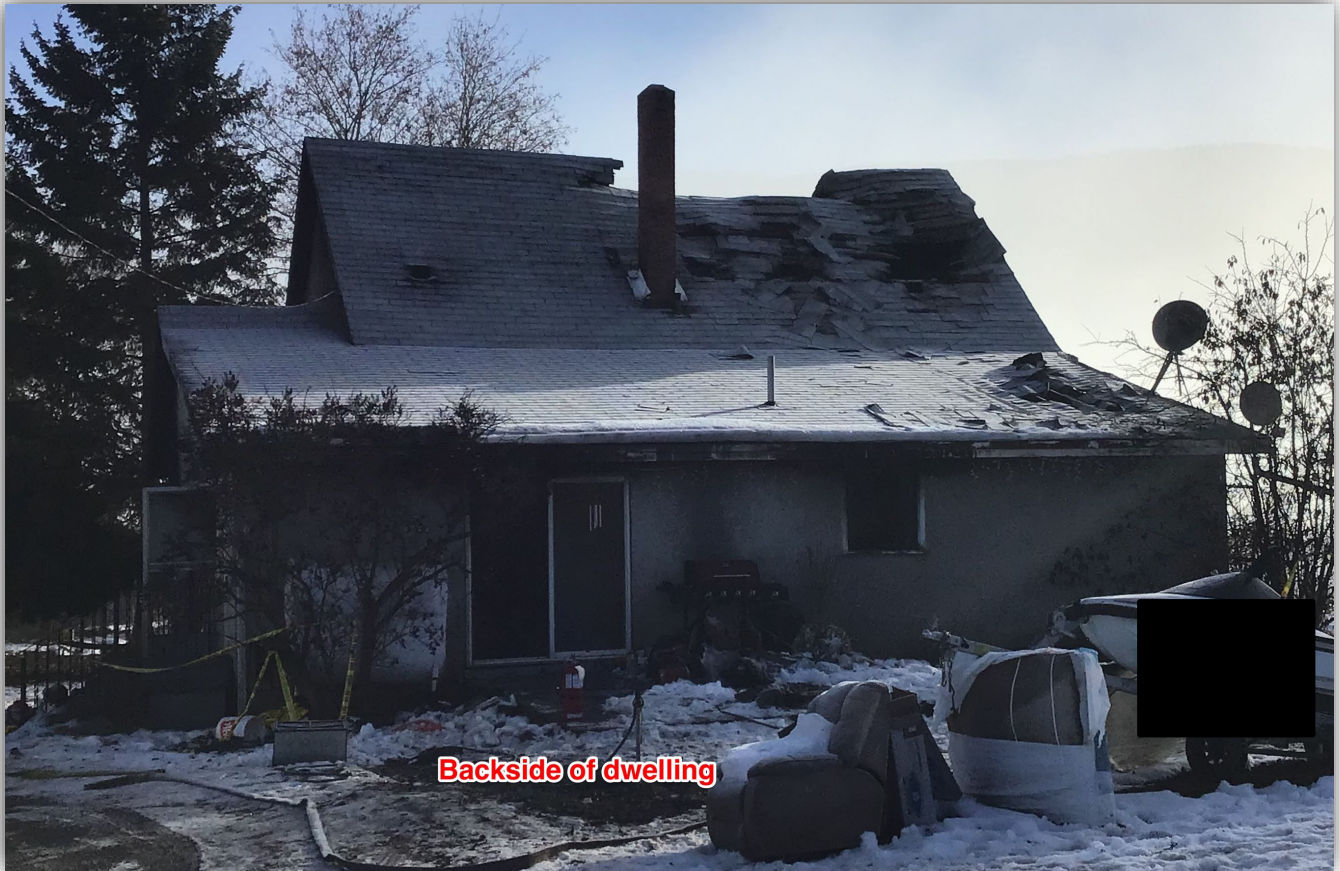
Photo 2 - Backside of dwelling from Northwest side, roof burnt through near South end upper floor.

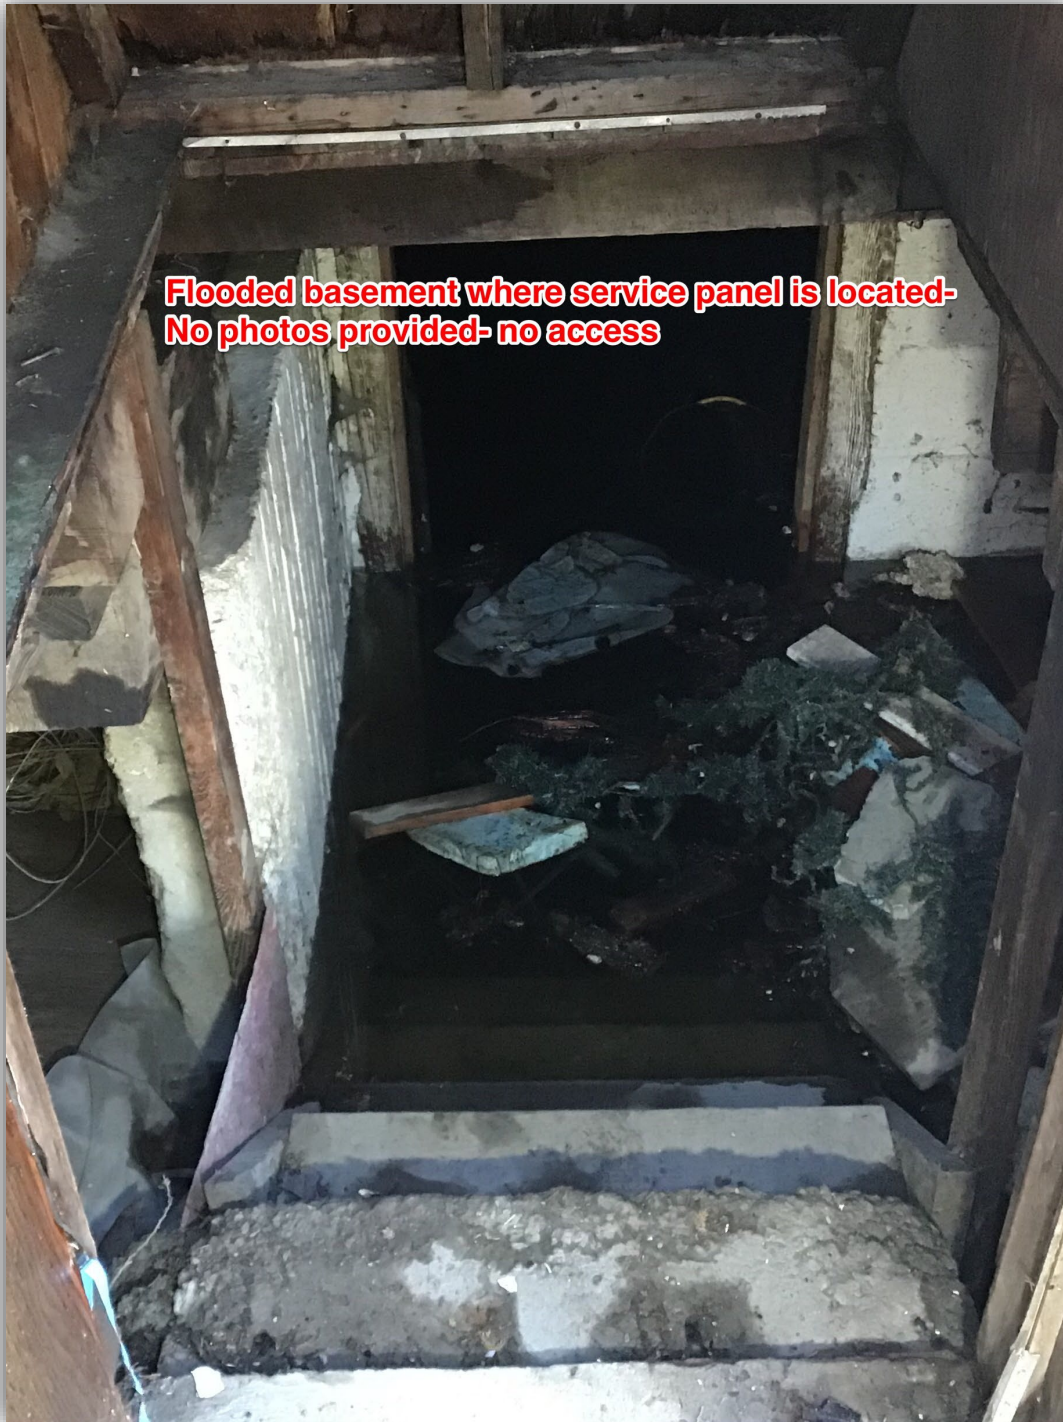
Photo 3 - Basement where service panel was located - no access or photos to review, access is from exterior only. Entry from exterior was flooded, with no further information available.

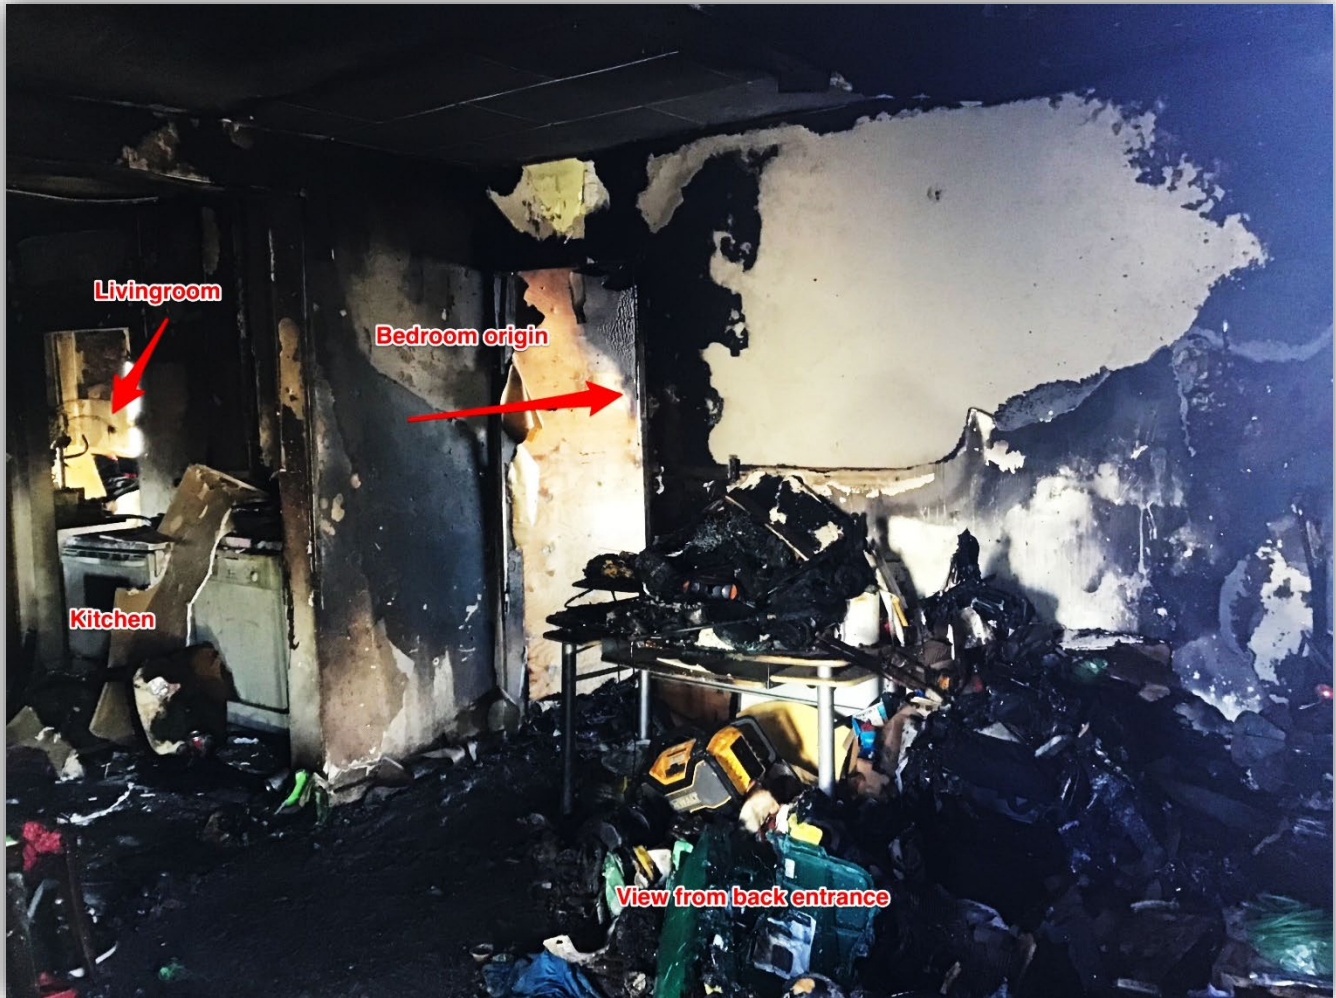
Photo 4 - Interior Southwards into mud room towards kitchen and bedroom/bathroom areas.

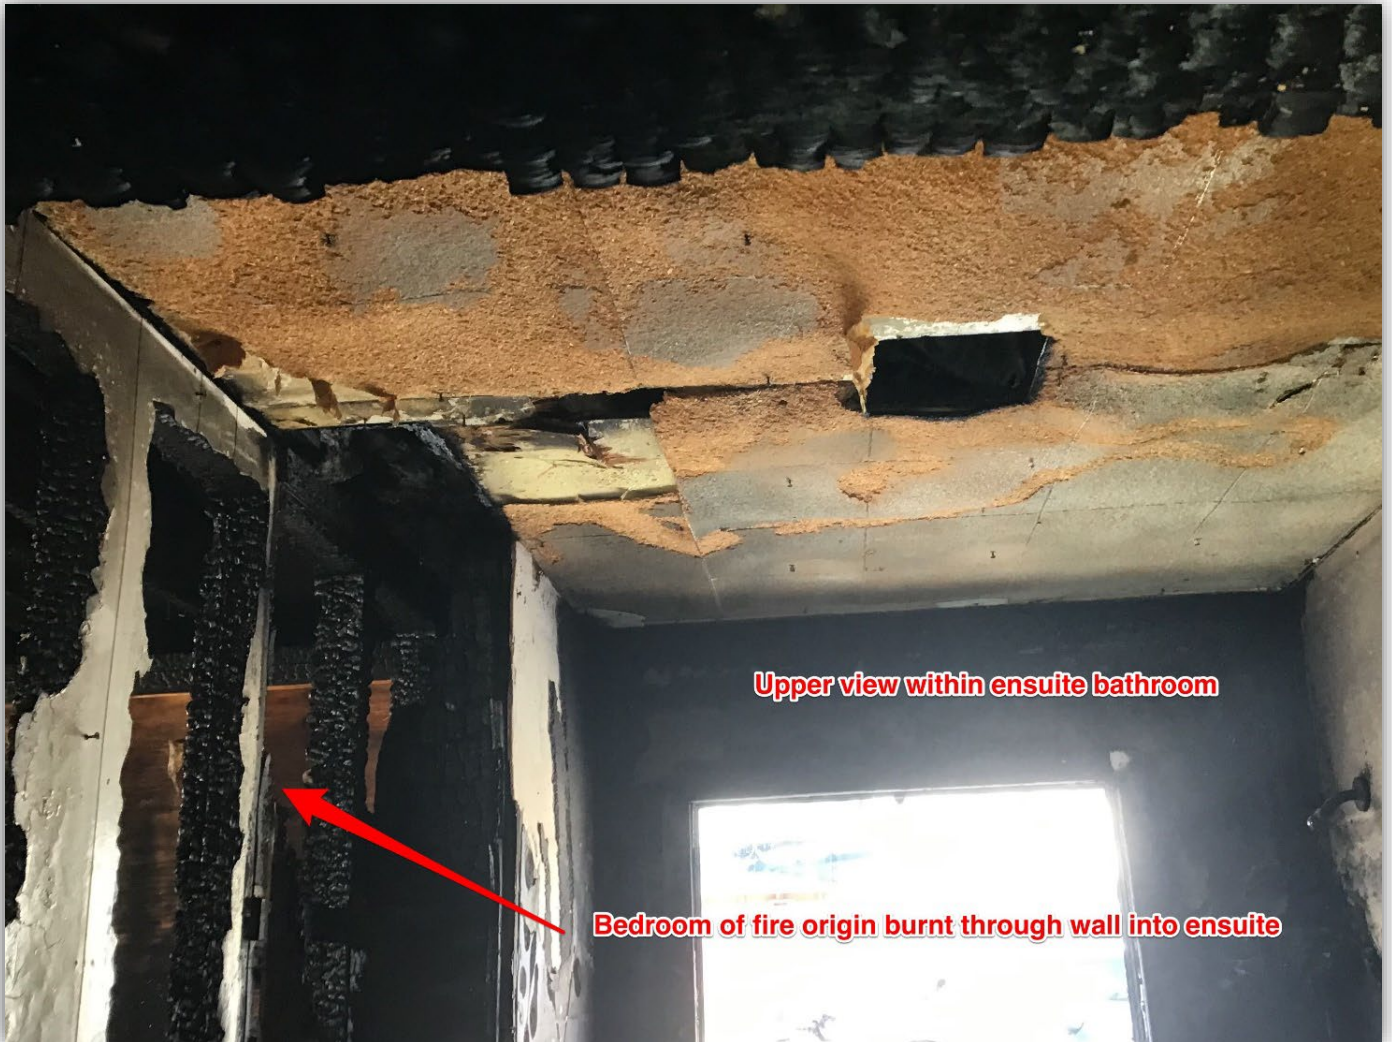
Photo 5 - Upper area within bathroom with heat/smoke damage as well as wall burnt through from bedroom area on left. The bedroom was fully involved during fire.

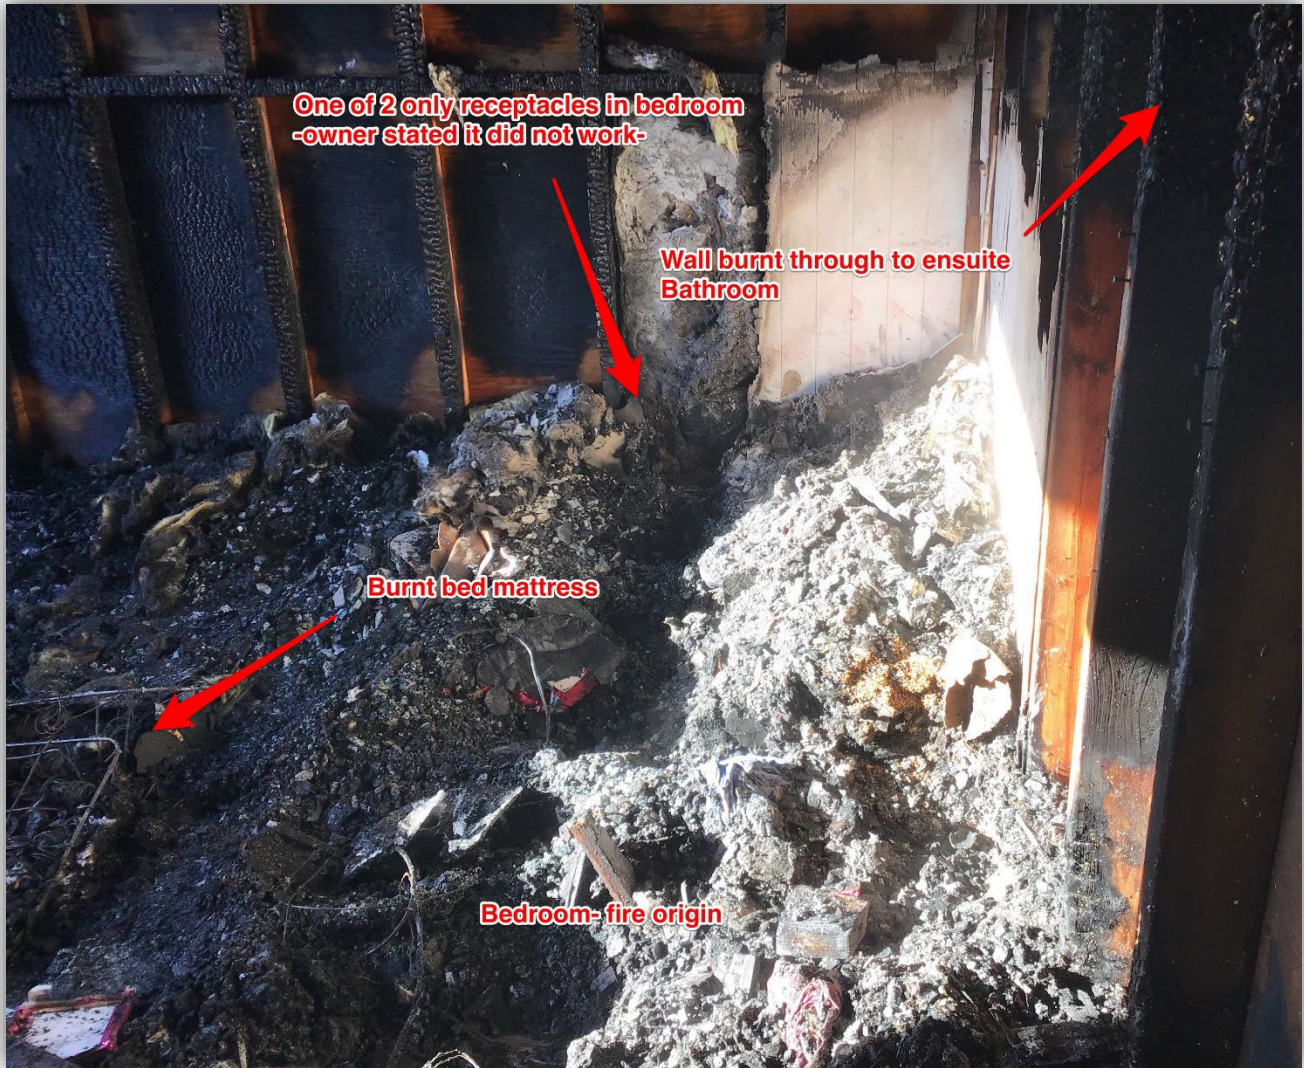
<p>Causes and contributing factors</p>	<p>It is very likely the incident of origin was the wall electrical outlet at the South-West side of bedroom where damage to the cord connector and receptacle overheated and shorted causing the fire. The reasons for this could include the bed mattress location 'in contact' with the cord end inserted in the outlet adding undue pressure/damage wearing on the cord connector and/or the load on the cord overheated the cord connector at the outlet location.</p>

Photo 6 – Origin of fire: Bedroom. Lower area studs with surface charring and the upper section of studs provide deep charring from fire within room. One receptacle (1 of 2 only in room) near back wall was noted as not operational prior to fire. The TV, gaming console and space heater were buried in the debris.

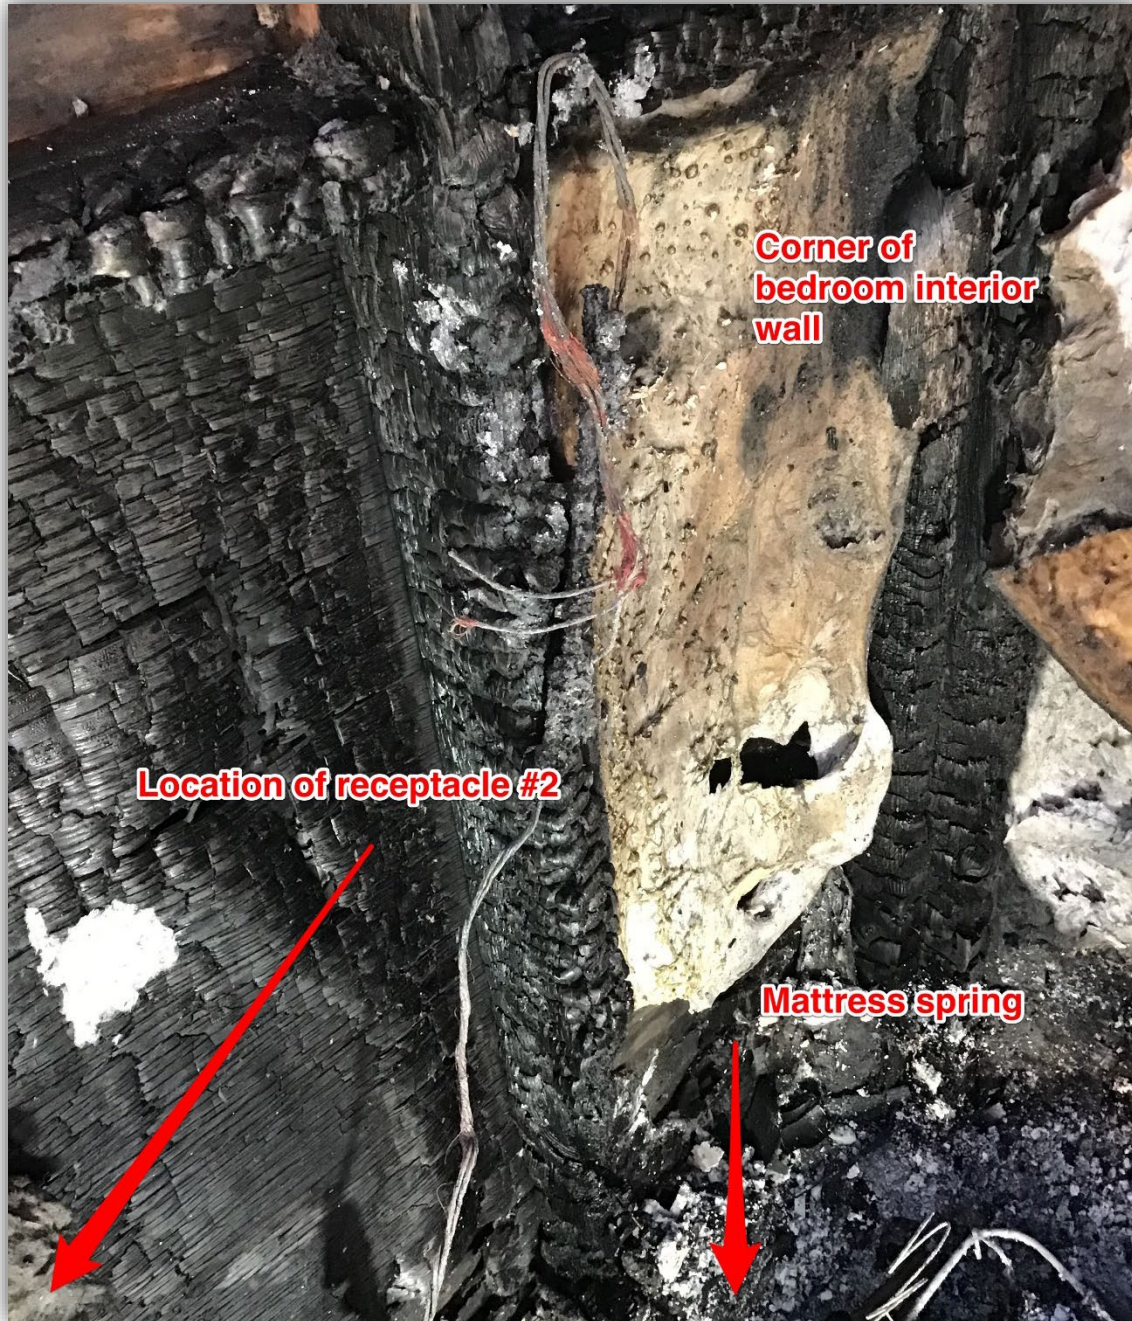
Photo 7 - View just above receptacle - fire spread within the area likely due to bed against wall igniting and spreading horizontally and upwards.

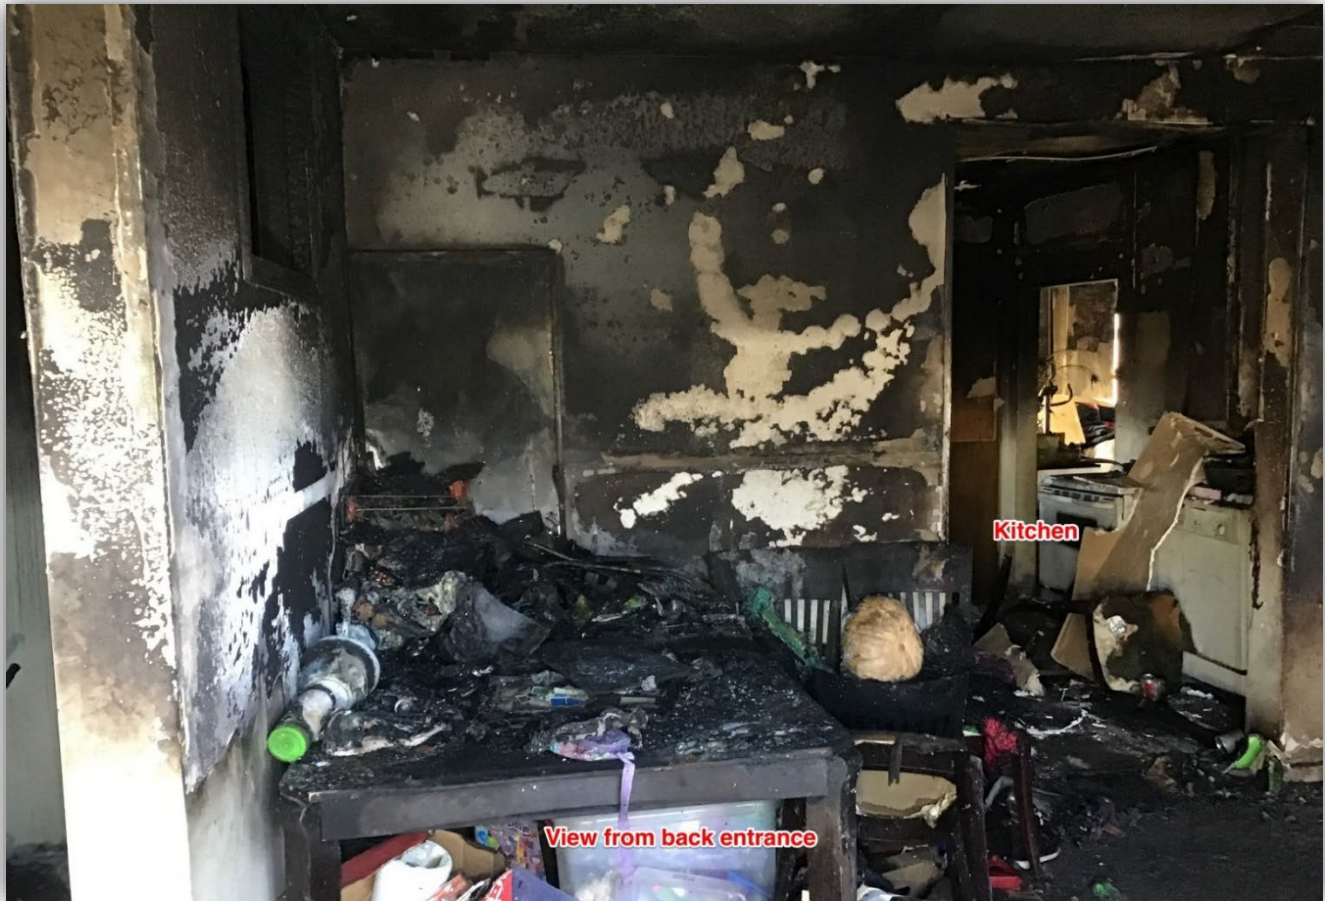
Photo 8 - View from inside back patio door through mud room towards kitchen East.

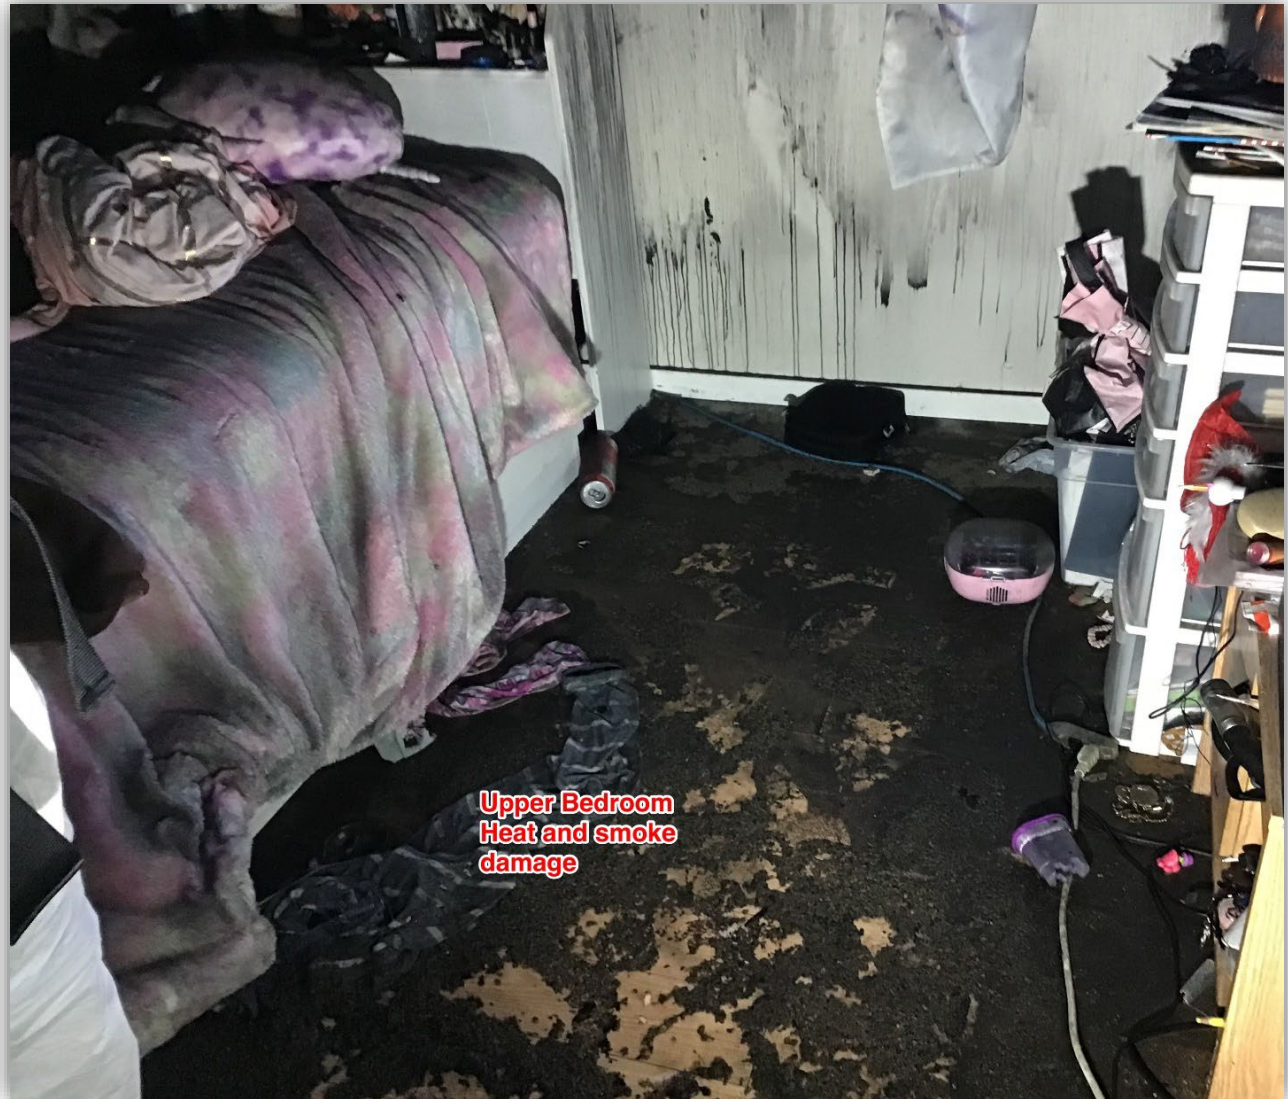
Photo 9 - Upper bedroom floor; North bedroom, with heat and smoke damage.
