Incident Summary (Reference #5615333) Final

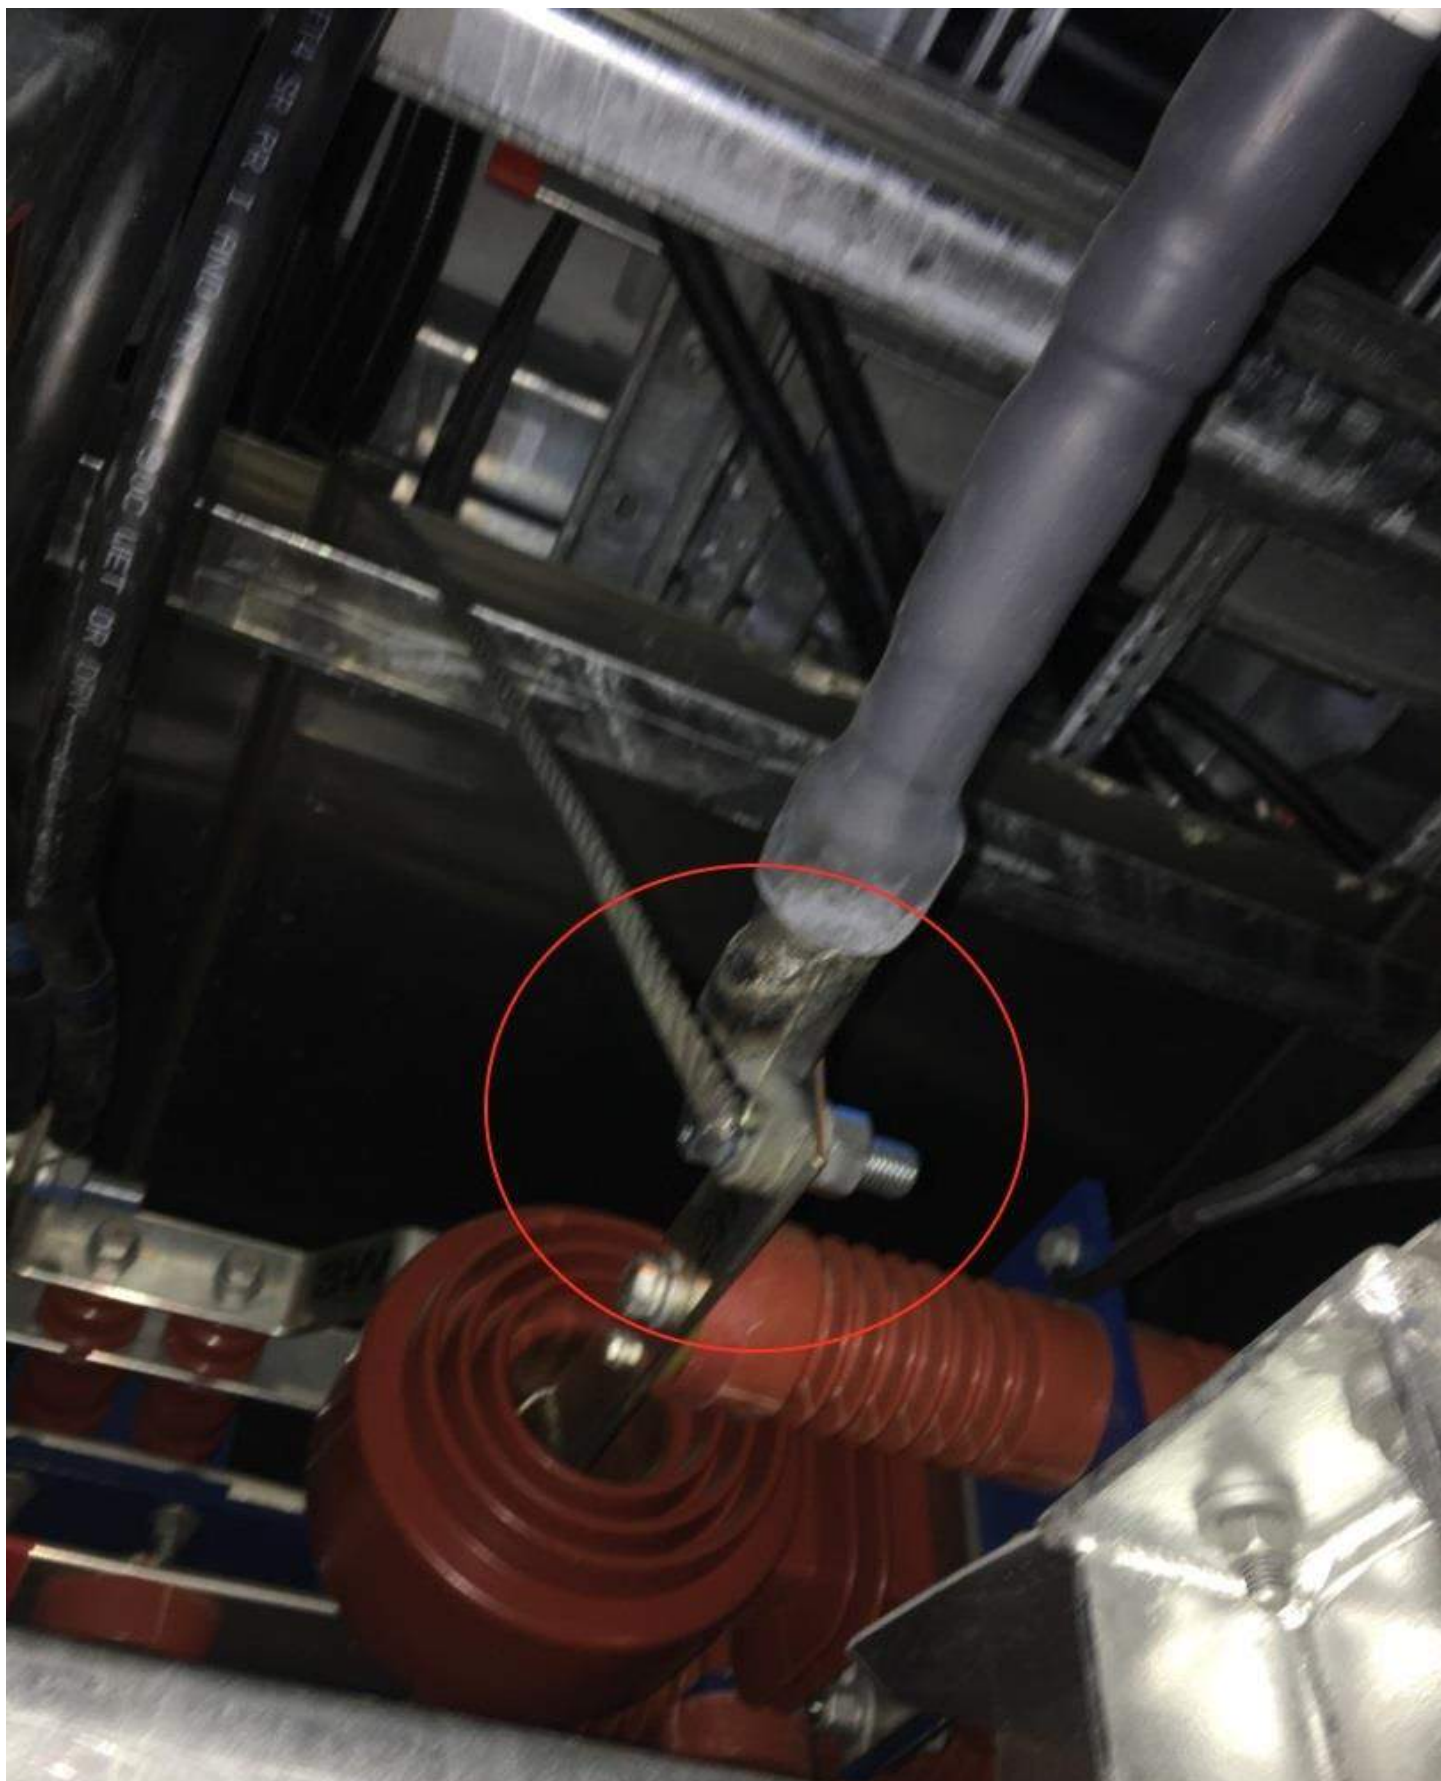
THE HOISTING ROPE CONTACTING THE TRANSFORMER TERMINAL IS HIGHLIGHTED IN THE CIRCLE ABOVE.

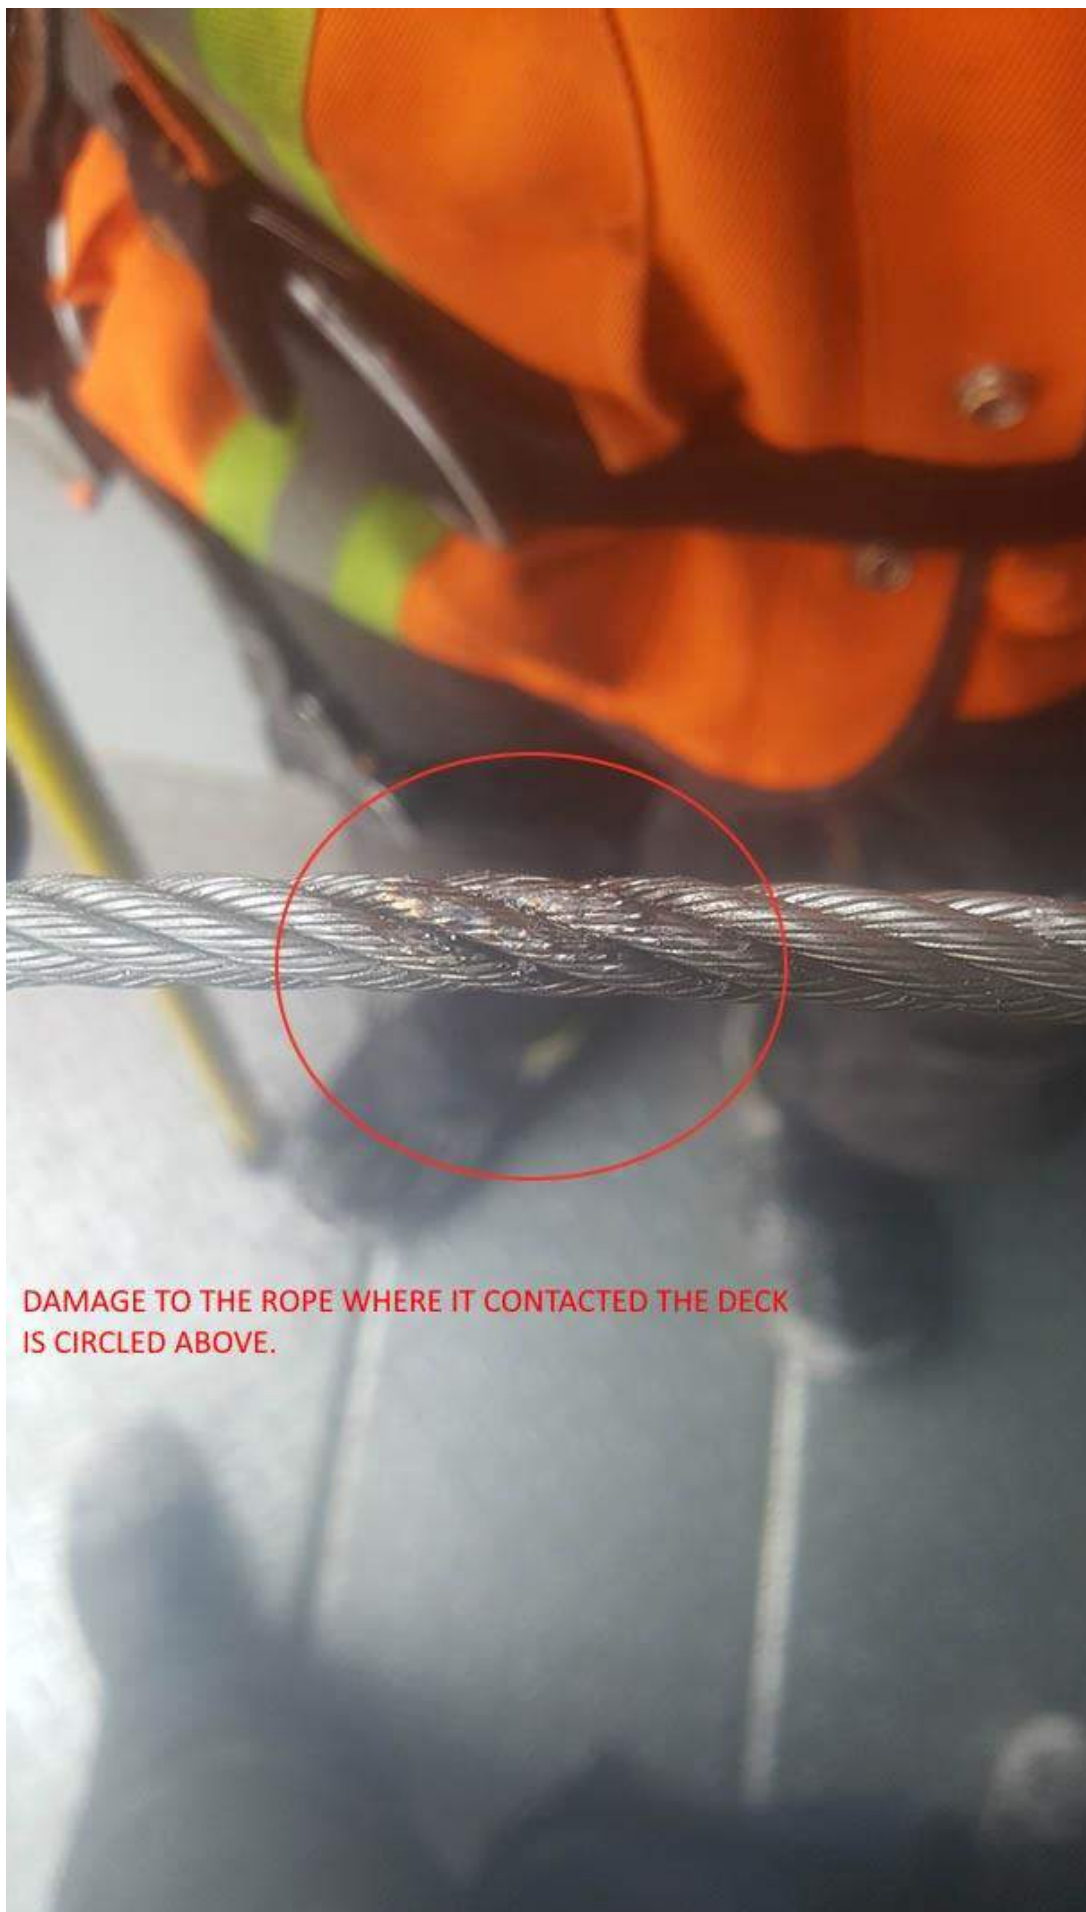
DAMAGE TO THE ROPE WHERE IT CONTACTED THE DECK IS CIRCLED ABOVE.

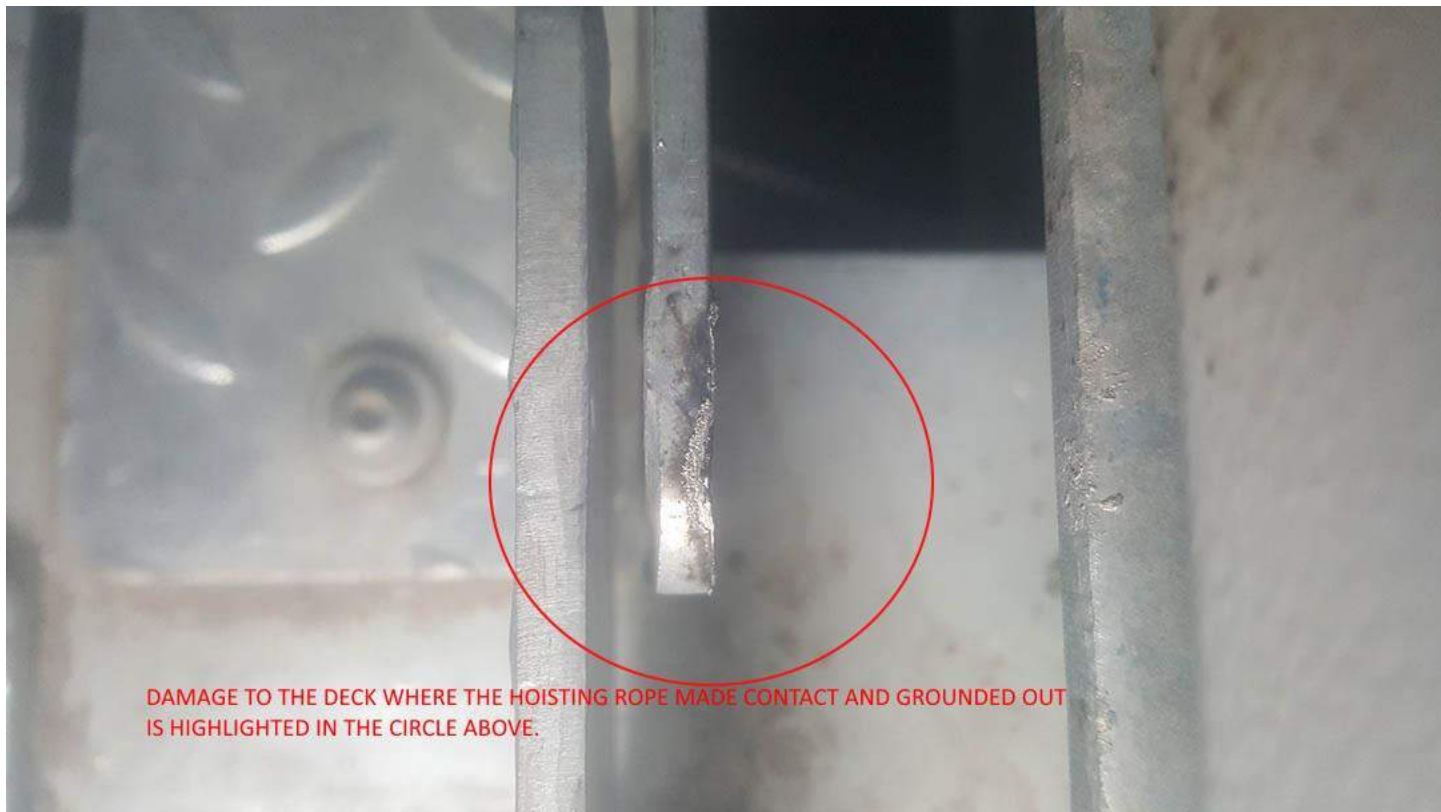
DAMAGE TO THE DECK WHERE THE HOISTING ROPE MADE CONTACT AND GROUNDED OUT IS HIGHLIGHTED IN THE CIRCLE ABOVE.
