Incident Summary #II-1605845-2023 (#39097) (FINAL)

SUPPORTING INFORMATION	Incident Date	September 16, 2023	
	Location	Rock Creek	
	Regulated industry sector	Electrical - Low voltage electrical system (30V to 1000V)	
	Impact	Qty injuries	0
		Injury description	N/A
		Injury rating	None
	Damage	Damage description	Feeder cable conductor insulation melted and discolored; cable exterior sheath discolored.
		Damage rating	Minor
	Incident rating	Minor	
Incident overview	Insulation around a mechanical conductor splice abraded and deteriorated over time eventually contacting the metallic equipment enclosure and created a ground-fault to the bonded-to-ground enclosure.		
INVESTIGATION CONCLUSIONS	Site, system and components	A public festival/rodeo venue is supplied with single phase 120/240 volt and three phase 120/208-volt energy from the area electric supply authority. The site features a common electrical room housing the service equipment. The venue structures receive energy via underground cable routes and are fitted with sub distribution panel boards. Electrical features at each structure are supplied from their respective panel boards by a combination of armoured and non-metallic shea

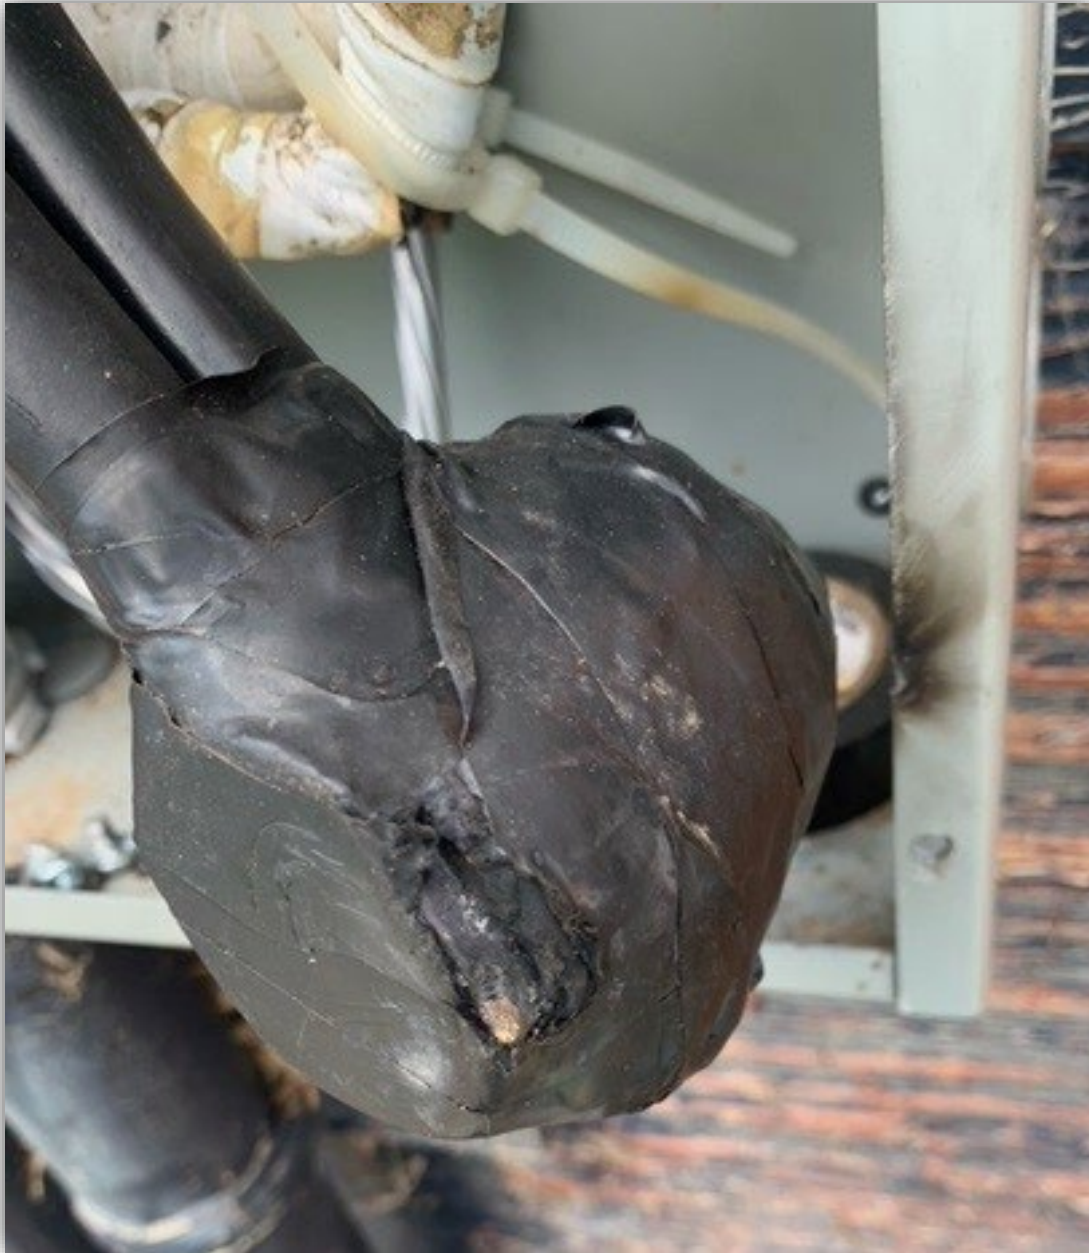
Failure scenario(s)	Insulation around a mechanical conductor splice housed in a sub distribution disconnect switch abraded and deteriorated over time (Image 1).	
		The deteriorated insulation exposed the energized split-bolt terminal, and the split-bolt contacted the metallic switch enclosure and created a short-circuit to the bonded-to-ground enclosure (Image 2).	
		The disconnect switch enclosure bonding was completed with unapproved equipment and in an unsafe wiring method (wood screws securing the bonding terminal) which resulted in a high impedance bonding circuit (Image 3).	
	The high impedance bonding termination prevented the short circuit fault current from actuating the overcurrent protection. Instead, the short-circuit fault-current routed through an alternate, unintentional bonding path via a 10AWG non-metallic-sheathed cable.		
	The 10AWG supply conductor and 12AWG bonding conductor sizes of the non-metallic-sheathed cable did not have a minimum ampacity rating to safely route the fault current to ground which resulted in a conductor overtemperature and insulation failure (Image 4 and Image 5).

Image 1 – Deteriorated split-bolt insulation.

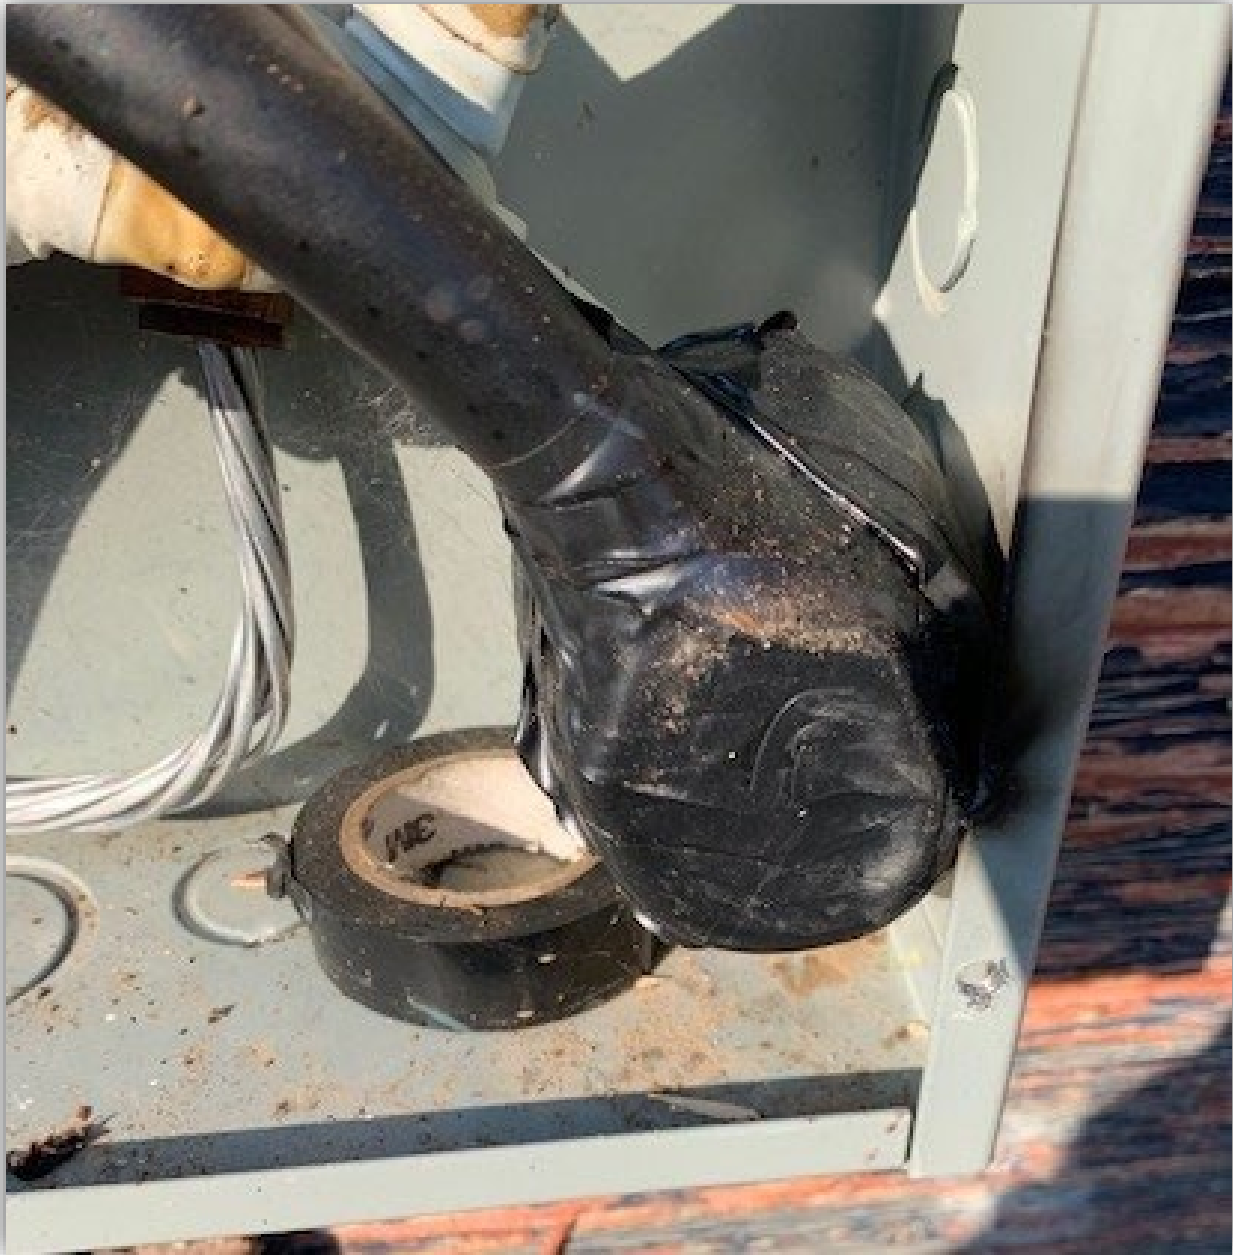
Image 2 - Split-bolt contact with equipment enclosure.

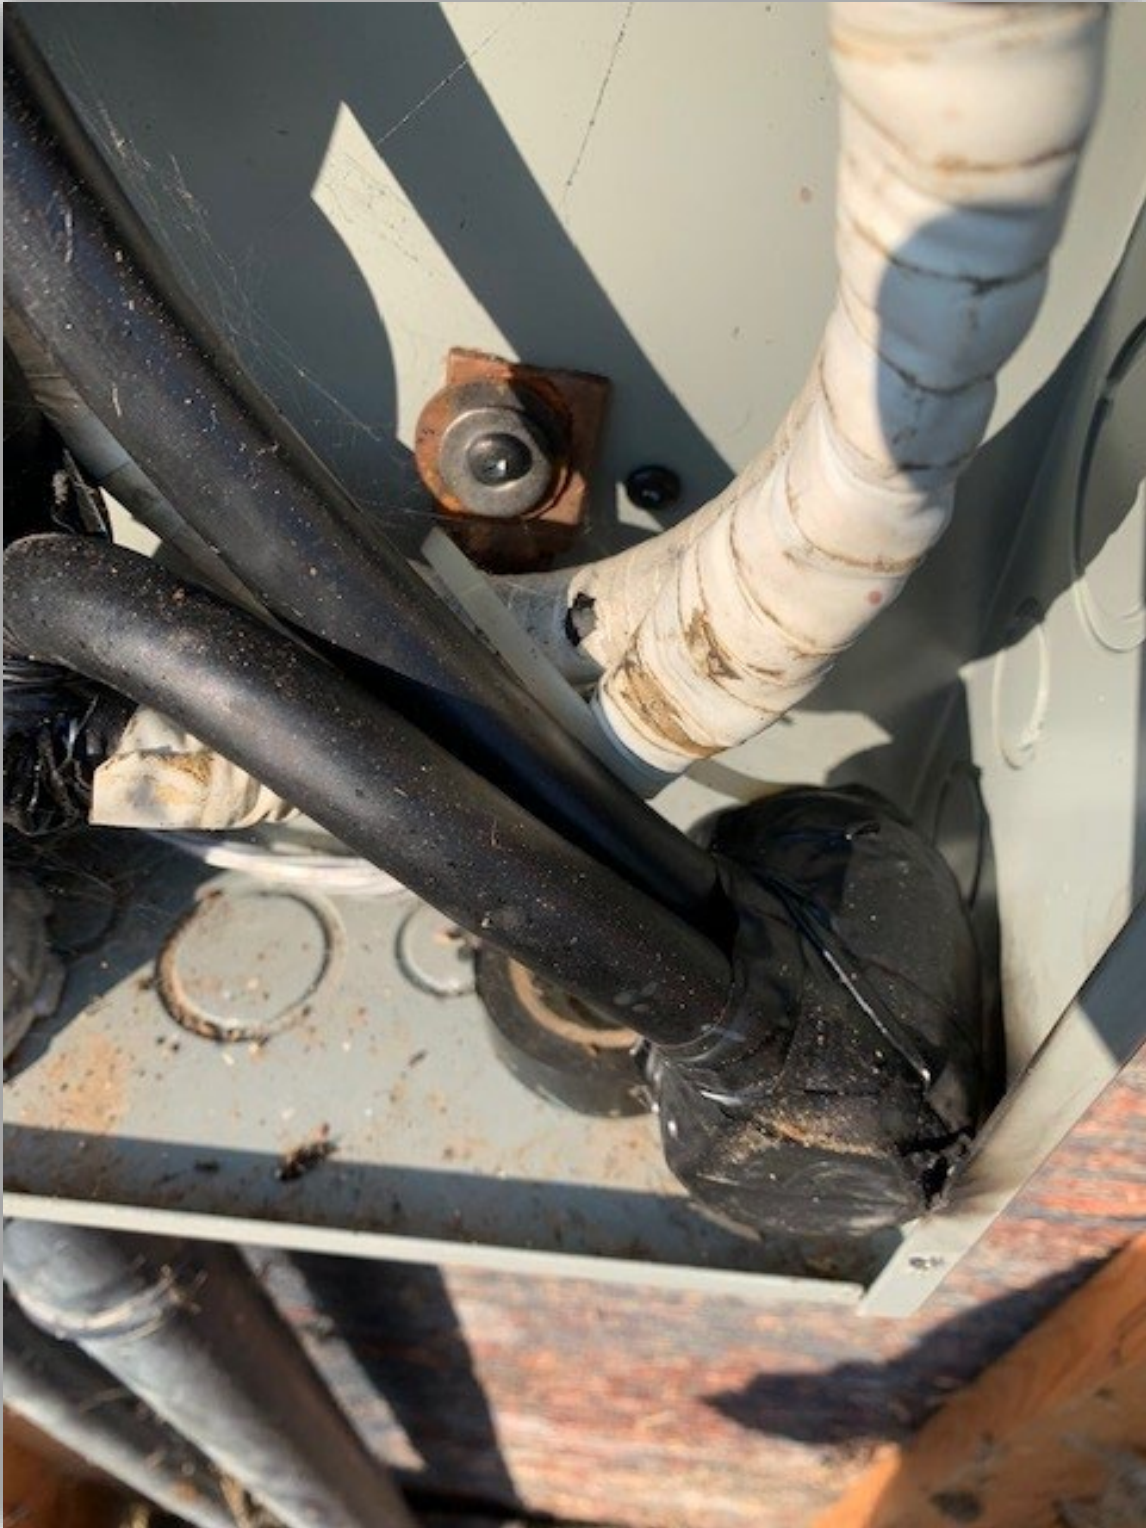
The use of unapproved bonding termination likely caused the incident when it was installed in an unsafe wiring method created the high impedance bonding termination that prevented the overcurrent protection from actuating when the short circuit occurred.

Image 3 - Unapproved equipment, unsafe wiring method, high impedance bonding termination.

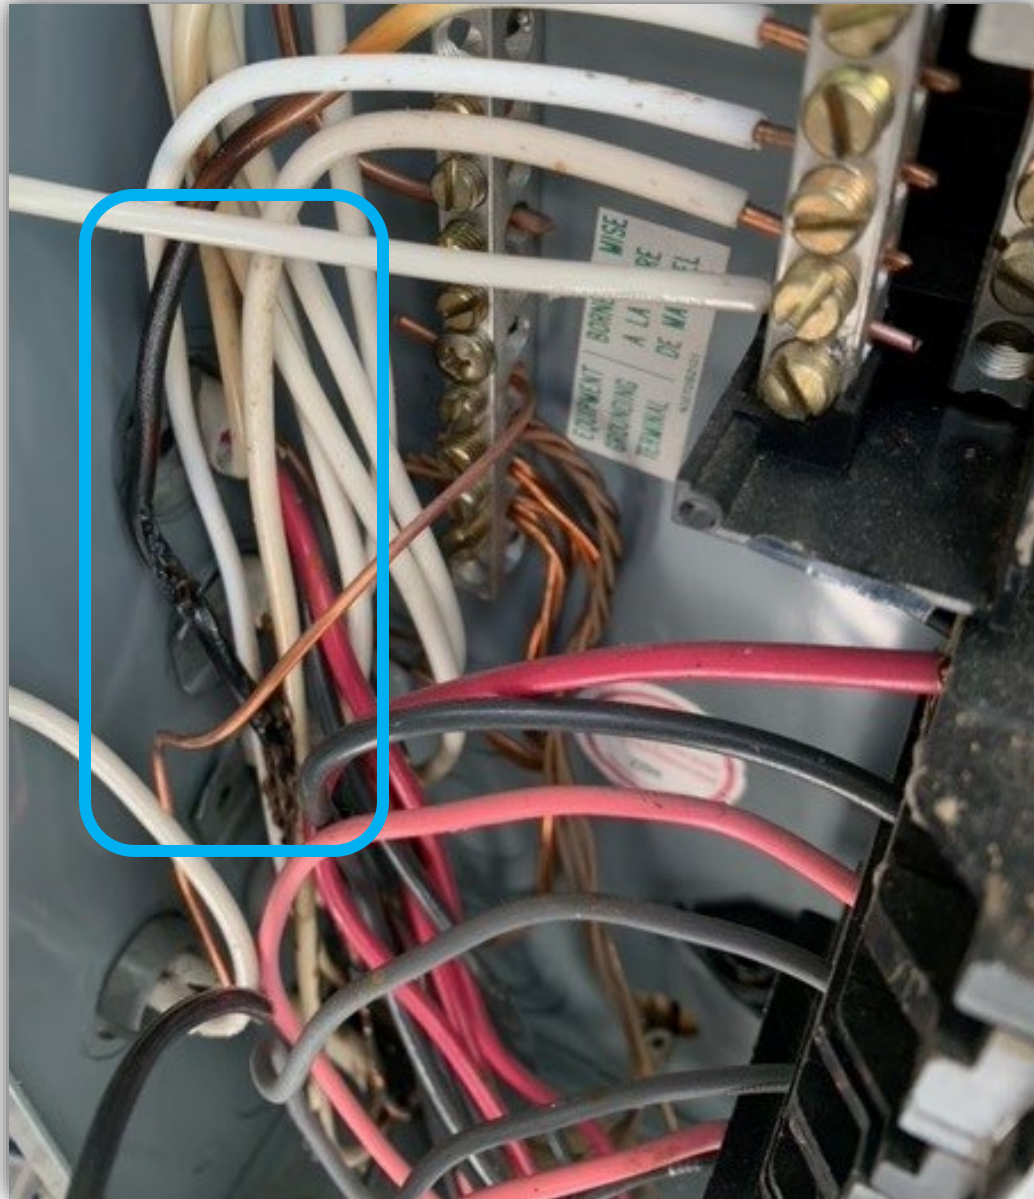
Image 4 – Overtemperature: Conductor insulation melting resulting from excessive current imposed on neutral conductor.

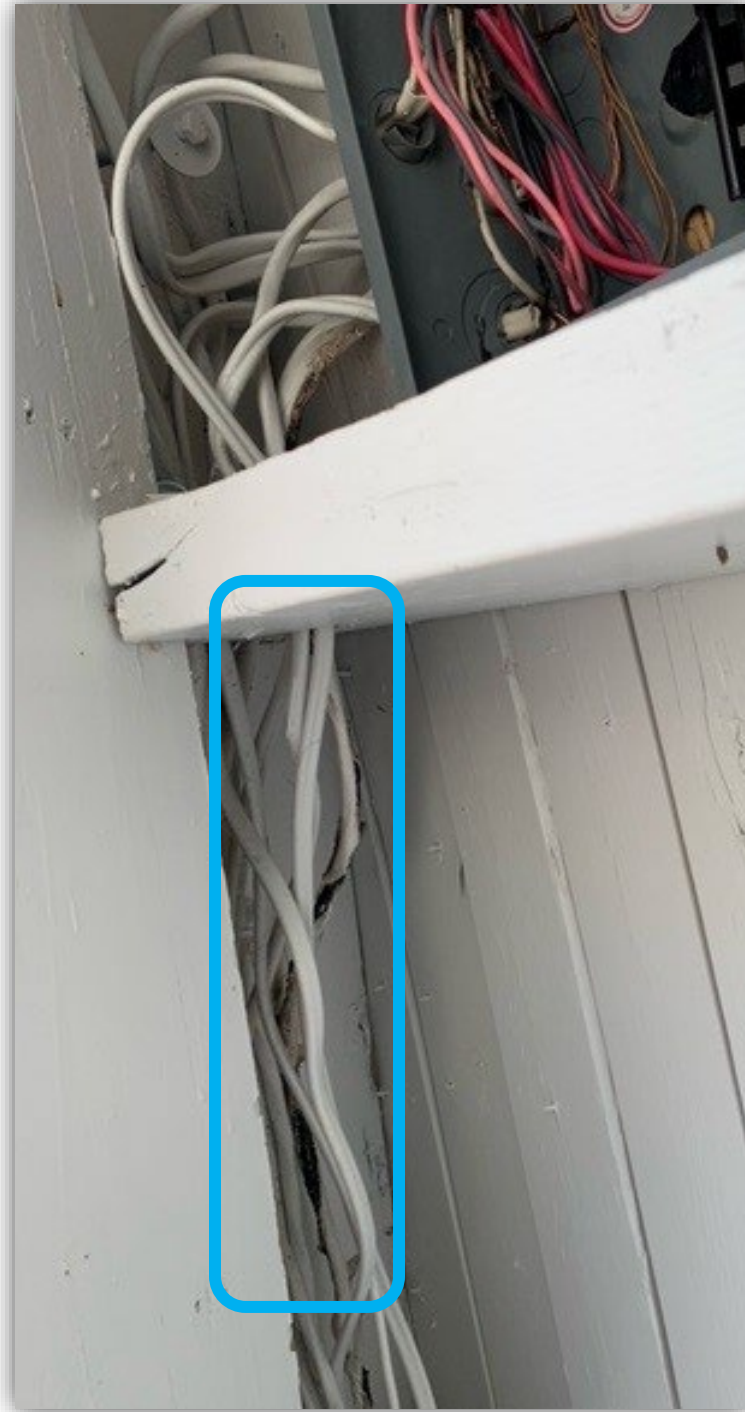
Image 5 – Overtemperature: Cable sheath discoloration resulting from excessive current imposed on neutral and bonding conductors.
