Incident Summary #II-891565-2019 (#14795) (FINAL)

SUPPORTING INFORMATION	Incident Date	August 12, 2019	
	Location	Vancouver	
	Regulated industry sector	Amusement Devices - Amusement ride	
	Impact	Qty injuries	0
		Injury description	N/A
		Injury rating	None
	Damage	Damage description	Failure of the upper gearbox on a pendulum type amusement ride
		Damage rating	Moderate
	Incident rating	Moderate	
Incident overview	While in operation for the public, a pendulum type amusement device was stopped by staff during a ride cycle because a strange noise was heard and oil was leaking from the top of the device onto guests seated on the ride, (Photo 1). The device was safely unloaded of passengers after coming to a complete stop, the device did not return to normal operation.		
INVESTIGATION CONCLUSIONS	Site, system and components	A twenty passenger open gondola is attached to a pendulum arm. The gondola is loaded at the 6 o'clock position, and as the ride cycle is initiated, begins to swing with ever increasing speed and height until raised to 120 degrees from the starting point. This swinging action is facilitated through use of 2 sets of motor driven gearboxes located at the top of the dev

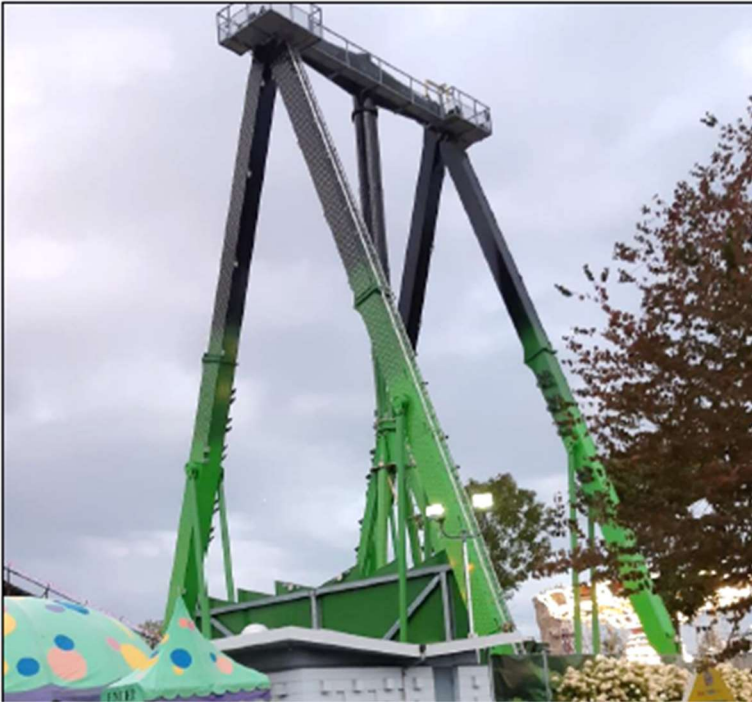
Photo 1: A-framed pendulum type amusement device, [Lab report].

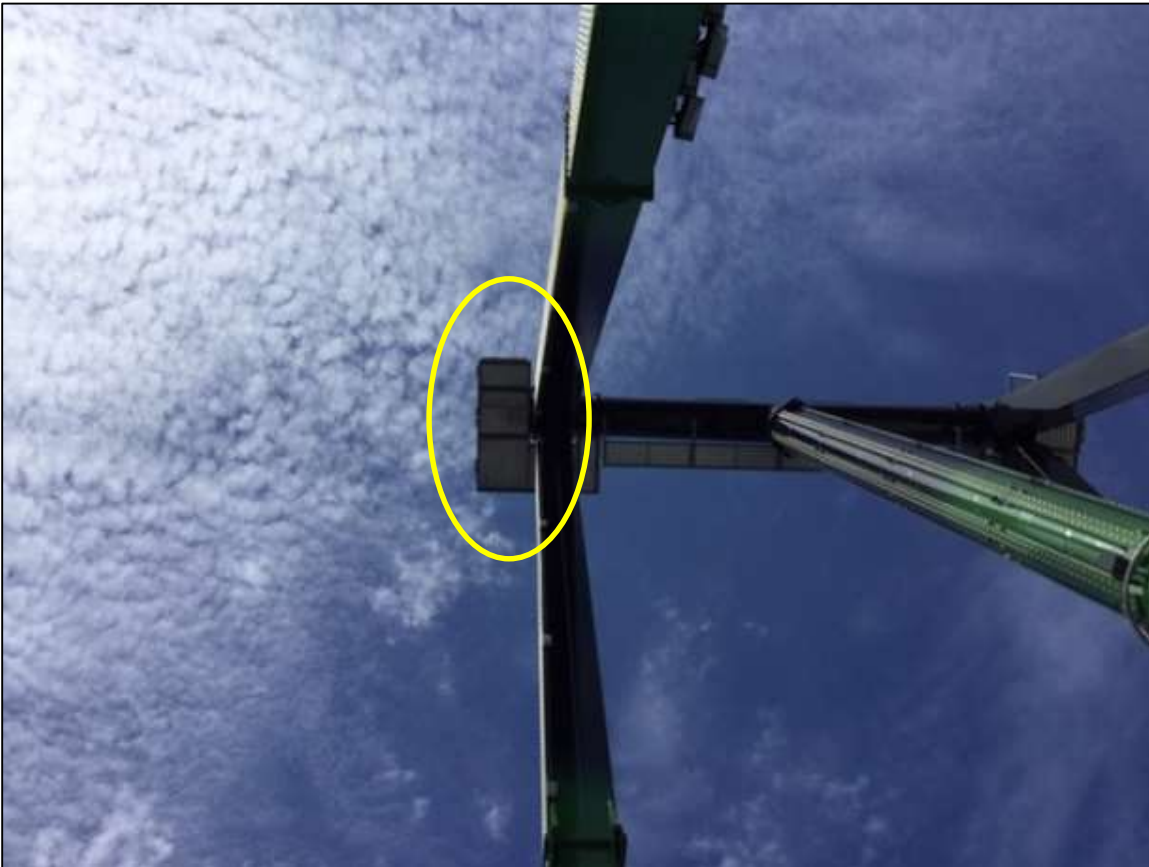
Failure scenario(s)	<p>The south gearbox was identified as the damaged component, (Photo 2). Upon examination of the failed gearbox components, evidence of reverse bending fatigue was discovered on the components caused by high bending stresses applied on the gearbox during normal ride operation. According to further investigation, these bending stresses exceeded the fatigue endurance limits of steel components within the gearbox.</p> <p>Contributing factors include the bolted connections that hold the gearbox in place having become loose, or being installed without specific torque, or insufficient number of bolts connecting the gearbox motor to the cylinder casing.</p>	
	Facts and evidence	The gearbox was in service for 3 years, failure occurred after approximately 1500 hours, or 300,000 cycles (a cycle being one swing of the pendulum). The gearbox is attached to an electric motor drive also installed at the top of the A-frame structure. The motor is attached to the gearbox and is aligned to the gearbox using two adjustable threaded rods, one is shown in Photo 3.

Photo 2: South side gearbox location.

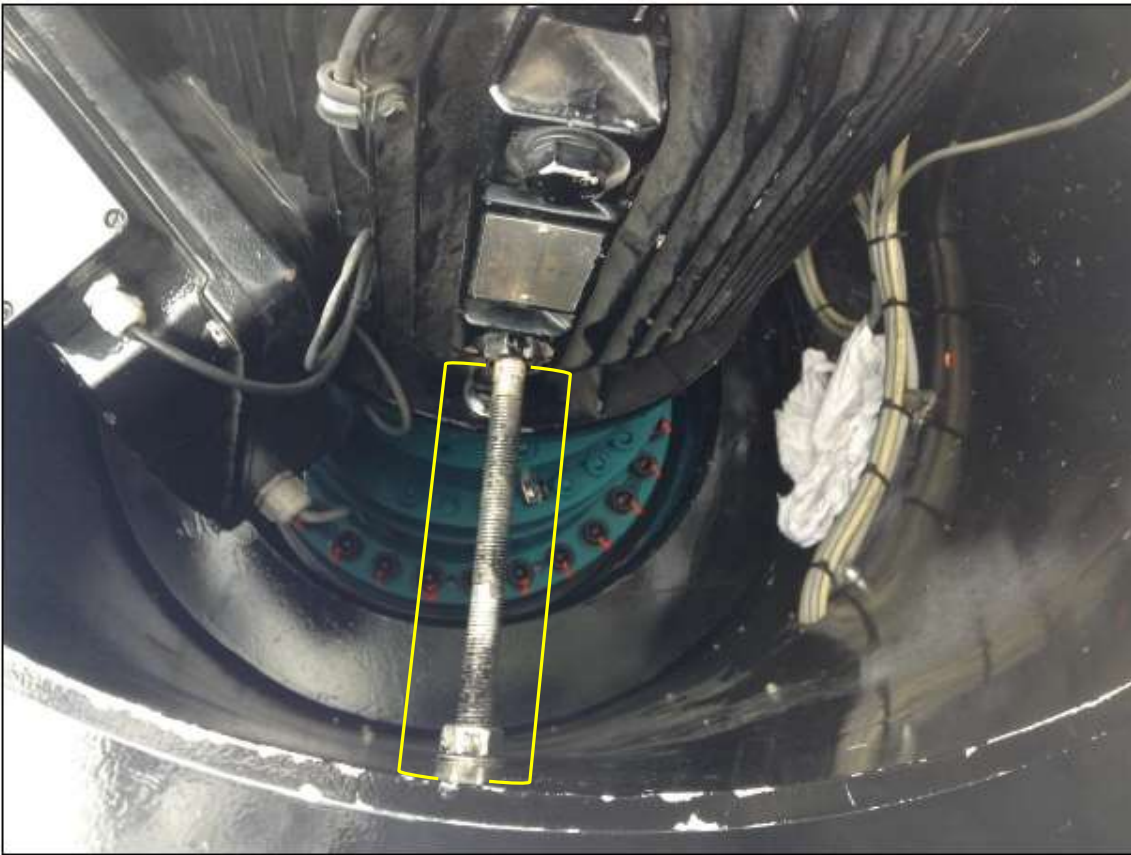
<p>Causes and contributing factors</p>	<p>It is likely that the design and robustness of the gearbox, was inadequate to maintain loads necessary for the normal operation of the device, over its expected lifespan. A possible contributing factor was inadequate fastening of the gearbox motor mounting bolts.</p>

Photo 3: Threaded fastener aligning drive motor to cylinder and gearbox, outlined in yellow, [Lab report].

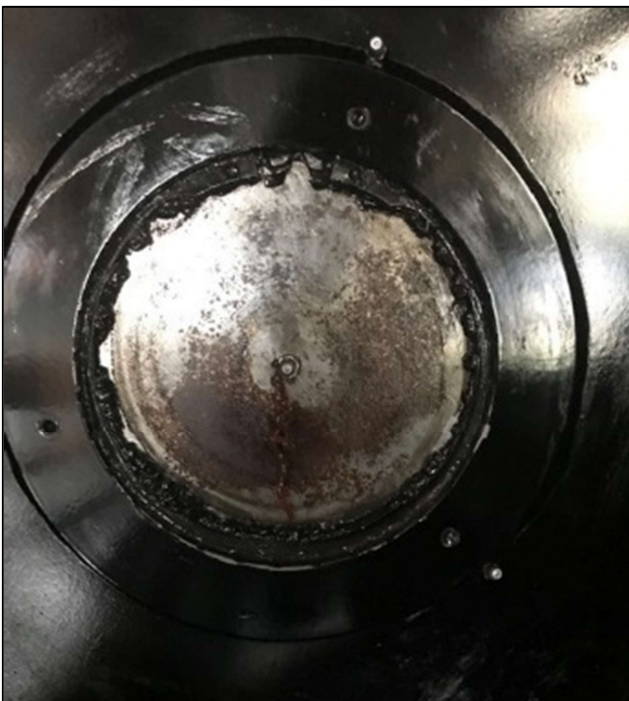
Photo 4: Initial inspection, snap ring pushed out of position by gearbox end plate, due to axial load.

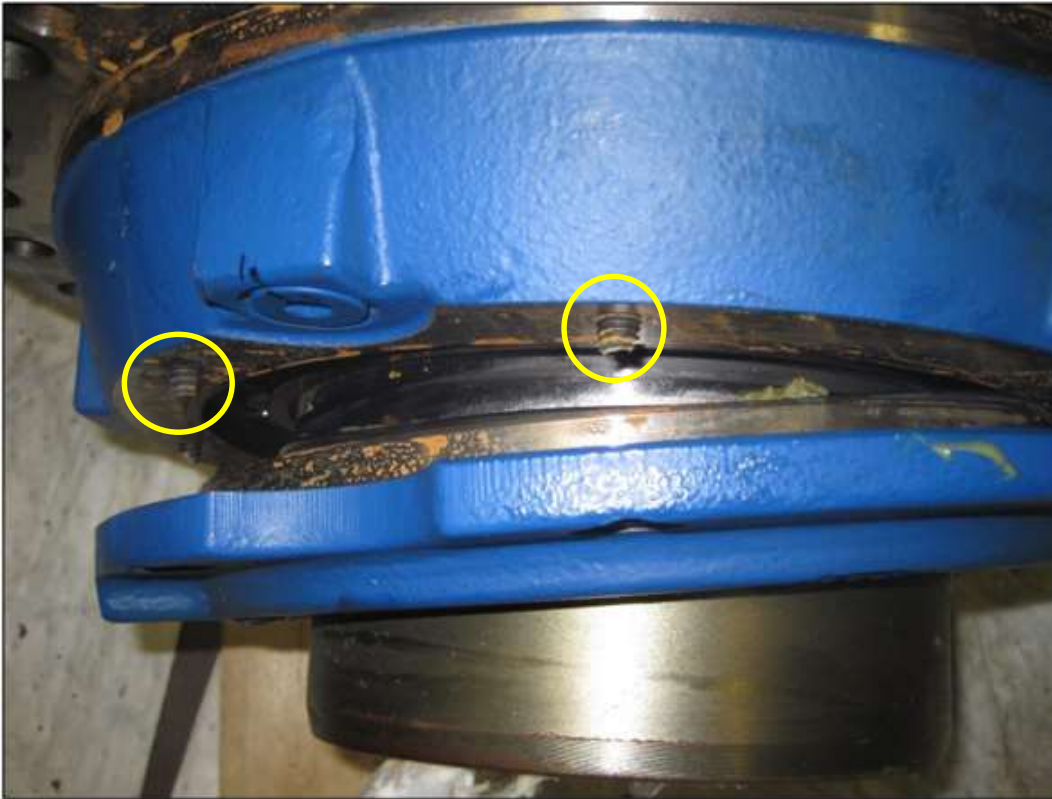
Photo 5: End plate separated from gearbox housing and bolts fractured (circled), [Lab report].

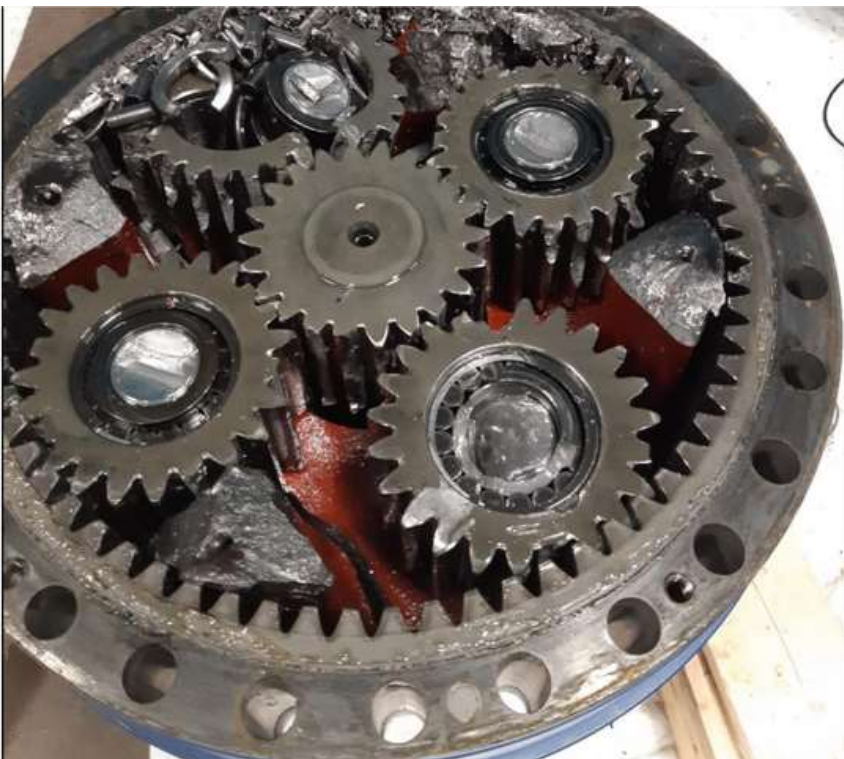
Photo 6: Gearbox Stage 3 Planetary gear set damage, complete fracture of all four posts, [Lab report].

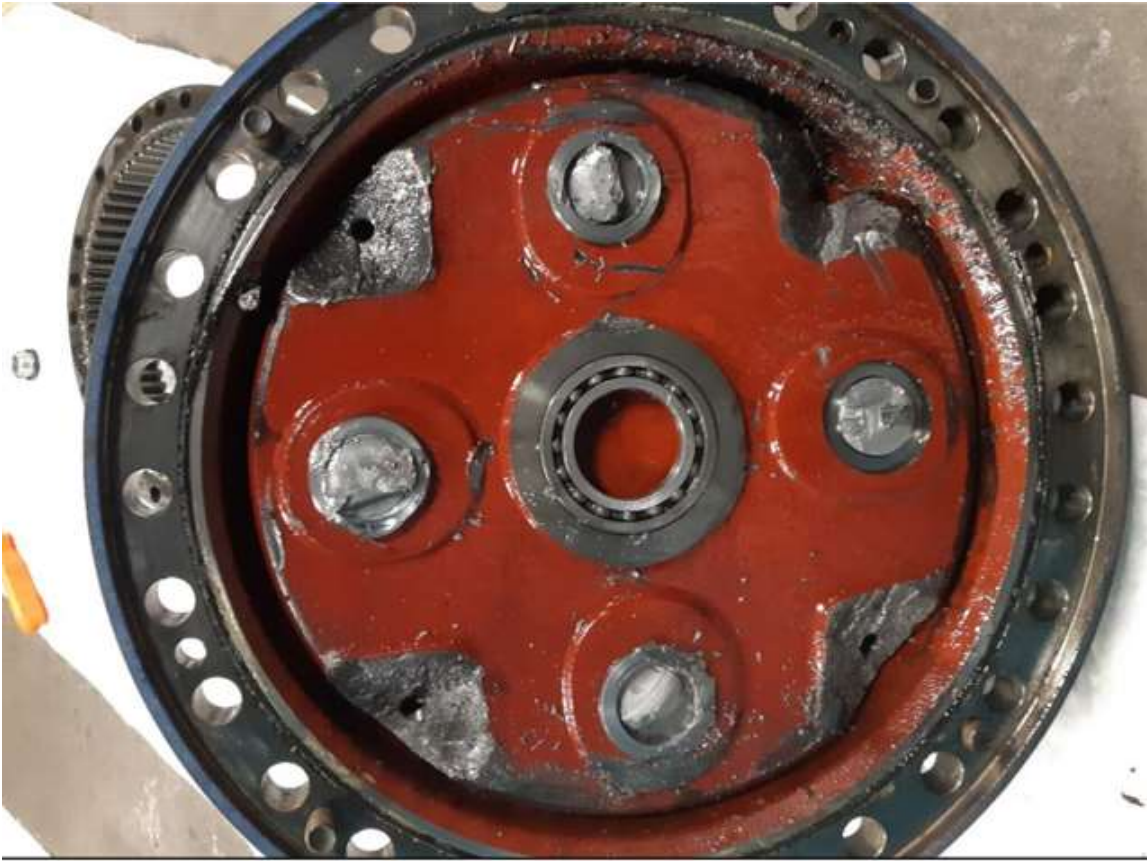
Photo 7: Gearbox Stage 3, planetary gear carriage, fractured gear posts and carrier plate, [Lab report].

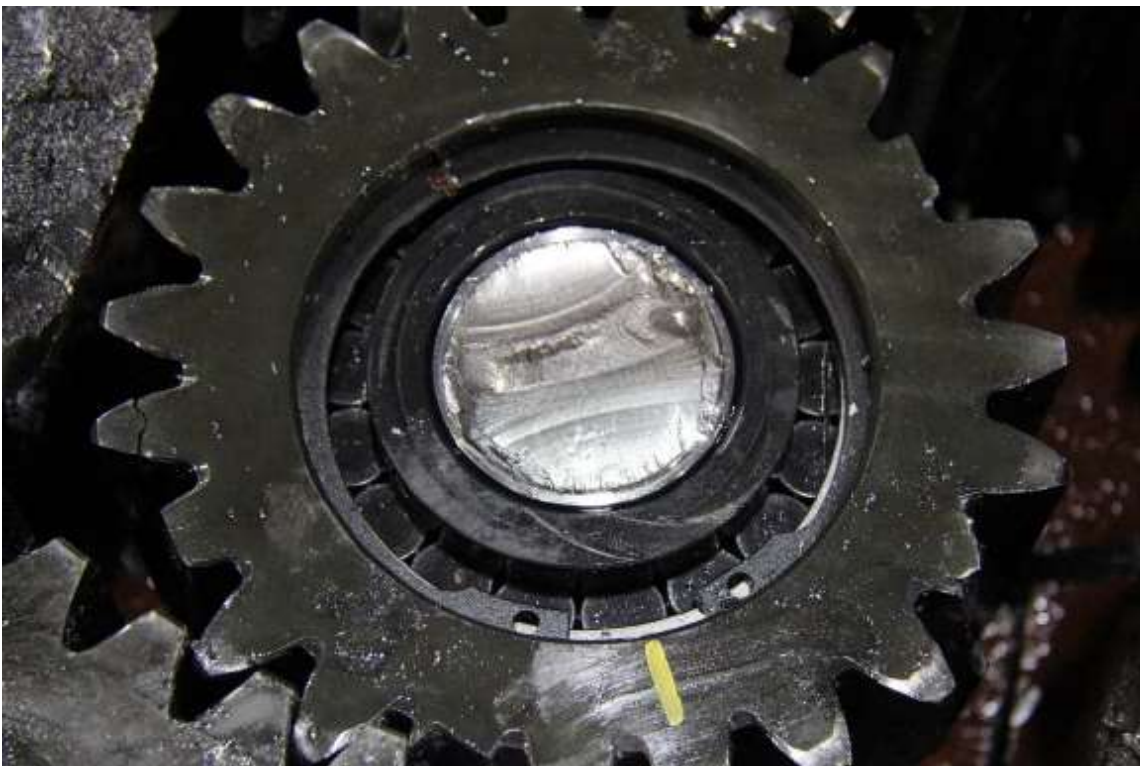
Photo 8: Planetary gear post fracture surface shows reverse bending fatigue cracking, [Lab report].

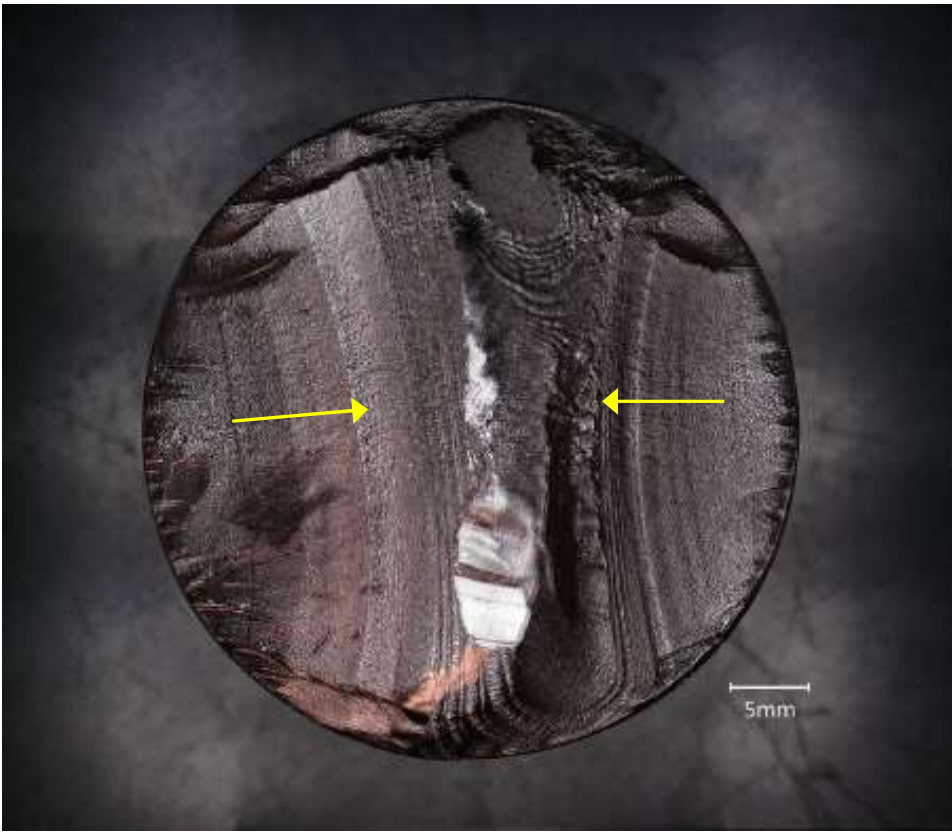
Photo 9: Close up of fracture surface showing fatigue cracking striations propagating in opposing directions. Arrows indicate crack propagation direction, [Lab report].
