Incident Summary #II-860382-2019 (#13027) (FINAL)

SUPPORTING INFORMATION	Incident Date	May 31, 2019	
	Location	Richmond	
	Regulated industry sector	Elevating devices – Construction hoist (personnel & equipment)	
	Impact	Qty injuries	0
		Injury description	None
	Damage	Injury rating	None
		Damage description	During operation of a construction hoist damage occurred to several components that included cracking of the hoist rack, a pinion gear tooth, and the splined shaft connecting the pinion gear to the gearbox [Figure 3].
		Damage rating	Moderate
Incident rating	Moderate		
Incident overview	While using a construction hoist, the operator heard a loud noise followed by the hoist suddenly shutting down.		
INVESTIGATION CONCLUSIONS	Site, system and components	<p>A temporary construction hoist is used to transport personnel and equipment to various floors of a building while it is under construction. The hoist consists of a mast, car, electrical motors, rack and pinion propulsion system.</p> <p>The mast [Figure 1] is a vertical metal structure that is anchored to the ground and outside of the building at fixed intervals. The mast contains rails for the car to ride along as well as a rac

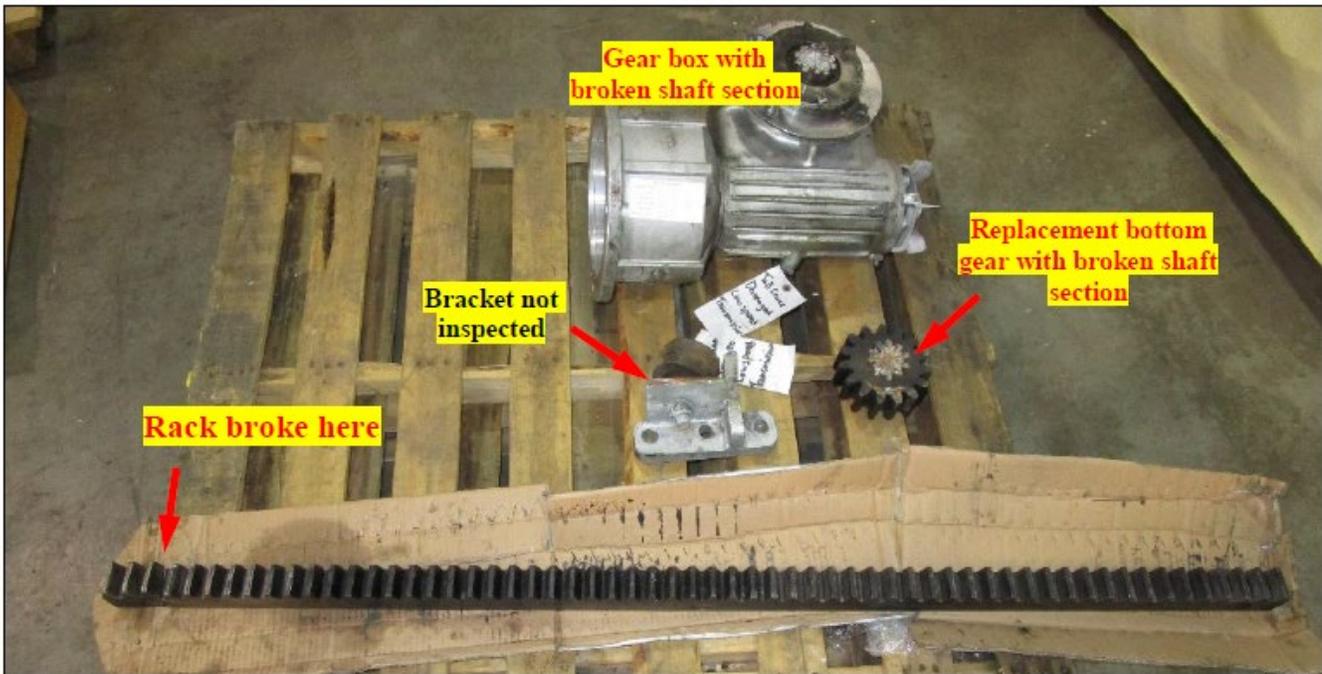
Figure 3: Various components from the failed hoist.

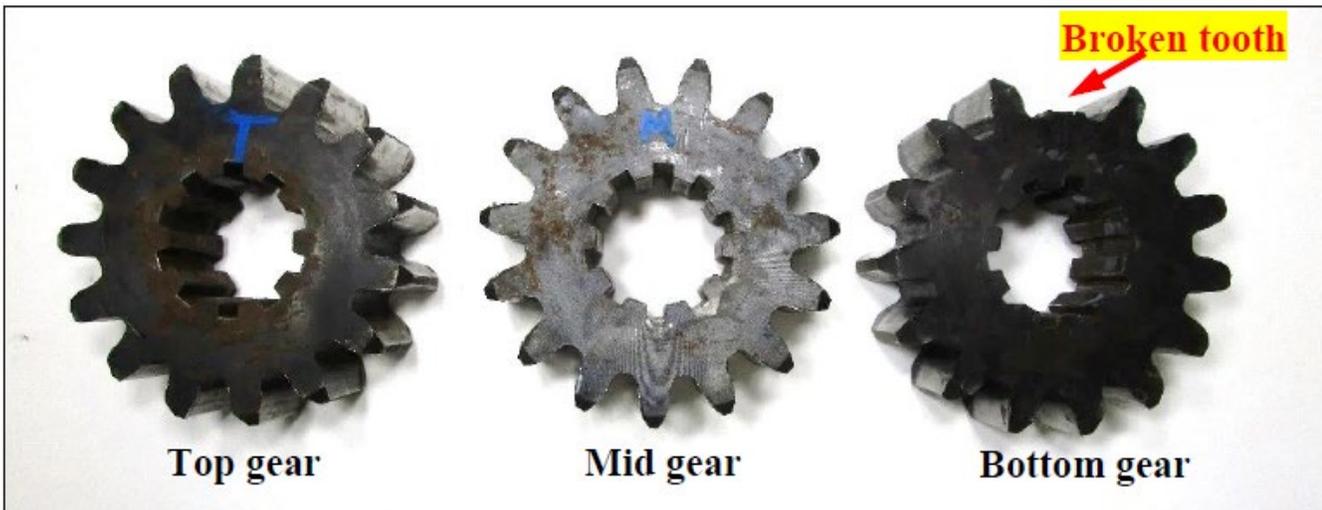
Failure scenario(s)	<p>During operation of the construction hoist, a tooth broke off the bottom pinion gear [Figure 4] and the hoist remained in operation without immediately replacing the gear. Every time the pinion gear made a full rotation, the rack experienced an impact due to the missing tooth on the pinion. Due to this impact loading at the location of the missing tooth, the rack eventually fractured at a location where it was bolted to the mast [Figure 5]. The bottom gear was eventually replaced during routine maintenance and the hoist was put back into service (note: the broken rack was not repaired when the pinion gear was replaced). The new bottom gear was subject to greater operational loads due to the severe wear on the flanks of the top and middle pinions. Lastly, the splined shaft connecting the bottom pinion to the gearbox sheared off and the pinion gear wedged between the car and the mast, causing the hoist to come to an abrupt stop.</p>

Original Bottom Gear (with broken tooth):

The original bottom gear failed by fatigue cracking that had started long ago. The fatigue failure of the original bottom gear was caused by the use of a gear having inadequate wear and fatigue resistances for the application.

The middle gear was through-hardened, as opposed to tooth hardened. It sustained severe wear and suffered fatigue cracking due to inadequate wear and fatigue resistances for the application. The top gear sustained severe wear and suffered fatigue cracking, also indicative of inadequate wear and fatigue resistances.

- Severe wear/material flow on the flanks of the teeth indicate insufficient hardness for the intended application.
- Fatigue cracking was noted at the roots of both gears.
- Rough surface finish was due to the manufacturing processes. Rough surface finishes can act as stress risers and promote formation of cracks.
- Middle gear was determined to have insufficient hardness for the intended application.

Figure 4: Top and middle pinion gears, and the original bottom pinion gear.

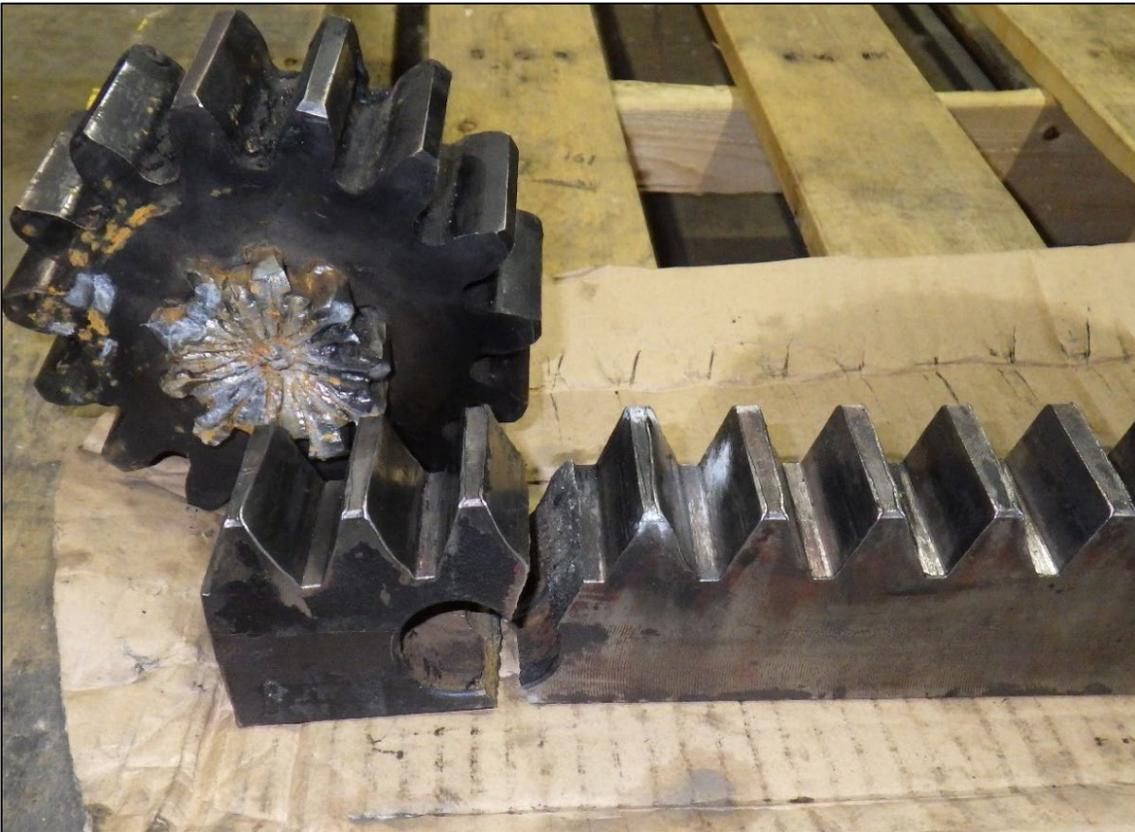
The brittle failure of the rack section was caused by an impact load by the bottom gear after its tooth broke off.

- The rack exhibited brittle fracture at its bottom bolt hole [Figure 5].
- Excessive plastic flow was found on both the drive and non-drive flanks near the fracture, and the fracture surface was worn, indicating that the lift was operated after the rack fractured.
- The fracture pattern of the broken rack indicated the fracture was caused by impact loading.

Torsional fatigue cracking of the bottom gear shaft may have started after the tooth broke off the original bottom gear. The cracking may have been accelerated after installation of the replacement gear, which took a higher share of load. The shaft ultimately broke by torsional fatigue cracking a month later.

- The shaft failed by rotational fatigue cracking in its splined section.
- The fracture appeared to be relatively recent in comparison to the other failed parts (minimal corrosion).

Figure 5: The failed bottom pinion gear shaft and broken rack section.

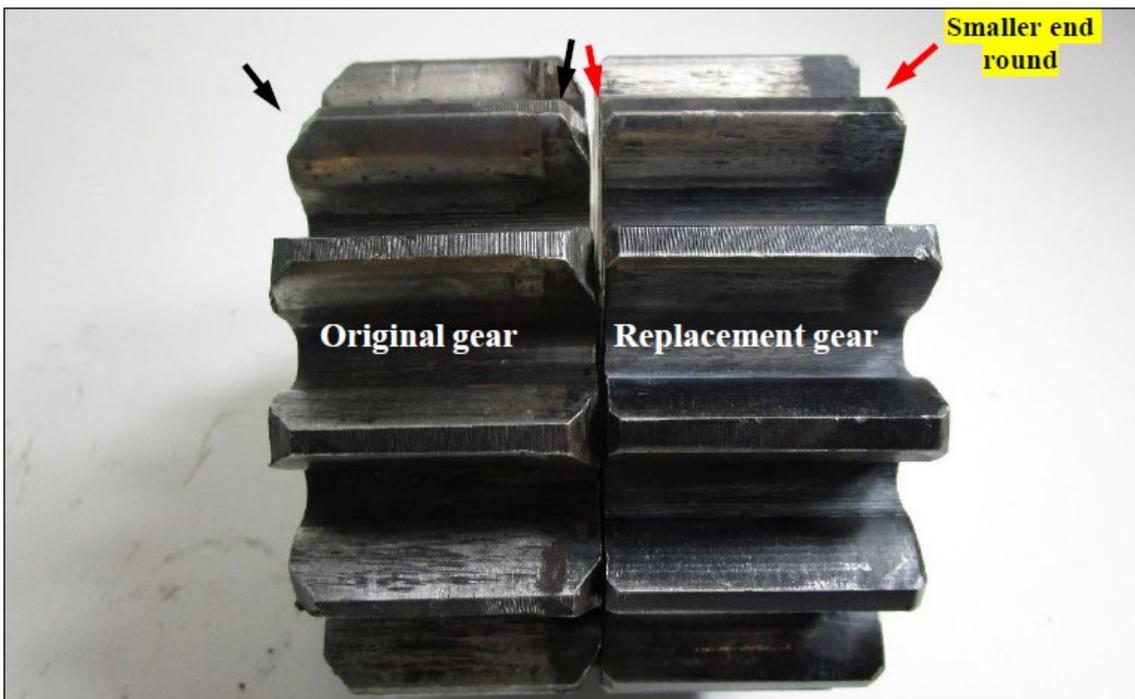
The replacement gear exhibited a better tooth hardening pattern and higher hardness on the fillet/root area than the other gears. However, fatigue cracking of this gear occurred after only a month in service. This premature fatigue cracking was likely due to excessively high load due to unbalanced load sharing among the gears. Rough surface finish was also a contributing factor to the fatigue cracking.

- The ends of the teeth on this gear were rounded to a smaller radius by the manufacturer [Figure 6] compared to the other three gears, indicating it was manufactured from a different batch of gears.
- This gear was hardened through the root [Figure 6], which resulted in increased fatigue resistance.
- Fatigue cracking was identified at the roots of the teeth.

Figure 6: Comparison between replacement bottom pinion gear and the original bottom pinion gear.

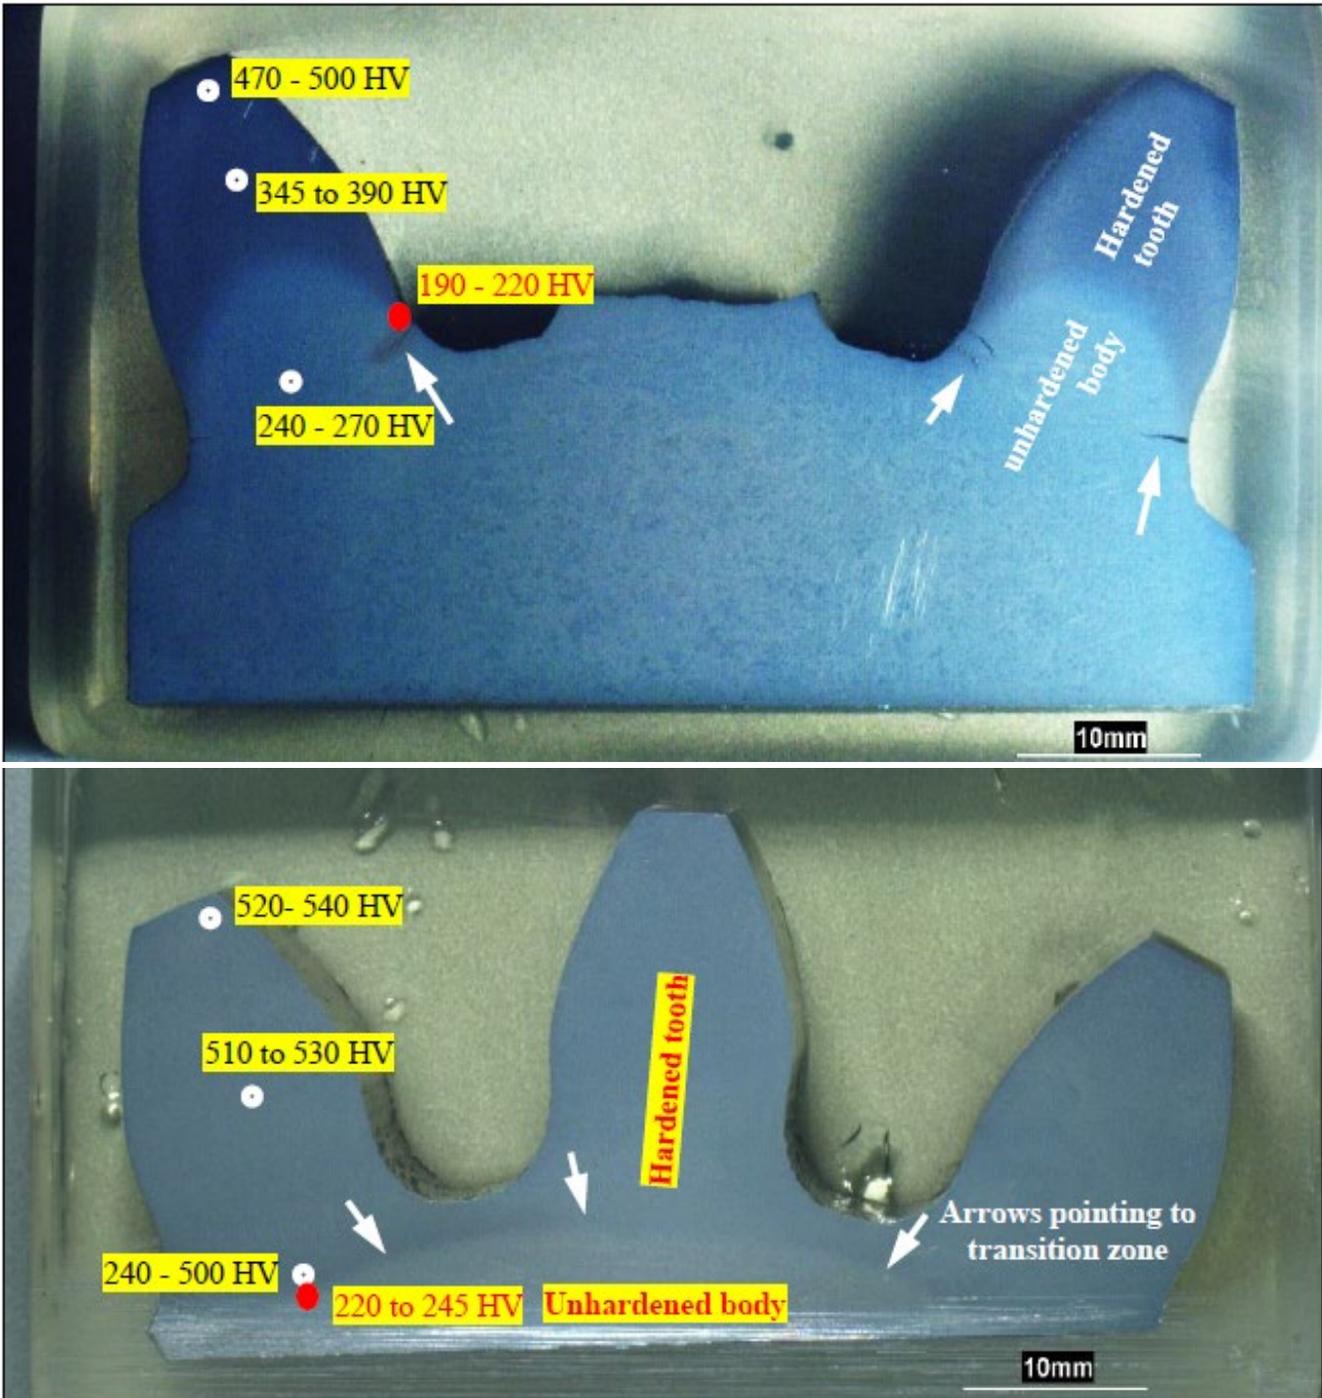
- Gear was found to have hardened teeth and flank, but minimal hardening at root [Figure 7], resulting in insufficient fatigue strength for its intended application.
- The hardness of the teeth and flank was not sufficient to resist flank wear.
- Substantial corrosion was observed on the exposed face of the broken tooth, indicating it had fractured well before the hoist failed to operate.

Figure 7: Metal hardness gradient of original bottom pinion gear (Top) and the replacement gear (Bottom).
