Incident Summary #II-1480971-2022 (#30678) (FINAL)

| | Regulated industry sector | Electrical - High voltage electrical system (greater than 750V) | |
| Incident overview | A roofer was preparing for roof drain connections near the underside of the roof in an industrial building with unlocked entrance doors. While working from a ladder, the roofer contacted an energized high voltage bus bar running near the ceiling and experienced a serious injury from the exposure to the high voltage electrical energy. | | |

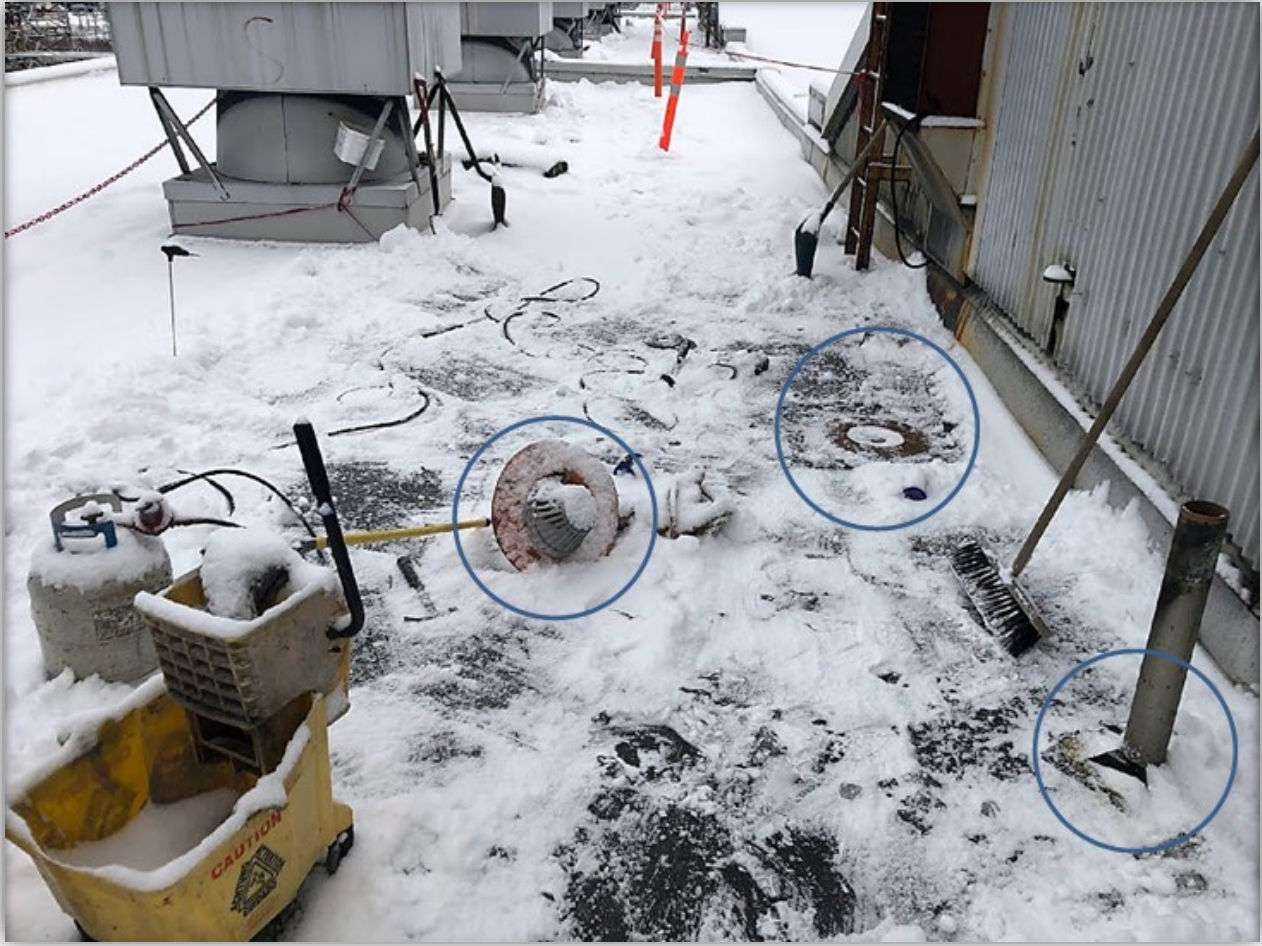
Photo 1 – Roofing components including roof drains and pipes.

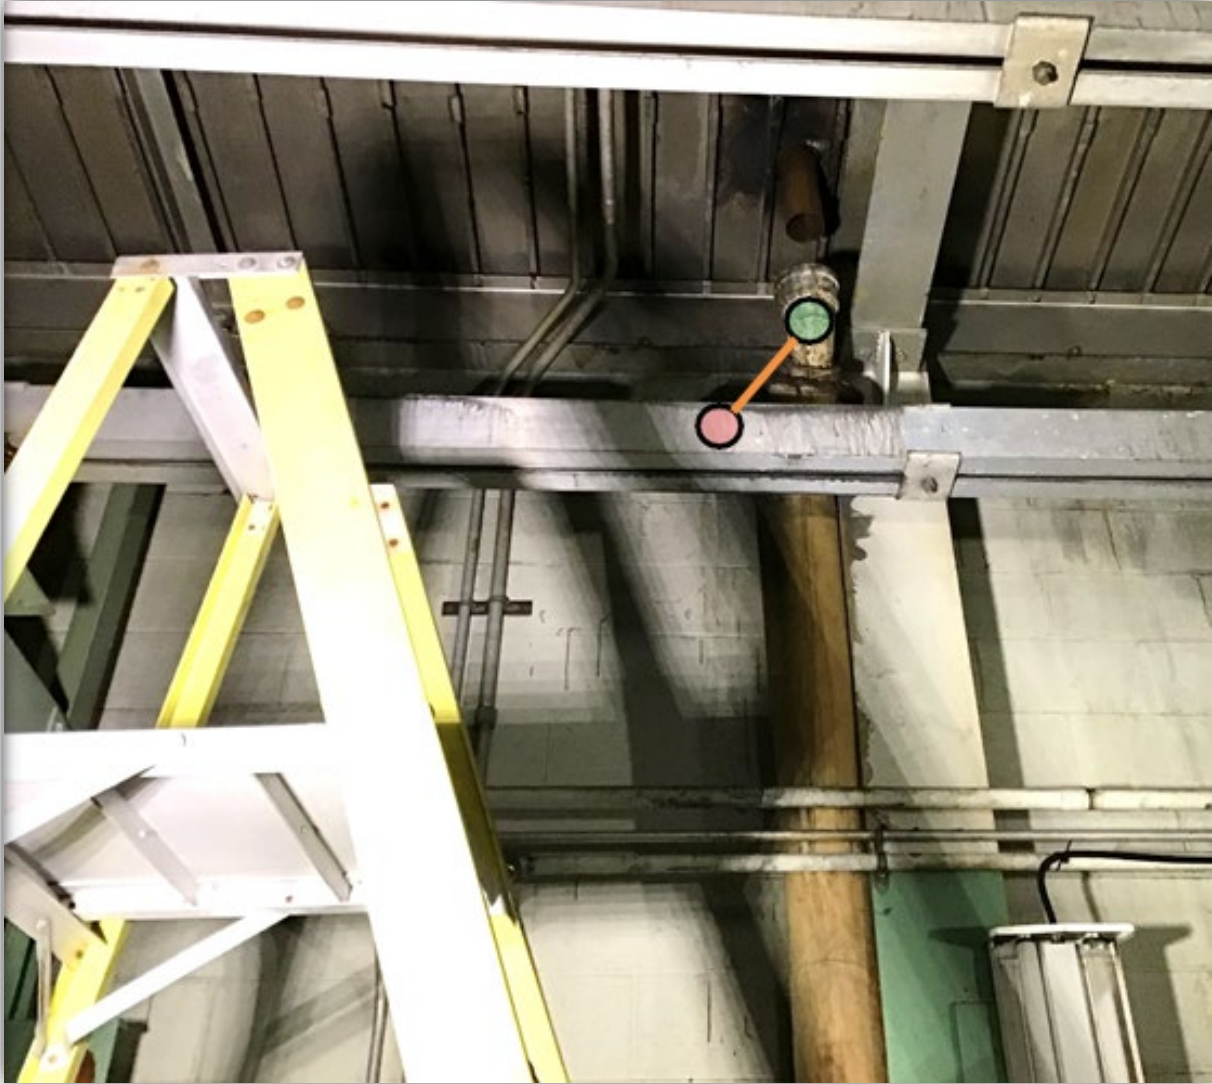
“As I brought my arm down with the pipe in my hand, my elbow must have hit that...bus bar, it’s the first I’ve heard of what a bus bar is. And then I got that shock into my arm.”

Photo 2 – High voltage bus bar, drainpipe, and ladder. The 7,620-volt shock occurred between one bus bar (RED) and the grounded metal drainpipe (GREEN).

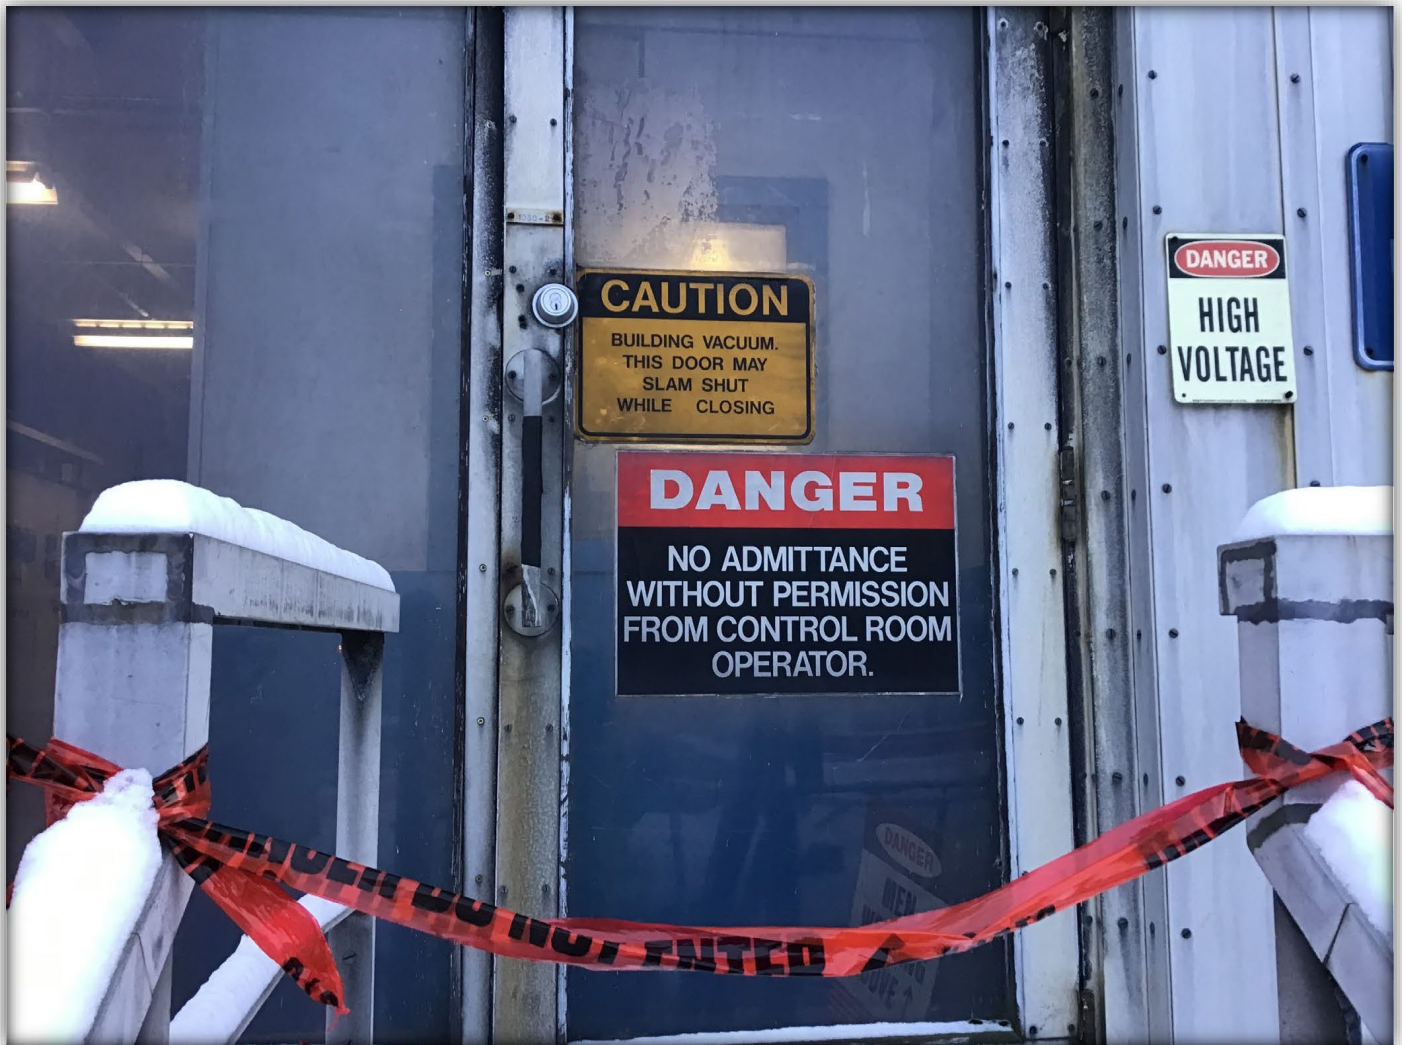
- Multiple doors unlocked.
- North person door damaged and unlockable.
- Poor lighting on third floor.

“[The doors] say...call control room for access, danger high voltage. There’s a lot of signage on the doors but the doors weren’t locked and that’s a downfall.”

Photo 3 – Entrance door to the area where the incident occurred.

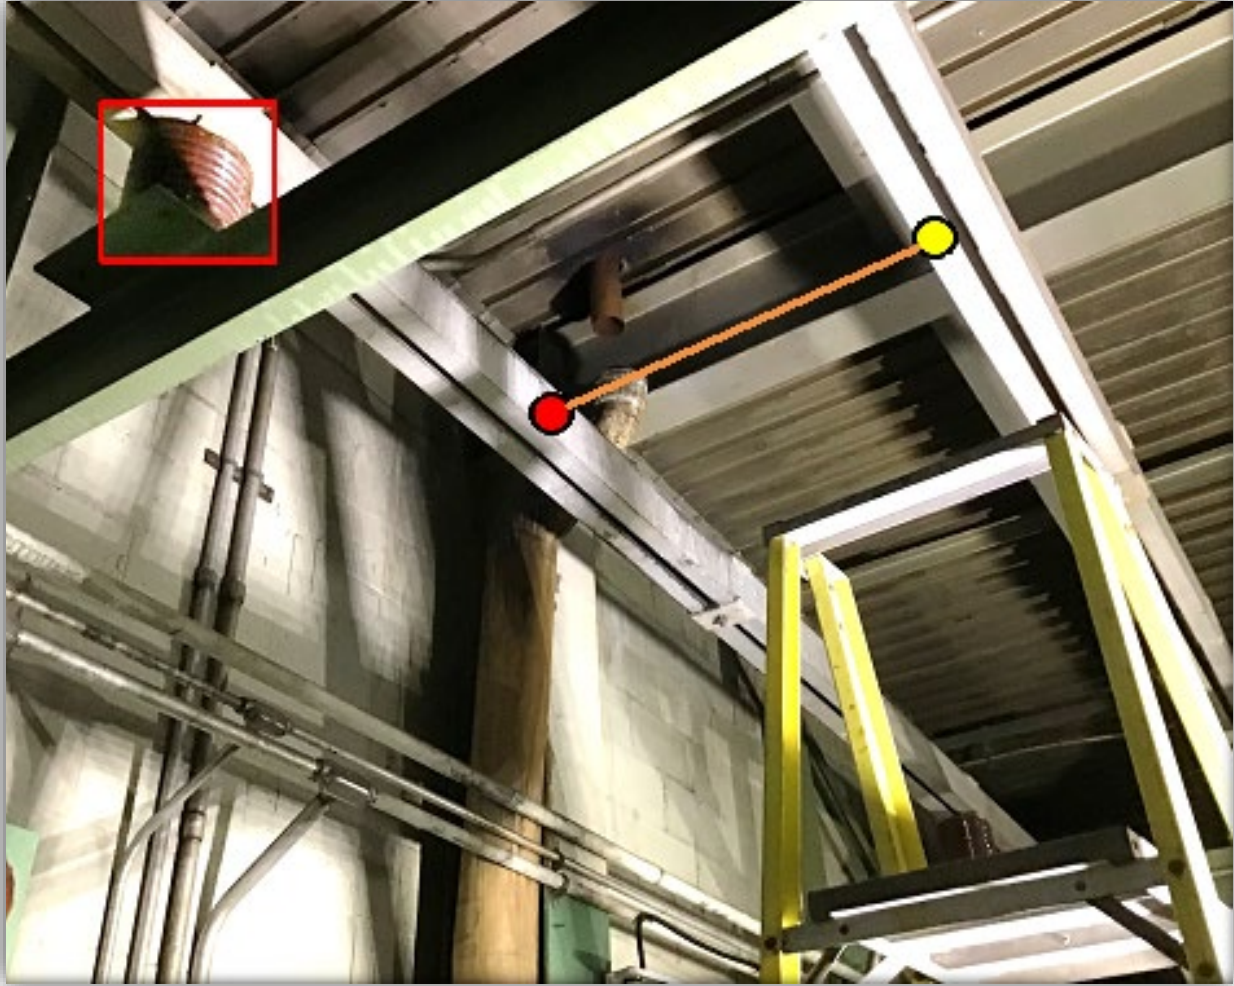
“Structure and bus look a lot the same, aluminum structure and it’s all-aluminum bus and the only way you know the difference is due to the standoffs on the insulator, and that only comes through experience.”

Photo 4 – (RED & YELLOW DOTS) High voltage bus bars and work area. There was 13,200-volts line to line voltage present. (RED BOX) Insulator.

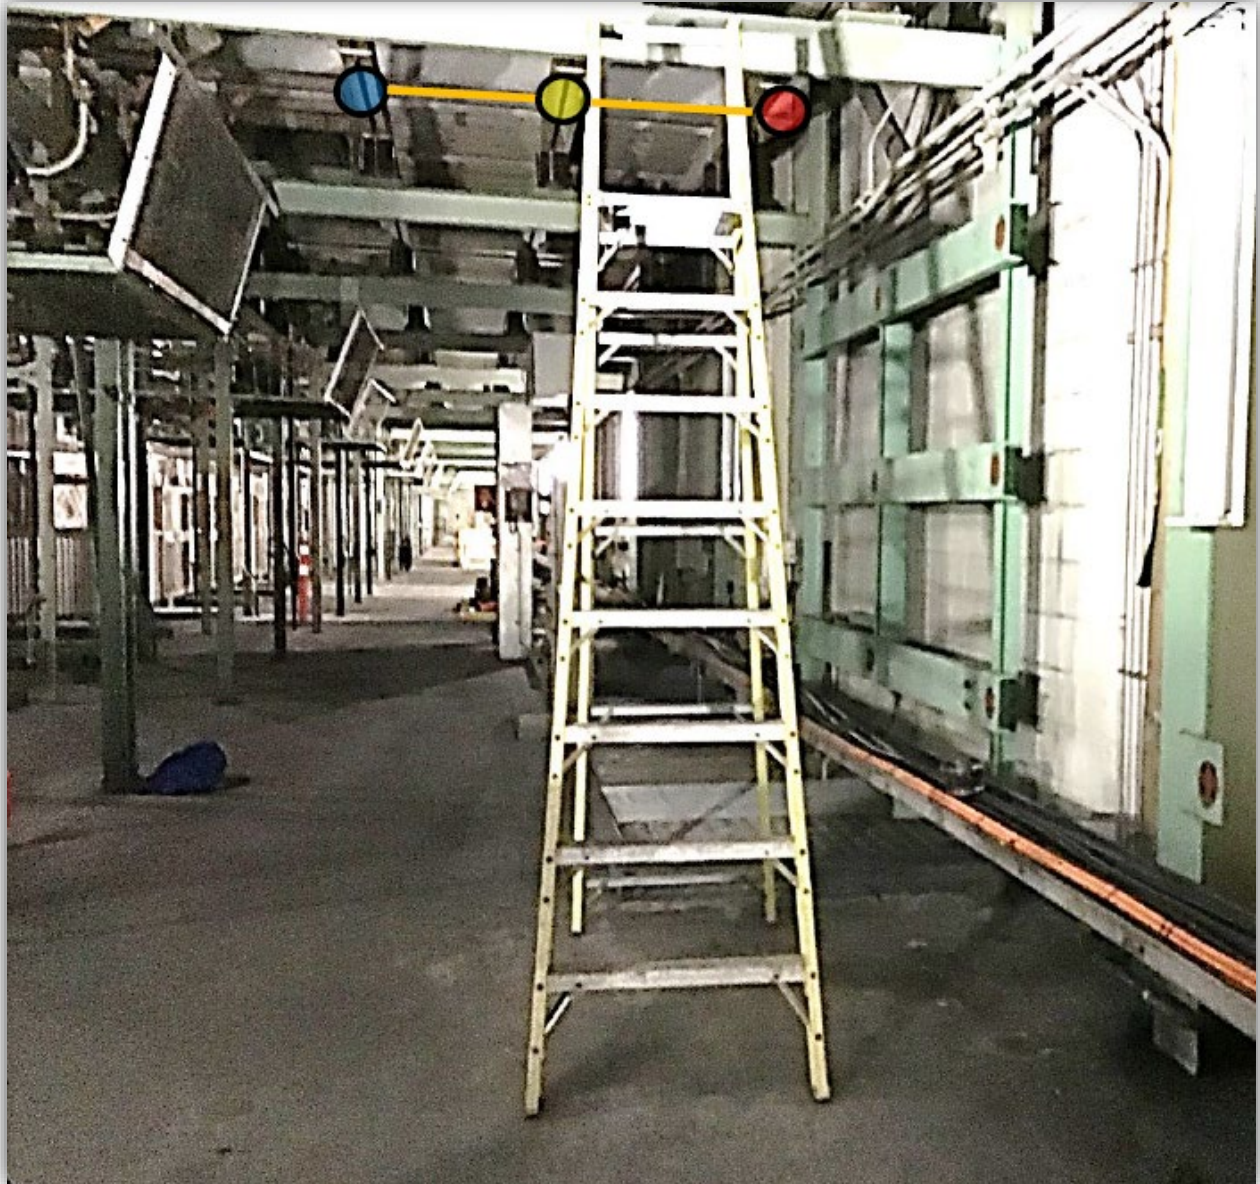
Photo 5 - General area of incident showing three phase high voltage bus bars (3 phase - 13,200/7620-volt) *Phase colours shown for reference only.*
