Incident Summary Report II-729058-2018 (8210)

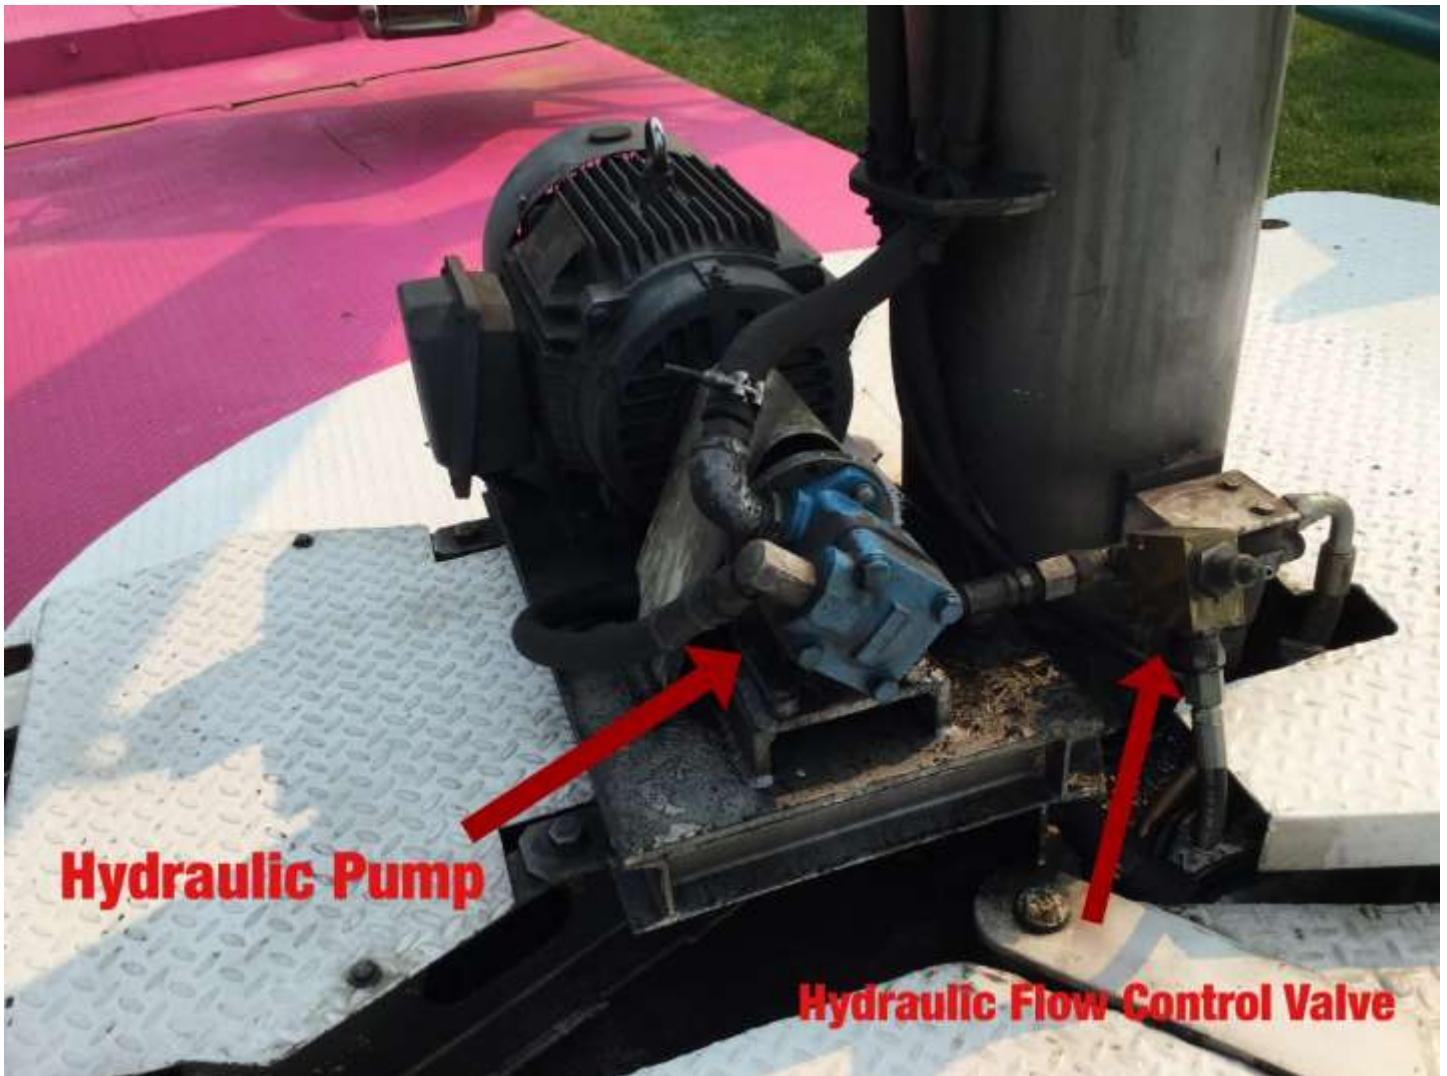
Main Spindle with Electric Motor, Hydraulic Pump and Flow Control Valve

Failure scenario(s)	The hydraulic flow control valve was not secured in a set position. This amusement ride is setup and moved on weekly basis, allowing for components to become inadvertently adjusted.	
	Facts and evidence	<p>Incident Investigation the following day discovered:</p> <ul style="list-style-type: none"> - A lock nut (jam nut) was missing on the hydraulic flow control valve - Ride was recorded operating 20% over speed - Daily ride checks did not include ride RPM - No documentation of ride speed for this setup location <p>As reported by the rider:</p> <ul style="list-style-type: none"> - Fell unconscious during ride - Complained of sore ribs and back - Seated with son and daughter <p>As reported by the contractor:</p> <ul style="list-style-type: none"> - Rider exited by herself unassisted - Daily checks were performed prior to operation - Each setup owner/contractor operates each ride, not documented

Causes and contributing factors	It is very likely that a missing lock nut on the hydraulic flow control valve caused the valve to be adjusted resulting in ride operating too fast. The incompleteness of the daily and setup checks of ride speed is a contributing factor.
