Incident Summary #II-771091-2018 (#9584) (FINAL)

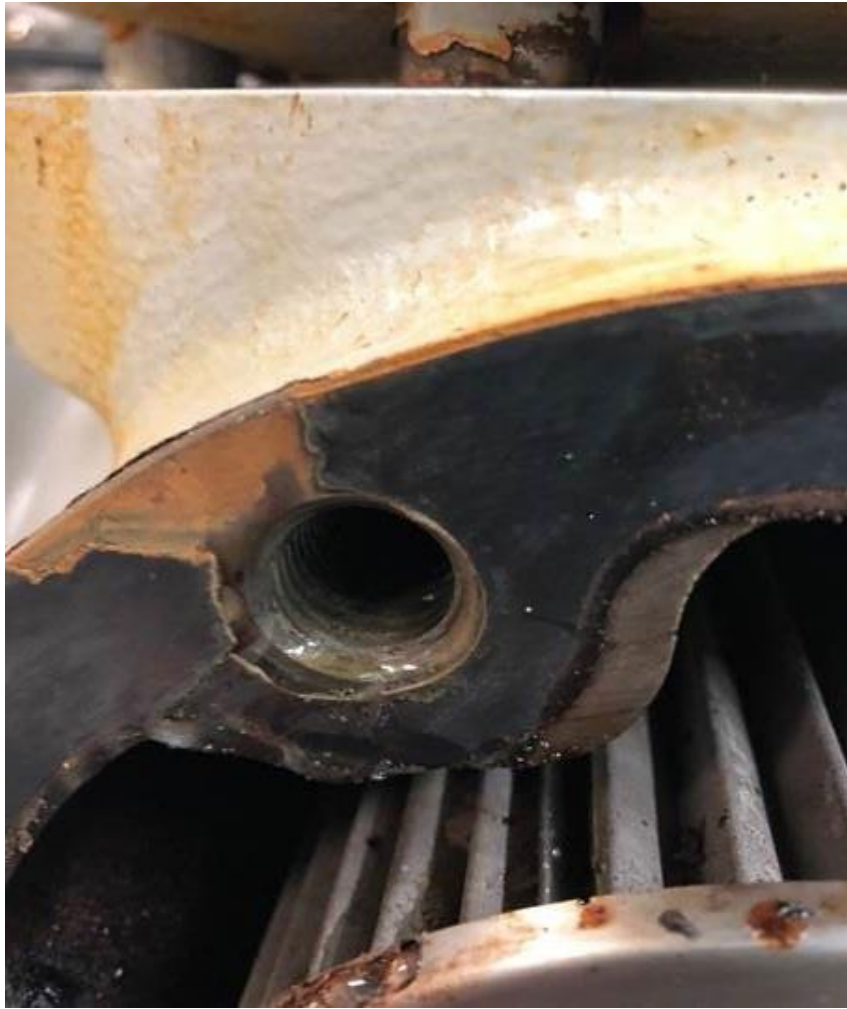
Photo 4: Photo provided by Refrigeration Contractor and used with permission. Not failure on bottom left side of gasket below bolt hole. Also rust on suction valve body where gasket was missing above the bolt hole.

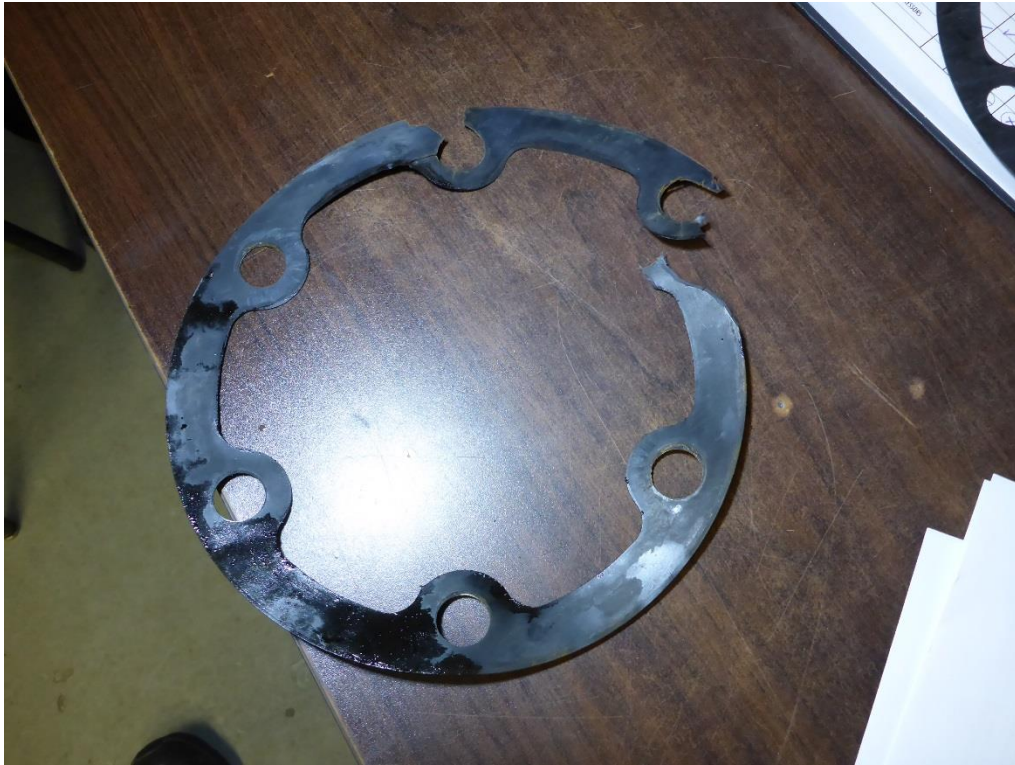
Photo 5: Photo by Boiler Safety Officer-actual gasket.
