Incident Summary #II-1670853-2024 (#44157) (FINAL)

SUPPORTING INFORMATION	Incident Date	January 31, 2024	
	Location	Lake Cowichan	
	Regulated industry sector	Electrical - Low voltage electrical system (30V to 750V)	
	Impact	Qty injuries	1
		Injury description	Electric shock.
		Injury rating	Minor
	Damage	Damage description	NA
		Damage rating	None
	Incident rating	Minor	
Incident overview	Individual received an electric shock from concrete stairs at a school.		
INVESTIGATION CONCLUSIONS	Site, system and components	<ul style="list-style-type: none"> • Trace heaters commonly referred to as heat trace are used to heat surfaces and/or to prevent freezing. • Trace heaters can be concealed in walls, driveways, roofs, ceilings, and stairs, or surface mounted on piping systems, water lines, and sewer lines. They are used everywhere from industrial to residential applications. • Trace heater is defined as “a device of linear geometry designed for the purpose of producing heat on the principle of electrical resistance”. • Trace heaters are designed to self-regulate or are controlled by a thermostat commonly called a Resistive Thermal Device or RTD or a temperature probe. • Modern electrical

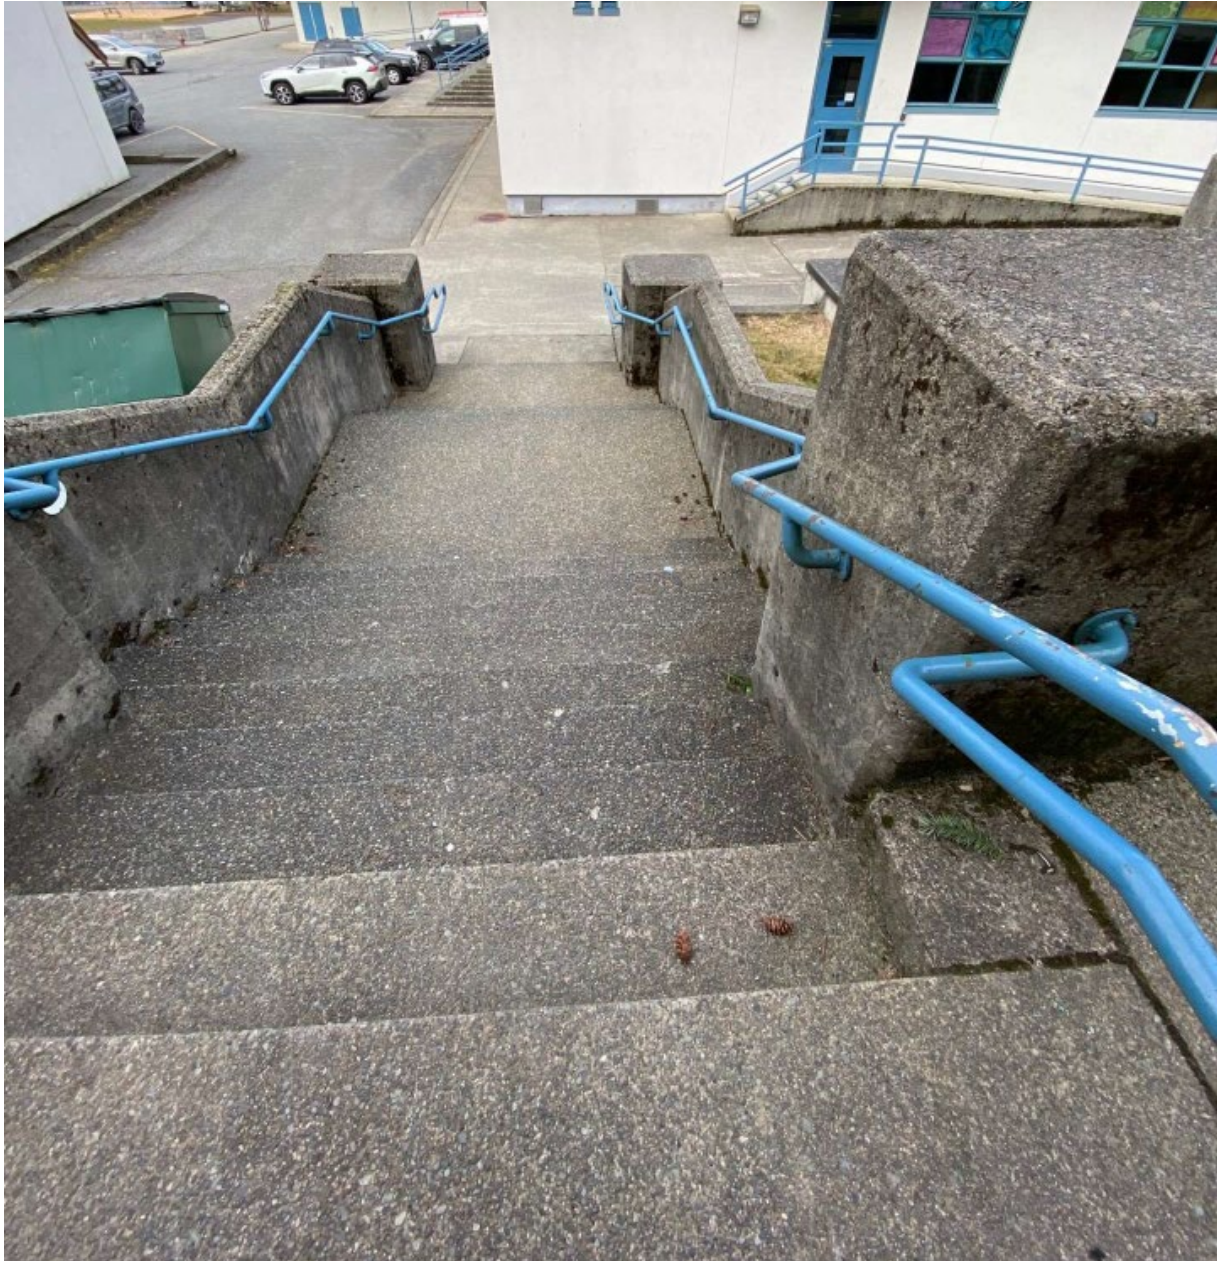
Failure scenario(s)	<p>On January 31st a teacher looked out the window at a gathering of students. The students were congregated at a set of concrete steps that led to the shop building. The teacher approached the students and asked them what the meeting was about. The students replied that the stairs were vibrating. The teacher bent down to feel the vibrating steps and received an electric shock.</p> <p>The school district dispatched an electrician to the site where they found a heat trace circuit was shorting out to the concrete steps. The circuit was permanently disconnected.</p>

Image 1 - Stairs where the incident occurred.

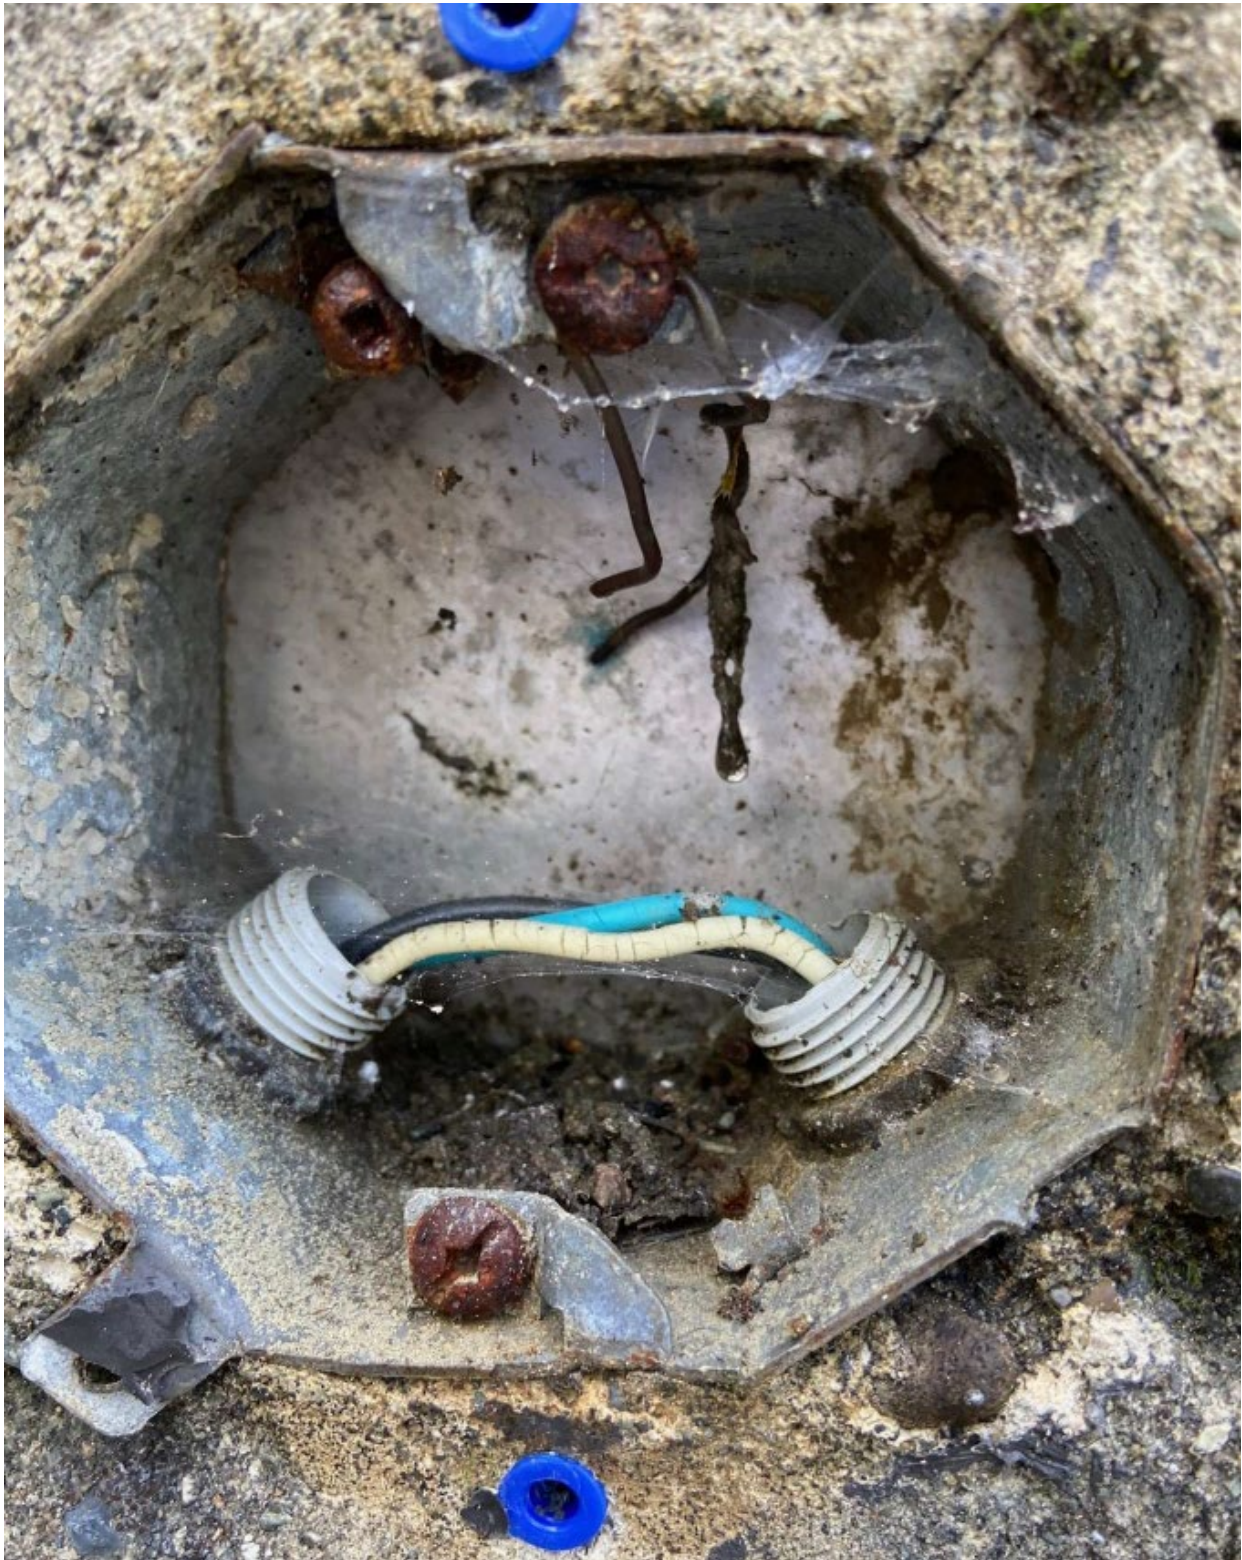
Facts and evidence	<ul style="list-style-type: none">• Wiring in the junction boxes on the stairs thought to have fed the heat trace was brittle and cracking. It was likely not approved for the location.• The junction box that was examined was not bonded.• No GFCI protection was installed on the circuit.• Insulation resistance test revealed a short to ground.
Causes and contributing factors	<p>Based on the condition of the wiring in the junction box it is likely that the deteriorated insulation on the circuit conductors caused a short circuit in the concrete. GFCI protection of heat trace was not a requirement of the code at the time of this installation. Although the electrical code is not retroactive, for operators of older trace heat systems in public places or schools it is encouraged to add GFCI protection.</p>

Image 2 - Deteriorated insulation on circuit conductors.

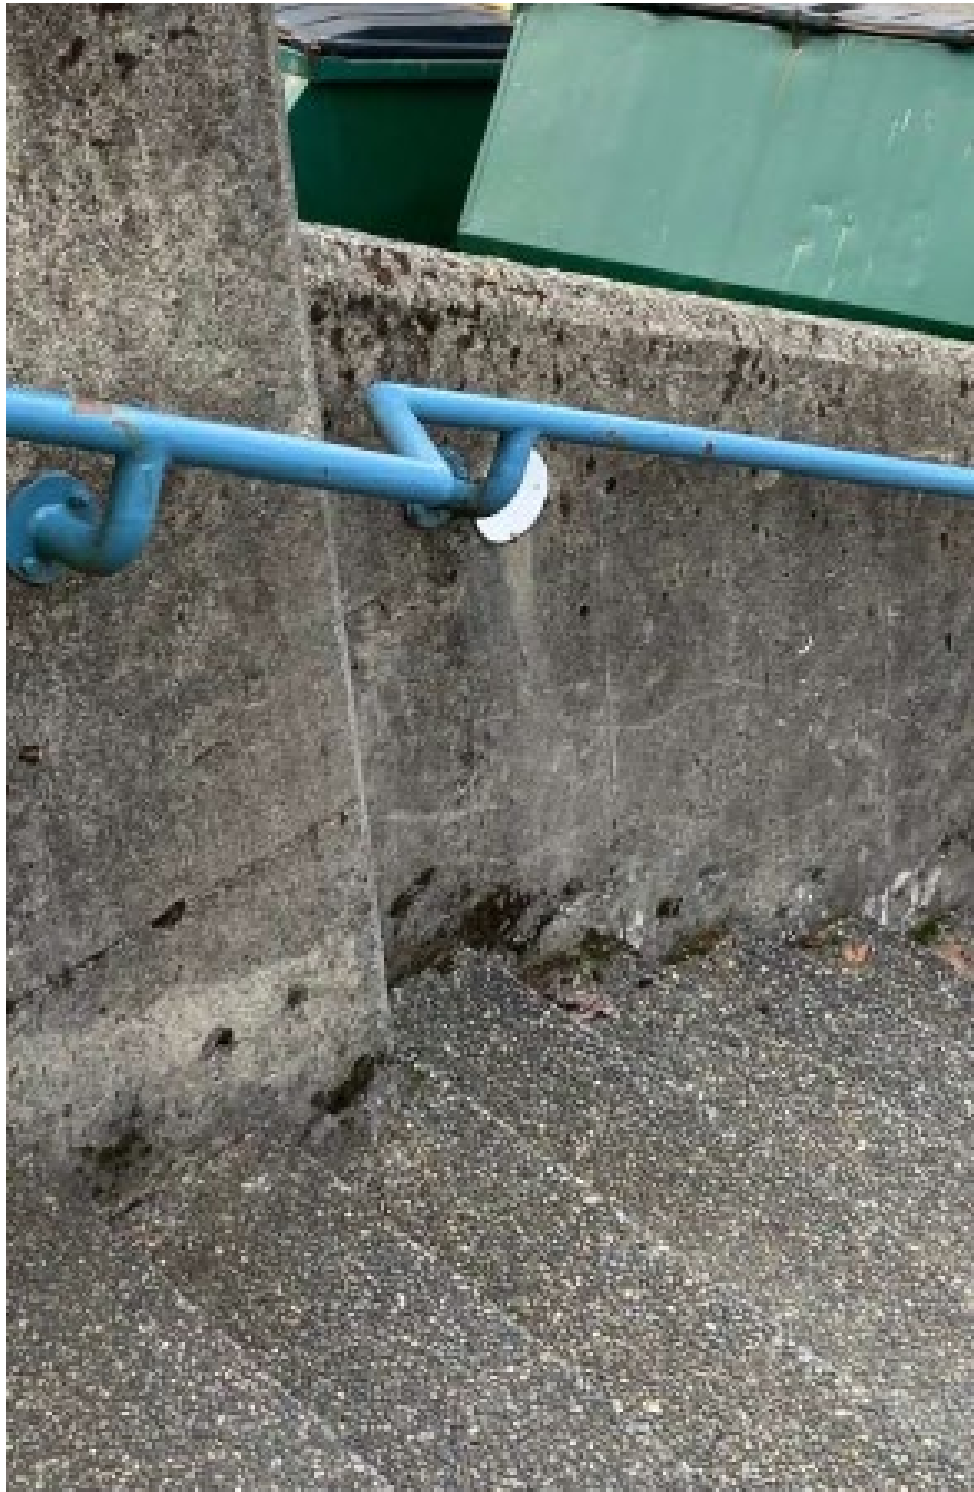
Image 3 - Junction box location on stairs.

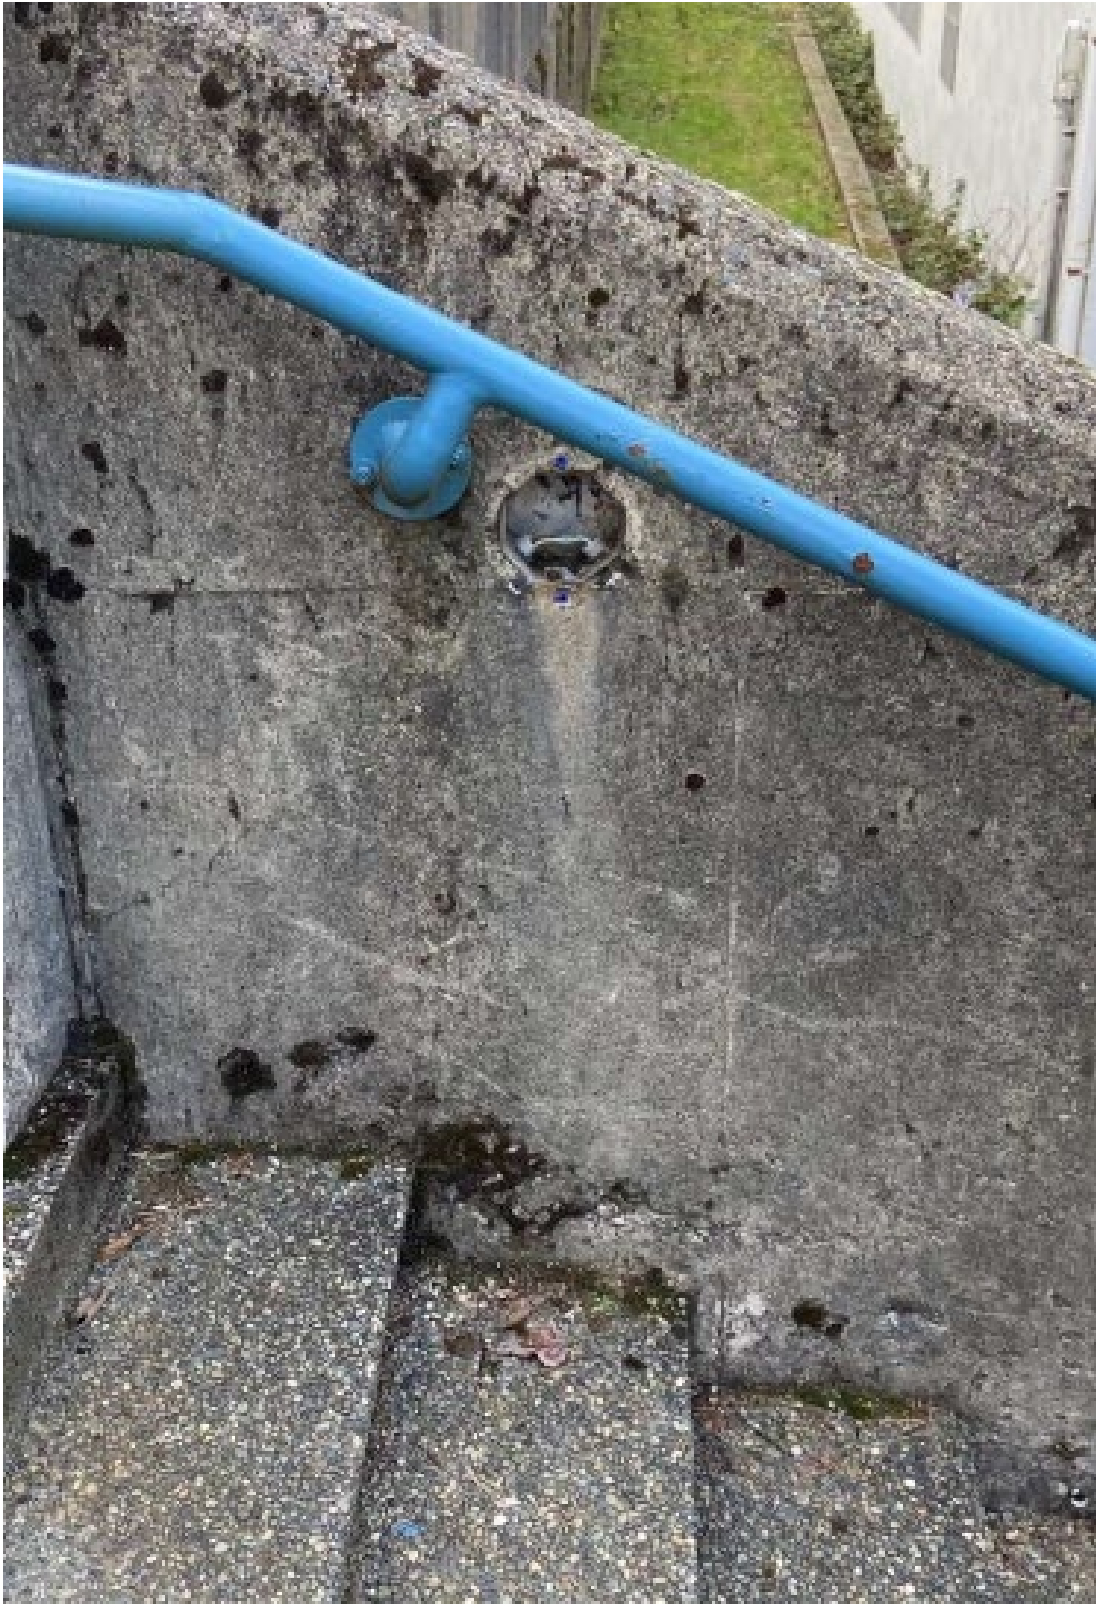
Image 4 - Stairs and junction box.

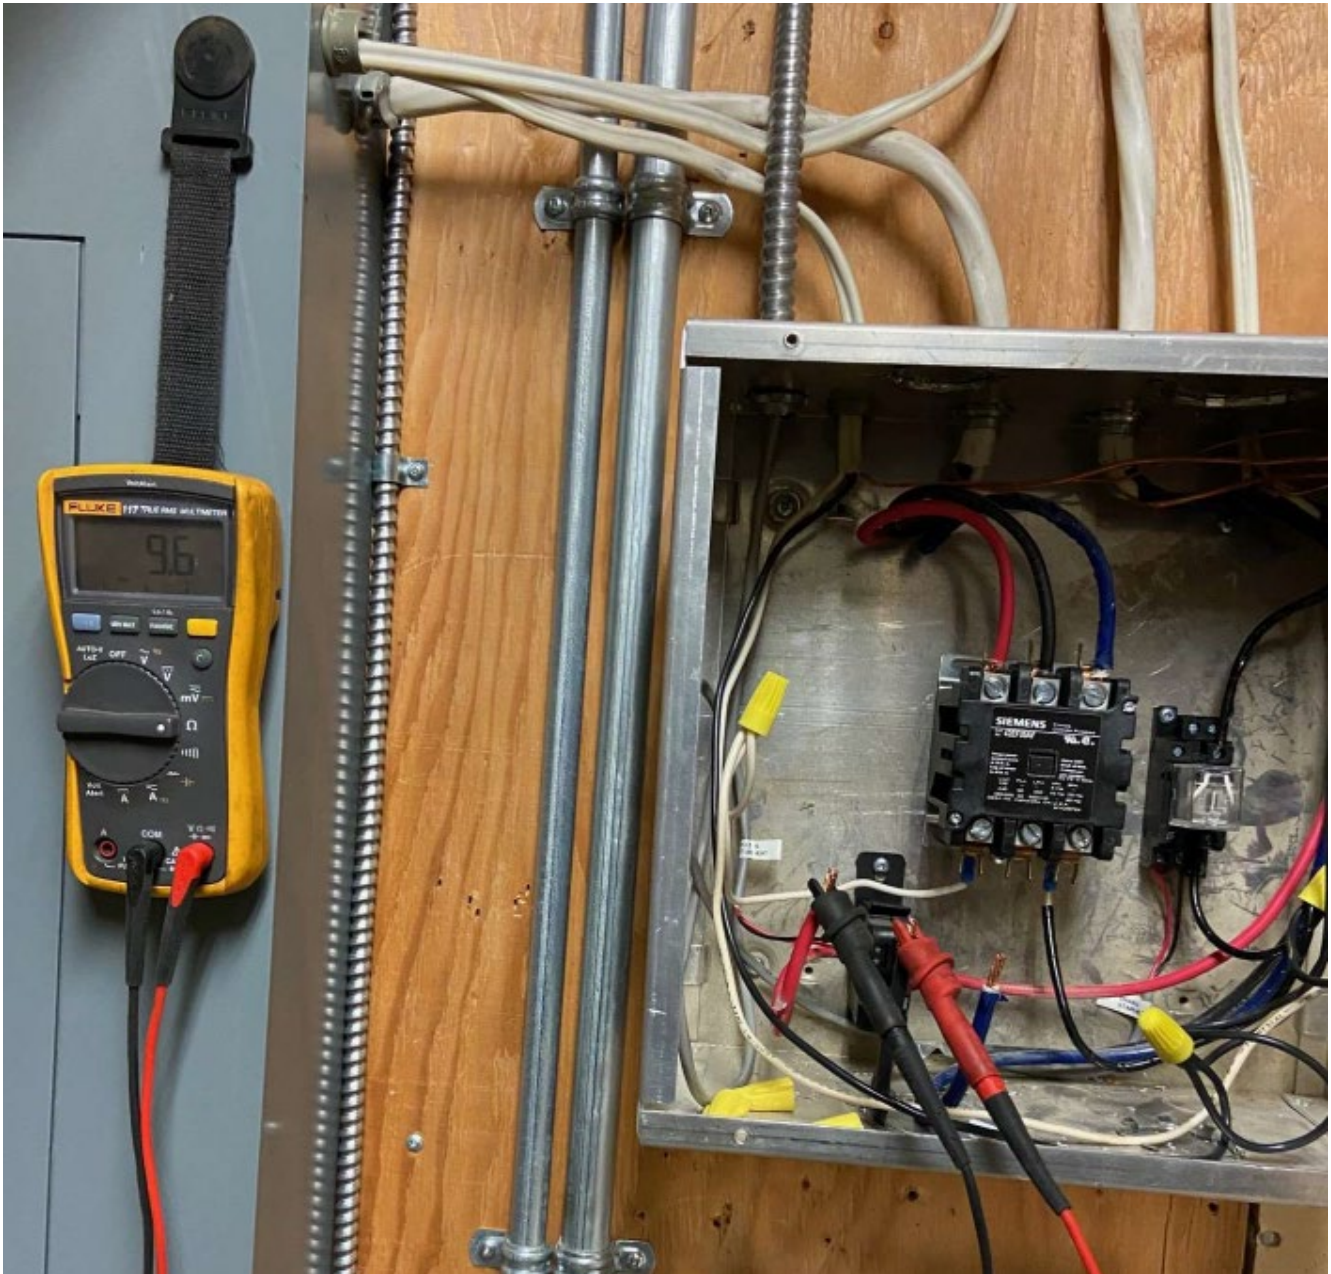
Image 5 - Insulation resistance testing of the heat trace circuit.
