Incident Investigation Report Houston BC Pellet Dryer Explosion

Technical Safety BC

OVERVIEW

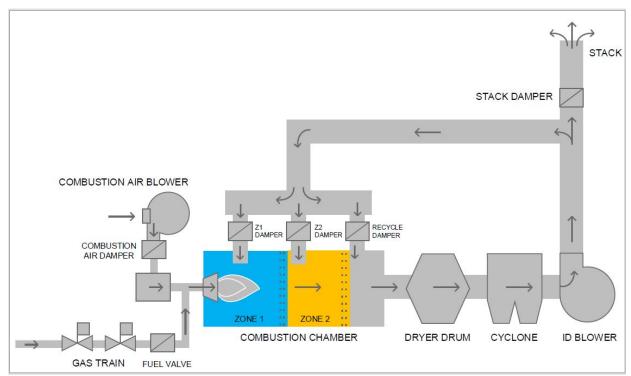
Data from the temperature sensors show that during the last two burner restarts temperatures in dilution zones 1 and 2 spiked unexpectedly before main burner input was increased from its low fire position. The temperatures were reduced by the operator by opening other airflow dampers to cool the temperatures down. During the last burner restart before the incident the temperature in the zone farthest away from the burner (Zone 2) exceeded that in the zone closer to the burner (Zone 1) before being controlled by manual airflow adjustments in the burner dilution zones (Graphs 2 and 3). This could indicate incomplete combustion at the burner throat with combustion occurring farther down the combustion chamber. This could result from an over rich air fuel ratio produced by either insufficient combustion air or an excess of natural gas.

Image 2 - Highlighting the location of combustion chamber dilution zones # 1&2

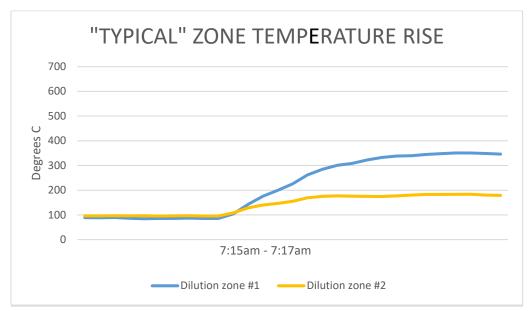
The data in Graph 1 represents the ignition of the main burner but before burner input is increased above 0% (low fire start).

Graph 1 - 11/24/2020 Temperature rise in the combustion chamber dilution zones during a "typical" burner restart.

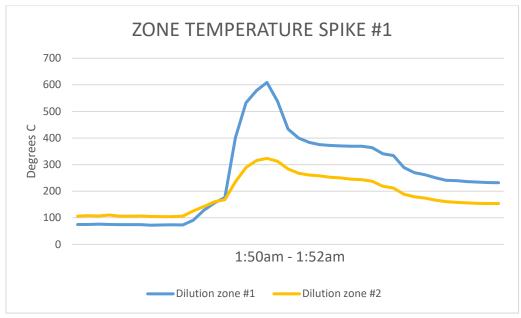
The data in Graph 2 represents the ignition of the main burner but before burner input is increased above 0% (low fire start). The temperature in zone #1 spiked abnormally high and needed to be controlled by manual airflow adjustments by the plant operator in the burner dilution zones.

Graph 2 - 11/25/2020 Temperature rise in the combustion chamber dilution zones during the burner restart that occurred during the night shift before the incident.

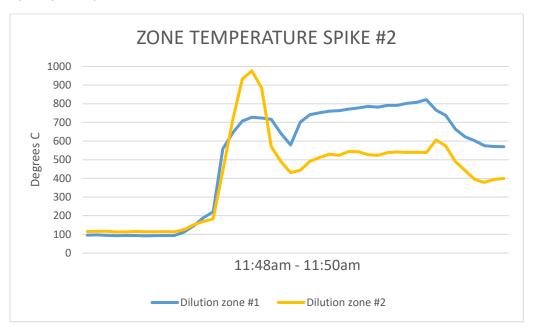
The data in Graph 3 represents the ignition of the main burner but before burner input is increased above 0% (low fire start). The temperature in zone #1 spiked abnormally high and the temperature in zone #2 exceeded the zone #1 temperature and needed to be controlled by manual airflow adjustments by the plant operator in the burner dilution zones.

Graph 3 - Temperature rise in the combustion chamber dilution zones during the burner restart that occurred 4 minutes before the explosion.

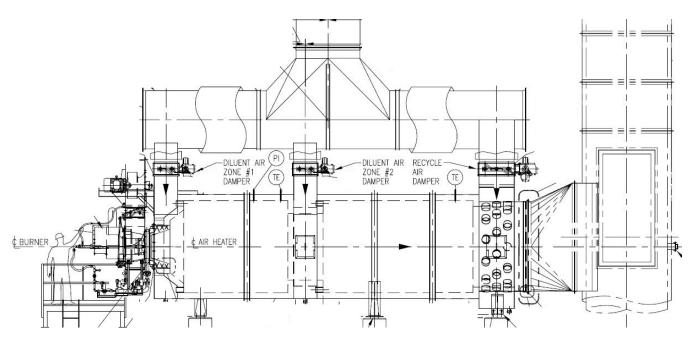
Image 3 showing locations of dilution zone and recycle air dampers. (TE) represents the location of the temperature probes for dilution zones 1&2.

Image 3 - Burner and combustion chamber detail (From drawing CAN06-DM-101 provided by manufacturer)

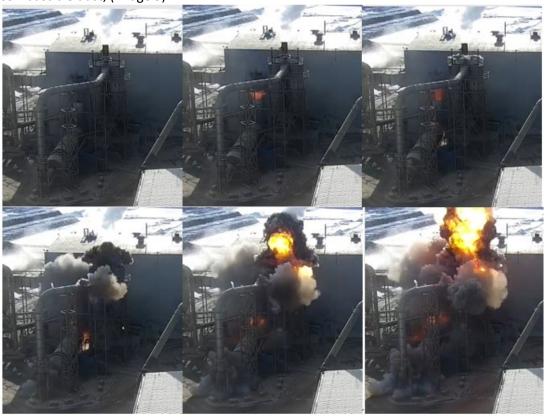
The concussion from the gas explosion is believed to have traveled through the dryer system causing a large amount or dust to become airborne which likely contacted the gas burner resulting in an ancillary explosion and fireball at the dust collection equipment location.

Video surveillance footage of the equipment involved was reviewed. Still images from the video show that the initial explosion originated between the burner and the dryer drum, (Image 4). A secondary explosion and fireball occurred at the cyclone dust collection system.

Image 4 – Video still images show origin of initial explosion (burner/dryer drum) and secondary explosion/fireball at the cyclone dust collection system.

- C. Combustible dust is present in the ductwork and collection system. The initial explosion disturbed the combustible dust causing it to be airborne within the duct. The airborne dust then ignited causing a secondary dust explosion and fireball. The ancillary dust explosion and fireball may have been prevented through the use of explosion isolation systems including isolation dampers, valves or barriers.

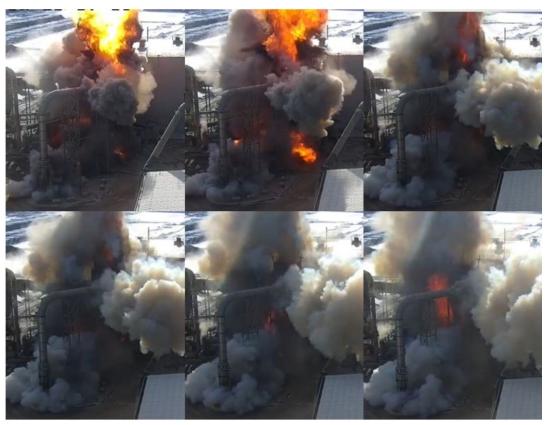
Video still images also show the progression of the explosion and subsequent fireball due to ignition of combustible dust, (Image 5).

Image 5 – Video still images show progression of explosion and subsequent combustible dust fireball.
