Incident Summary #II-1116466-2020 (#20151) (FINAL)

SUPPORTING INFORMATION	Incident Date	December 10, 2020	
	Location	Coquitlam	
	Regulated industry sector	Electrical - High voltage electrical system (greater than 750V)	
	Impact	Qty injuries	0
		Injury description	N/A
		Injury rating	None
	Damage	Damage description	Underground high voltage conductors were damaged and severed with fuse blown.
		Damage rating	Major
	Incident rating	Major	
	Incident overview	While excavating for the installation of new sewer lines at a public community center and school, a high voltage 12.5KV (12,500 volt) underground electrical feeder cable was struck by a mechanical excavator, severing the feeder cable, and creating a short circuit arc fault.	
INVESTIGATION CONCLUSIONS	Site, system and components	<p>The electrical supply for the buildings on the property consists of the following (Image 1):</p> <ul style="list-style-type: none"> • Utility owned overhead power lines with fused cut outs mounted on a utility owned power pole located on public property. • A high voltage (12.5KV) utility supply service cable that runs down the utility power pole and then underground feeding power to the first building lo

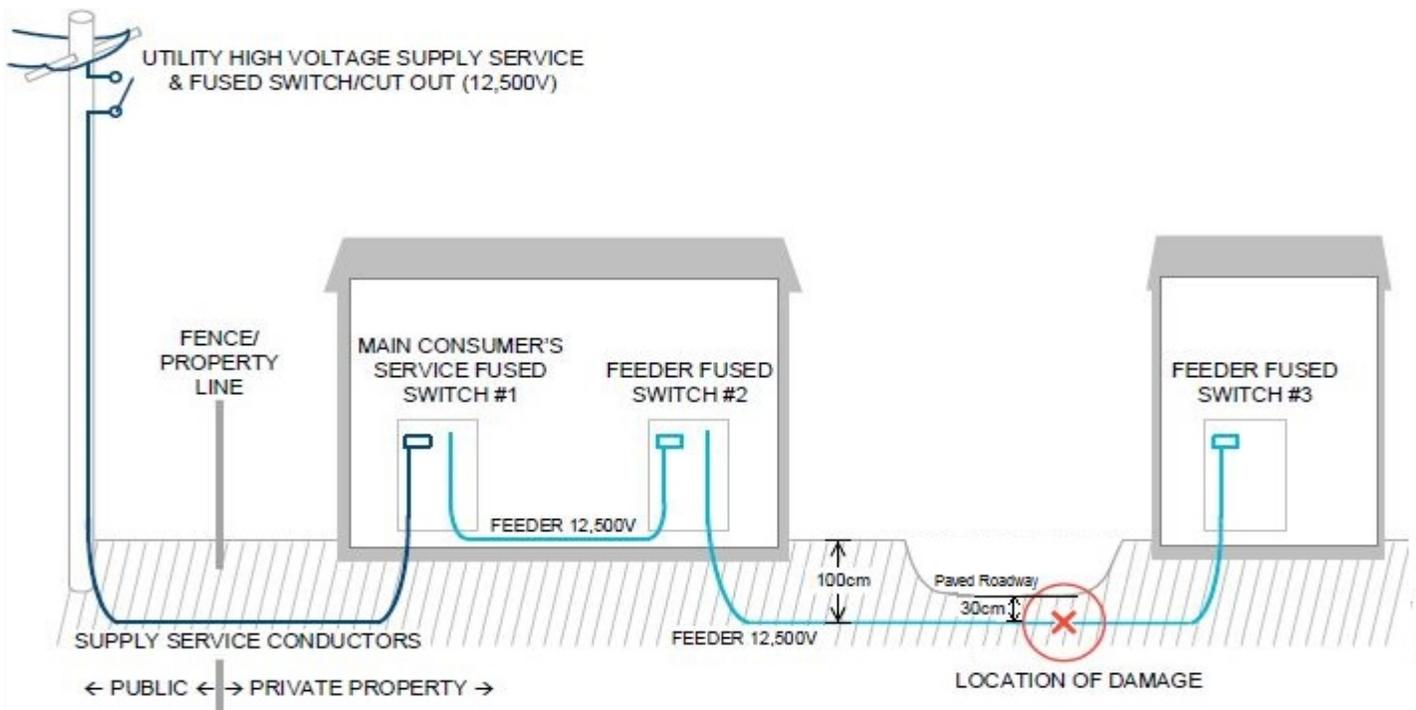
Image 1 – Diagram showing the electrical supply to buildings on the site. The black conductors are utility owned and identified through "BC 1 Call" services. The blue "feeder" conductors are privately owned and not identified through "BC 1 Call" services.

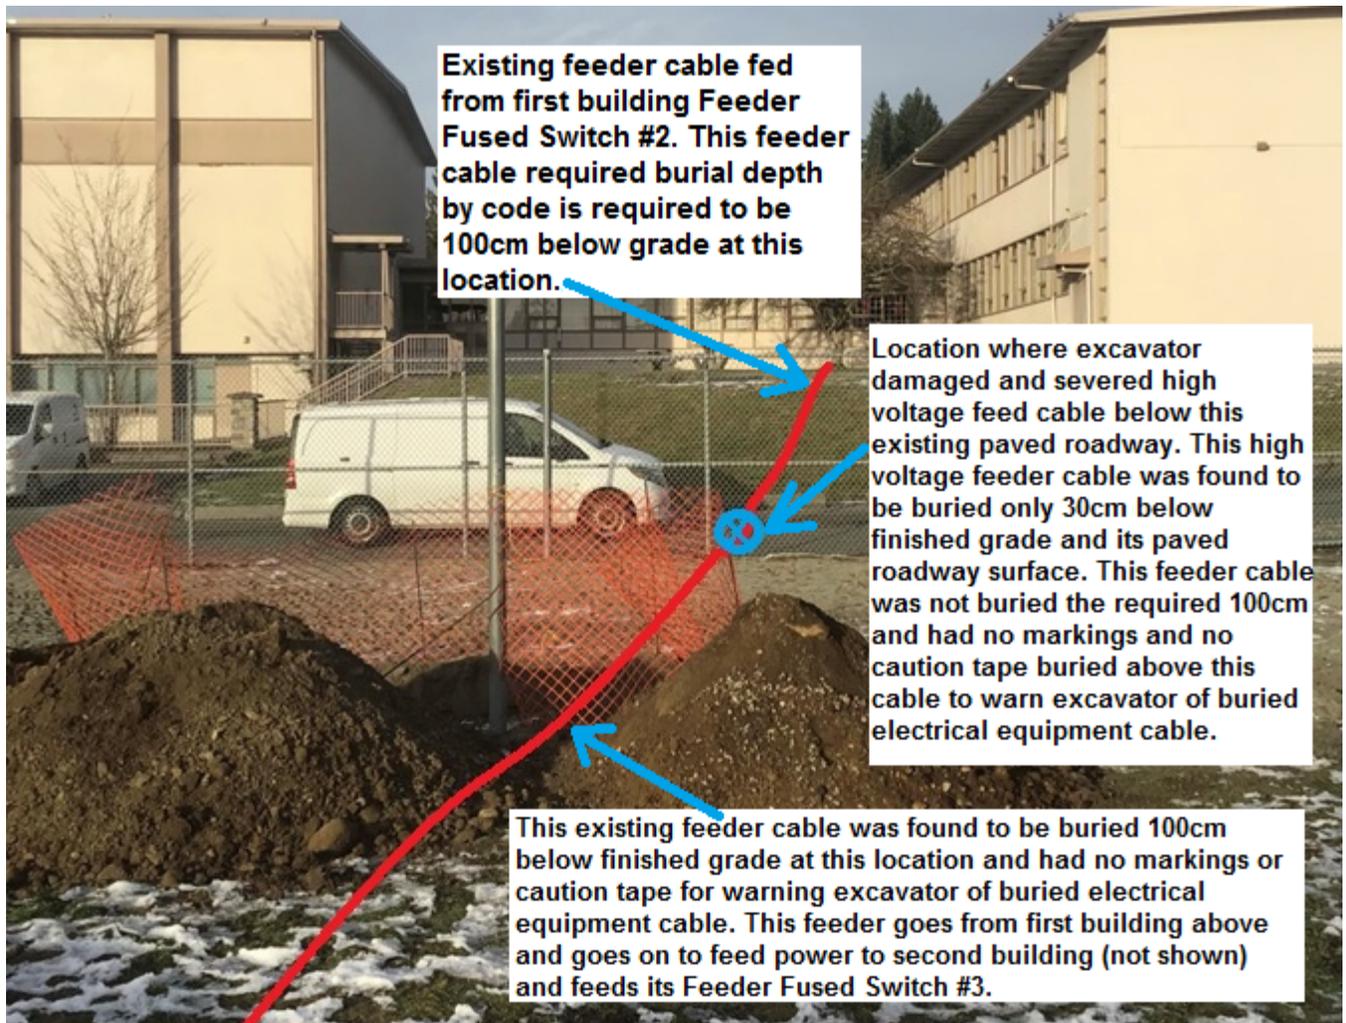
- Measurements were taken and the feeder cable was found to be only 30cm deep below the paved roadway surface which is 70 cm less than the required 100cm burial depth for the feeder cable.
- The feeder cable was damaged and completely severed during excavation.
- A test hole was dug approximately 15-20 meters horizontally away from the paved roadway where the feeder cable was struck and damaged. This test hole found this same feeder cable was buried at the appropriate required depth but still without identification, warning markers or mechanical protection as required for the high voltage feeder cable.

Image 2 - The red line represents the existing high voltage feeder cable. At the top of the photo is the existing earth grade that requires high voltage feeder to be buried to 100cm. The blue circled "X" at the middle of paved roadway the same feeder cable was found buried only 30cm due to the previous excavation of the earth grade for installation of the paved roadway.

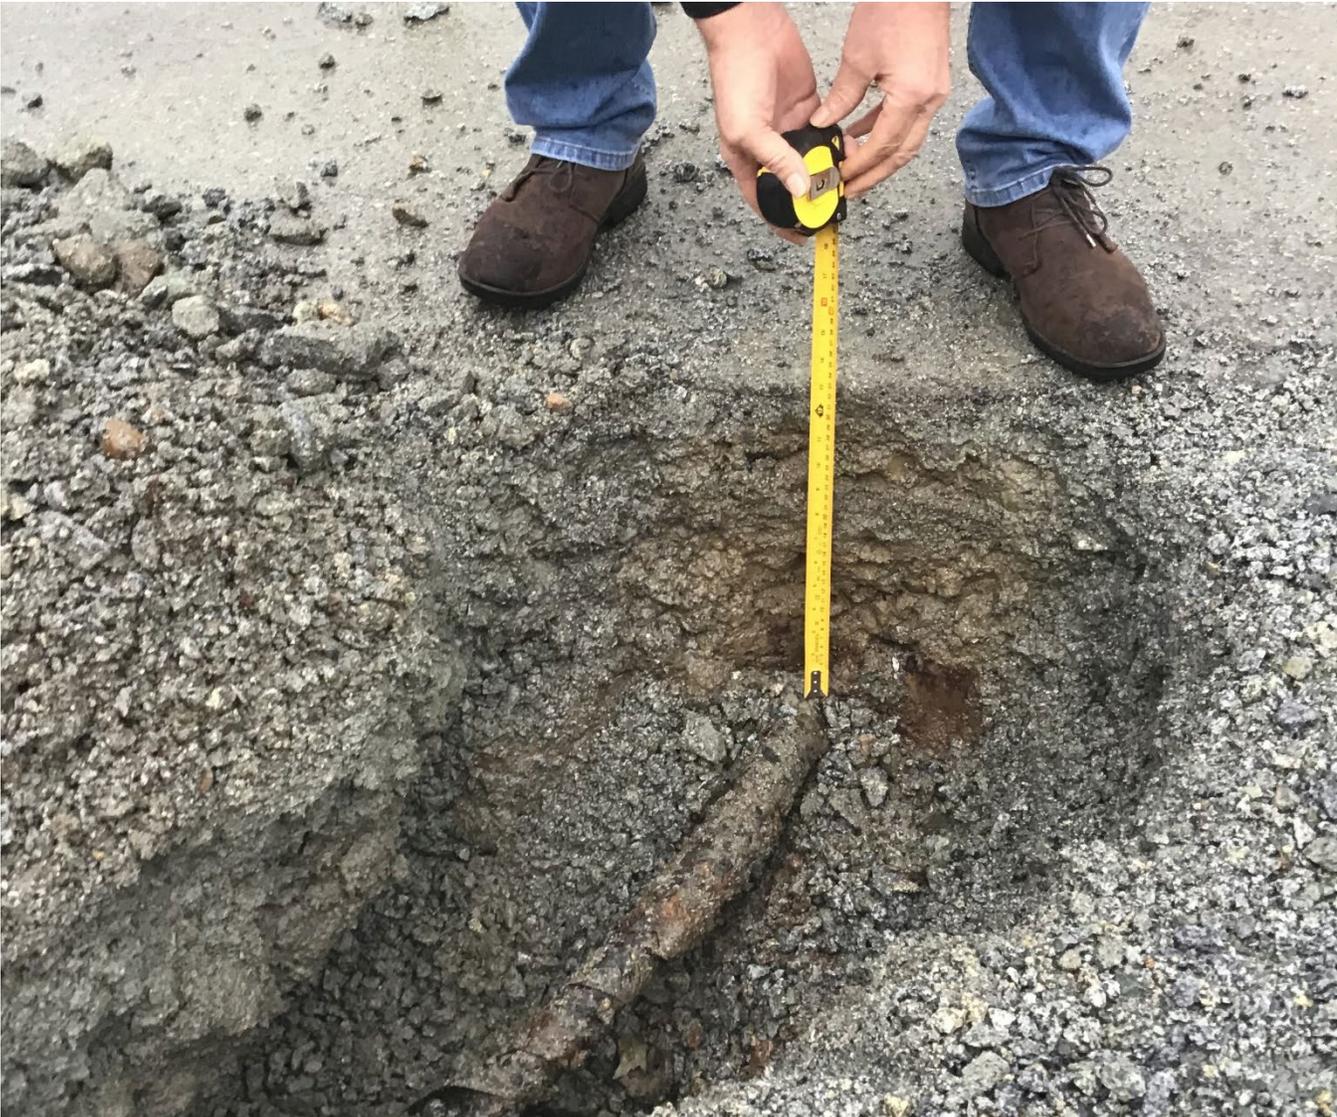
Image 3 - The measuring tape shows the high voltage cable is only buried 30cm below finished grade at roadway and there is no caution tape buried in earth above the cable to warn excavator of buried electrical equipment cable. This cable is required to be buried at least 100cm below finished grade surface and must have a cautionary marker tape or other markings to warn excavators of buried electrical equipment.

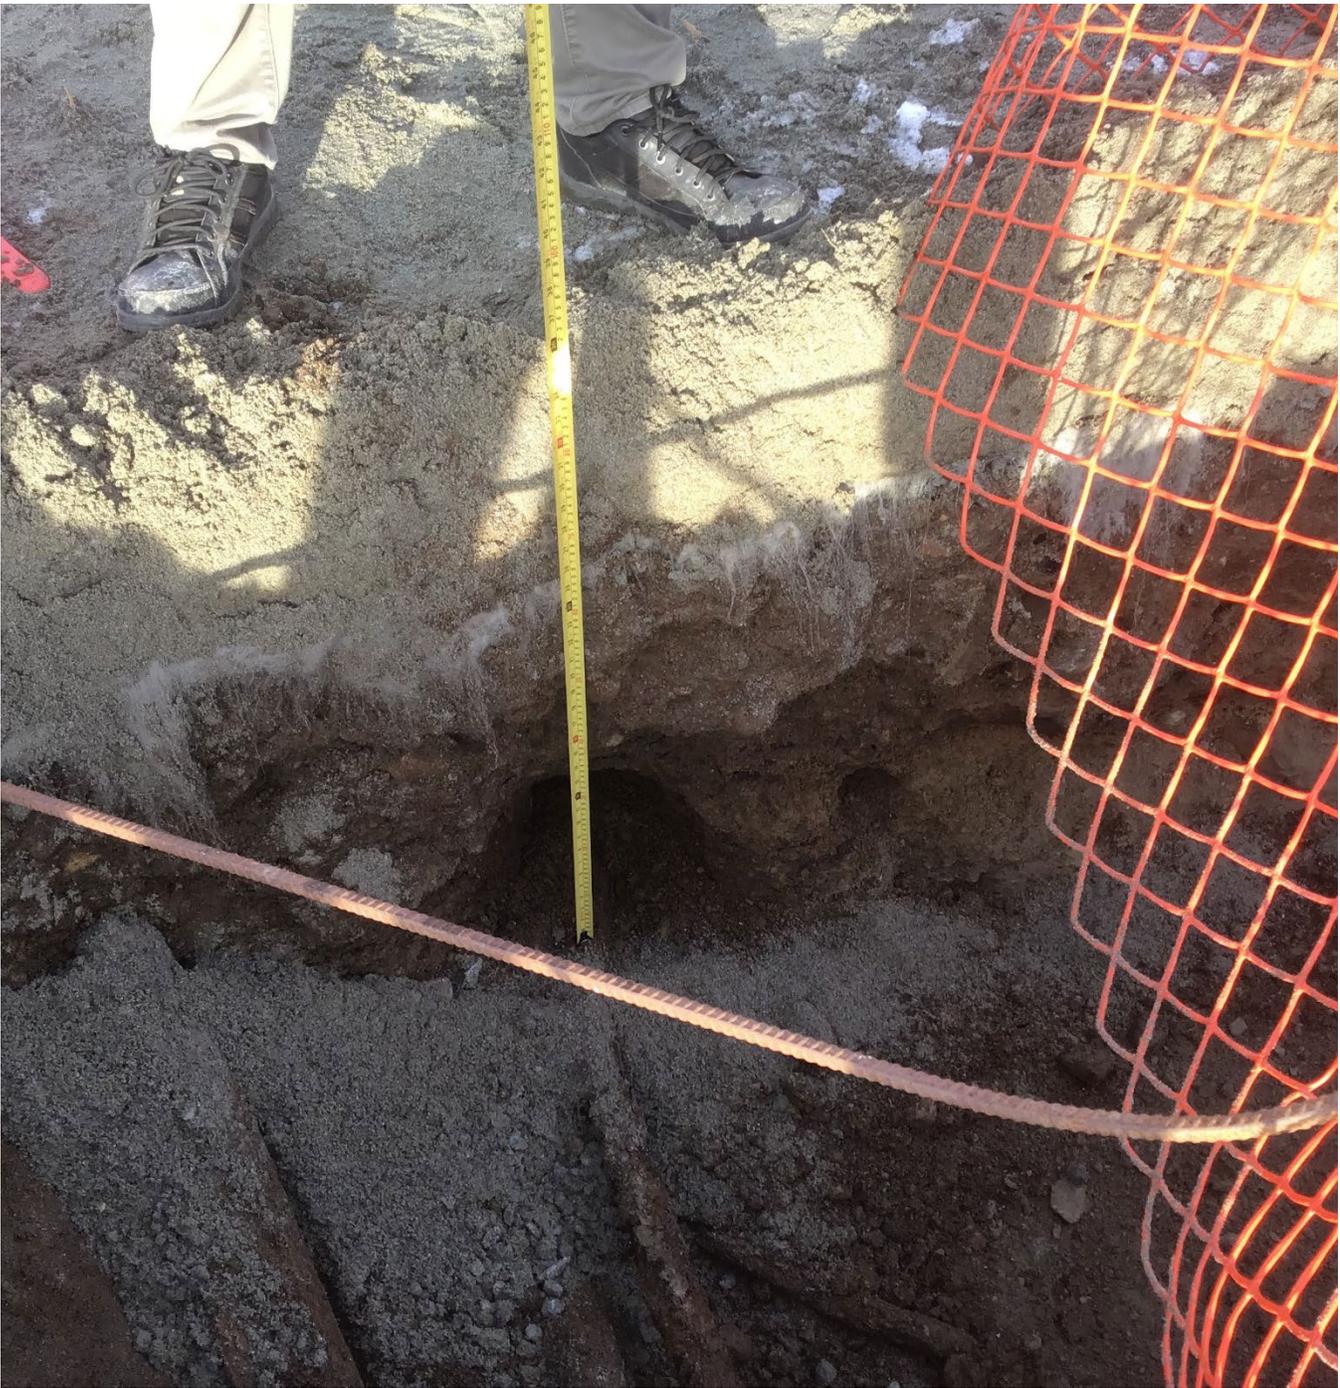
Image 4 - Test hole excavated away from roadway showing the cable was buried to proper 100cm depth but did not have any markings caution tape or mechanical protection.
