Incident Summary #II-1511042-2023 (31971) (FINAL)

SUPPORTING	Incident Date	February 14, 2023	
	Location	Kitimat, BC	
	Regulated industry sector	Electrical - High voltage electrical system (greater than 750V)	
	Injury	Qty injuries	1
		Injury description	Arc flash burns to the face and hands.
	Impact	Injury rating	Moderate
		Damage	Damage description
	Damage rating		Moderate
	Incident rating	Moderate	
Incident overview	While performing troubleshooting on a 600-volt motor control center (MCC), an electrician was exposed to an arc flash. Voltage tests were being performed in a bucket of the MCC with a multi-meter that had the test lead connected to the amperage port and an under rated fuse. When connected to the 600-volt source, the multi-meter shorted leading to an arc flash. The arc flash caused burns to the face and hands and pushed the worker back, landing on their knees.		
INVESTIGATION CONCLUSIONS	Site, system and components	<p>The site is an industrial facility and the incident occurred in a power control building. In the power control building, an MCC contains buckets that consist of overcurrent protection (fuses), control wiring with safety switches and control relays that ca

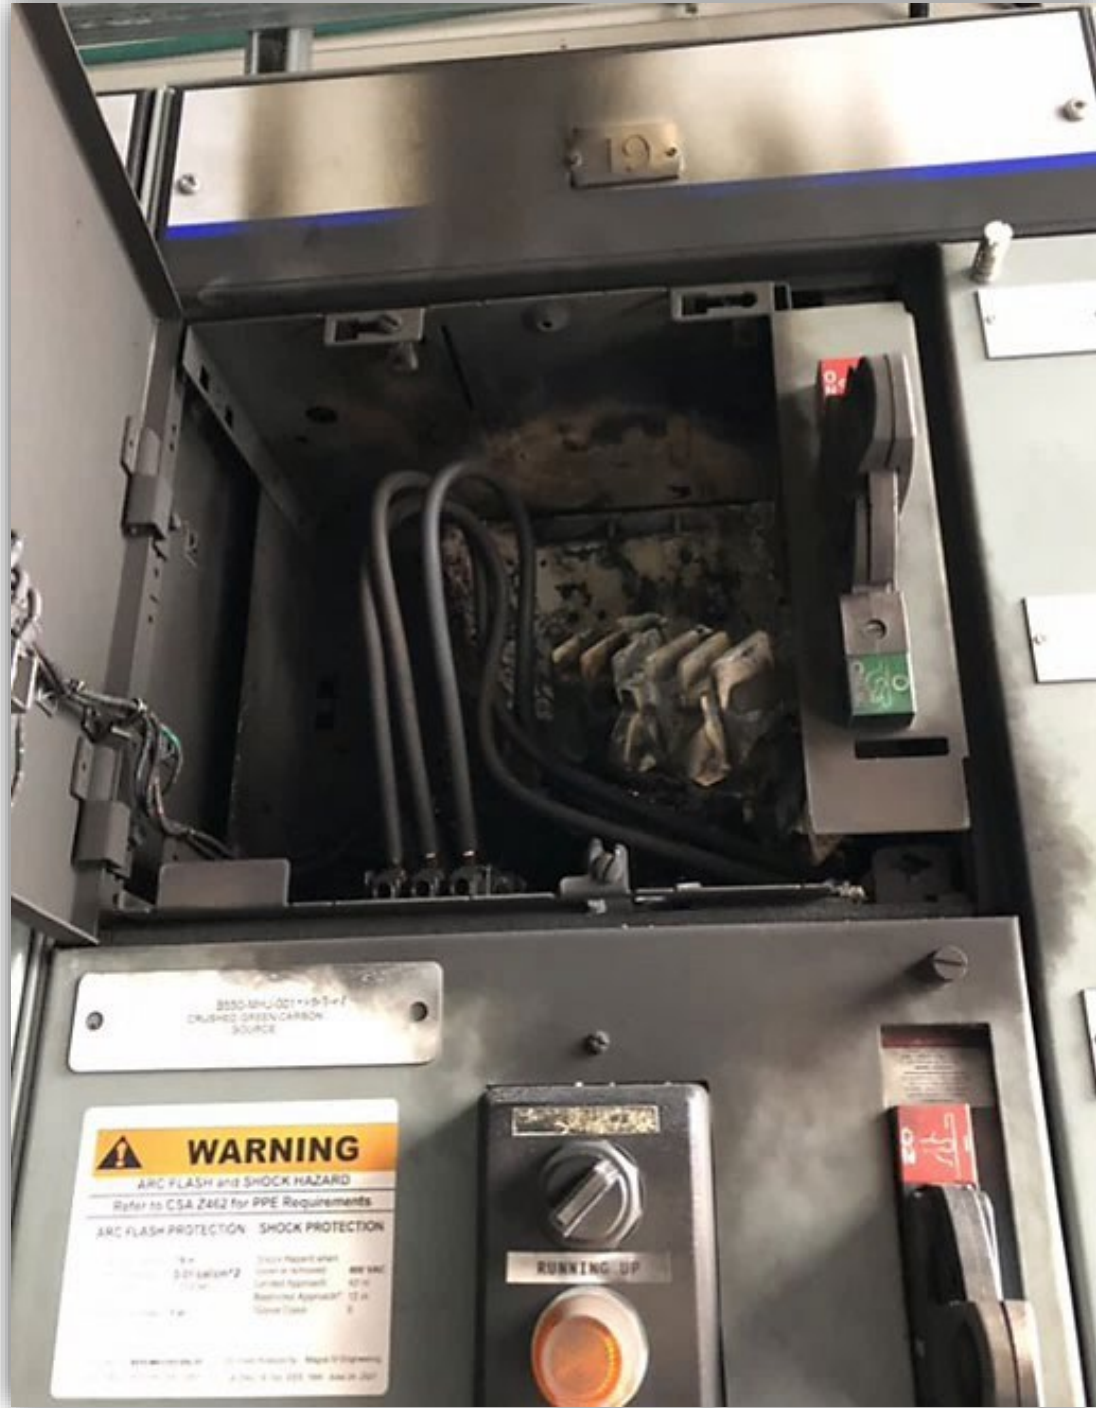
Photo 2 – MCC bucket with burn damage.

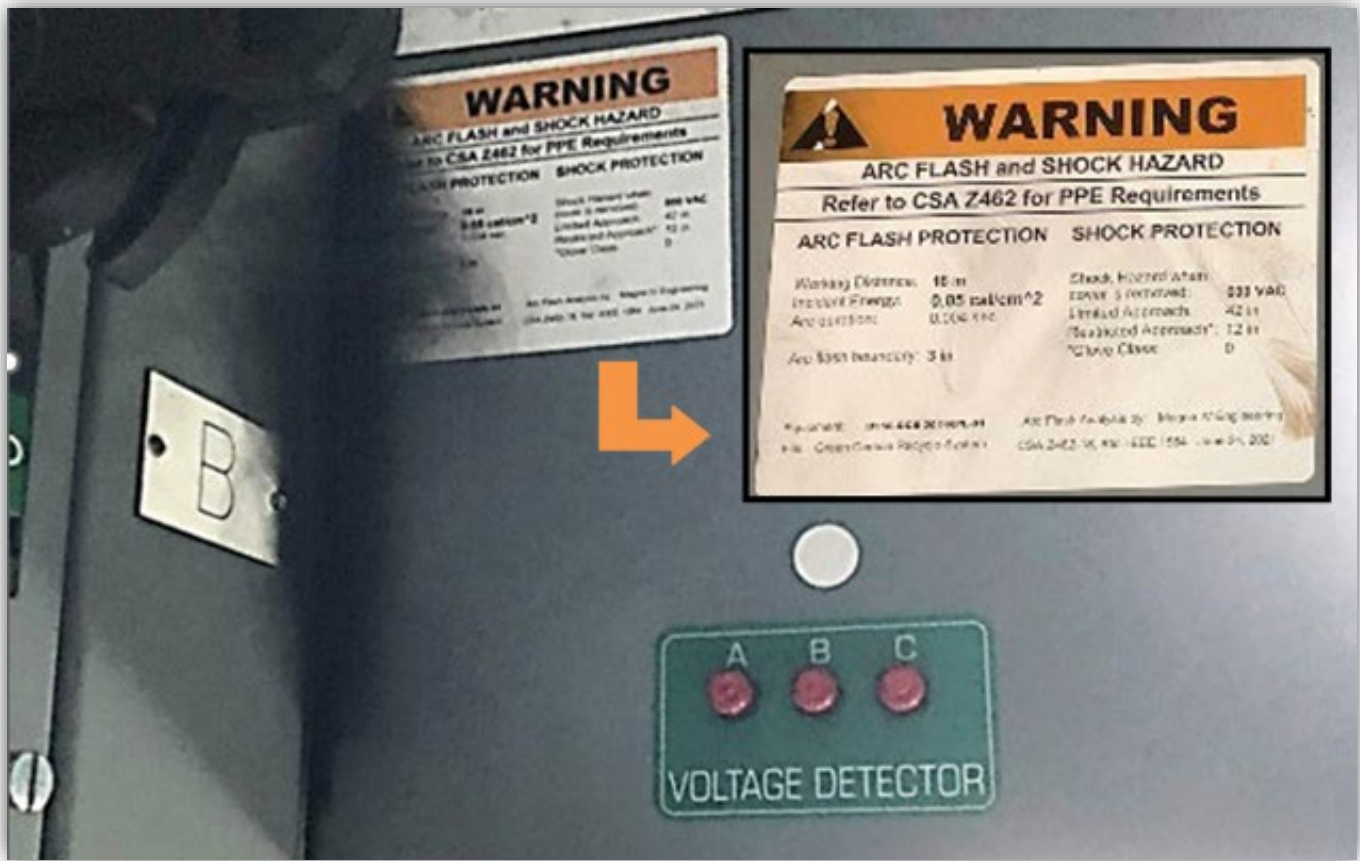
Photo 3 – MCC burn damage to cover with arc flash warning label. (0.05 cal/cm²) incident energy requiring category 1 arc flash gear.

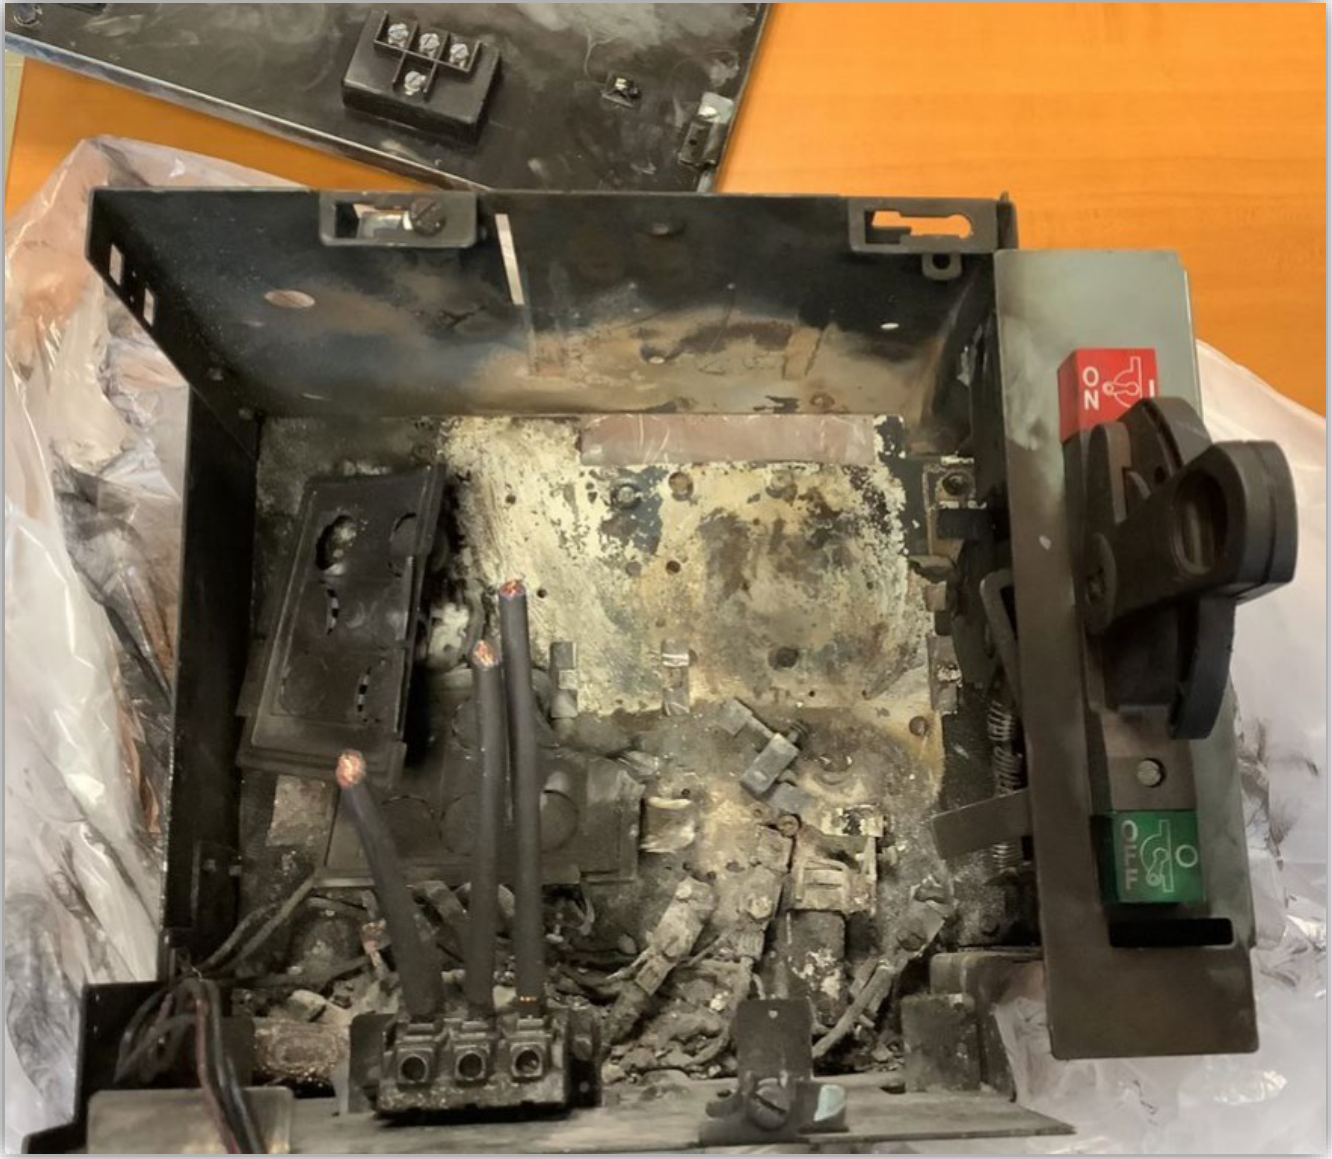
Photo 4 - Damaged MCC bucket removed from unit.

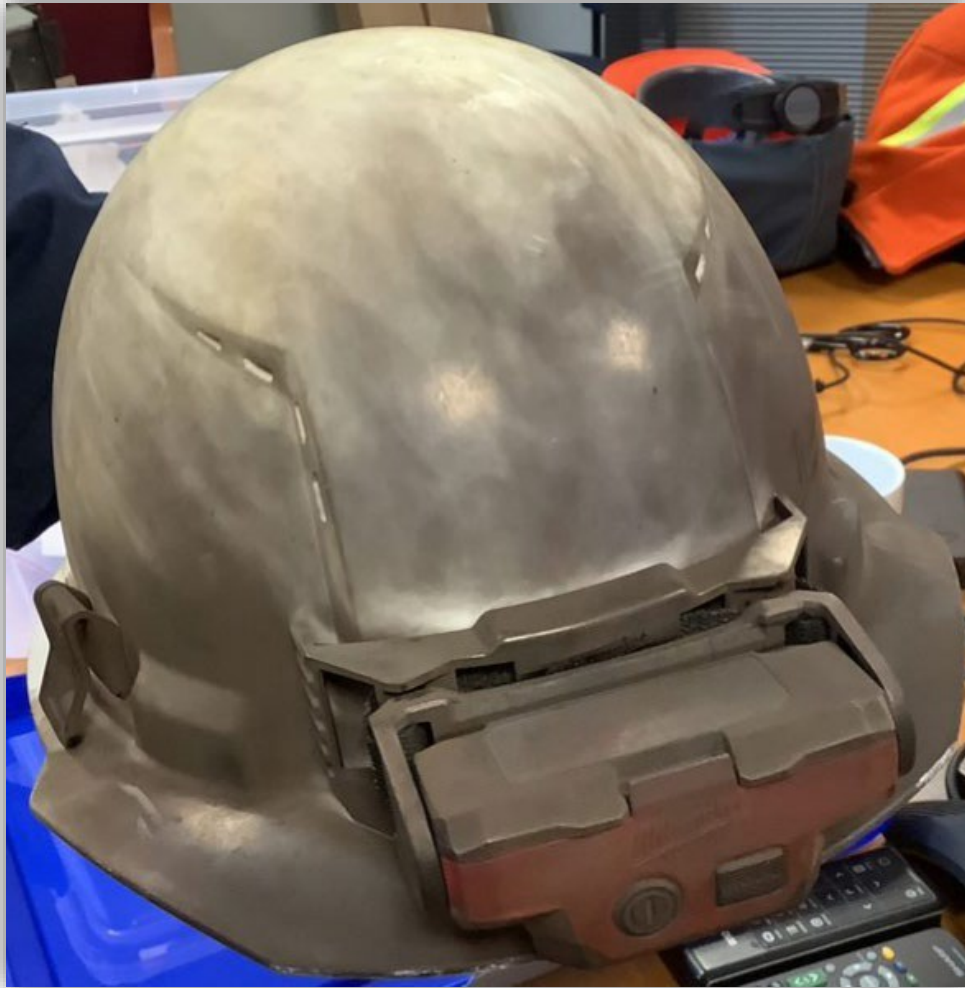
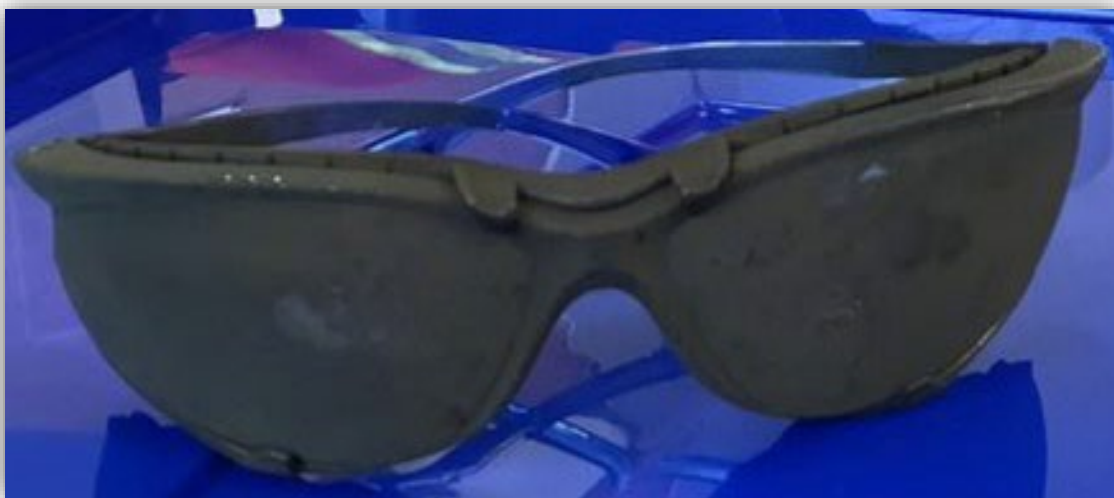
Photos 5 & 6 – Burn damage to hard hat and safety glasses.

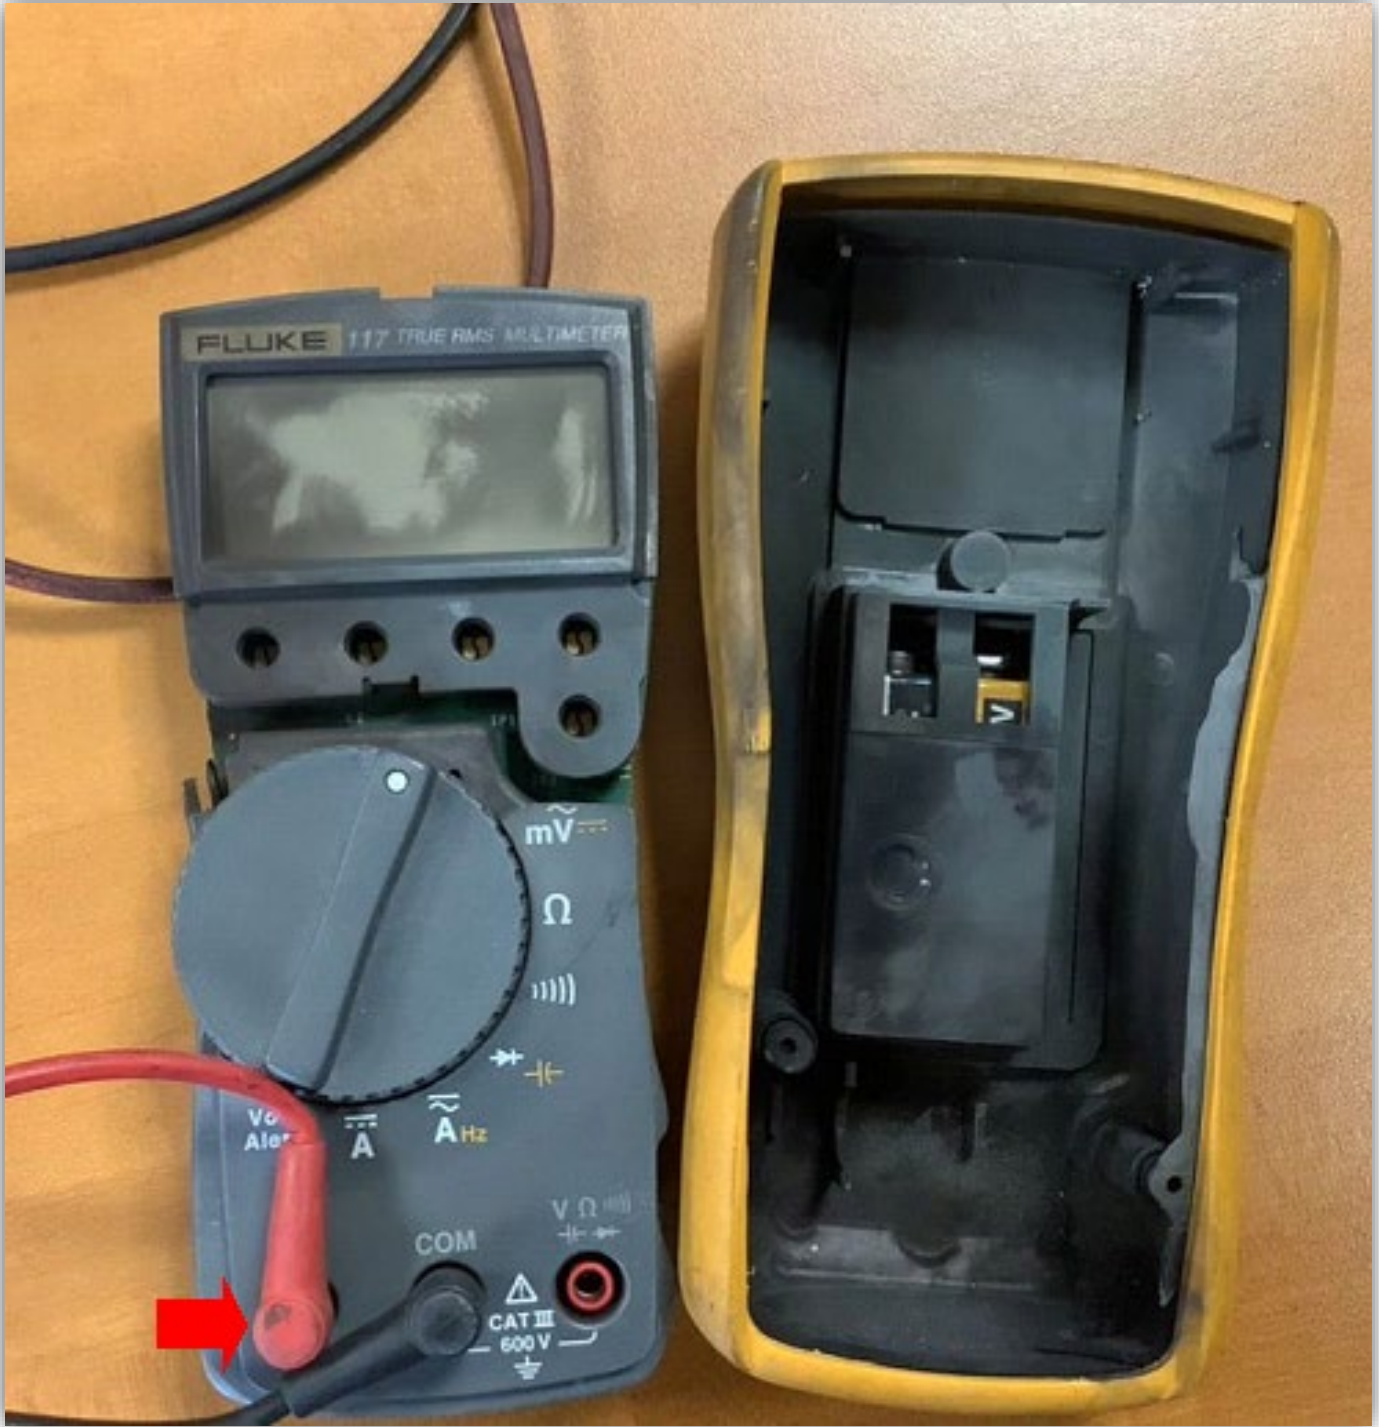
<p>Facts and evidence</p>	<ul style="list-style-type: none"> • One of the multi-meter leads was in the ammeter port rather than the voltmeter port. (Photo 1) • Fuse amperage and voltage ratings were 250-volt and do not match the manufacturer's specifications which were 1000-volt. • The injured worker stated having category 2 arc flash coveralls, wool shirt underneath, a hard hat and safety glasses at the time of the incident. • PPE used does not match the warning label on the MCC (Arc flash analysis/shock hazard) requirements.
<p>Causes and contributing factors</p>	<p>The cause of the incident was the use of the multimeter test lead in the ammeter port during voltage tests.</p> <p>Contributing factors include:</p> <ul style="list-style-type: none"> • The multimeter fuse being underrated was a contributing factor. • The bypassing of the safety door switch to open the bucket door while energized. <p>If the required level of arc flash gear was used, burns could have been minimized and/or eliminated.</p>

Photo 7 – [ARROW] test lead plugged into the ammeter port.

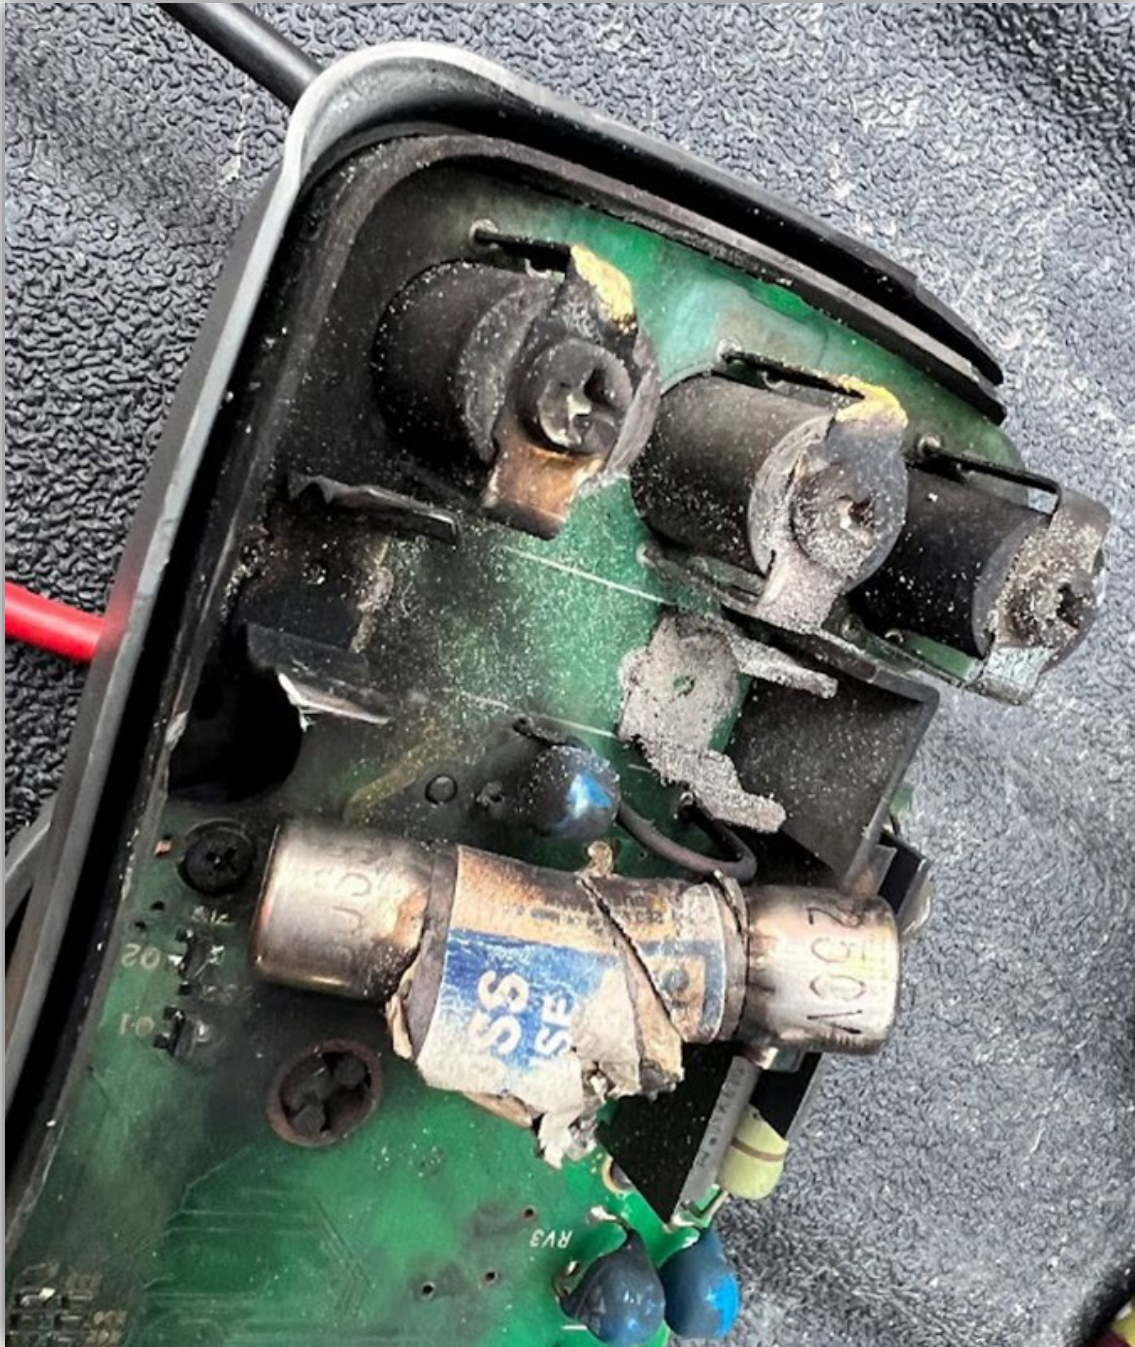
Photo 9 – Damaged multi-meter with undersized (250-volt) fuse.
