Incident Summary (Reference #5583910) (Final)

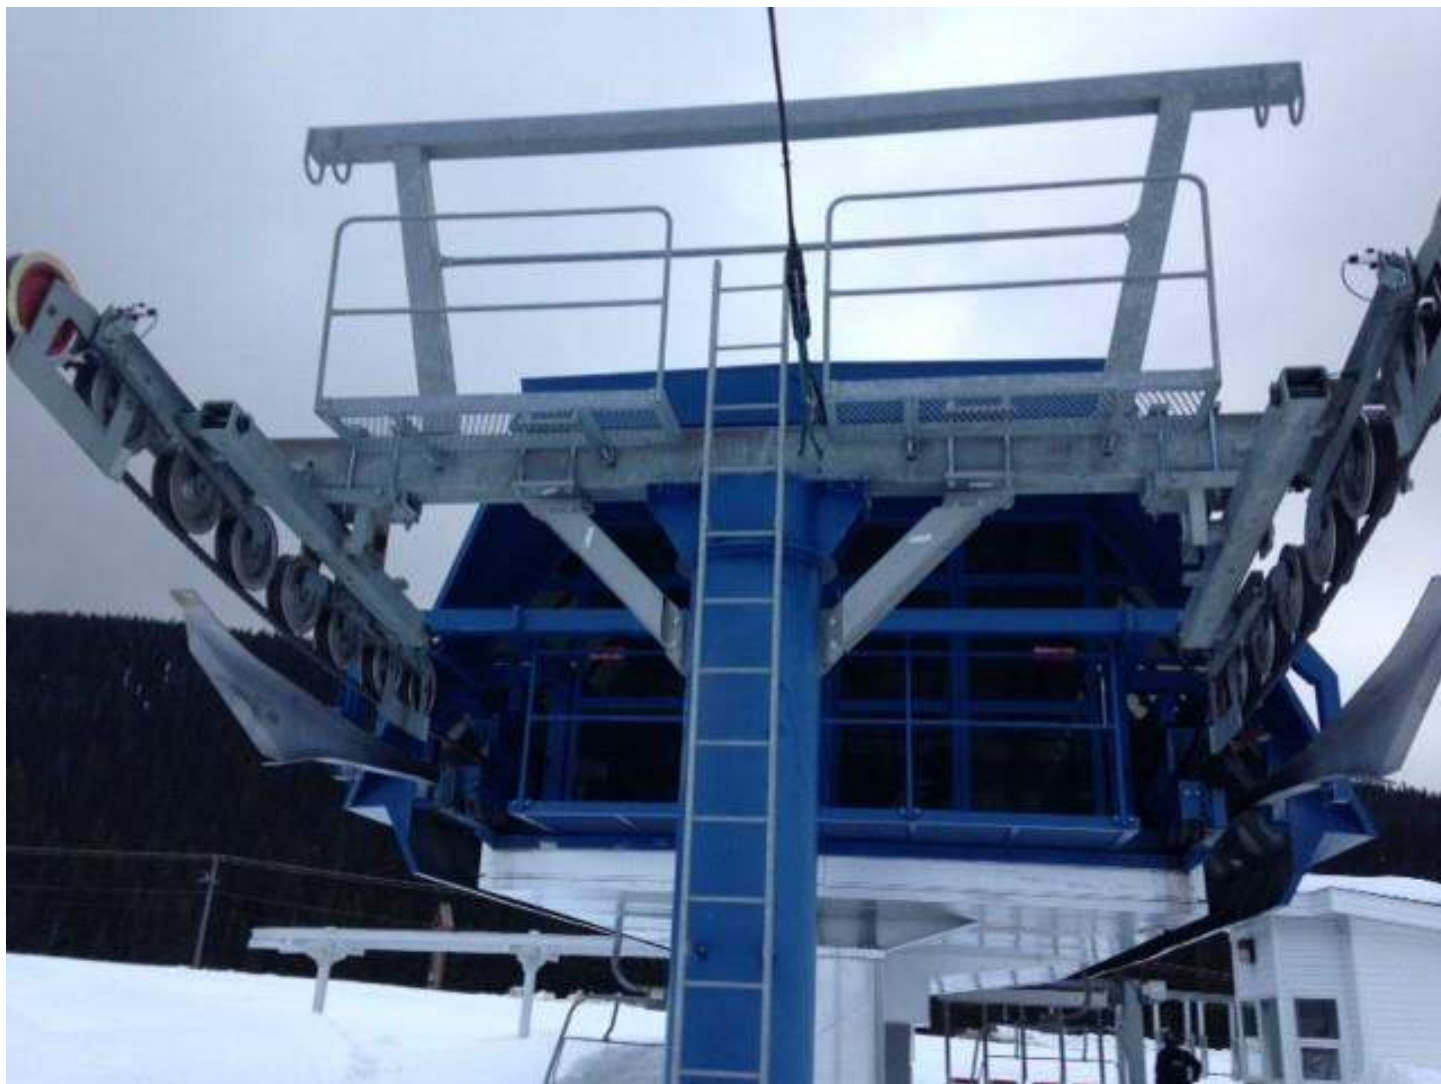
SUPPORTING INFORMATION	Incident Date		March 17, 2016	
	Location		Kelowna	
	Regulated industry sector		Passenger Ropeways - Above Surface	
	Impact	Injury	Qty Injuries	0
			Injury description	N/A
			Injury rating	N/A
	Damage		Damage description	33 mm long crack in tower cross arm, that was repaired using the manufacturers repair procedure.
			Damage rating	Minor
	Incident rating		Minor	
Incident overview		While conducting a visual inspection of tower one a 33 mm long crack was found in the tower cross arm. This inspection was being conducted as a follow up to a manufacturers safety bulletin.		
INVESTIGATION CONCLUSIONS	Site, system and components		4 person detachable high speed chairlift. Steel cross arm of a tubular steel tower used to support chairlift components.	
	Failure scenario(s)			
	Facts and Evidence			
	Causes and Contributing Factors

Tower 1 uphill side.
