Incident Summary #II-1260939-2021 (#24215) (FINAL)

SUPPORTING INFORMATION	Incident Date	September 28, 2021	
	Location	Peace River Region	
	Regulated industry sector	Boilers, PV & refrigeration - Boiler and pressure vessel system	
	Impact	Qty injuries	0
		Injury description	None
		Injury rating	None
	Damage	Damage description	A biomass-fired thermal fluid heater's steel shell buckled and melted away several large sections, it also shifted and permanently deformed its steel helical coil and its steel soot blower piping melted away a large hole.
		Damage rating	Major
Incident rating	Major		
Incident overview	A biomass-fired thermal fluid heater developed a secondary fire causing damage to the lower portion of its heat exchangers shell, helical coil, refractory, and soot blower piping rendering the heater inoperable.		
INVESTIGATION CONCLUSIONS	Site, system and components	<p>This lumber manufacturers biomass-fired thermal fluid heater has five main components, the fuel, the reciprocating step-gate furnace, the helical coil heat exchanger, the soot blower piping, and the induced draft fan.</p> <p>The fuel burned in this reciprocating step-gate furnace is known as hogged fuel. Hogged fu

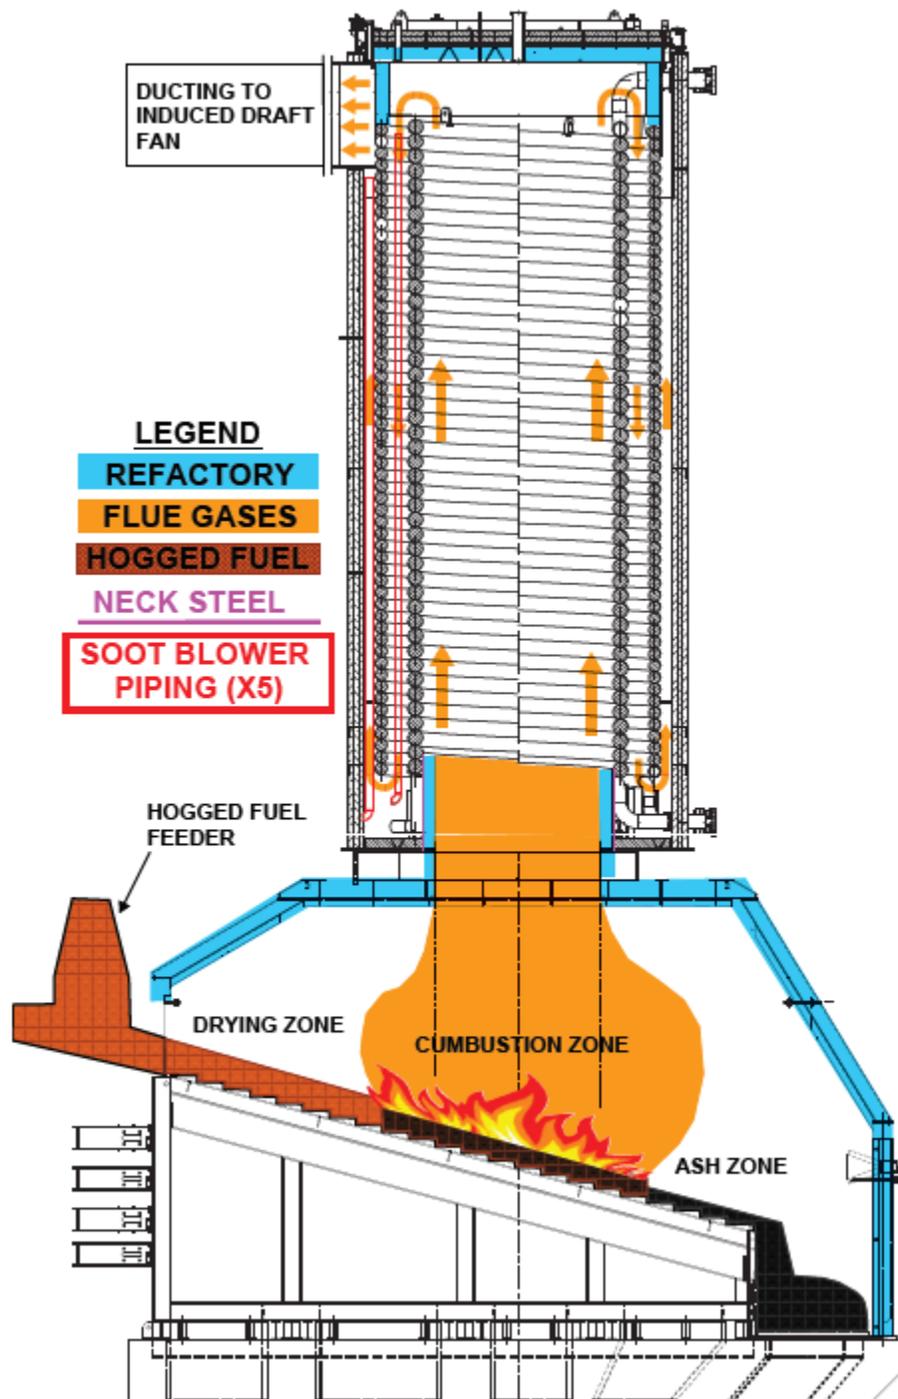
Normal combustion of hogged fuel reciprocating step-gate furnace and path of flue gases through helical coil heat exchanger.

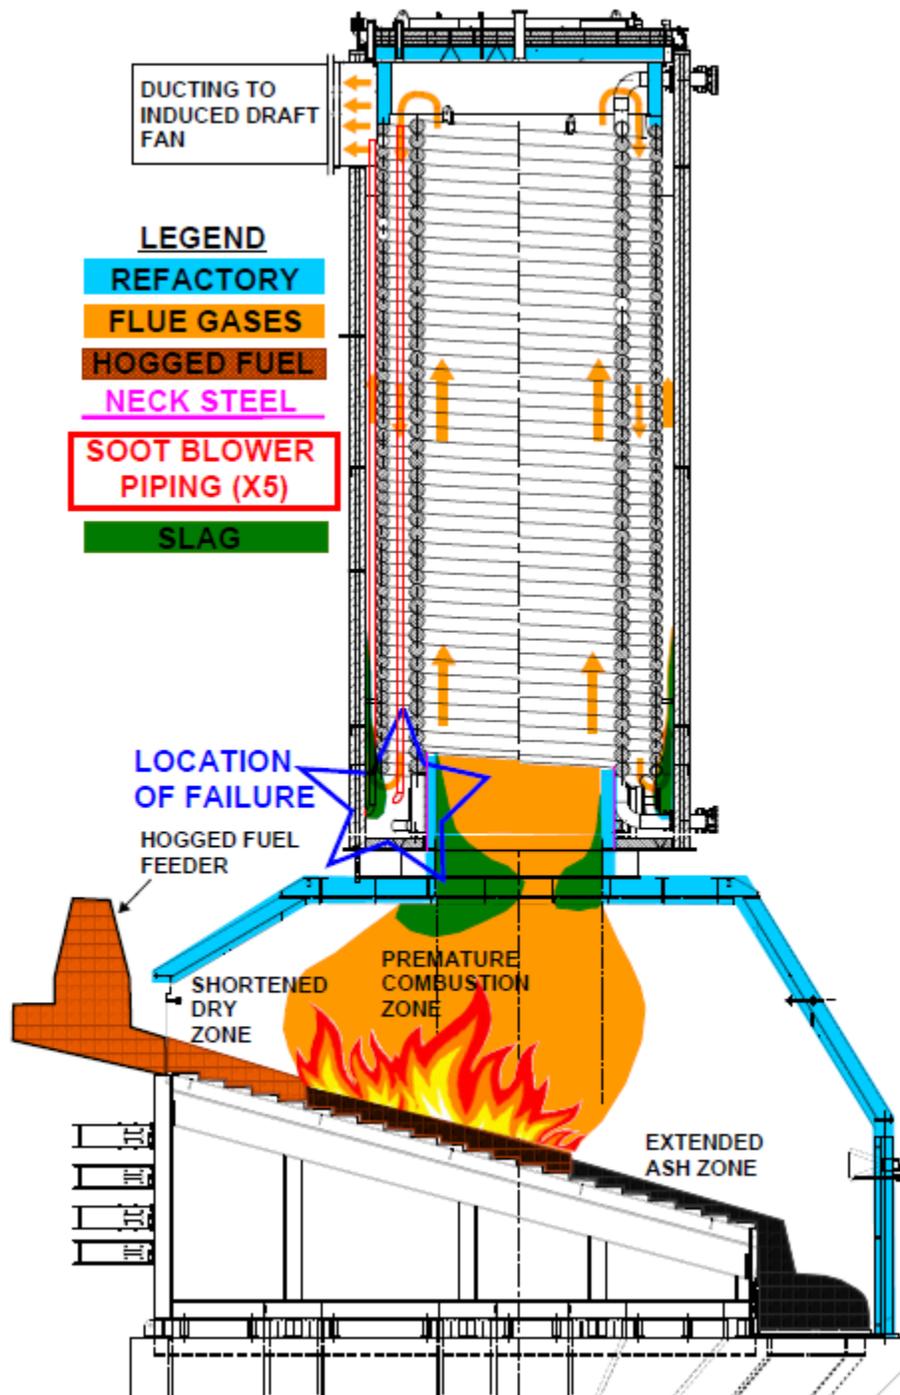
Failure scenario(s)	Dry hogged fuel contaminated with sand was burned prematurely within the drying zone of the furnace.

Premature combustion of hogged fuel, slag accumulations, and location of failure.

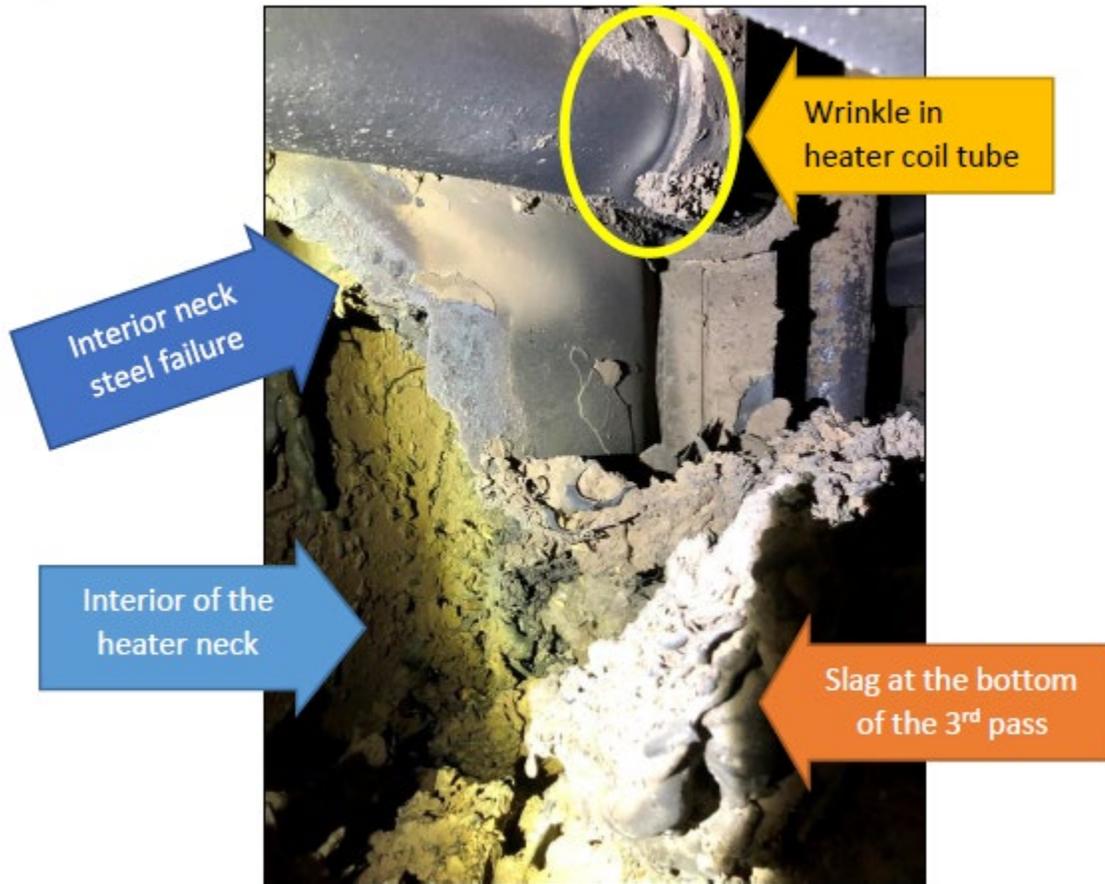
Heater neck shell failure, slagging, and deformed coil.

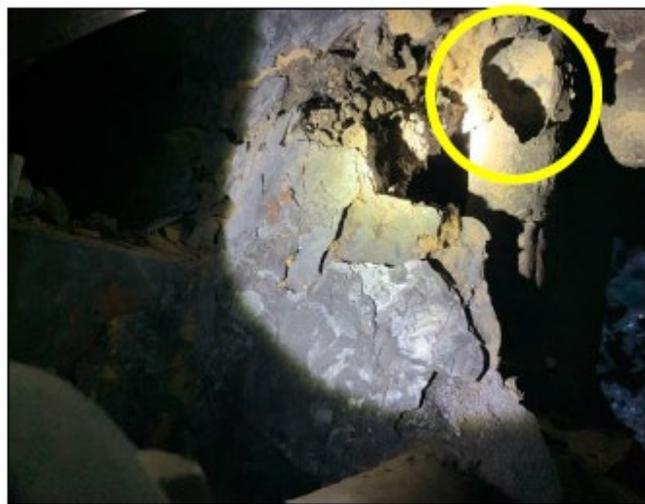
Failed shell and hole in soot blower piping.

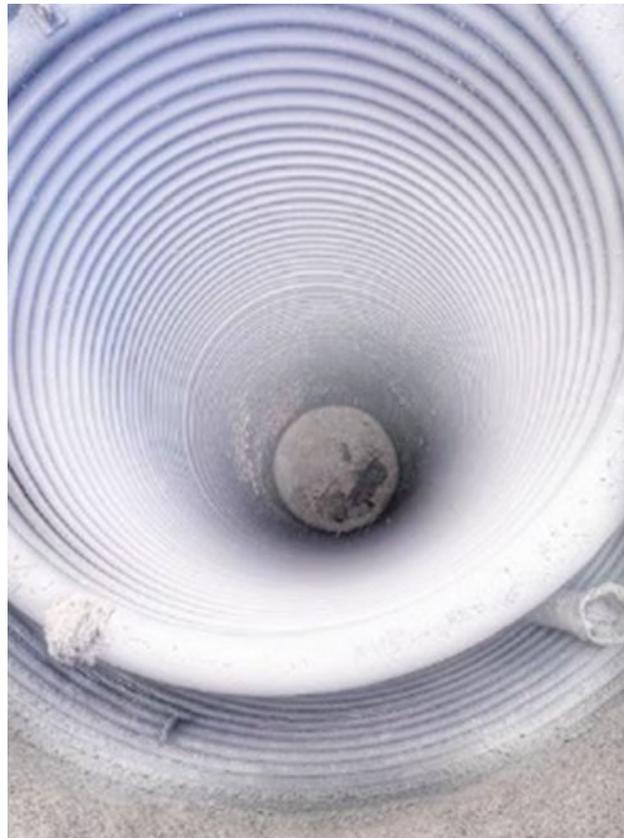
Helical coil neck obstruction.

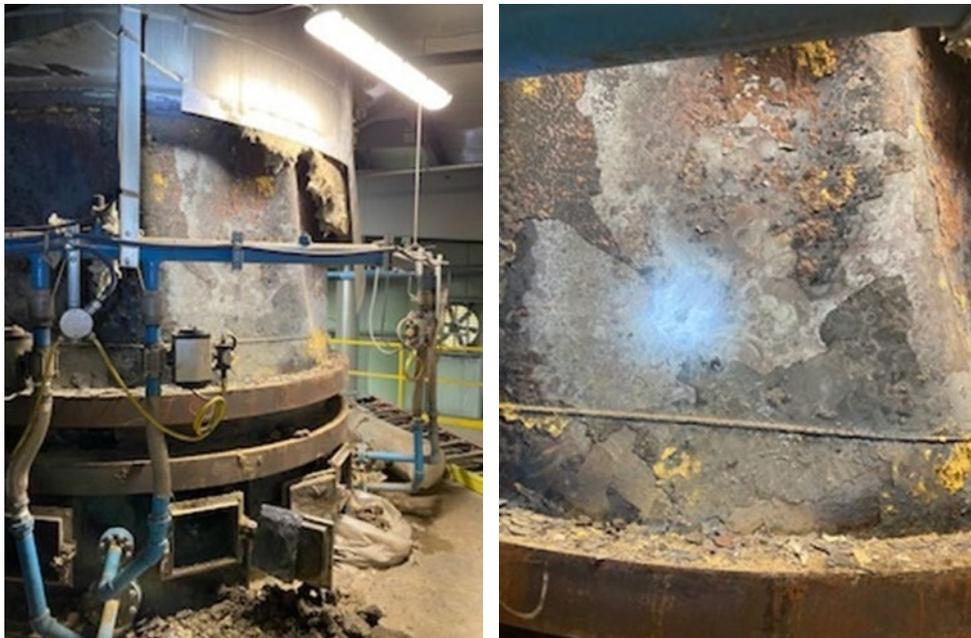
Buckled shell.

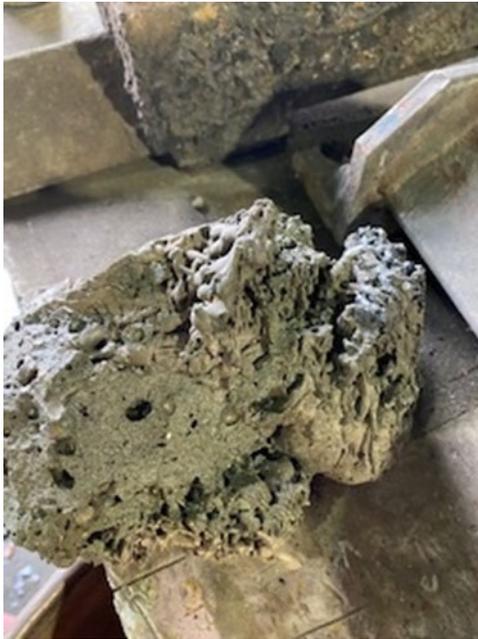
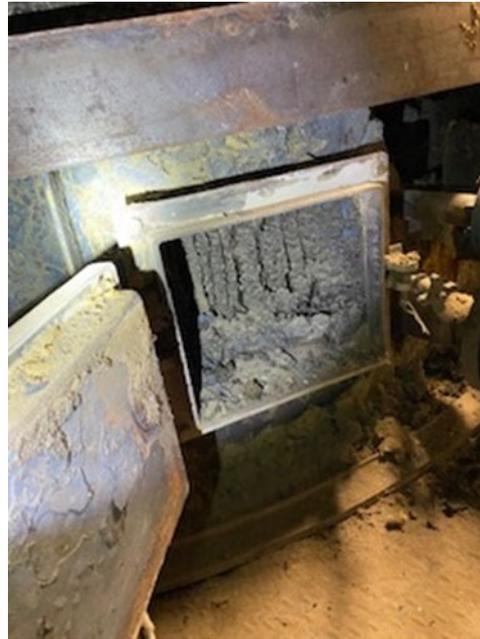
Slag (clinker) sample and deposit of slag on outer shell.

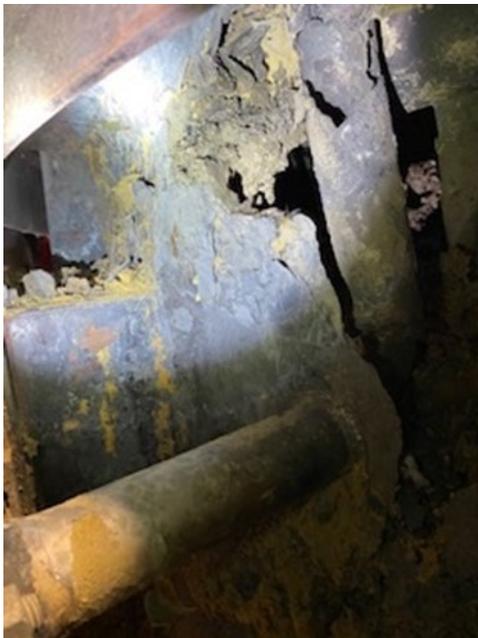
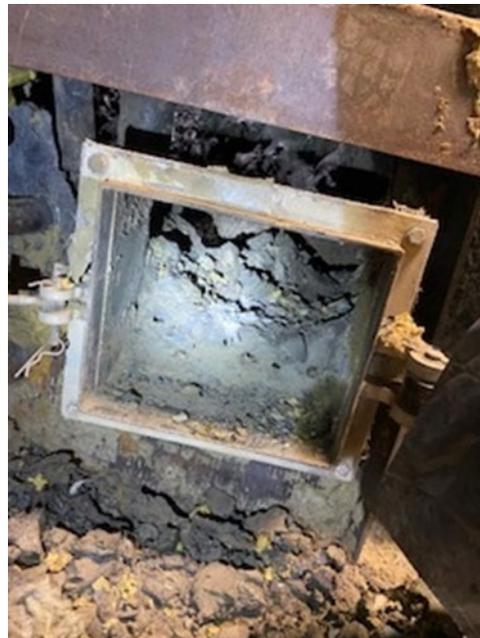
Outer shell steel melted away.

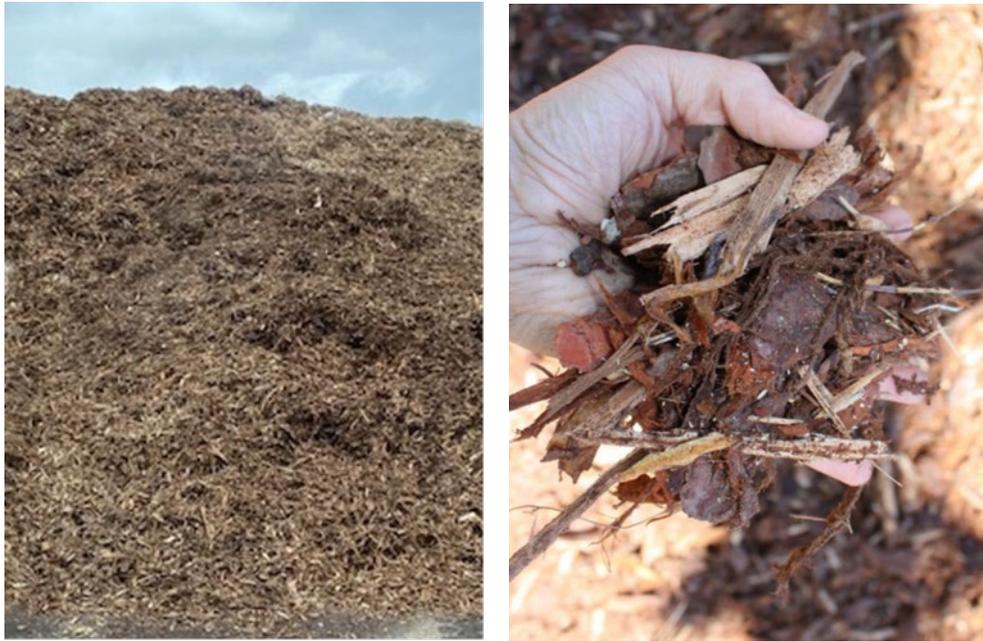
Hogged Fuel.
