Incident Summary #II-1293154-2021 (#25200) (FINAL)

SUPPORTING INFORMATION	Incident Date	October 7, 2021	
	Location	Port Alberni, BC	
	Regulated industry sector	Electrical - Low voltage electrical system (30V to 750V)	
	Impact	Qty injuries	0
		Injury description	N/A
		Injury rating	None
	Damage	Damage description	A cable, a receptacle, and a cord for a piece of electric vehicle supply equipment were damaged beyond repair.
		Damage rating	Minor
	Incident rating	Minor	
	Incident overview	A receptacle, cord end, and cable providing power to electric vehicle supply equipment were damaged when an accumulation of thermal energy at and around the receptacle caused temperatures high enough to melt the plastic components of the equipment.	
INVESTIGATION CONCLUSIONS	Site, system and components	<ul style="list-style-type: none"> In the attached garage of a single-family dwelling, a 50-amp receptacle supplied by a 40A branch circuit breaker was provided for cord connection of a piece of electric vehicle supply equipment (EVSE). 8/3 Teck 90 cable was run exposed approximately 10m through the garage to a metallic outlet box, on which a NEMA 14-50R receptacle was installed. The nameplate rating o

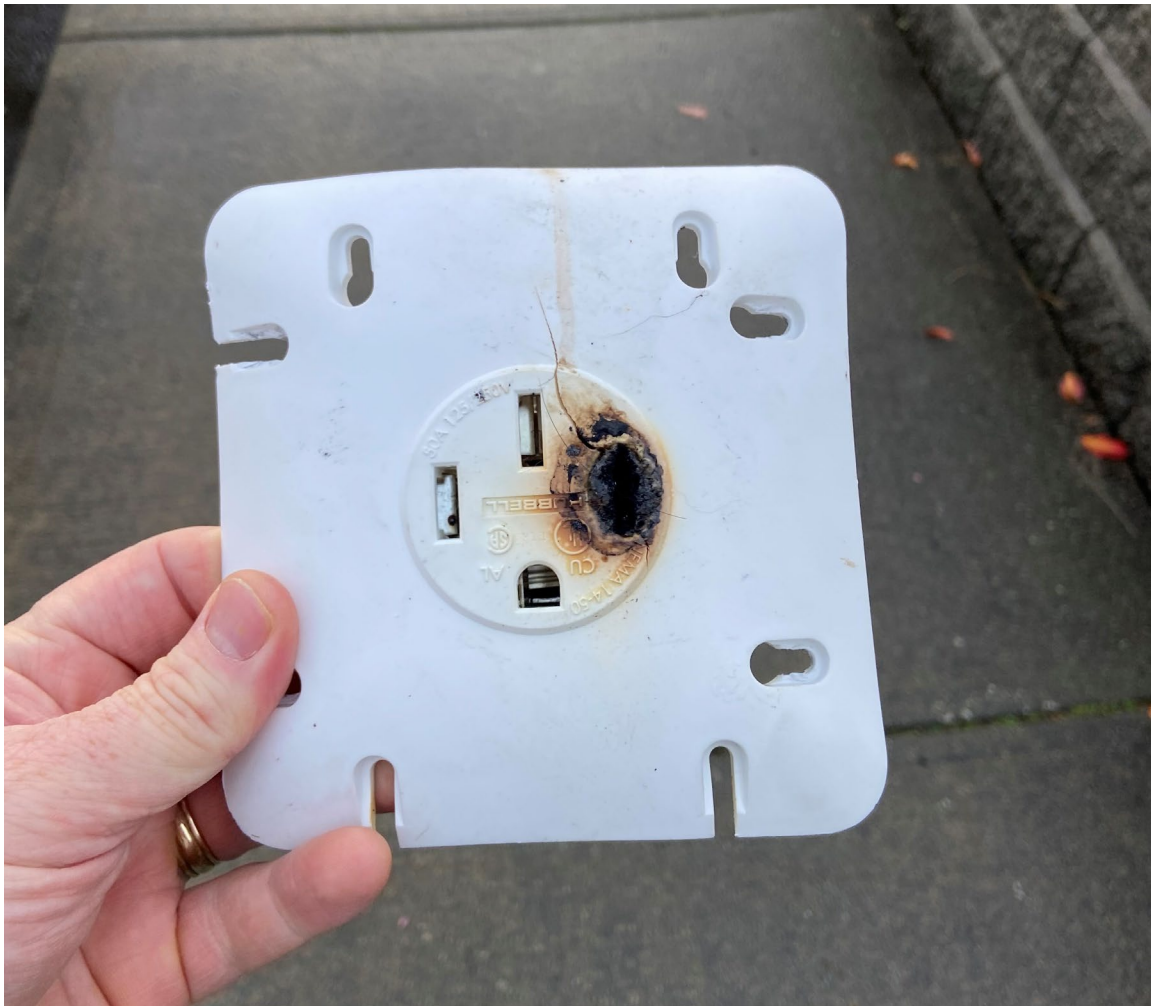
Facts and evidence	<p>Visual inspection of the damaged equipment showed:</p> <ul style="list-style-type: none">• The damage was highly localized and confined to the female contact of the plug/receptacle interface (Figure 1), the termination point of the conductor to the receptacle (Figure 2 and 3) and on the blade/prong of the plug (Figure 4 and 5).• Heat conducted by the copper cable supplying the receptacle caused the insulation and jacket of the cable to melt progressively away from the failure point (Figure 4 and 5). <p>Statements from the homeowner indicated the following:</p> <ul style="list-style-type: none">• The damage ceased once the plug was removed from the receptacle.• The circuit breaker did not trip during the event.• The vehicle was charging at the time of the event.• The plug of the charging equipment had only been inserted into the receptacle once, it was not routinely inserted and removed.• The receptacle had been installed while the home was owned by prior occupant(s). <p>Further investigation of the site and associated records showed:</p> <ul style="list-style-type: none">• Construction of the dwelling was completed under an electrical permit closed in 2016.• Based on the wiring route and method, as well as conversation with the constructing electrical contractor, the receptacle was added after the permit was finalized.• No permit could be found for the addition of an EVSE receptacle to this dwelling.

Causes and contributing factors	<p>While the vehicle was charging, heat began to build up at the receptacle. Vehicle charging is a significant and sustained load, and it is likely that this failure had been worsening over time.</p> <p>Given the localization of the damage, it is highly likely the cause of the heat production was a high resistance electrical connection at the receptacle socket/ plug prong interface. There are several locations where this could occur, including:</p> <ol style="list-style-type: none">1) Where the branch circuit conductor is terminated to the receptacle.2) In the pressure connection where the blade of the plug is wedged between the female contacts of the receptacle.3) In the plug where the conductor of the cord is terminated on pressure contact where the prong of the plug is pressed between the female contacts of the receptacle.

Figure 1 - Front of receptacle

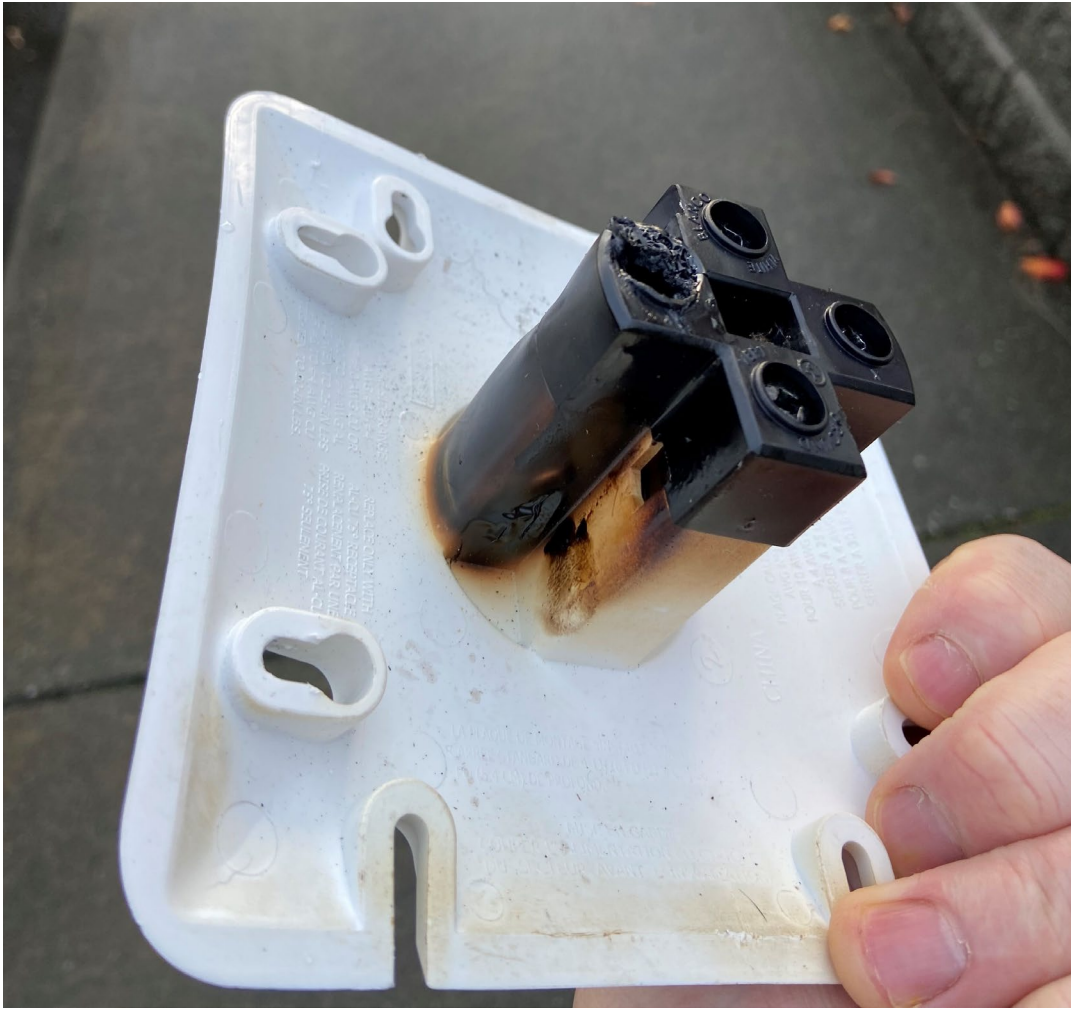
Figure 2 - Rear of receptacle

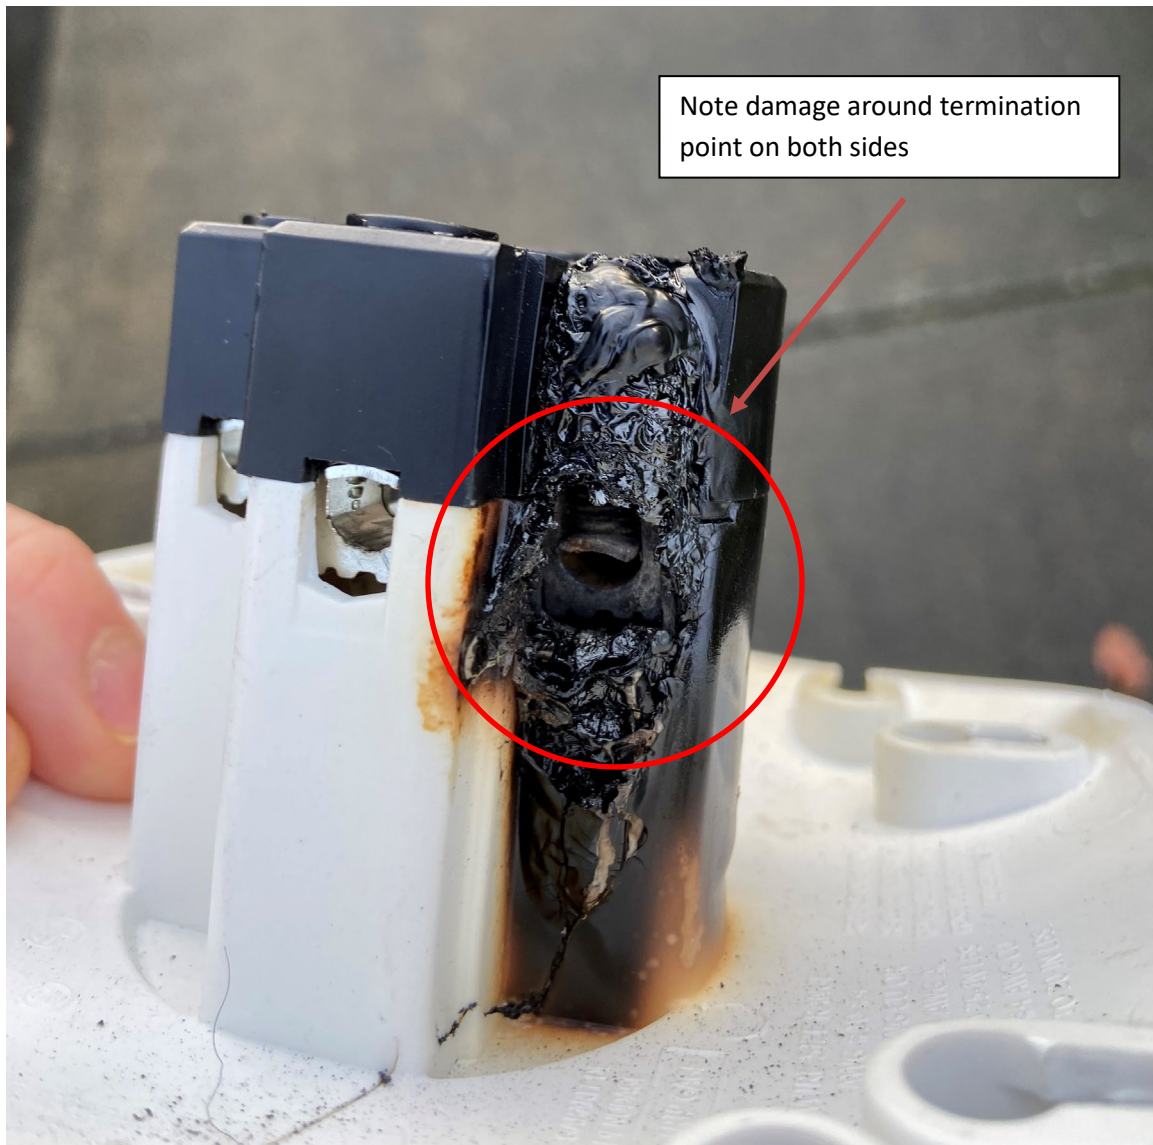
Figure 3 - Receptacle termination side with conductor openings

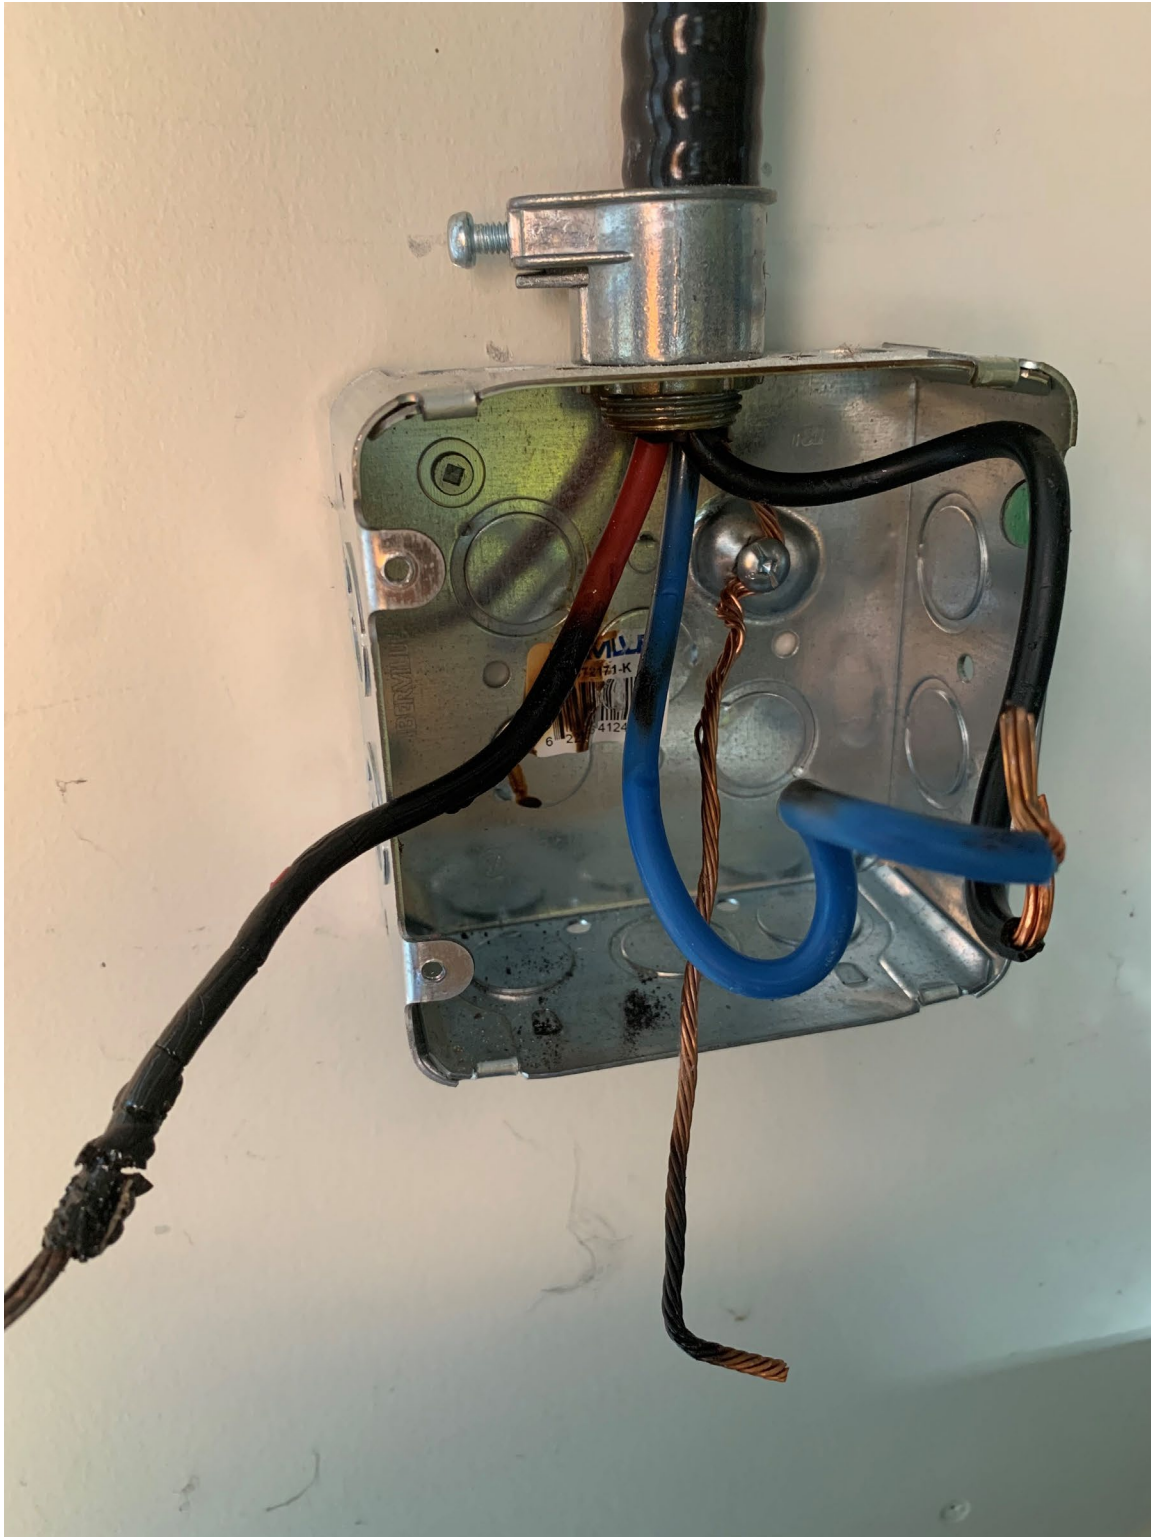
It seems slightly more likely that the fault occurred at a termination point rather than the factory terminations in the plug or receptacle, or the plug/receptacle interface itself, but no exclusion of these other possibilities could be made.

A loose field installed connection would be exposed to long periods of high current draw due to the nature of electric vehicle charging.

Figure 4 - Damage to conductor in enclosure

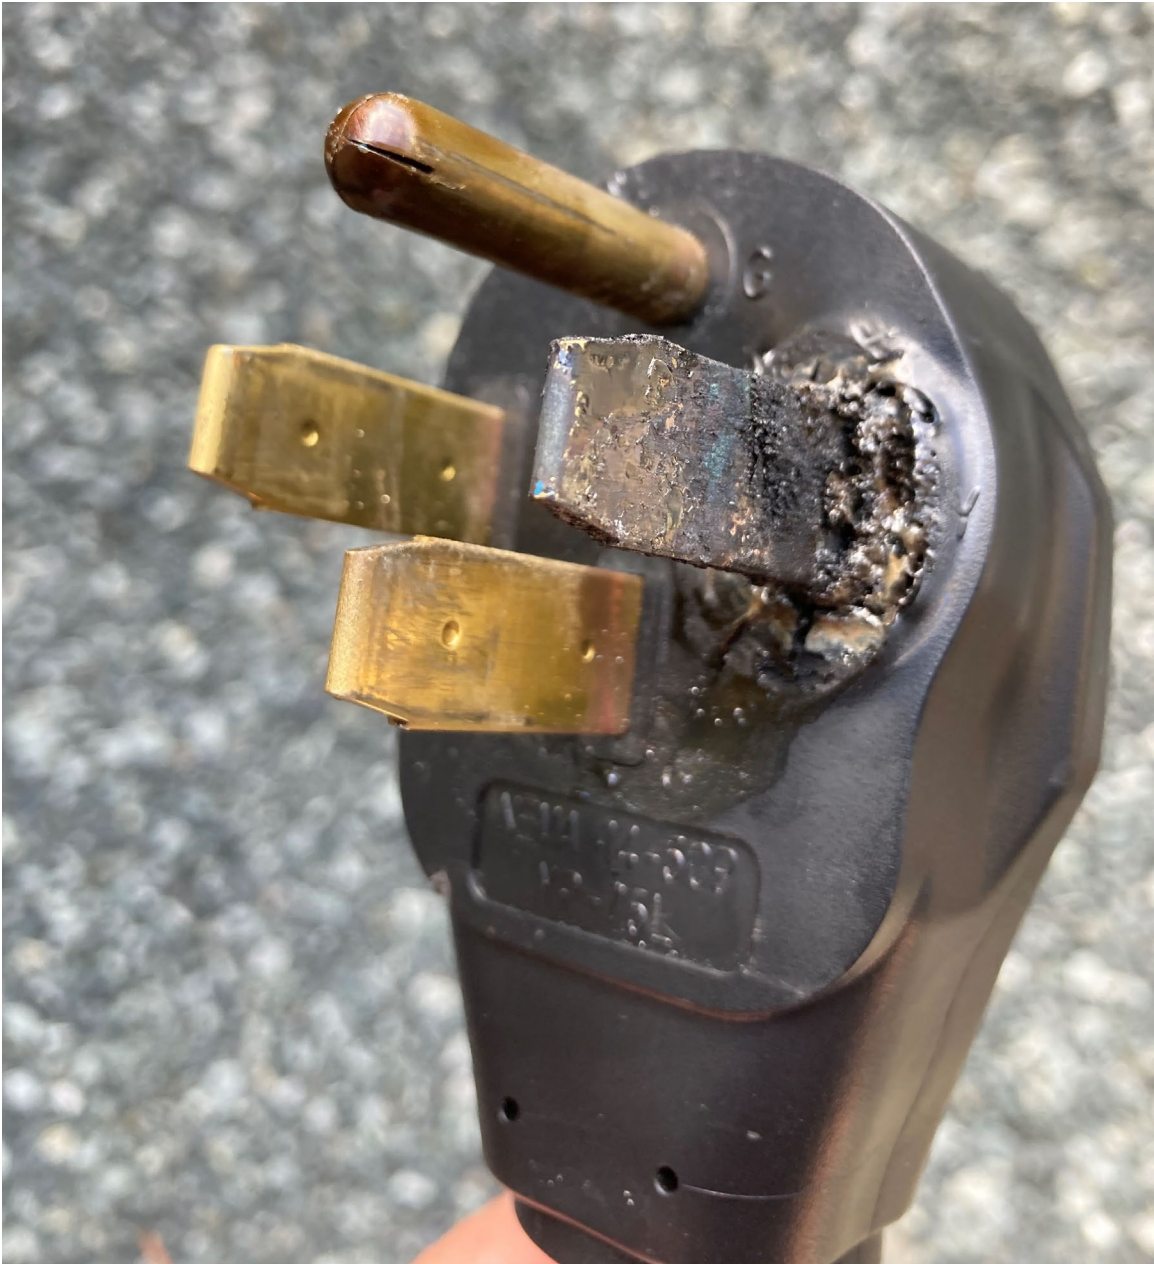
Figure 5 - Damage to plug
