Incident Summary #II-1263238-2021 (#24277) (FINAL)

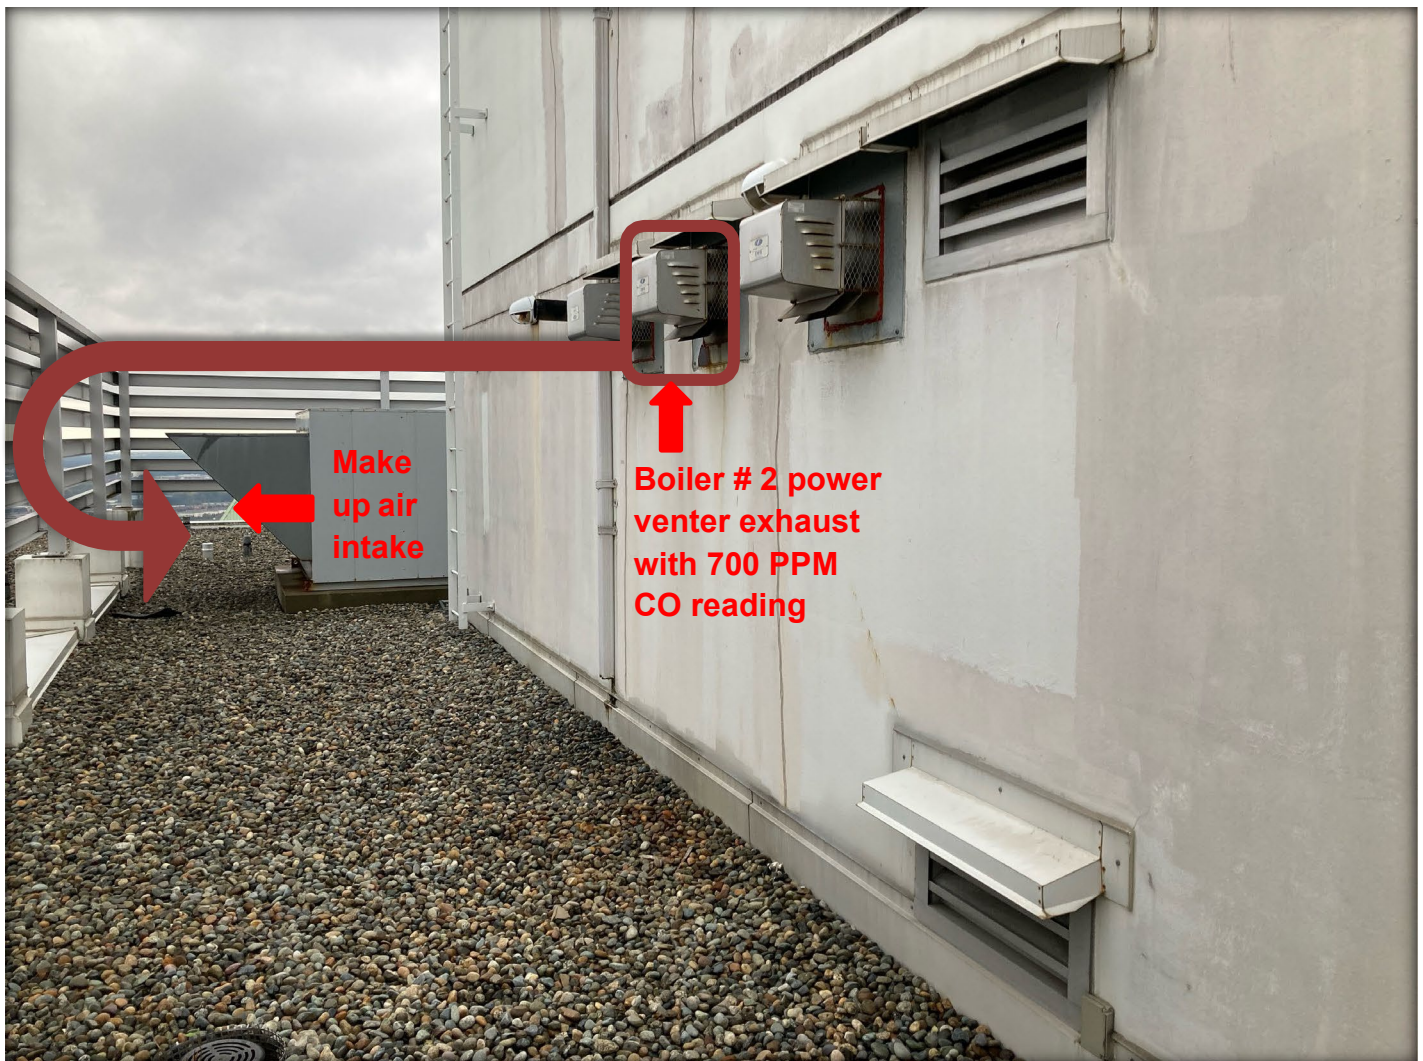
<ul style="list-style-type: none">• The regulator for the three boilers was set at 7-inch water column and the lock up pressure test was at 10 inch water column. This was not deemed to be a factor in the CO carbon buildup.• The power venter for boiler 2 was found to be working after the incident.• All three boilers had quarterly maintenance visits.• The gas fitter determined during troubleshooting that the MUA had no cracks in its heat exchanger and was not a likely source of CO as such. <p>Emergency personnel CO measurements:</p> <ul style="list-style-type: none">• 290 PPM in the boiler room.• 500 PPM from the boiler 2 exhaust.• Levels ranging from 2-100 PPM in the lobbies and dwellings.
Causes and contributing factors	<p>The likely cause of the hazardous CO levels in the flue gas of boiler 2 was a faulty gas valve that led to improper combustion. The CO likely accumulated on the rooftop and was drawn in through the AHU into the building as well as through the air intakes into the mechanical room.</p>

Image 1 – Likely path of travel for exhaust from boiler # 2 power venter to make up air intake. Boiler # 2 power venter exhaust measured at 700 PPM CO.

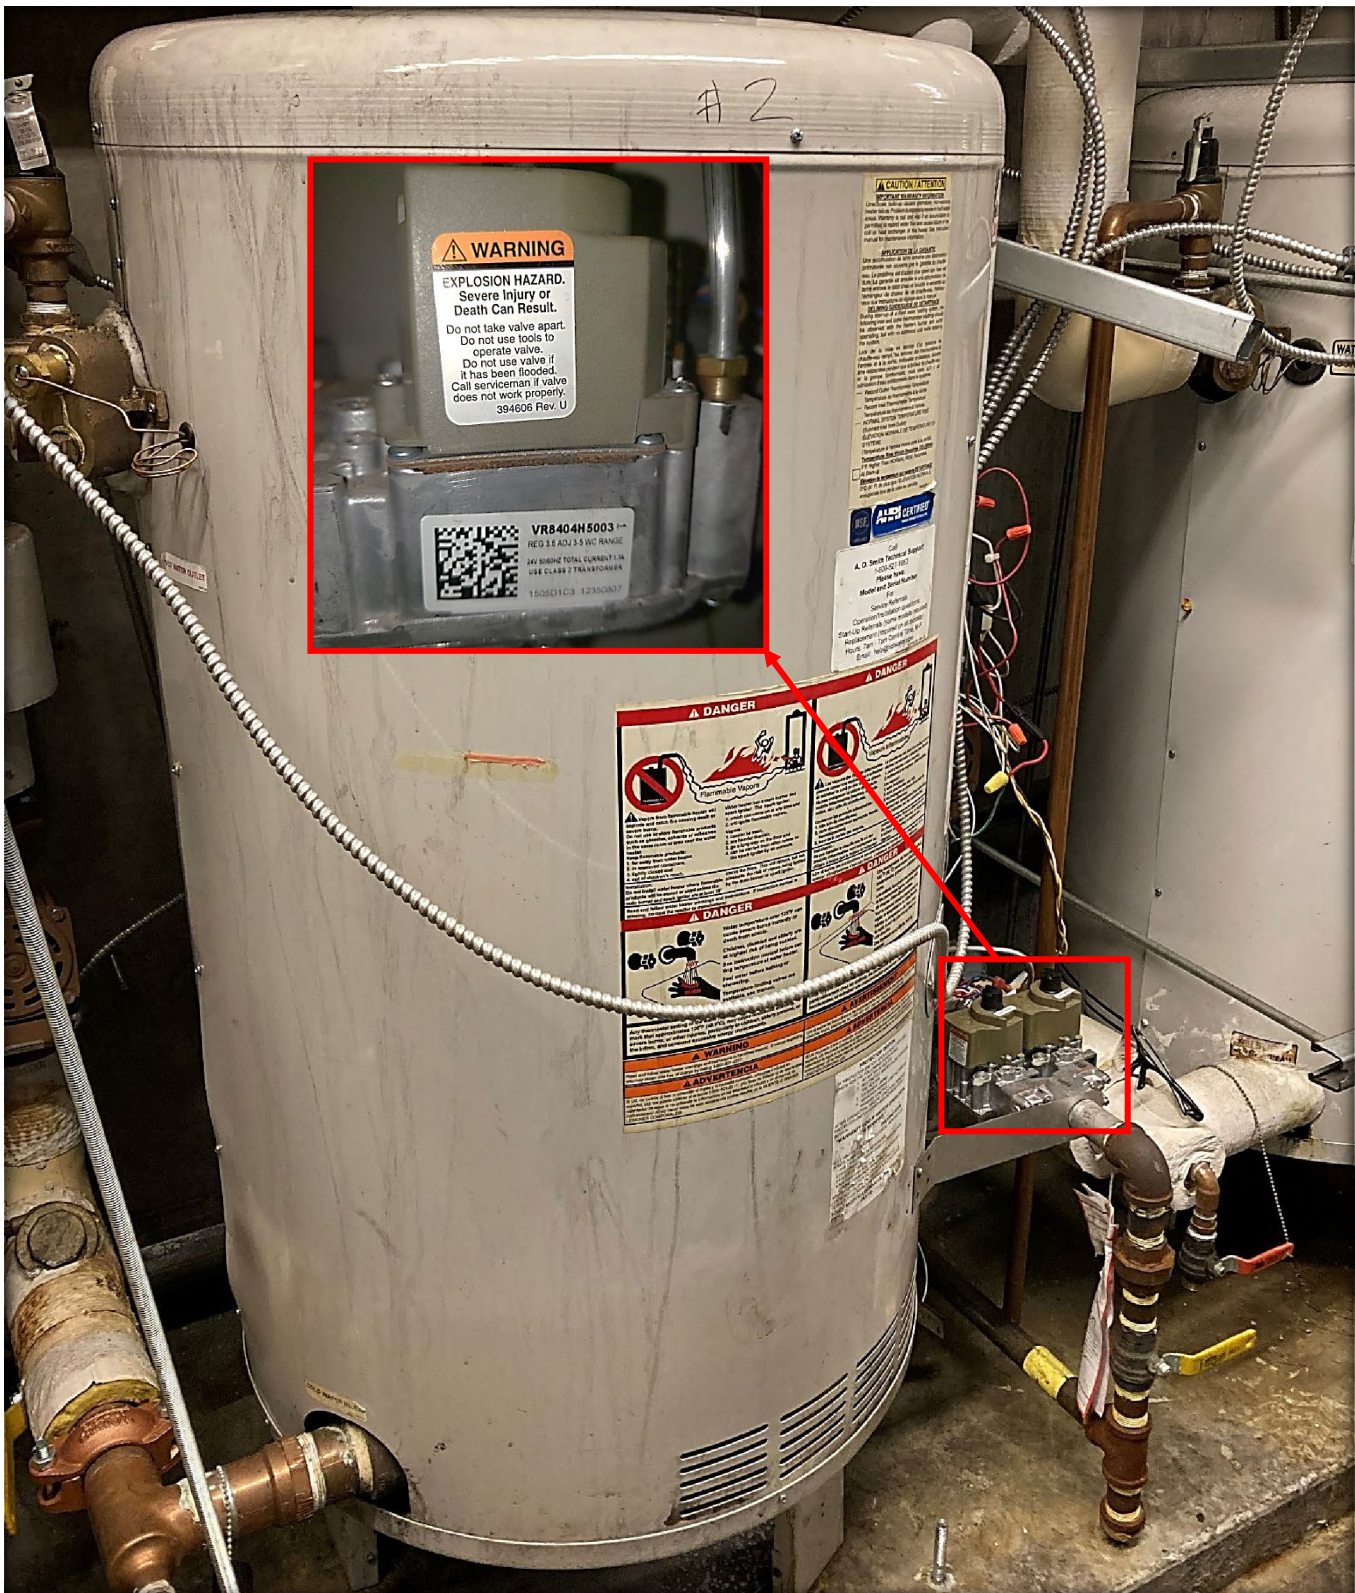
Failure scenario(s)	<p>Boiler 2, one of the three rooftop boilers, had a gas valve that was experiencing fluctuating highs and lows of gas manifold pressure. The gas pressure outside of the boilers specified range led to improper combustion and the emission of elevated levels of CO and black carbon soot buildup in the boiler and in the exhaust venting system. The nearby air handling unit likely drew in the products of combustion from boiler 2 into the building until it triggered CO detectors including one in an apartment. The CO was also likely drawn back into the boiler room through the air intake openings for the mechanical room.</p>
Facts and evidence	<p>Utility technician statements</p> <ul style="list-style-type: none"> • The technician was dispatched to the site due to reports from the fire department of multiple units indicating an alarm status from the fire alarm system. • They reported that once on site, they were advised that the fire department had evacuated the building due to multiple CO alarms throughout the building. • As soon as the technician went on the open rooftop through the stairwell vestibule, they could smell the aldehydes (products of combustion) very strongly. • The wind was static, not blowing hard really when they attended after the incident. • The exhaust vent for the AO Smith Boiler #2 had a reading taken with over 500PPM CO. • The air handler unit's exhaust was tested for CO and levels of 150PPM were recorded. • The technician suspected that the CO was being sucked in by the nearby air handler and distributed throughout the building. • The two other boilers exhausts were found to have lower CO levels between 20-40 PPM. • There are gas pressure monitoring systems available for boilers like this, where if the gas pressure gets too high it will shut off the boiler. This type of system was not in place for this boiler. <p>Gas contractor statements</p> <ul style="list-style-type: none"> • During troubleshooting the flue gas a gas analysis test was performed for boiler 2 and measurements of 700 PPM CO were taken at the power venter, while boilers 1 and 3 had minimal levels of CO in their flue gases. • Boiler 2 was found to have thick black carbon soot all around the copper coils of its heat exchanger as well as in the venting. Boilers 1 and 3 did not have the same carbon buildup. • After cleaning the boiler of the carbon soot, a flue gas analysis test was performed, and the CO levels did not reduce. • The valve for the boiler is required to be set to provide a manifold gas pressure of 3.5 inches of water column (WC). • The gas valve for boiler 2 was measured with a manometer and levels intermittently fluctuating below 3.5 WC and as high as 4.6 inches WC during testing over a period of one hour. • The gas valve for boiler 1 was tested for comparison to boiler 2 with no fluctuations in gas pressure noted. • The gas fitter stated that with the higher gas pressure there may have been a need for additional intake air. • The air intake for all fuel burning appliances in the rooftop mechanical room was calculated to be a minimum requirement of 333 inches squared, while the actual available intake was 300 inches squared (90 %).

Image 2 – Boiler 2 gas valve (small red square) with side view of gas valve (large red square).
