Incident Summary (# II-710415-2018)(17800) FINAL

SUPPORTING INFORMATION	Incident Date	<i>June 27, 2018</i>	
	Location	<i>Coquitlam</i>	
	Regulated industry sector	<i>Electrical Low Voltage (30v to 750v)</i>	
	Impact	Qty injuries	<i>No injuries</i>
		Injury description	<i>none</i>
		Injury rating	<i>none</i>
	Damage	Damage description	<i>Damage to the electrical consumer service.</i>
		Damage rating	<i>Minor</i>
Incident rating	<i>Minor</i>		
Incident overview	<i>A worker power washing the exterior of a residential multi dwelling unit building in the area around the overhead electrical consumer service heard crackling and saw electrical arc flashes and smoke coming from a junction box located on the exterior soffit of the building.</i>		
INVESTIGATION CONCLUSIONS	Site, system and components	<p><i>The raceways and equipment for an overhead electrical consumer service contain the un-fused service conductors which feed power from the supply utility to the building. When located outside these components are required to be rated for use outdoors.</i></p> <p><i>The neutral or identified conductor of an electrical consumer service is to be without joints and splices. And any splice or joi

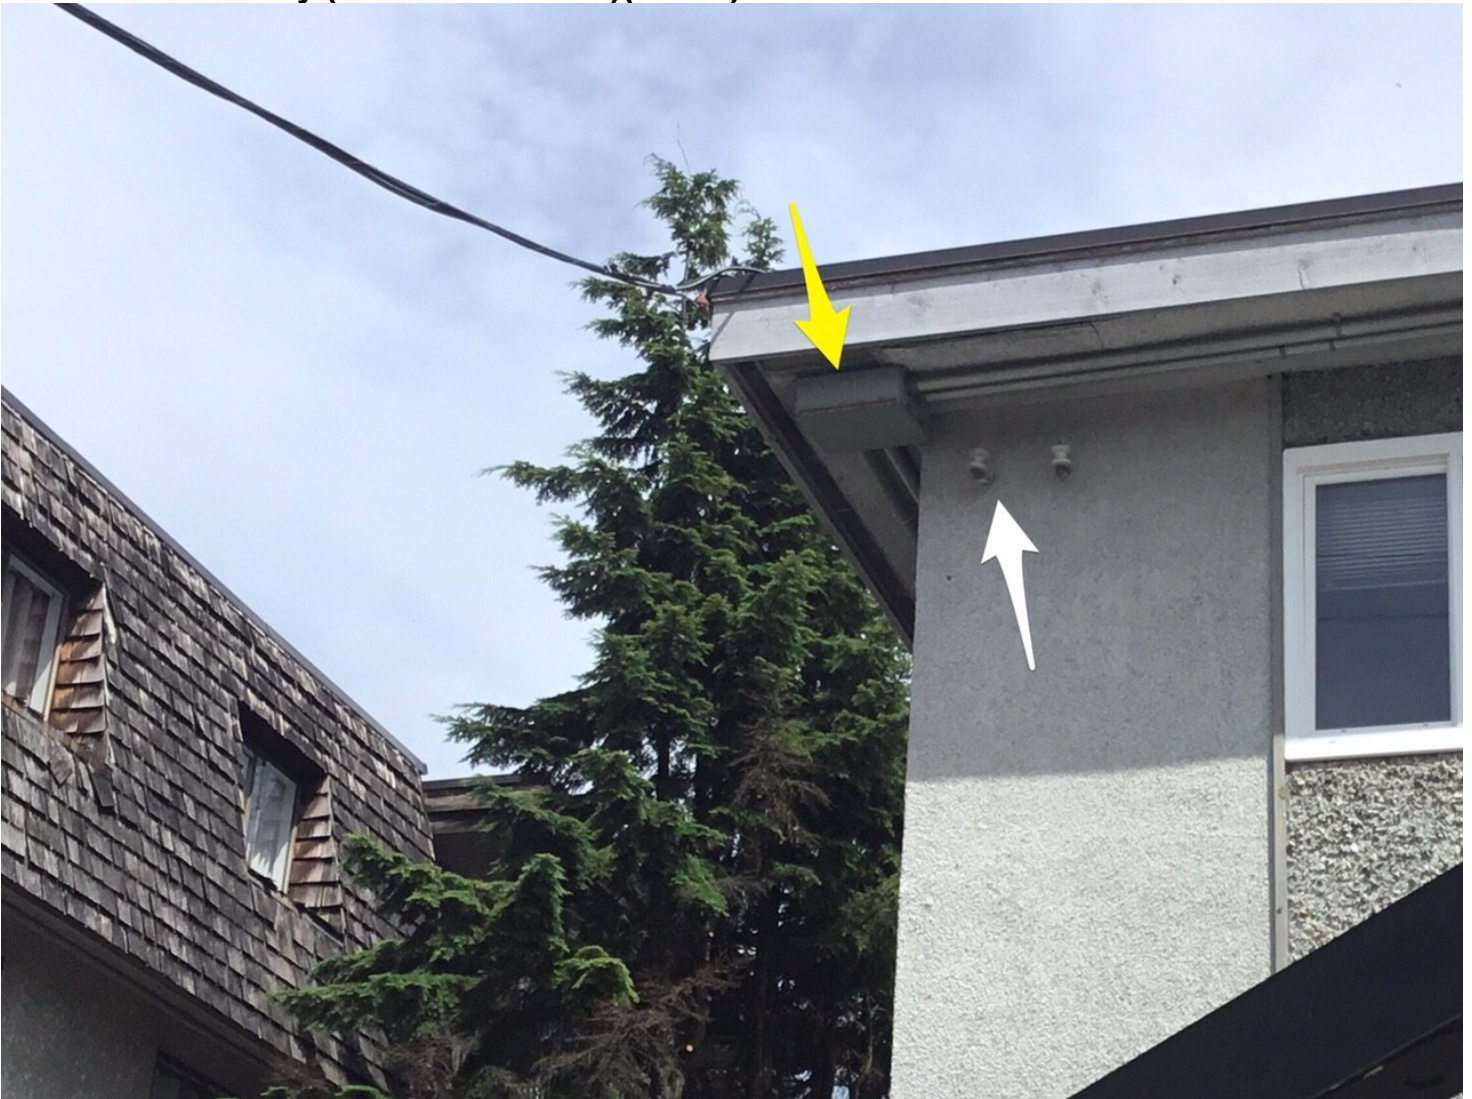
<p>Causes and contributing factors</p>	<p><i>The arc flashes and damage to the equipment was likely caused by the deteriorating vinyl electrical tape used to insulate the copper split bolt connection points which were used to extend the service conductors. The vibration caused by the power washer spray or water ingress from the power washer spray into the electrical junction box which was rated for use indoors only caused the already compromised insulation to fail and one phase to fault to ground.</i></p>

Yellow Arrow: The yellow arrow is pointing to the junction box where the incident occurred. The junction box was partially repaired when this picture was taken.

White Arrow: The white arrow is pointing to existing bolt through point of attachments located on the exterior of the building.

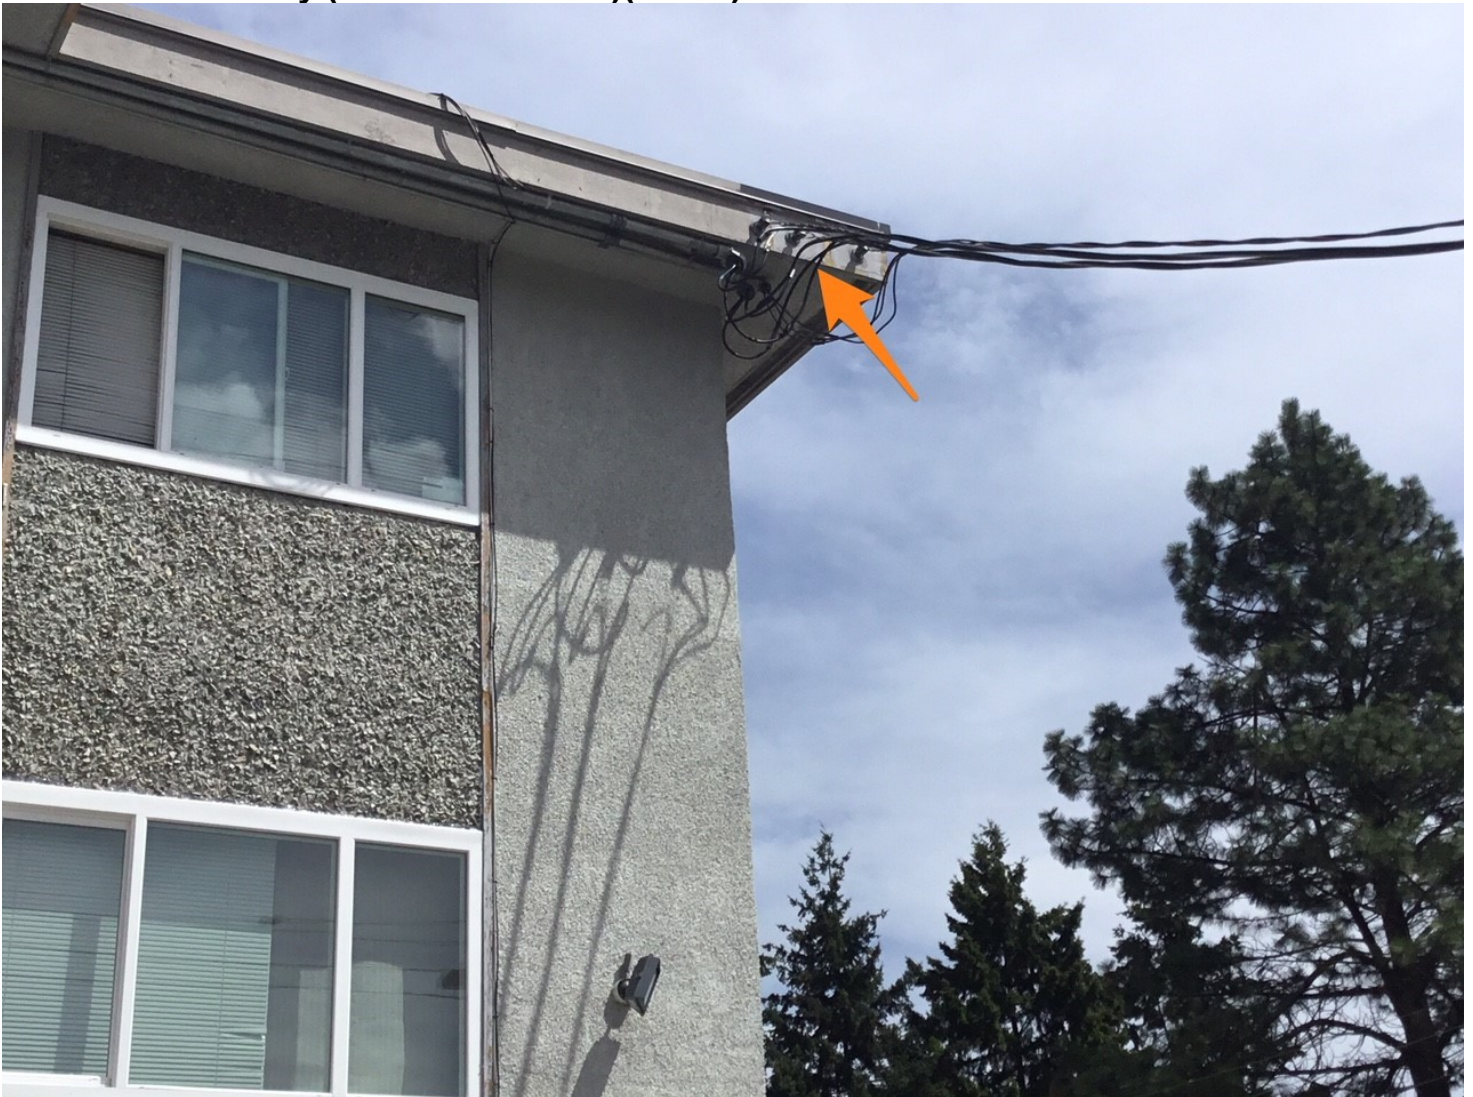
Orange Arrow: The orange arrow is pointing to the screw in point of attachments for the supply conductors feeding power to the building.

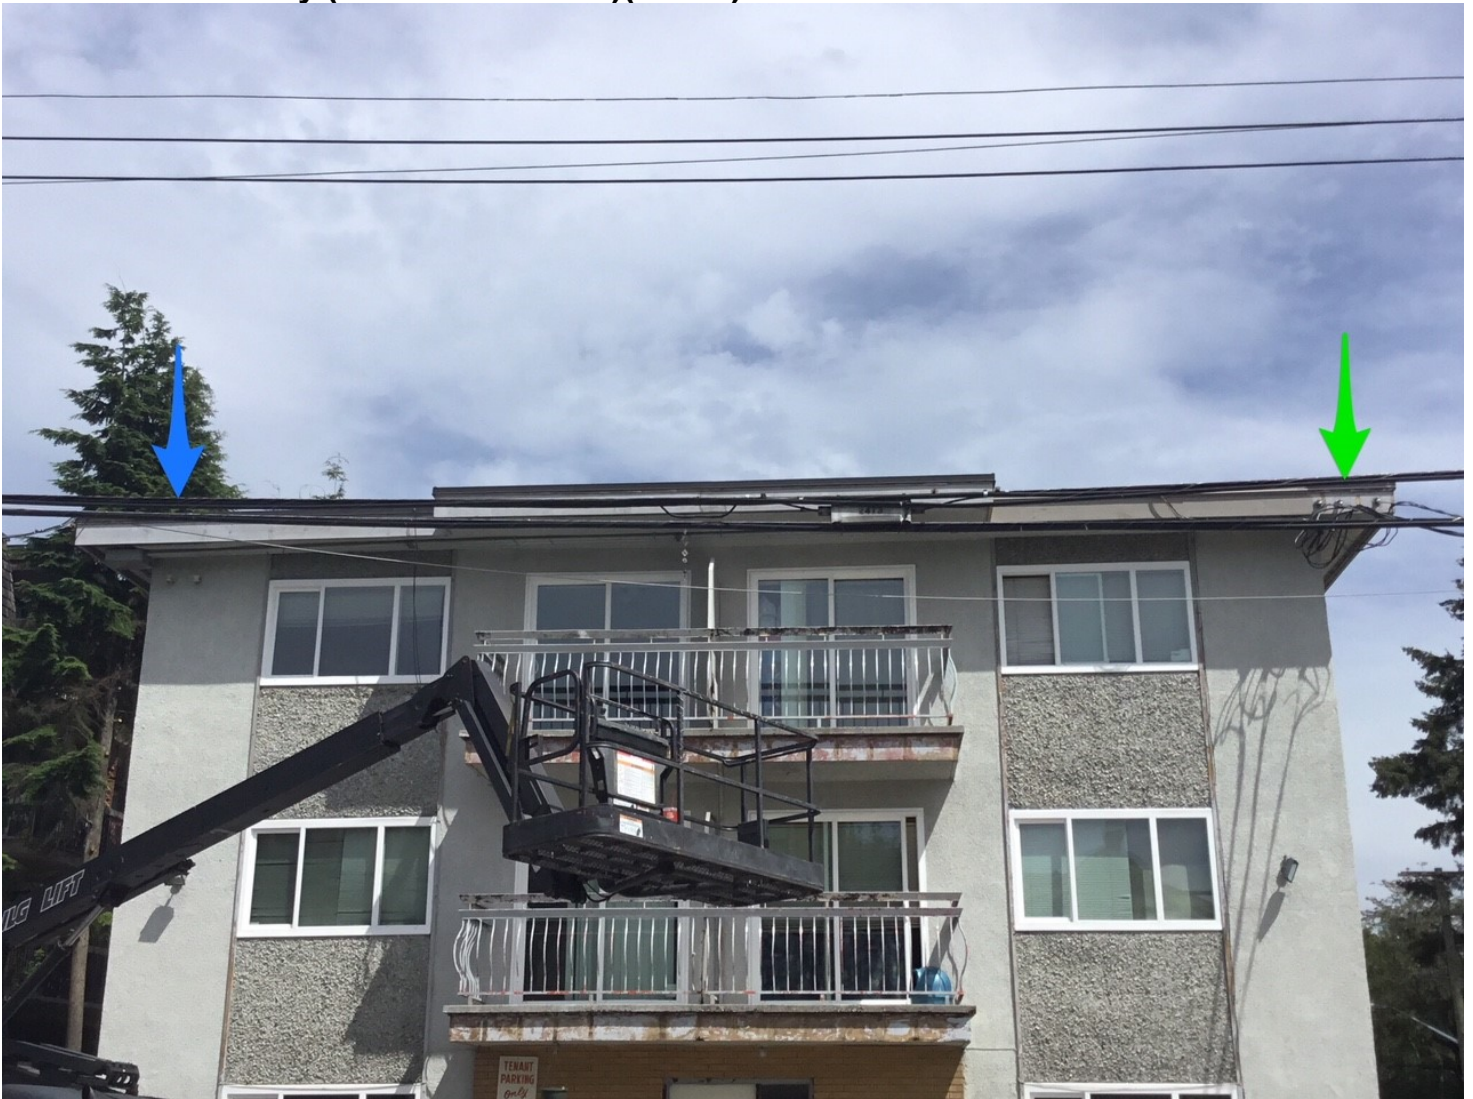
Blue Arrow: The blue arrow is indicating the location where the incident occurred.

Green Arrow: The green arrow shows the connection point to the supply authorities conductors.
