## Incident Summary (5604643)

SUPPORTING INFORMATION	Incident Date		September 6, 2016	
	Location		Abbotsford	
	Regulated industry sector		Low voltage electrical system (30V to 750V)	
	Impact	Injury	Qty injuries	0
			Injury description	N/A
			Injury rating	None
	Damage	Damage	Damage description	Electrical arcing damage to a child's play tent, a portable fan's attachment cord, and a cablevision outlet. Fire damage to the bed, play tent, and fire and smoke damage to the contents of a bedroom in a house.
			Damage rating	Moderate
	Incident rating		Moderate	
Incident overview		<p>A child woke to find his bed on fire. He called out to his mother who evacuated the family from the house and called the fire department.</p> <p>The fire occurred near an electrical outlet that a portable fan was plugged into and a cable vision outlet that were located on the wall adjacent to the bed.</p>		
INVESTIGATION CONCLUSIONS	Site, system and components		<p>A portable fan was plugged into a receptacle that was rated at 15 Amperes and 120 Volts. The fan cord attachment blades are intended to be fully inserted into a receptacle to provide positive electrical contact with the receptacle contacts and to pre

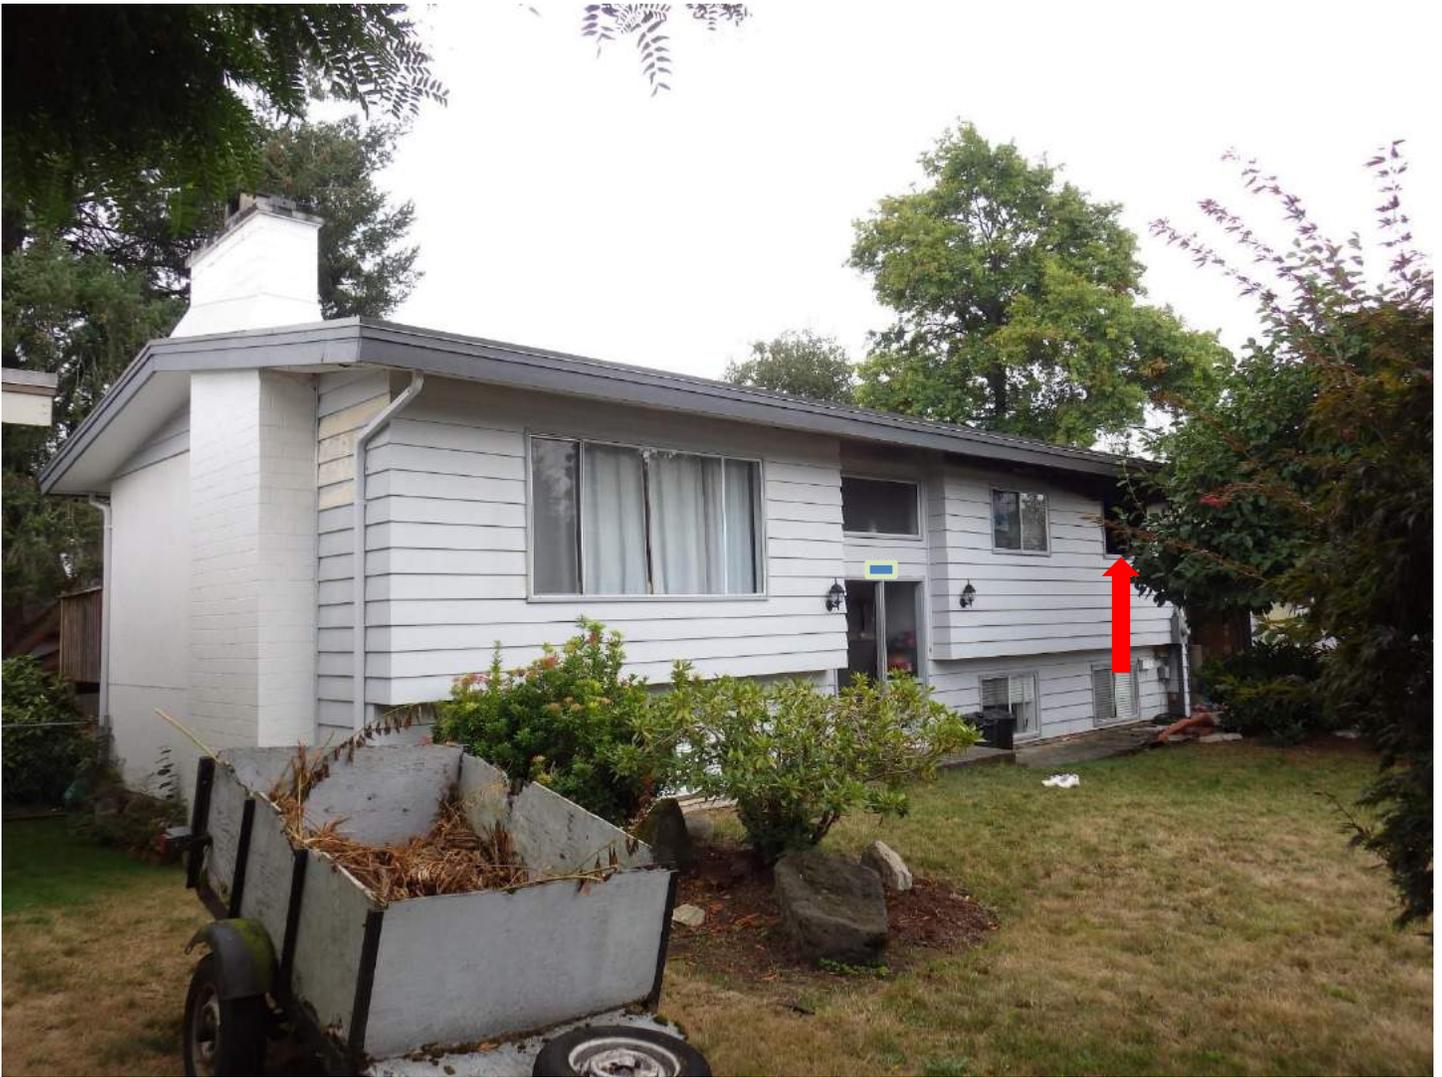
FIGURE 1

Front of house where incident occurred. The red arrow shows the upper floor bedroom window. This is the room where the incident occurred.

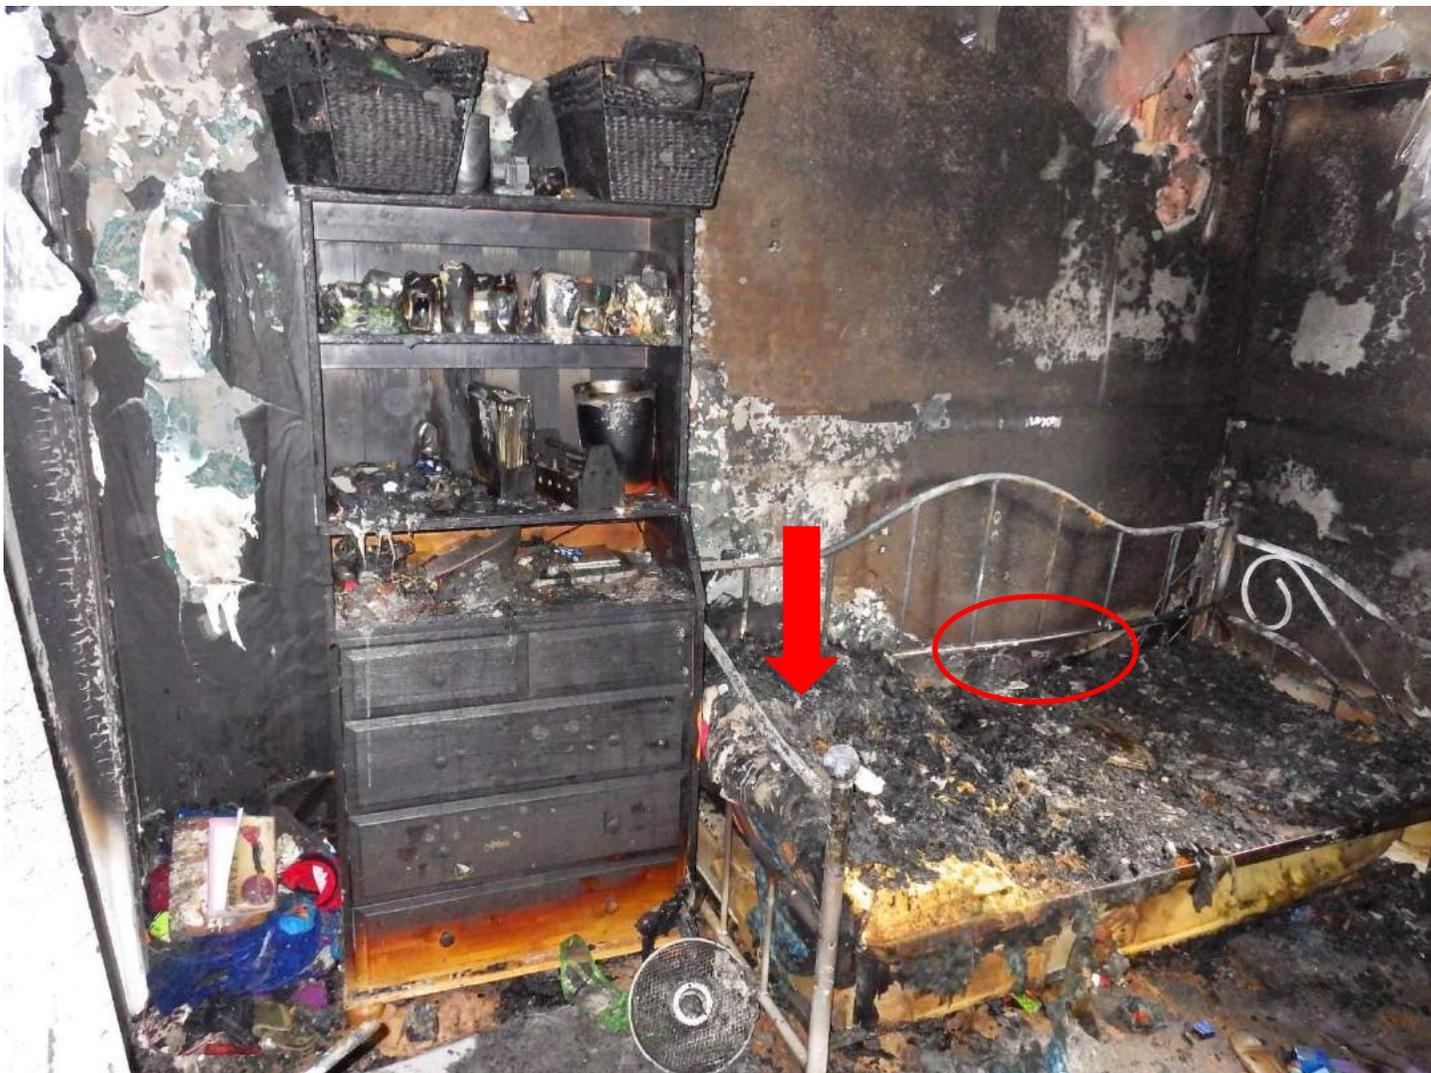
FIGURE 2

The red oval shows the area of origin where the bed is located adjacent to the wall. This is the area where the cable vision outlet is located. The red arrow shows the approximate location of the 15A 120V receptacle which is approximately 900mm away from the cable outlet.

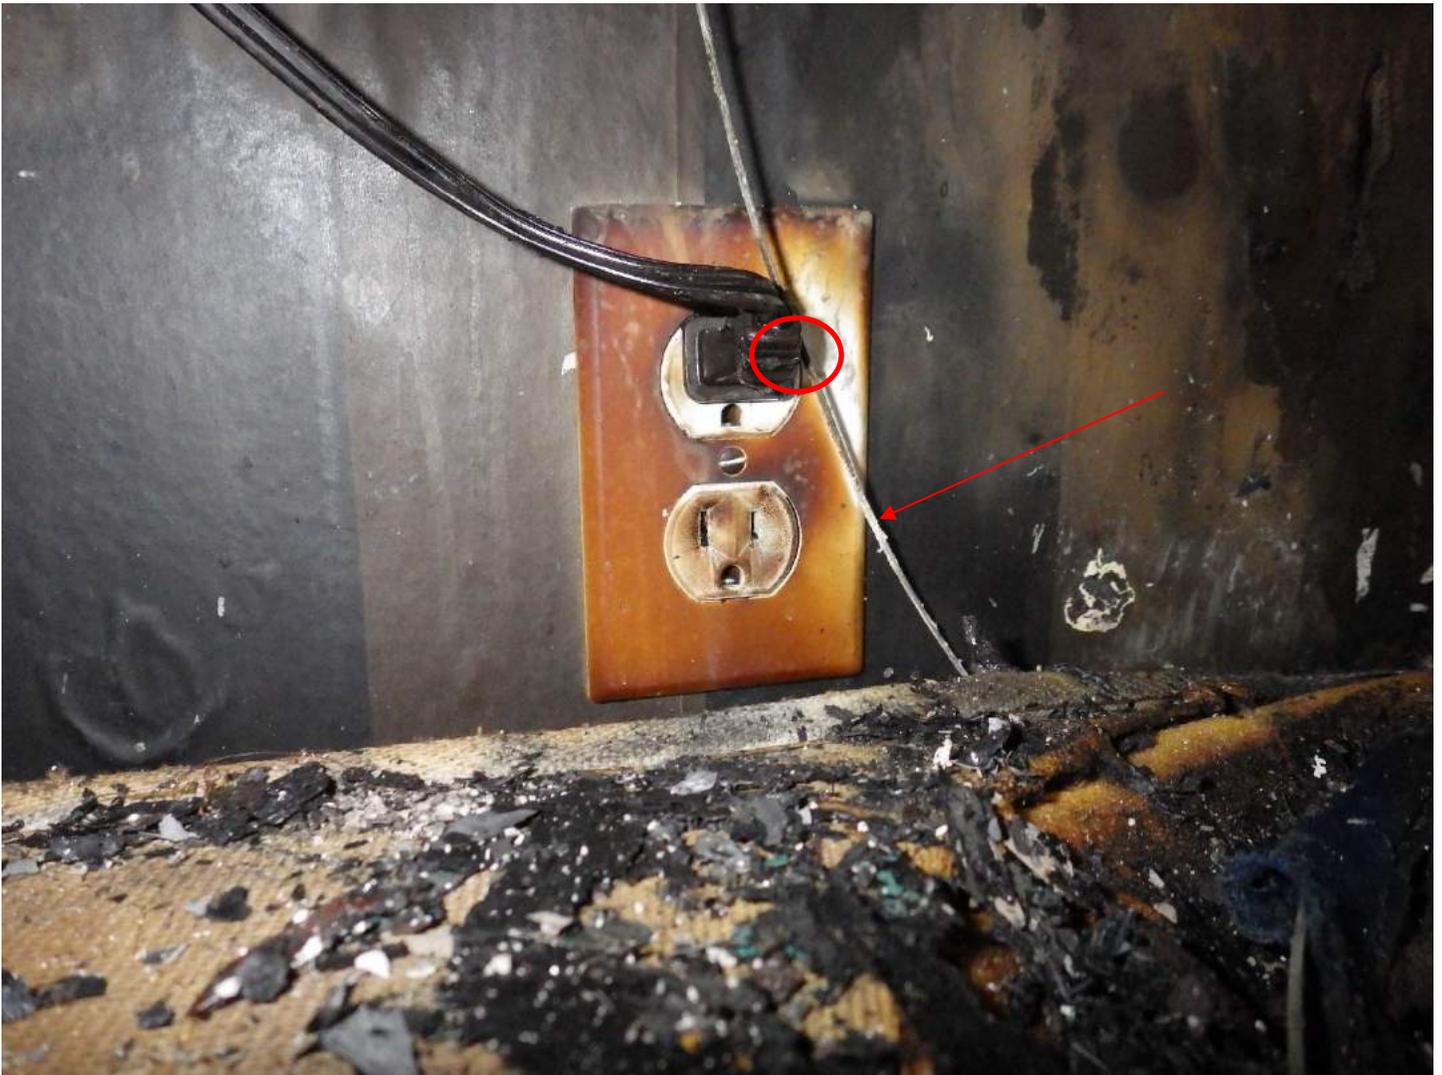
FIGURE 3

This is the receptacle that the fan cord was plugged into. The red arrow shows the thin metal frame of the child's play tent. The area of contact between the metal and the cord attachment blade is outlined by the red oval.

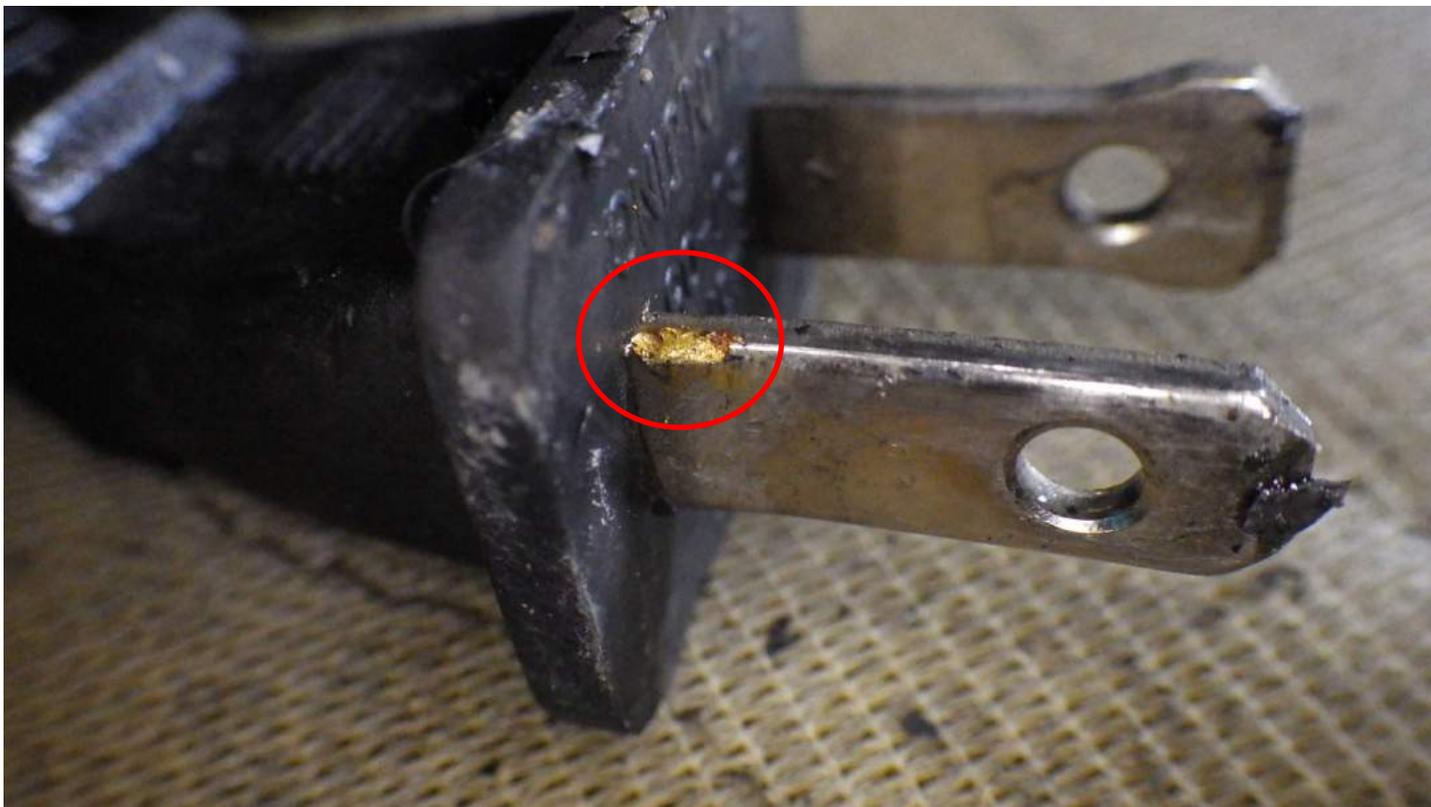
FIGURE 4

The red oval shows the electrical arcing damage to the attachment cord blade where contact was made with the tent's metal frame.

A materials engineering firm conducted a laboratory test evaluation of the components involved in the incident. Iron and alloy materials were transferred between the components at the contact points confirming electrical contact between the fan cord attachment blade (shown in the photo) and the metal frame of the play tent.

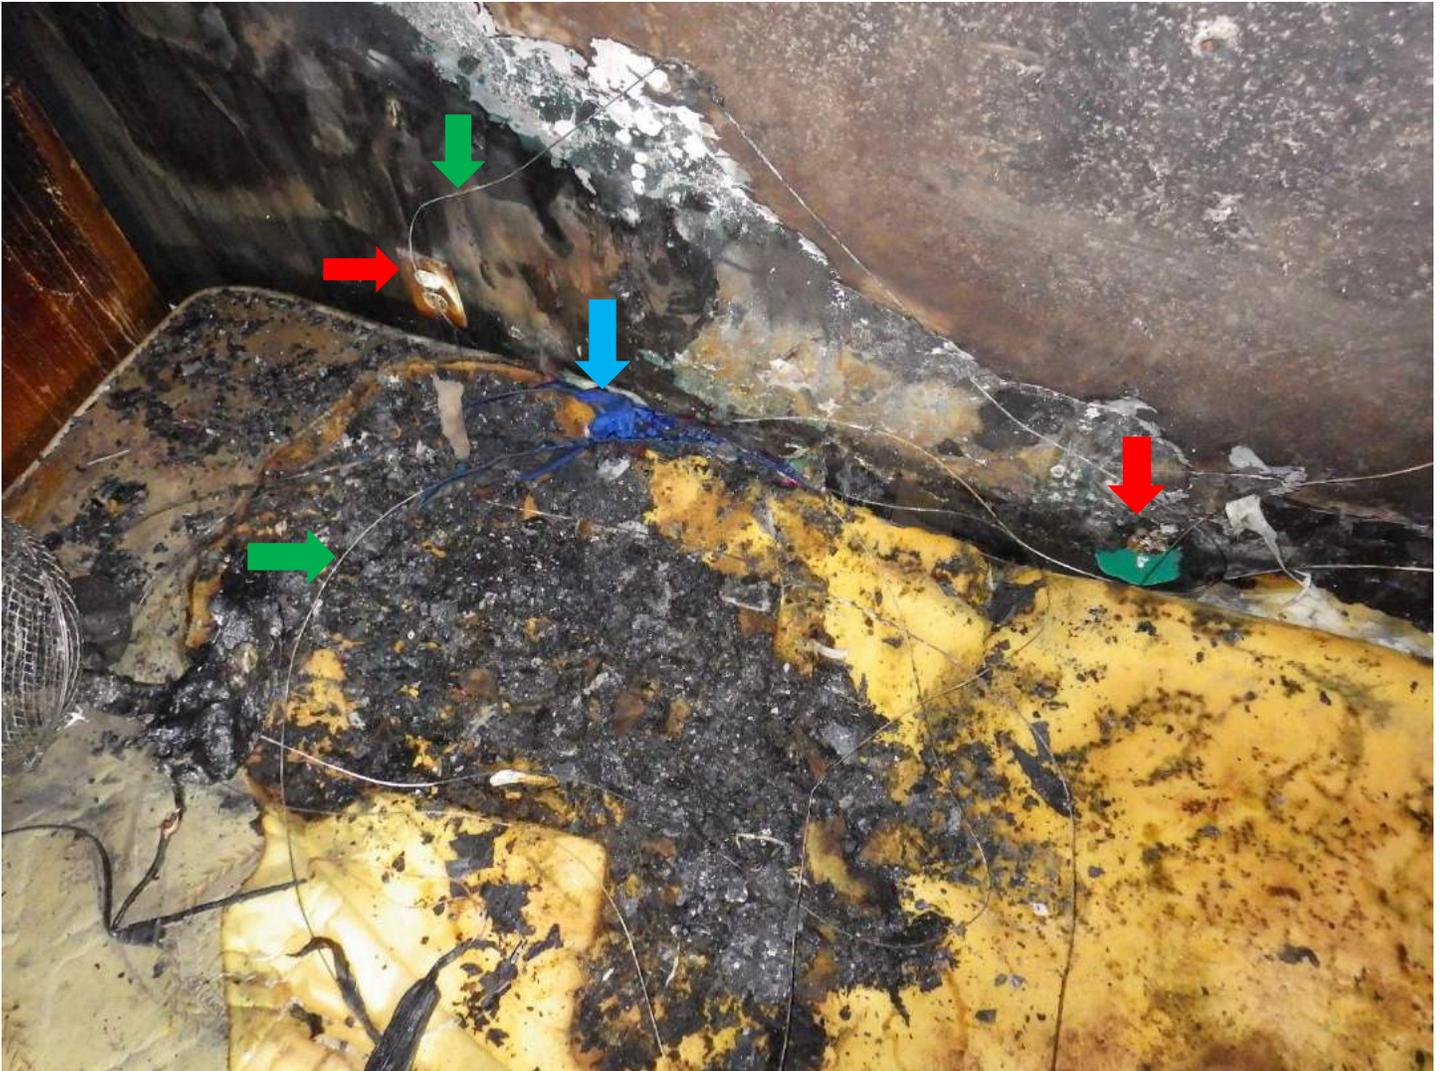
FIGURE 5

The red arrows show the location of the receptacle and the cablevision outlets that were approximately 900mm apart. The green arrows shows the metal frame from the child's play tent. The blue arrow shows remnants of the material from the play tent.

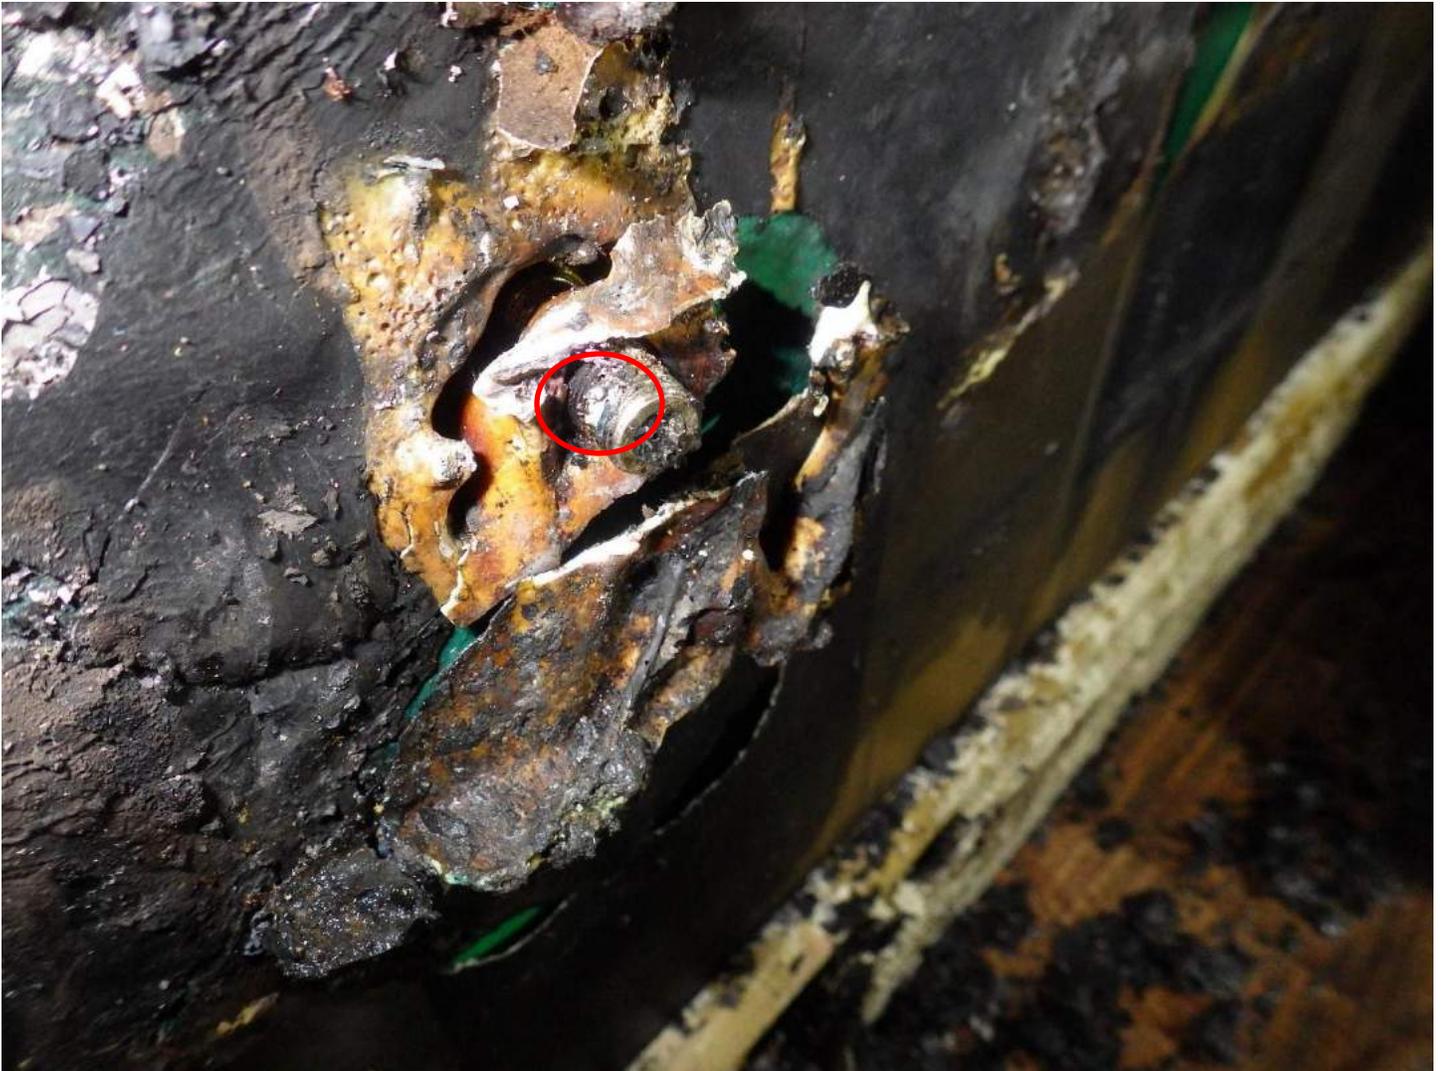
FIGURE 7

<p>Causes and contributing factors</p>	<p>It is very likely that the cause of this incident is the conductive metal frame of a children’s play tent contacting the energized attachment cord blade from a plugged in fan and a grounded cablevision outlet. A short circuit between the attachment cord blade and the cablevision outlet caused an electrical arc and the resulting heat that ignited the tent material and the bed.</p>

The red oval shows the location of the electrical arcing contact between the energized metal frame of the play tent and the grounded cable vision outlet.

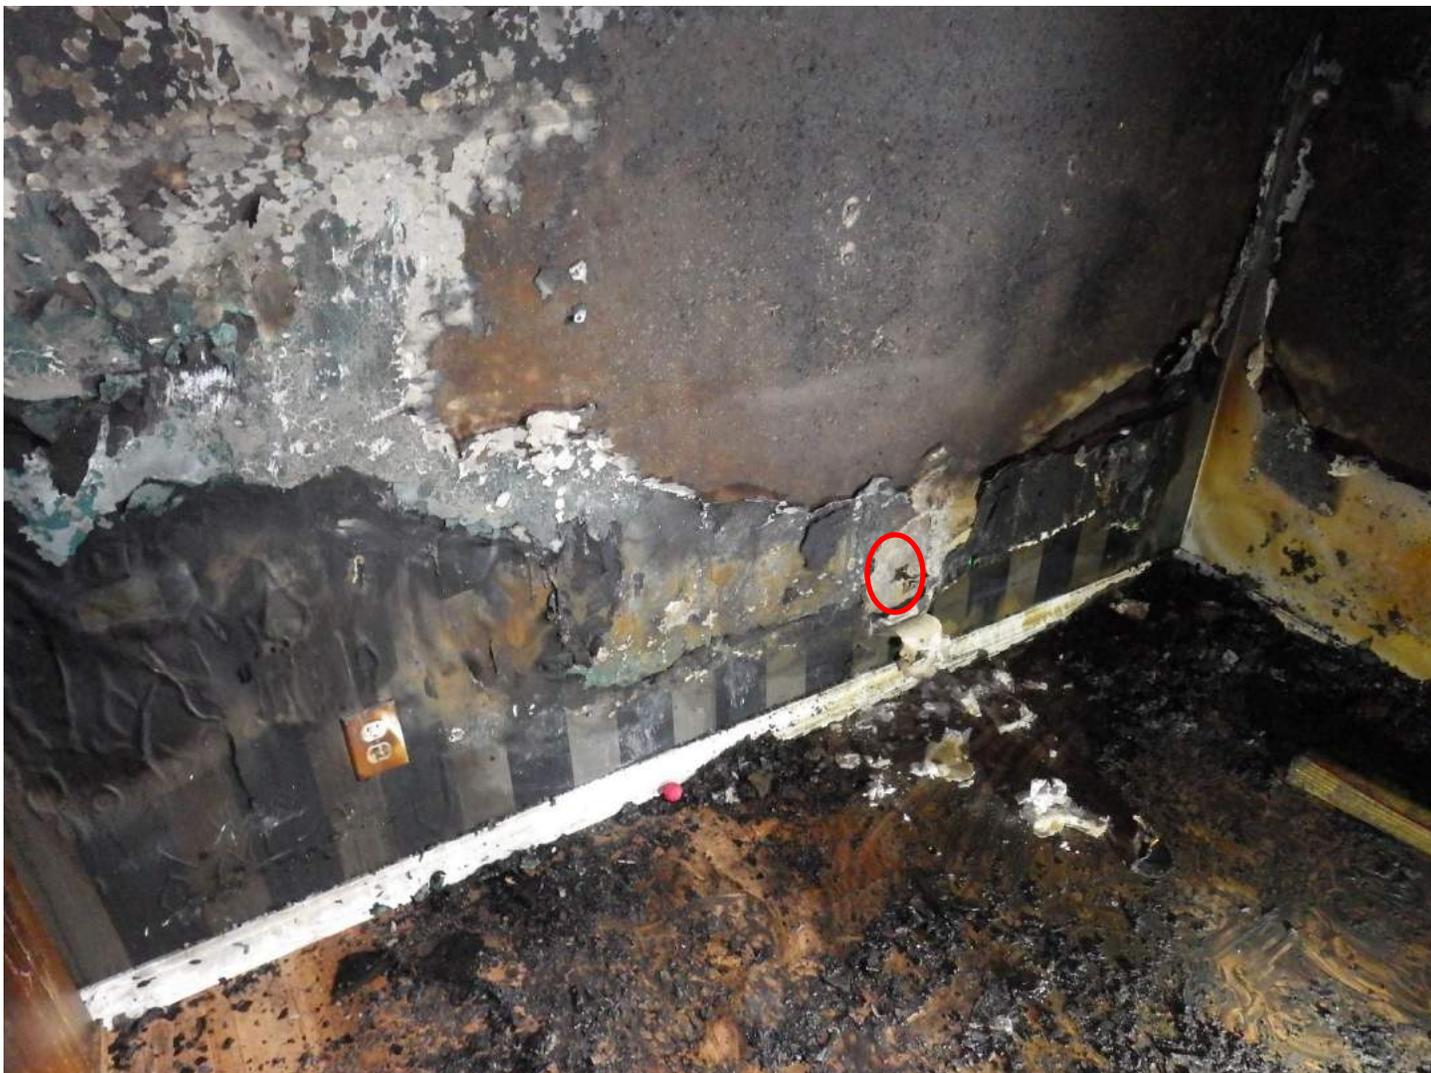
FIGURE 8

The red oval shows the location of the cable vision outlet which was the point of origin of this fire. With the bed and other materials removed from the area of origin the fire pattern was more visible.

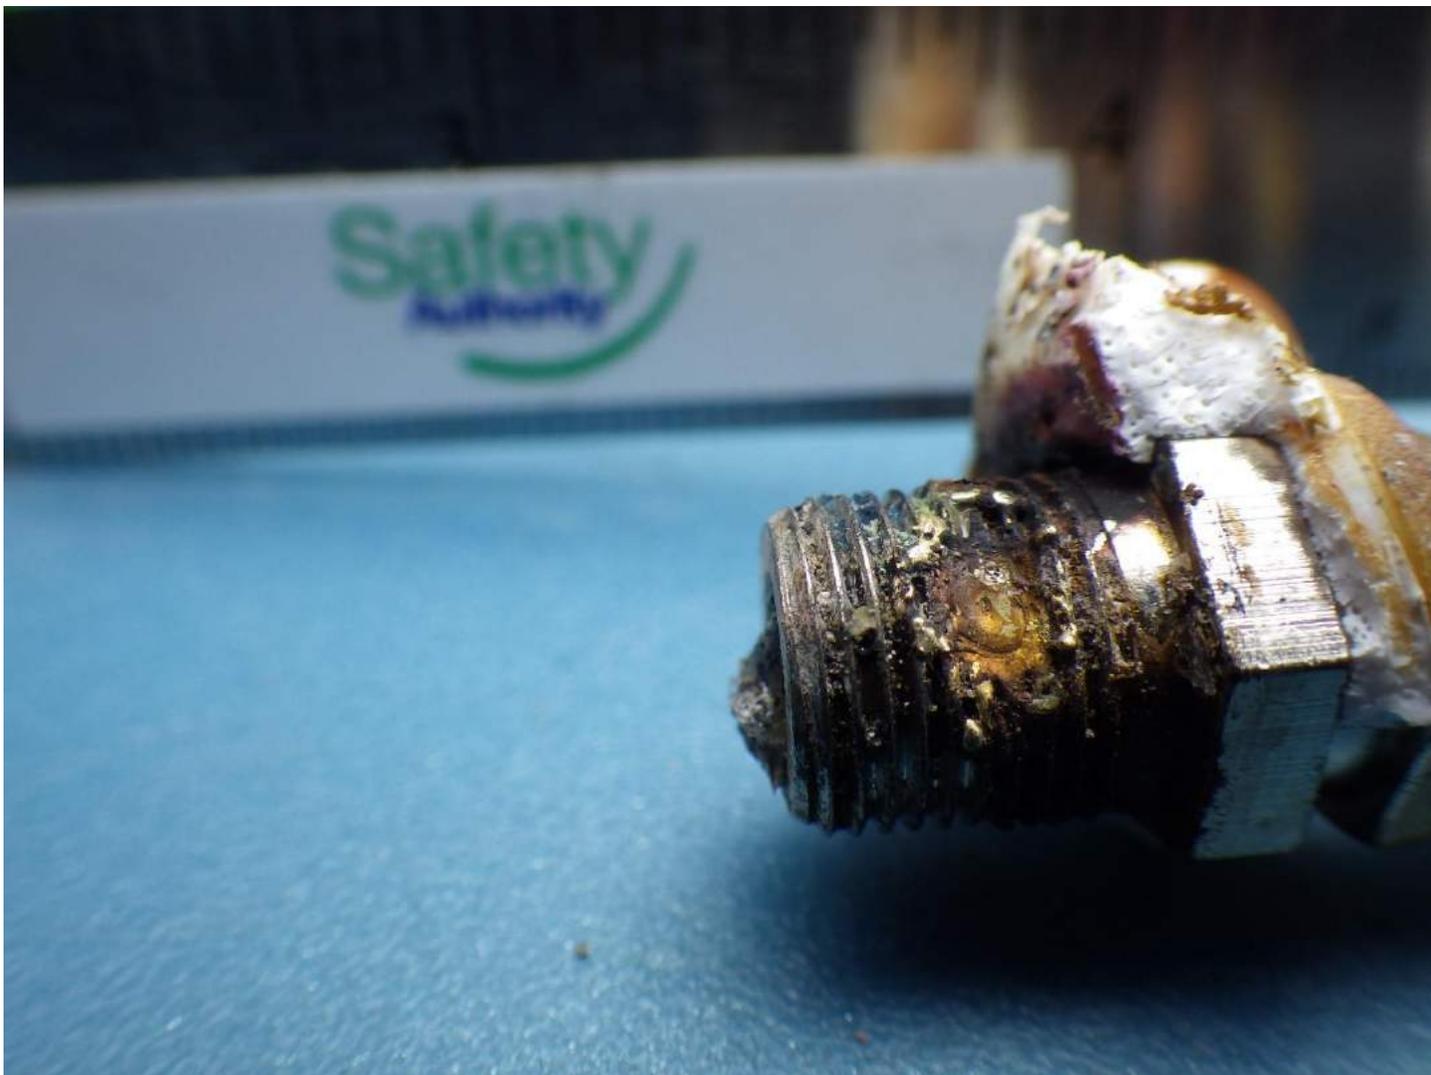
FIGURE 9

This photo shows electrical arc damage on the metal cable vision outlet where contact was made with the play tent's metal frame. The beading and pooling indicates the metal was heated to a molten state at the time of the arc.

A materials engineering firm conducted a laboratory test evaluation of the components involved in the incident. Iron and alloy materials were transferred between the components at the contact points confirming electrical contact between the cablevision outlet (shown in the photo) and the metal frame of the play tent.

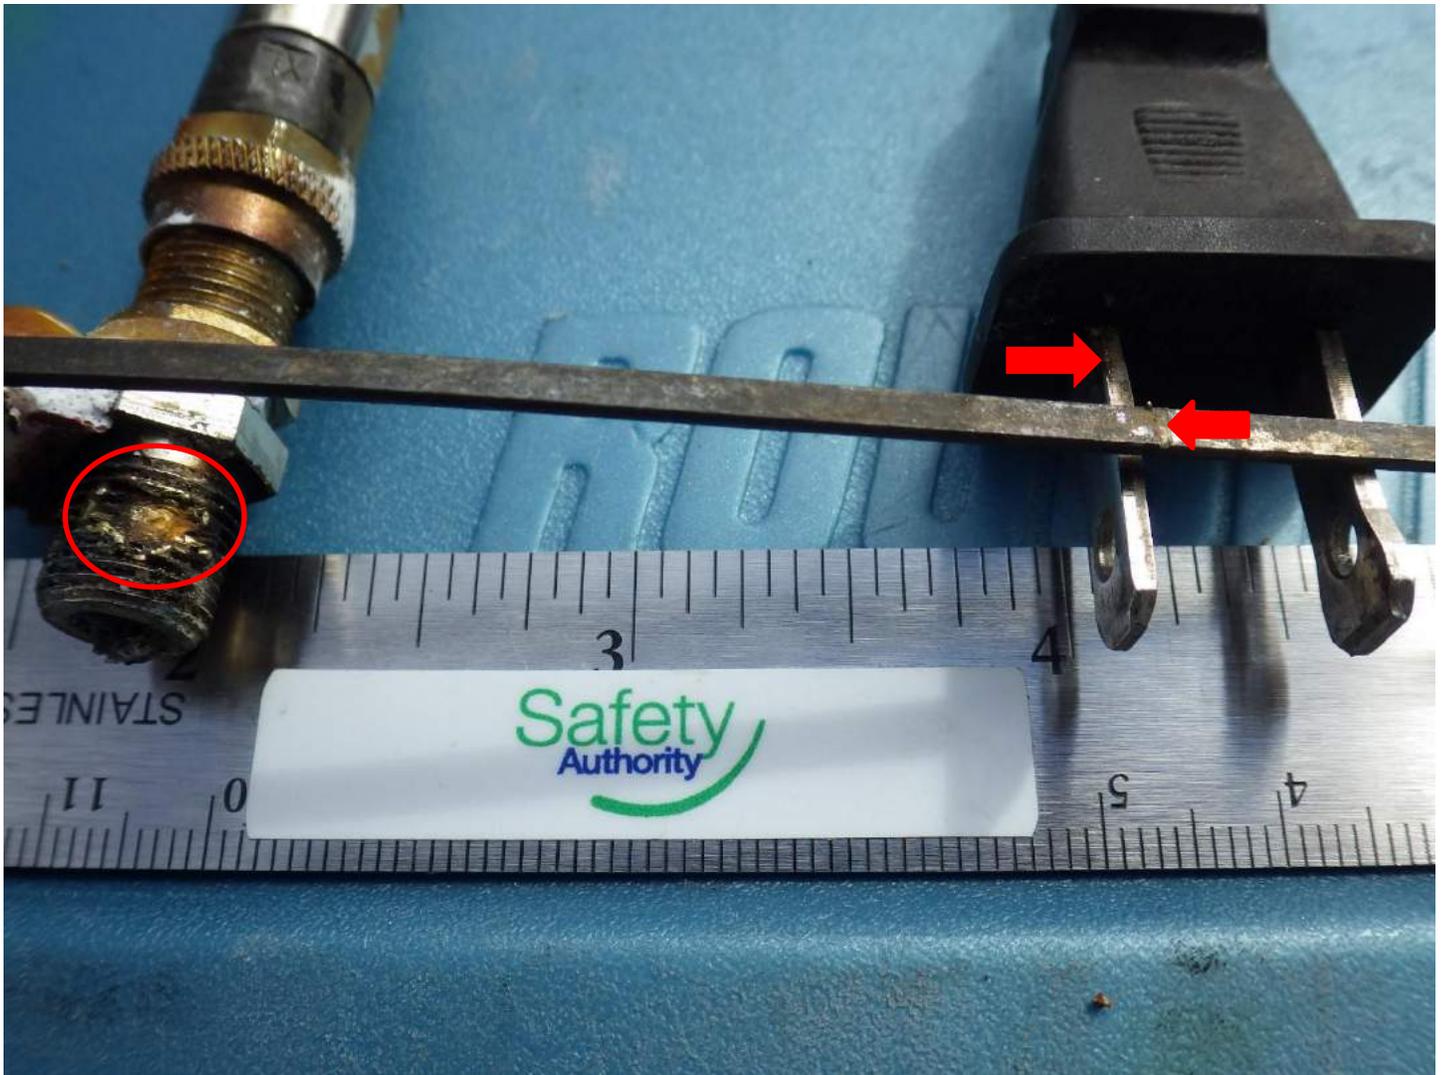
Figure 10

This photo shows the components involved in the incident and the locations of the electrical arcing damage.

A materials engineering firm conducted a laboratory test evaluation of the components involved in the incident. Iron and alloy materials were transferred between the components at the contact points confirming electrical contact between the components tested.

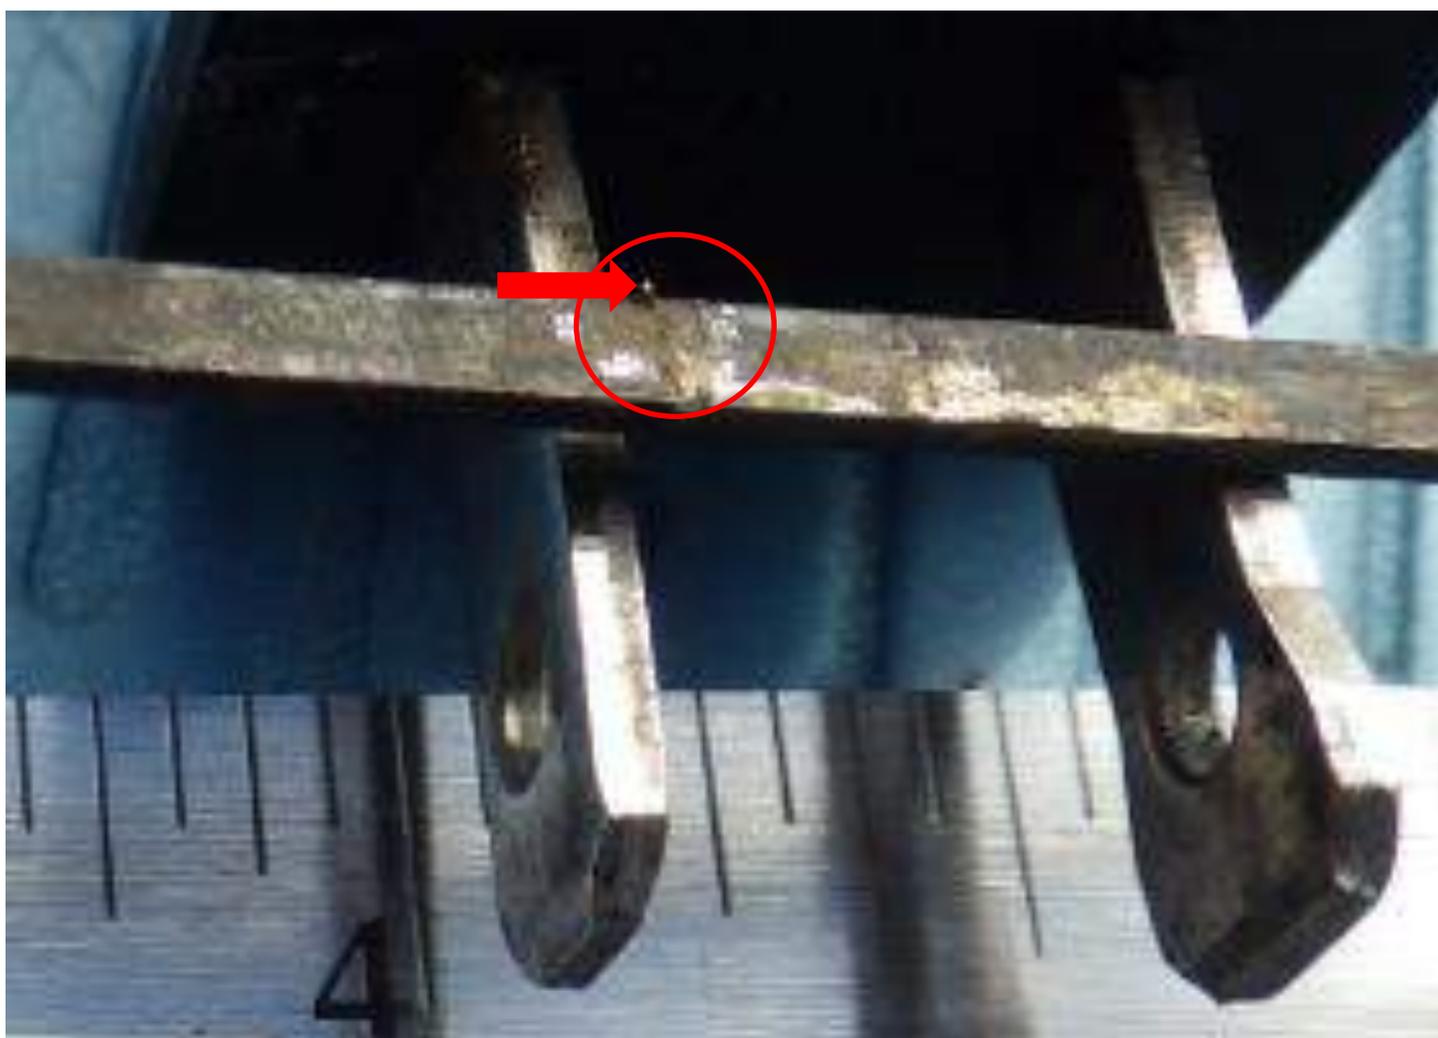
**FIGURE 11**

The red oval shape shows the area on the metal frame of the play tent that was damaged by the electrical arc from coming into contact with the receptacle blade. The red arrow shows a bead that was formed from the arc.

A materials engineering firm conducted a laboratory test evaluation of the components involved in the incident. Iron and alloy materials were transferred between the components at the contact points confirming electrical contact between the metal frame of the play tent (shown in the photo) and the attachment cord blade.

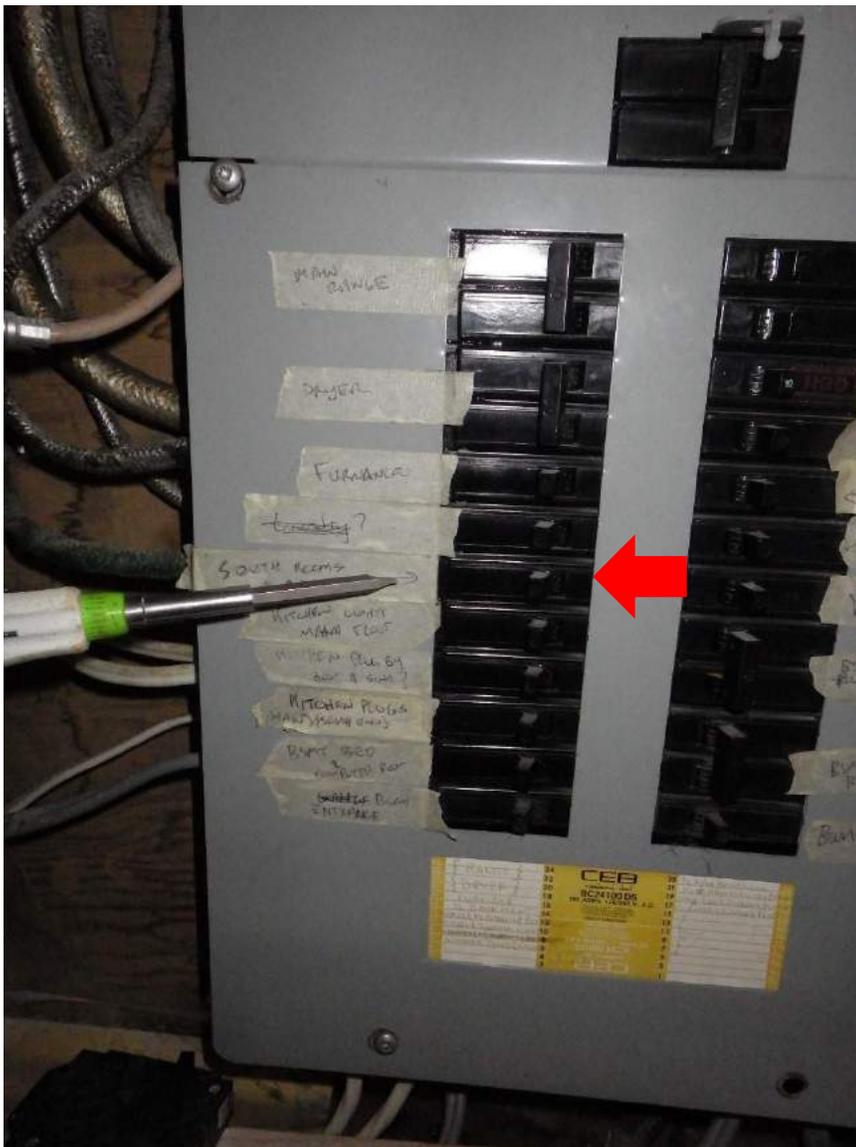
FIGURE 14

This photo shows the 15A rated circuit breaker that was tripping just prior to the incident occurring. The circuit breaker was circuit #12 and was labeled “south rooms & bath”.

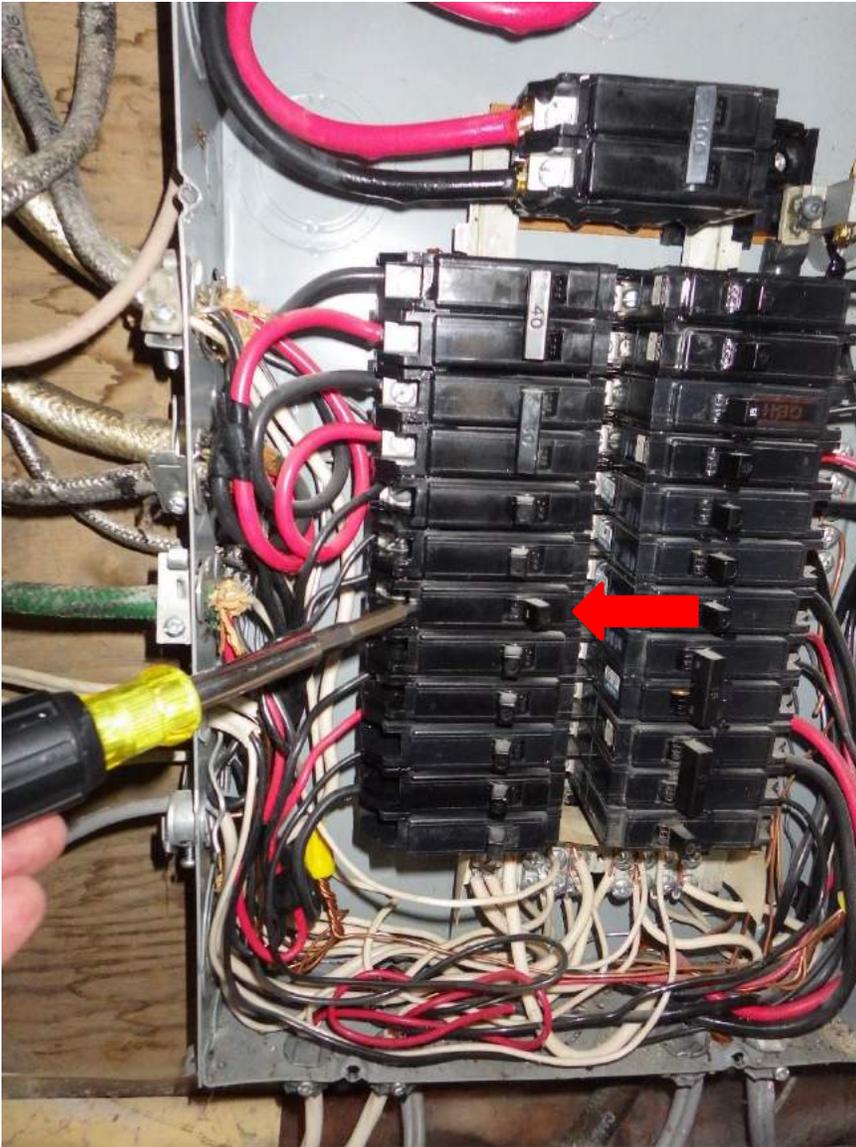
FIGURE 15

The branch circuit conductors (#12 awg aluminum) were properly terminated in the panel and at the receptacle (#14 awg copper). No evidence of previous problems with the circuit breaker or the branch circuit wiring was observed.

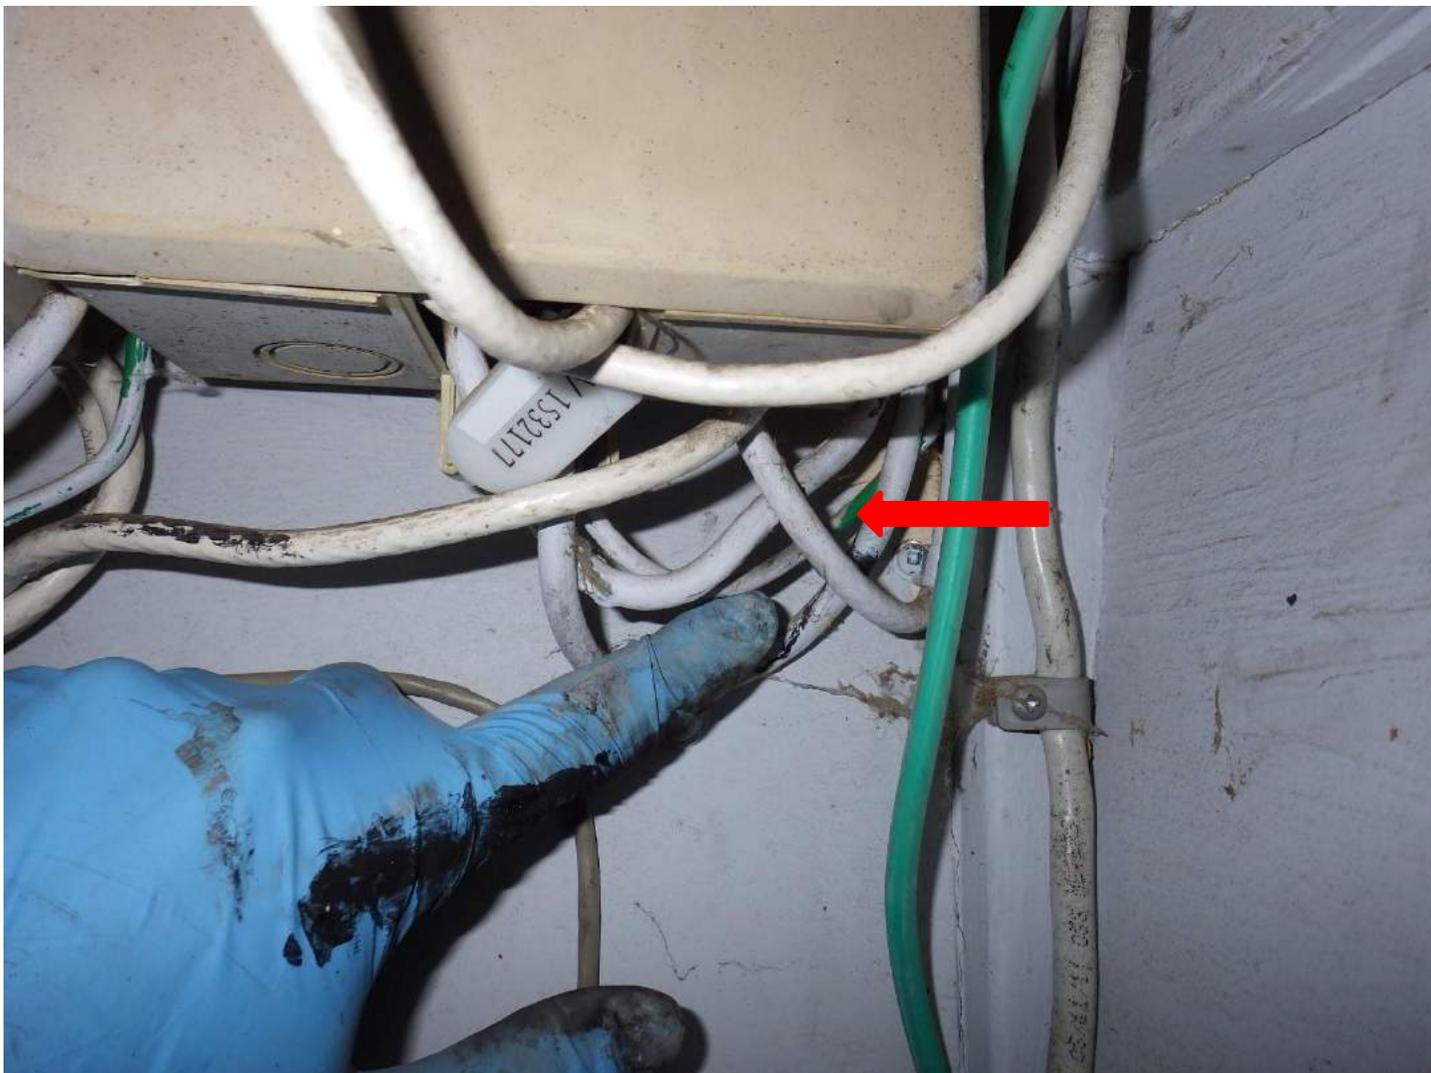
FIGURE 16

The cable vision cable was found to be bonded to the house electrical system at the cable utilities demarcation box with a green #10 awg copper bonding conductor. This conductor installed between the demarcation box and the main electrical system ground (shown by the red arrow) provided a path to ground for the current to flow during the fault between the attachment cord blade and the cable outlet.
