FIELD BULLETIN

Equipment: 2:1 Roped counterweight

Subject: Counterweight assemblies with 2:1 roping.

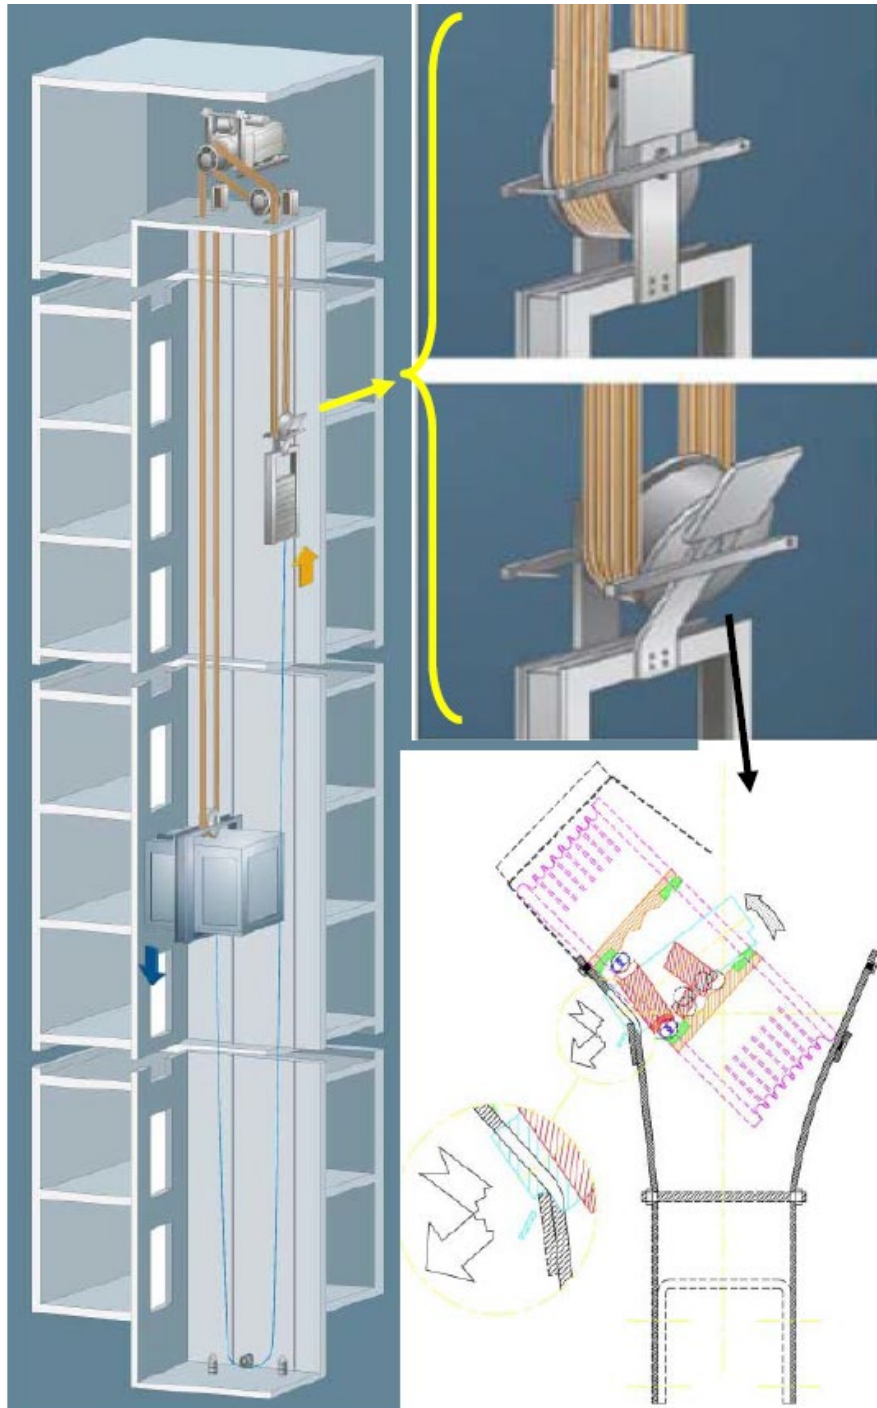
Figure 1: Illustration of bearing failure

The counterweight sheave shaft bearing can fail due to excessive service life, overload stress or lack of lubrication. The counterweight sheave would then jam on the counterweight shaft. The counterweight sheave is then on an angle placing pressure on the cheek plates which connect the counterweight to the counterweight sheave. This pressure can cause the shaft retaining means to fail and the sheave to separate from the counterweight, possibly resulting in the car being in a free fall condition activating the car safety gear in its most severe operating condition.

In the noted incident the bearings which failed were SKF-6218 sealed bearings which cannot be lubricated and were used on some Dover-Turnbull counterweights. Engineering calculations, based upon SKF data indicate the bearing service life should not exceed 27,000 hours. The life will vary depending on the duty cycle of the installation.

TKE have also designed a retrofit kit to replace the sheave shaft and bearings. The retrofit kit also includes additional rope retainers to mimic the seismic requirements which prevent the hoist ropes from jumping off the sheave. This is now more relevant now that full speed, full load buffer and safety tests are mandatory which apply further stresses to the system.
