## Incident Summary #II-1311754-2022 (#25721) (FINAL)

SUPPORTING INFORMATION	Incident Date	January 9, 2022	
	Location	Duncan	
	Regulated industry sector	Electrical - Low voltage electrical system (30V to 750V)	
	Impact Injury	Qty injuries	0
		Injury description	N/A
		Injury rating	None
	Damage	Damage description	Heavy charring of wall and roof trusses.
		Damage rating	Moderate
	Incident rating	Moderate	
Incident overview	A recessed wall mount electric forced air heater appears to have caused a fire.		
INVESTIGATION CONCLUSIONS	Site, system and components	<p>240v, 1500/750watt, forced air electric heater. Manufacturer Dimplex, Model 6100790000, Mod A, Date Code 0406</p> <p>The electric heater is designed to be installed inside a wall cavity. The heater uses a fan attached to an electric motor to move air across electrical heating elements to heat the space.</p>	
	Failure scenario(s)	The fan in an electric wall mounted heater became detached from the motor shaft. The reduction in airflow allowed the electric heater to overheat and started a fire in the surrounding combustible wall.

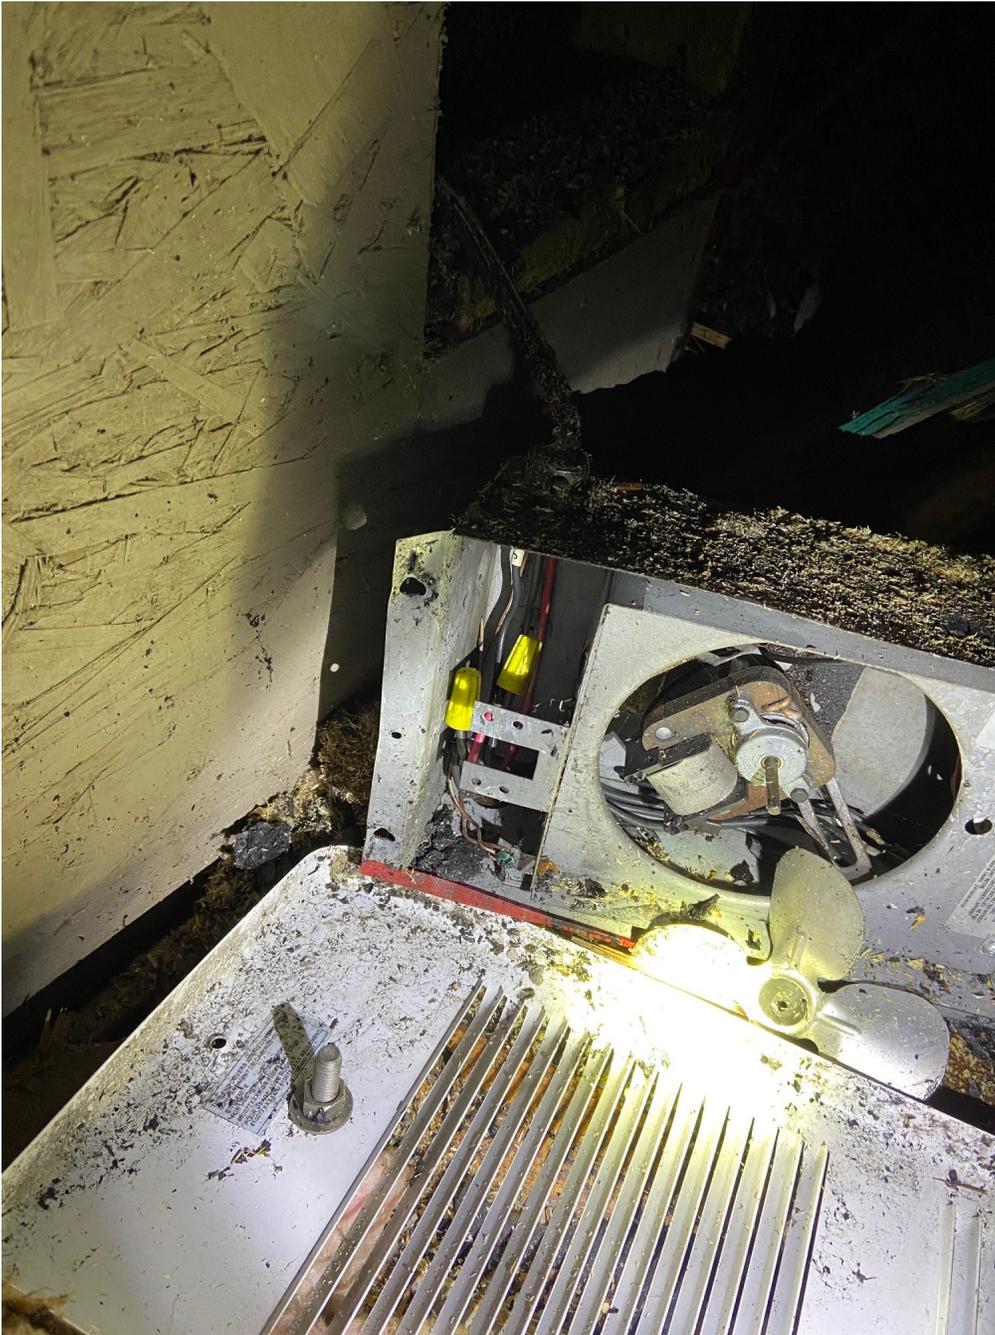
Facts and evidence	<p>The burn pattern indicated the fire started in the vicinity of the heater.</p> <p>The cable feeding the heater was burnt. The cable was the proper size for the application and there was no code violation noted with the feed.</p> <p>The heater was wired for 750watt operation. No deficiencies were noted with the wiring. There was corrosion noted on the heating elements and motor of the heater.</p> <p>When the cover was removed to inspect the internal mechanisms of the heater, the impeller fan fell out of the unit. The impeller had become detached from the motor shaft.</p> <p>The owner had noted that the heater had been acquired used and had been in operation for approximately 3 years.</p>	
	Causes and contributing factors	It is likely that the fire was caused by the heater. The manufactures states that blocking or reducing the air flow through these heaters can result in a fire. It is possible that the impeller became detached from the shaft and stopped circulating air, this would have caused the unit to overheat. The unit is equipped with a thermal

overload, it is unclear whether it was functioning correctly. The unit was used, and there was corrosion noted inside the heater.

Image 1 - Heater with cover removed. Note the impeller is not attached to the motor shaft.

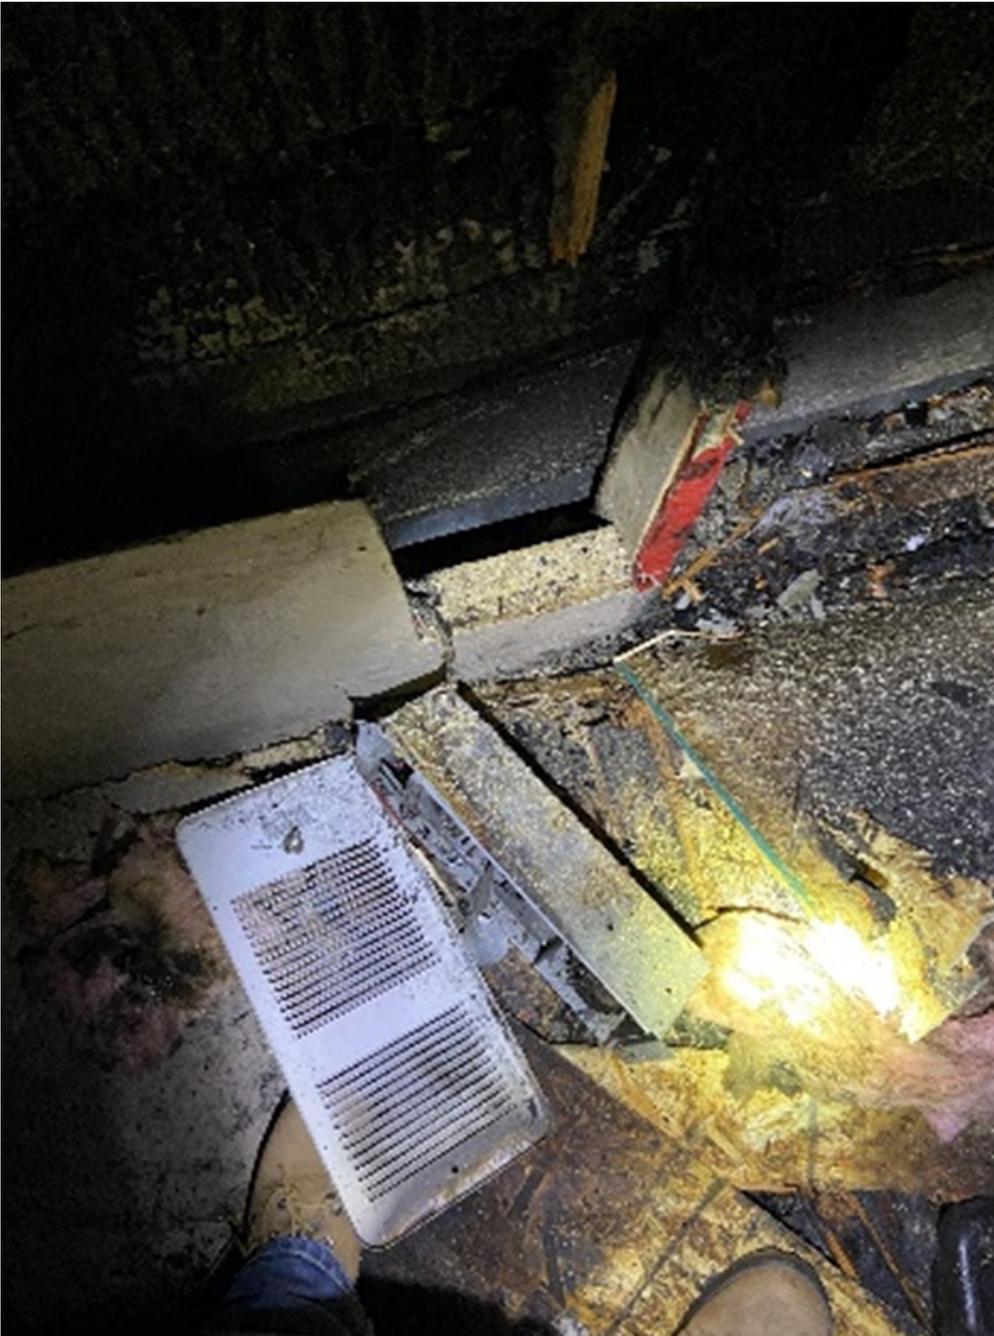
Image 2 - Heater with cover removed.

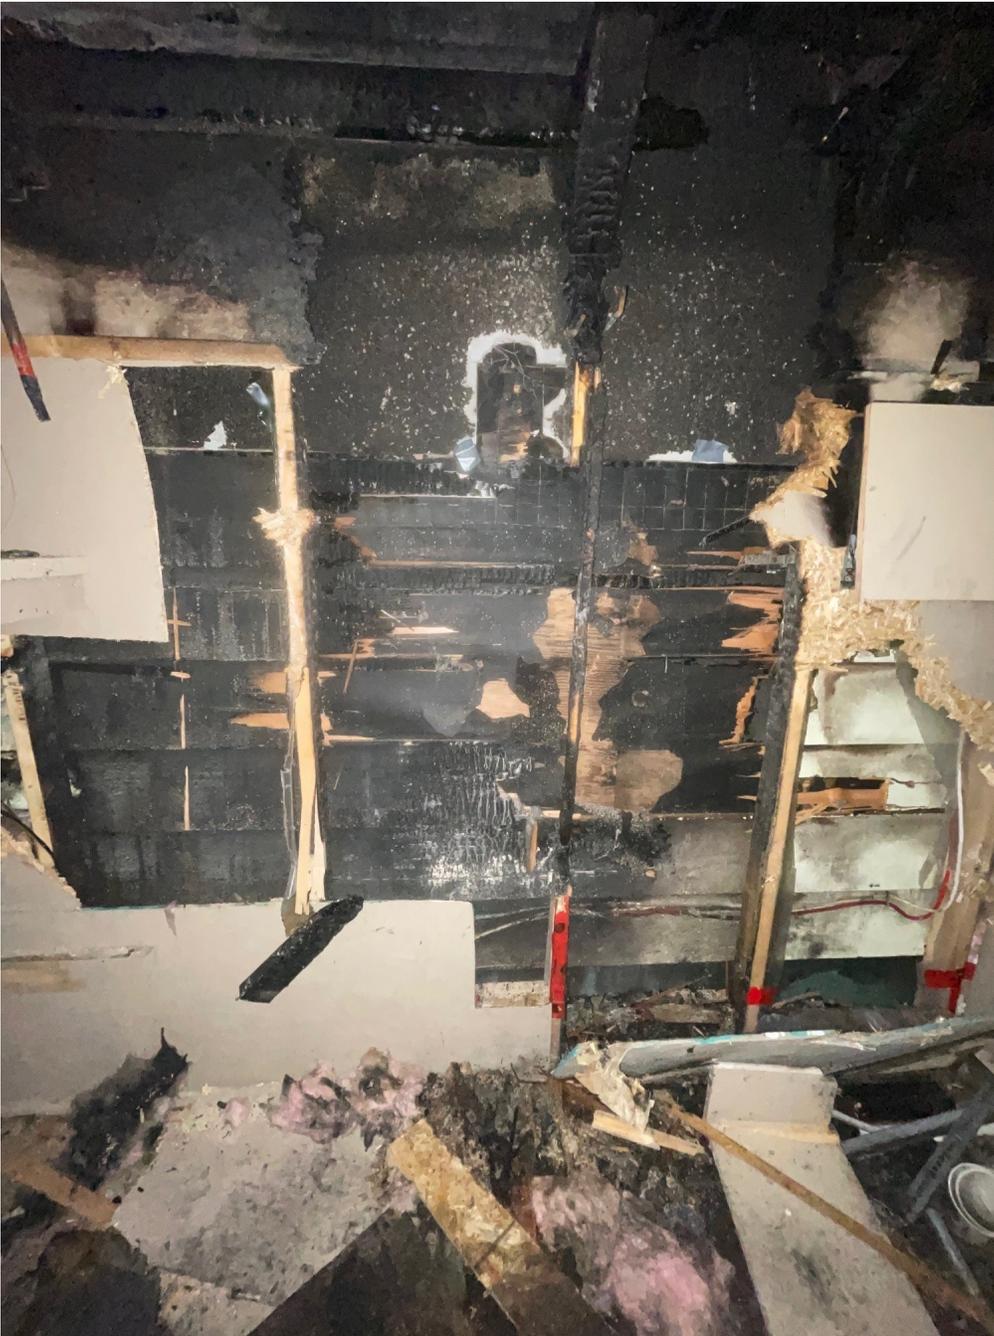
Image 3 - Image showing location where fire started. Note the damage to the center stud where the heater was attached.

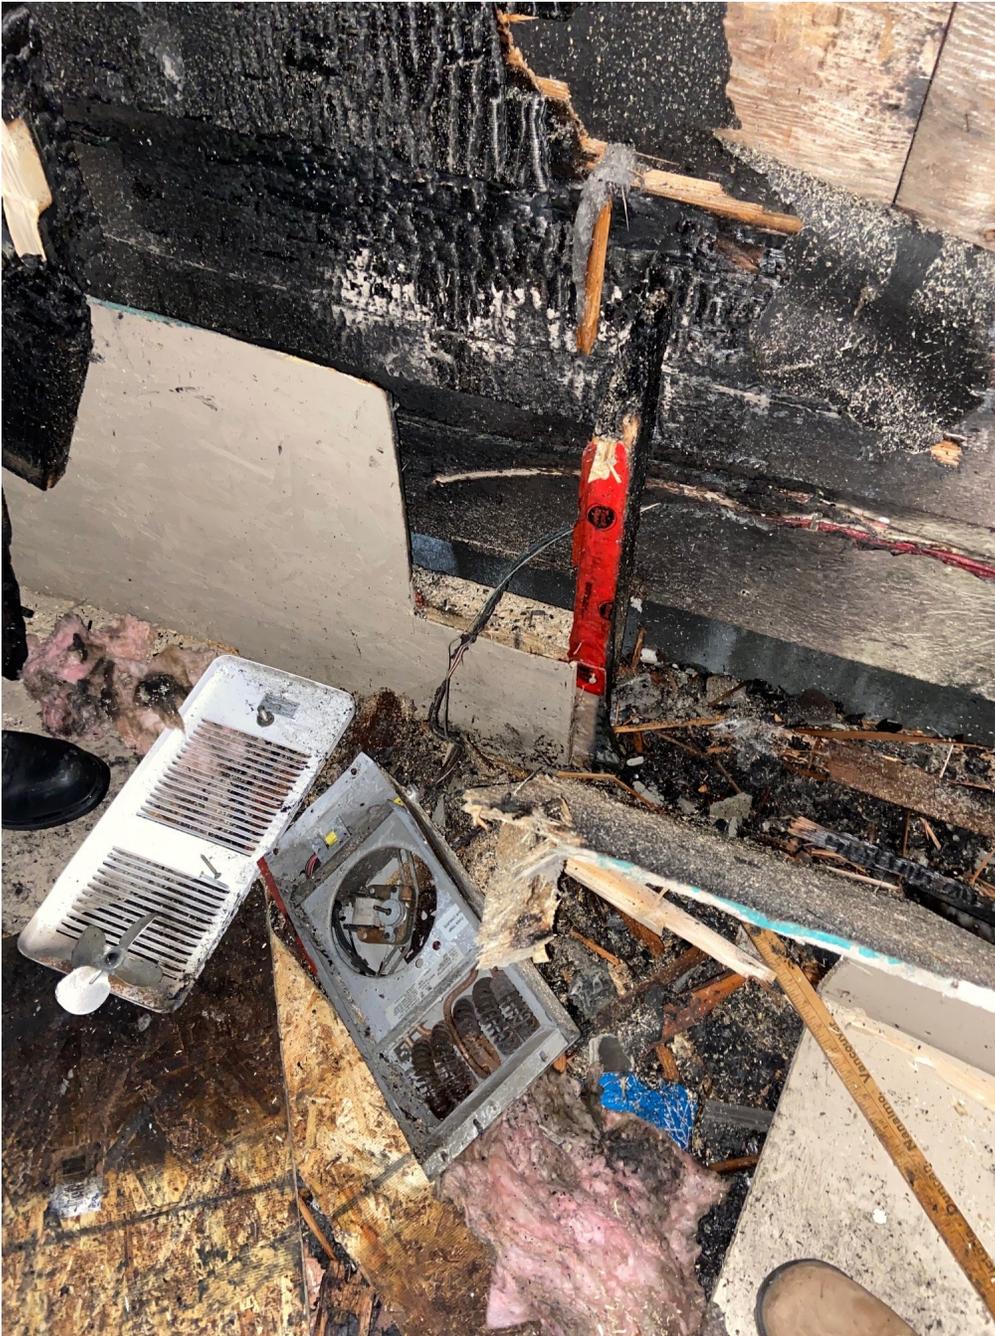
Image 4 - Heater with cover off.
