## Incident Summary #II-1303191-2021 (#25432) (FINAL)

SUPPORTING INFORMATION	Incident Date	December 13, 2021	
	Location	Whistler, British Columbia	
	Regulated industry sector	Electrical - Low voltage electrical system (30V to 750V)	
	Impact	Qty injuries	0
		Injury description	N/A
	Damage	Injury rating	None
		Damage description	Mechanical damage to the main electrical panelboard and the associated circuit breaker installed within the panelboard due to nail punctures.
			Mechanical damage to a feeder cable due to nail puncture.
	Damage rating	Minor	
	Incident rating	Minor	
Incident overview	<p>The main distribution panelboard, which was located within an exterior wall, had been struck and punctured by multiple nails used to fasten wood siding to the exterior of the house. A circuit breaker within the panelboard was damaged by one of those nails.</p> <p>A feeder cable extending from the main distribution panelboard was also discovered to have been damaged by a nail, however this nail had been driven from the interior of the house.</p> <p>The damaged panelboard and feeder cable were both discovered at the same time during unrelated electrical work being carried-out within the house.</

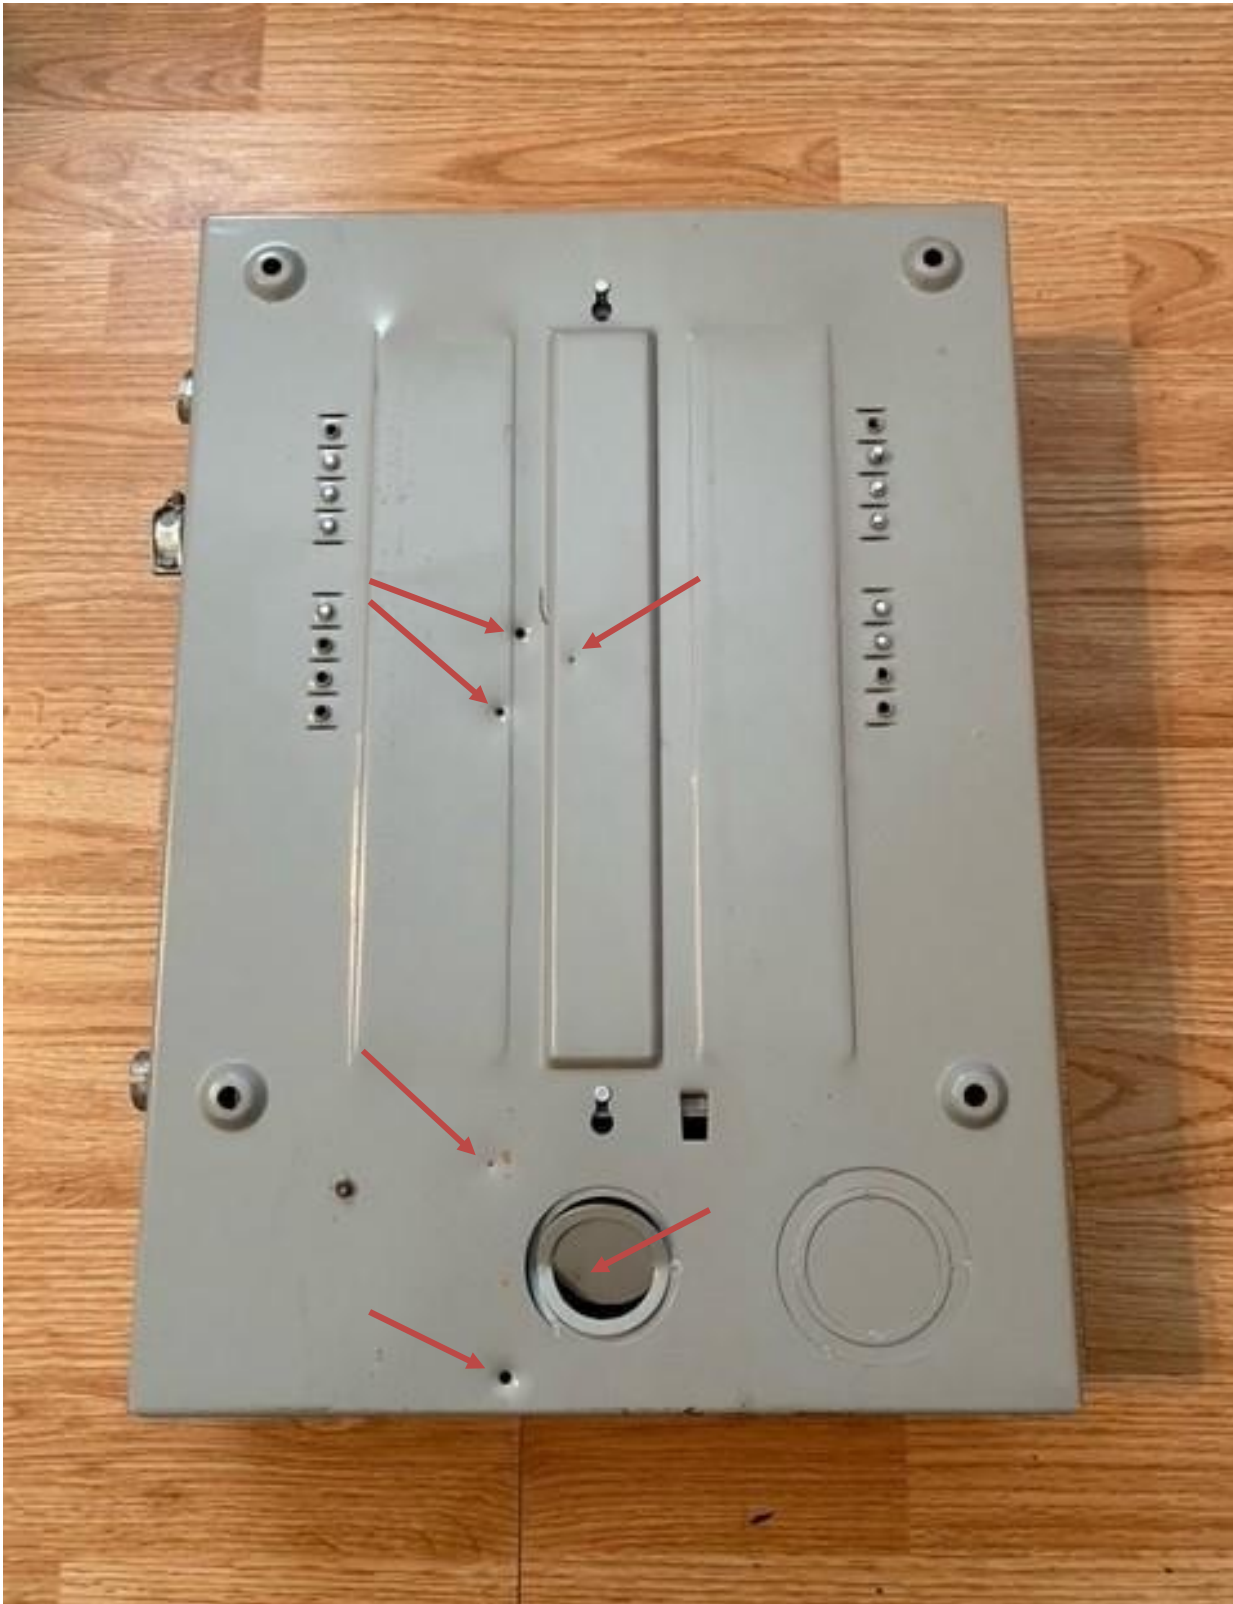
One nail punctured the rear of the panelboard enclosure and struck the backplate, but failed to penetrate the backplate. (See photo #1)

One nail struck an un-used knock-out located at the back of the service compartment, which partially dislodged the knock-out. (See photo #1 and #4)

Two nails appear to have struck the rear of the panelboard but did not penetrate into the enclosure. (See photo #1)

The location of the panelboard in a 2x4 exterior wall, which is not prohibited by the Canadian Electrical Code, resulted in exposure to mechanical damage by the siding nails which were likely driven by a pneumatic nailer.

Photo #1 – Back side of main distribution panelboard enclosure

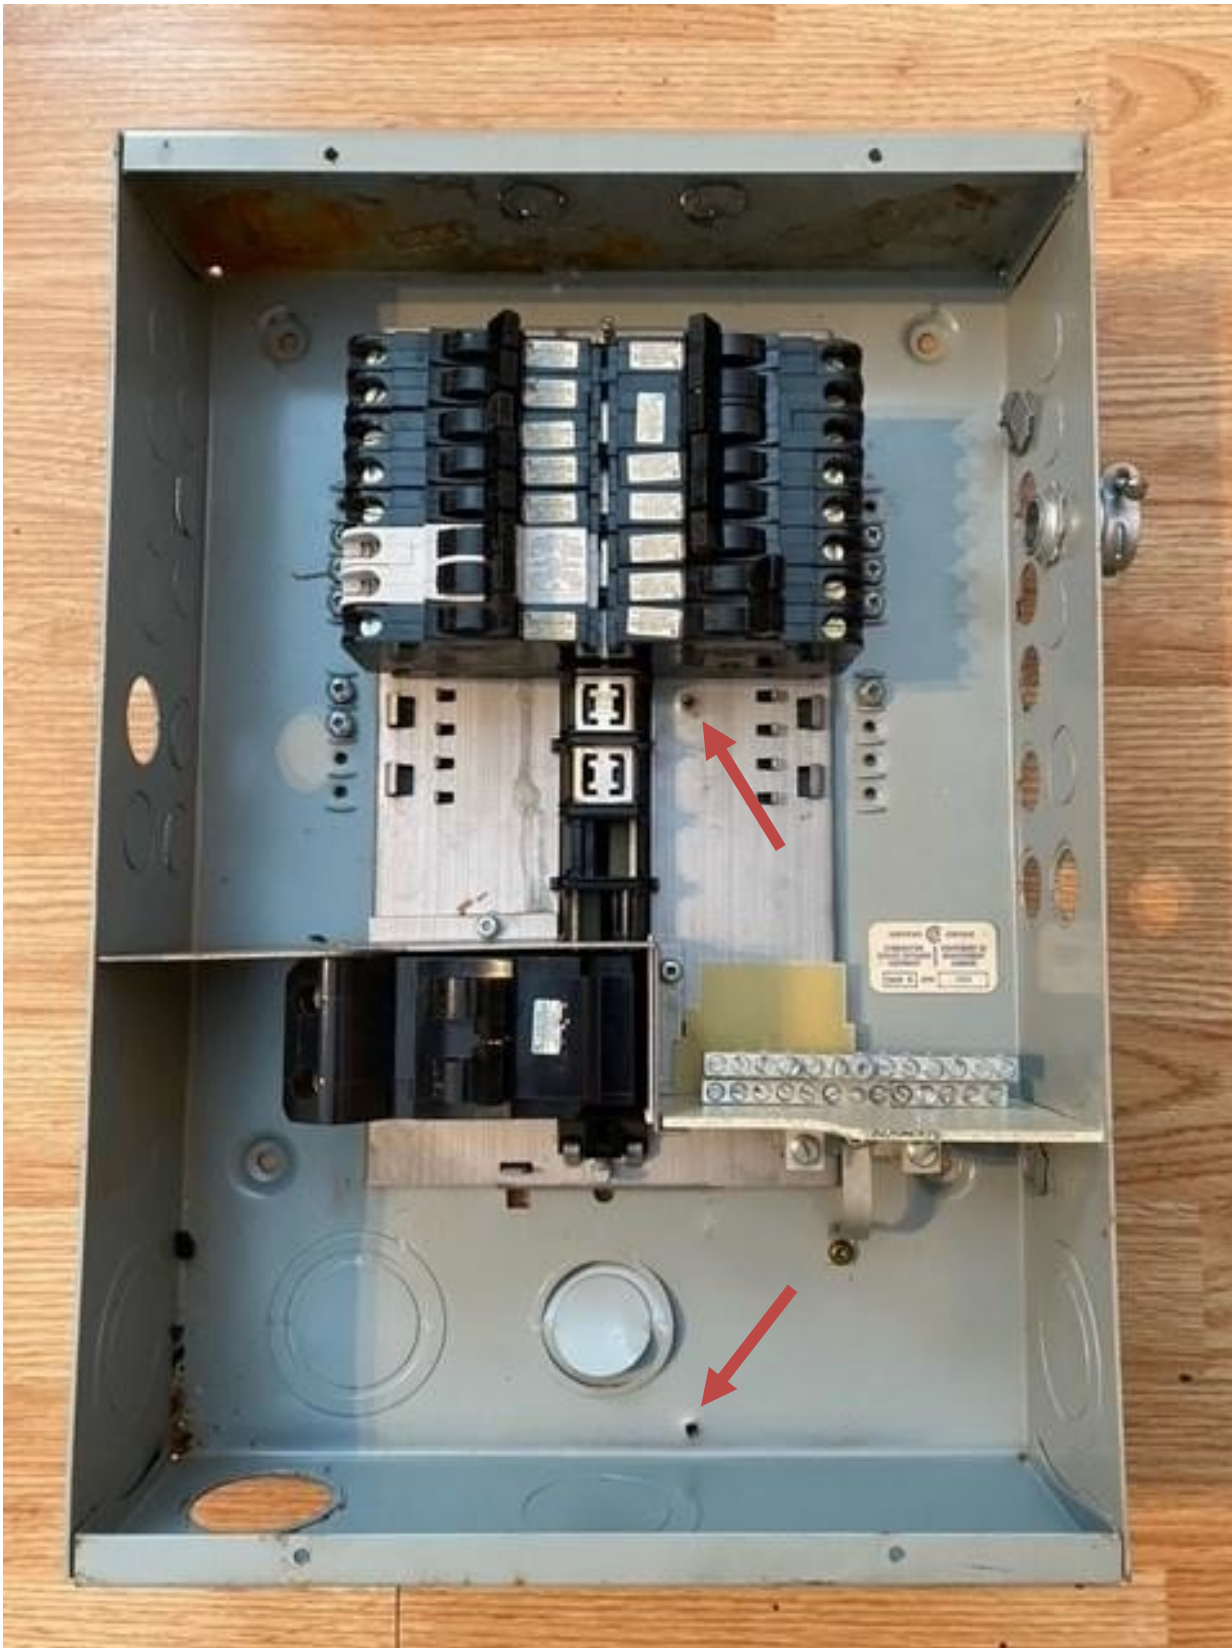
<p>Facts and evidence</p>	<p><b>Panelboard:</b></p> <p>An electrical contractor was hired by a restoration company to replace the main distribution panelboard which had sustained water damage due to a ruptured hot water tank located on the floor above. The electrical contractor discovered the nail damage to the panelboard and feeder cable in the process of carrying out their work.</p> <p>As stated by the on-site electrician: when they removed the mounting screws which secured the panelboard to the studs, they realized that the panelboard was not coming loose. Upon further investigation they noticed that there were several siding nails that had been driven through the exterior sheathing and into the panelboard enclosure, which were now holding the panelboard in place. The electrician was able to pull the panelboard away from the nails and out of the wall. The electrician estimates that the nails were approximately 2" long.</p> <p>Examination of the panelboard yielded the following observations:</p> <p>The panelboard enclosure shows evidence of having been struck by 6 separate siding nails. (See photo #1)</p> <p>One nail penetrated the rear of the panelboard enclosure, as well as the internal metal backplate upon which the circuit breakers are mounted, which then struck and damaged a circuit breaker. (See photo #2 and #3)</p>

One nail penetrated the rear of the panelboard enclosure and entered the service compartment section but did not appear to strike any components located within the compartment. (See photo #2 and #4)

Photo #2 – Interior compartment of main distribution panelboard

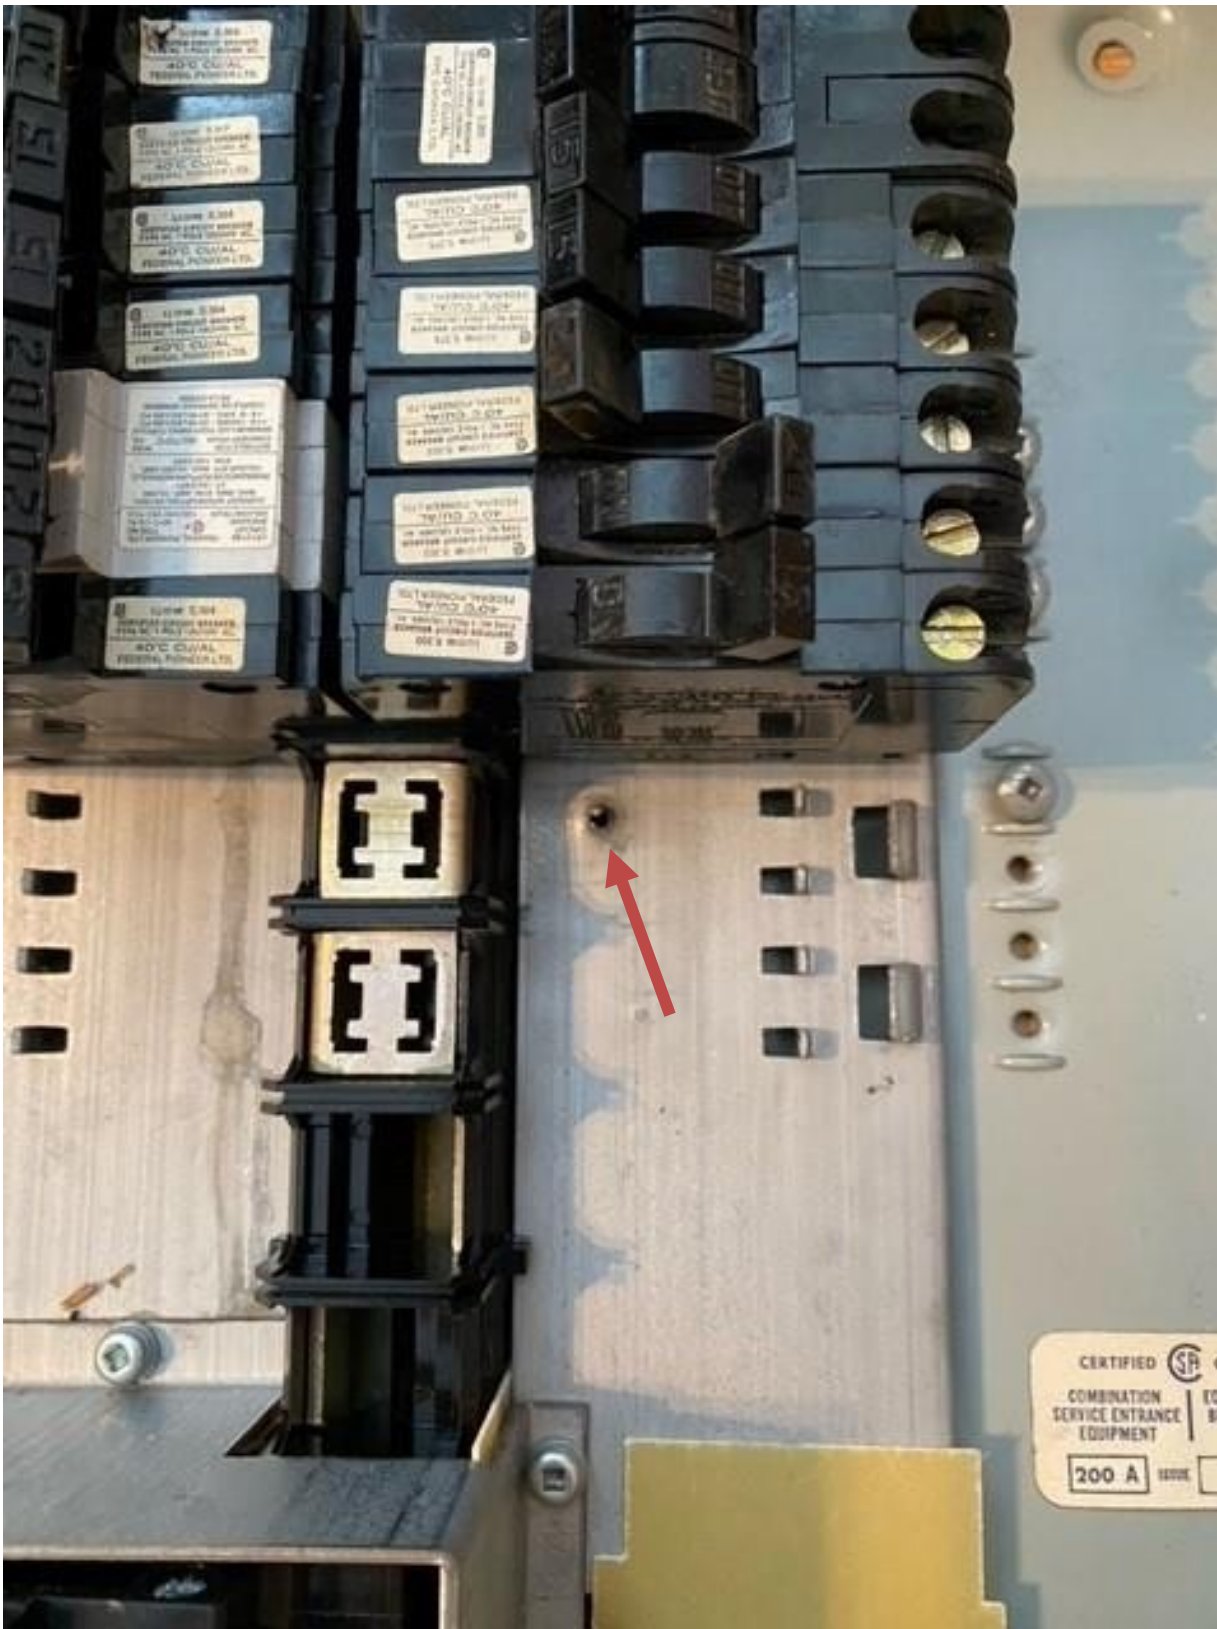
Photo #3 – Close-up of nail hole associated with damaged circuit breaker

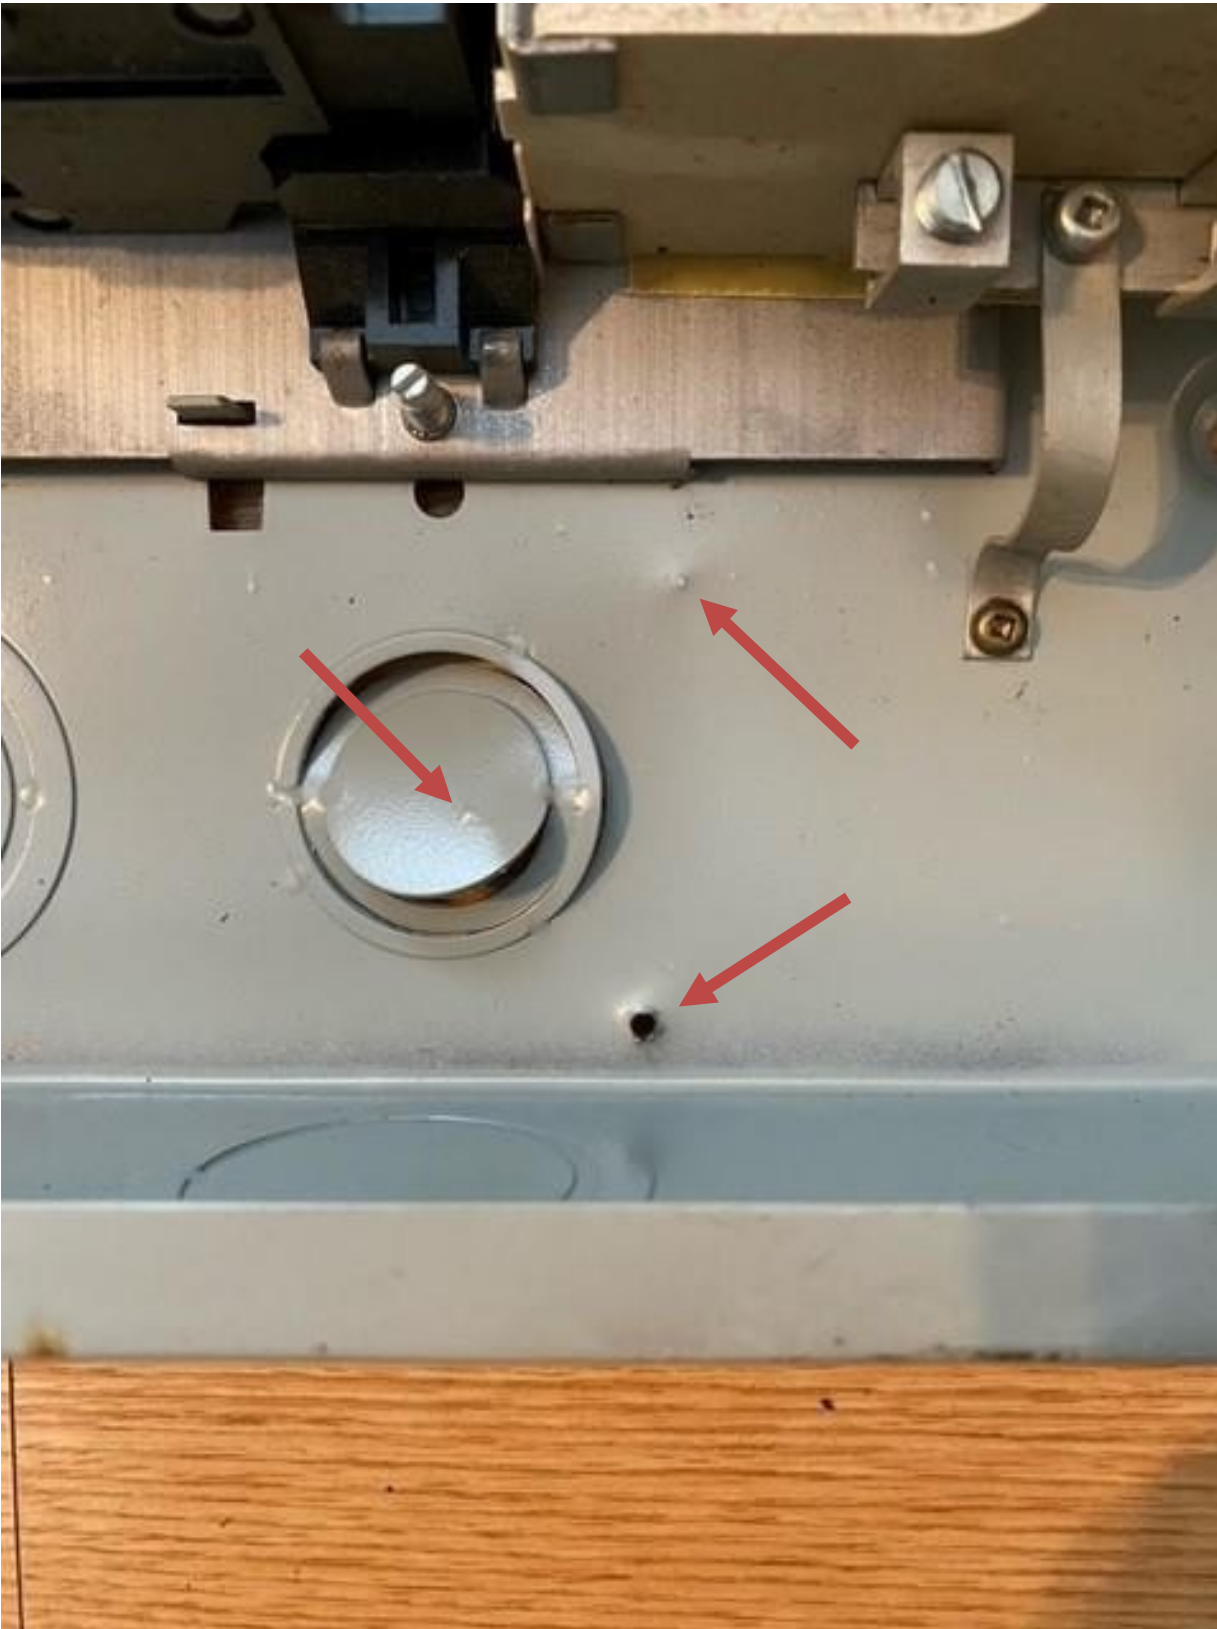
Photo #4 – Close-up of nail hole in the service compartment of the panelboard, indentation cause by second nail strike that did not penetrate the enclosure, and the partially dislodged knock-out caused by the nail strike.

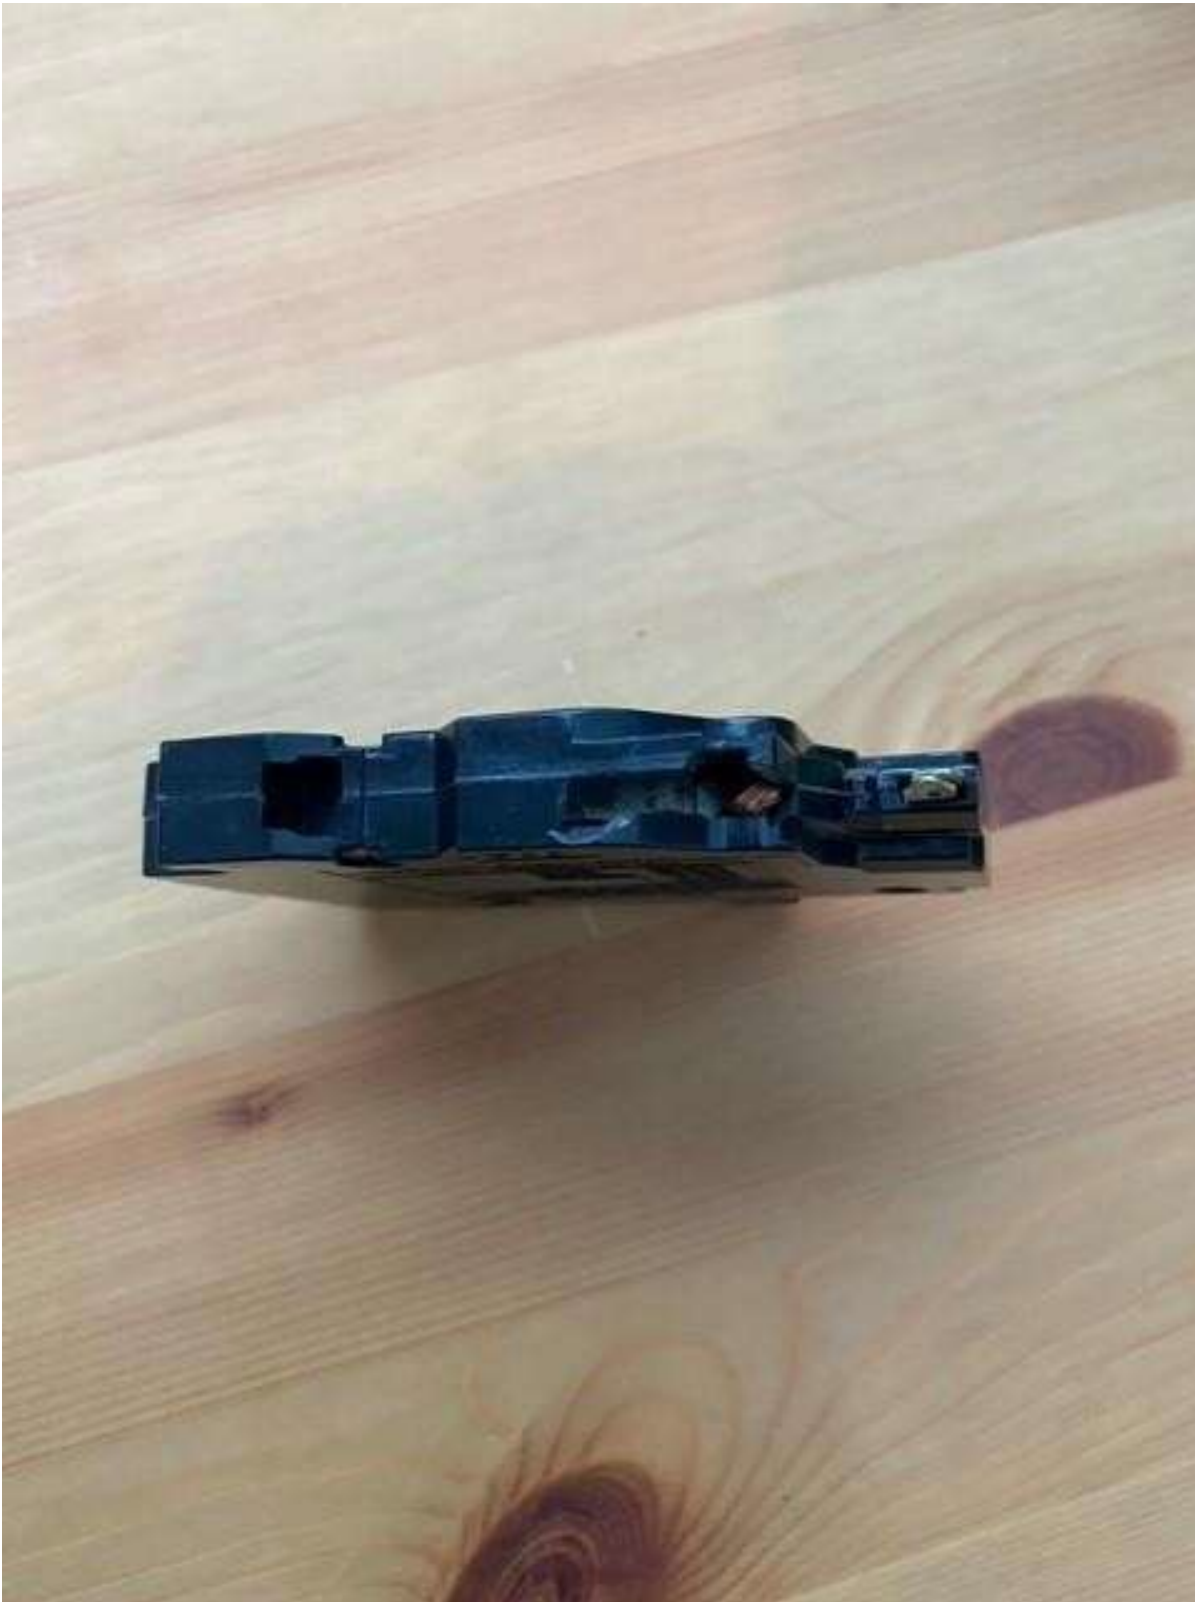
The nail that struck the circuit breaker damaged the outer molded frame of the breaker, which resulted in a penetration exposing the internal breaker components. No internal circuit breaker components appear to have been damaged by the nail, and the damage did not appear to affect the functionality of the circuit breaker. (See photo #5)

Photo #5 – Underside of damaged circuit breaker

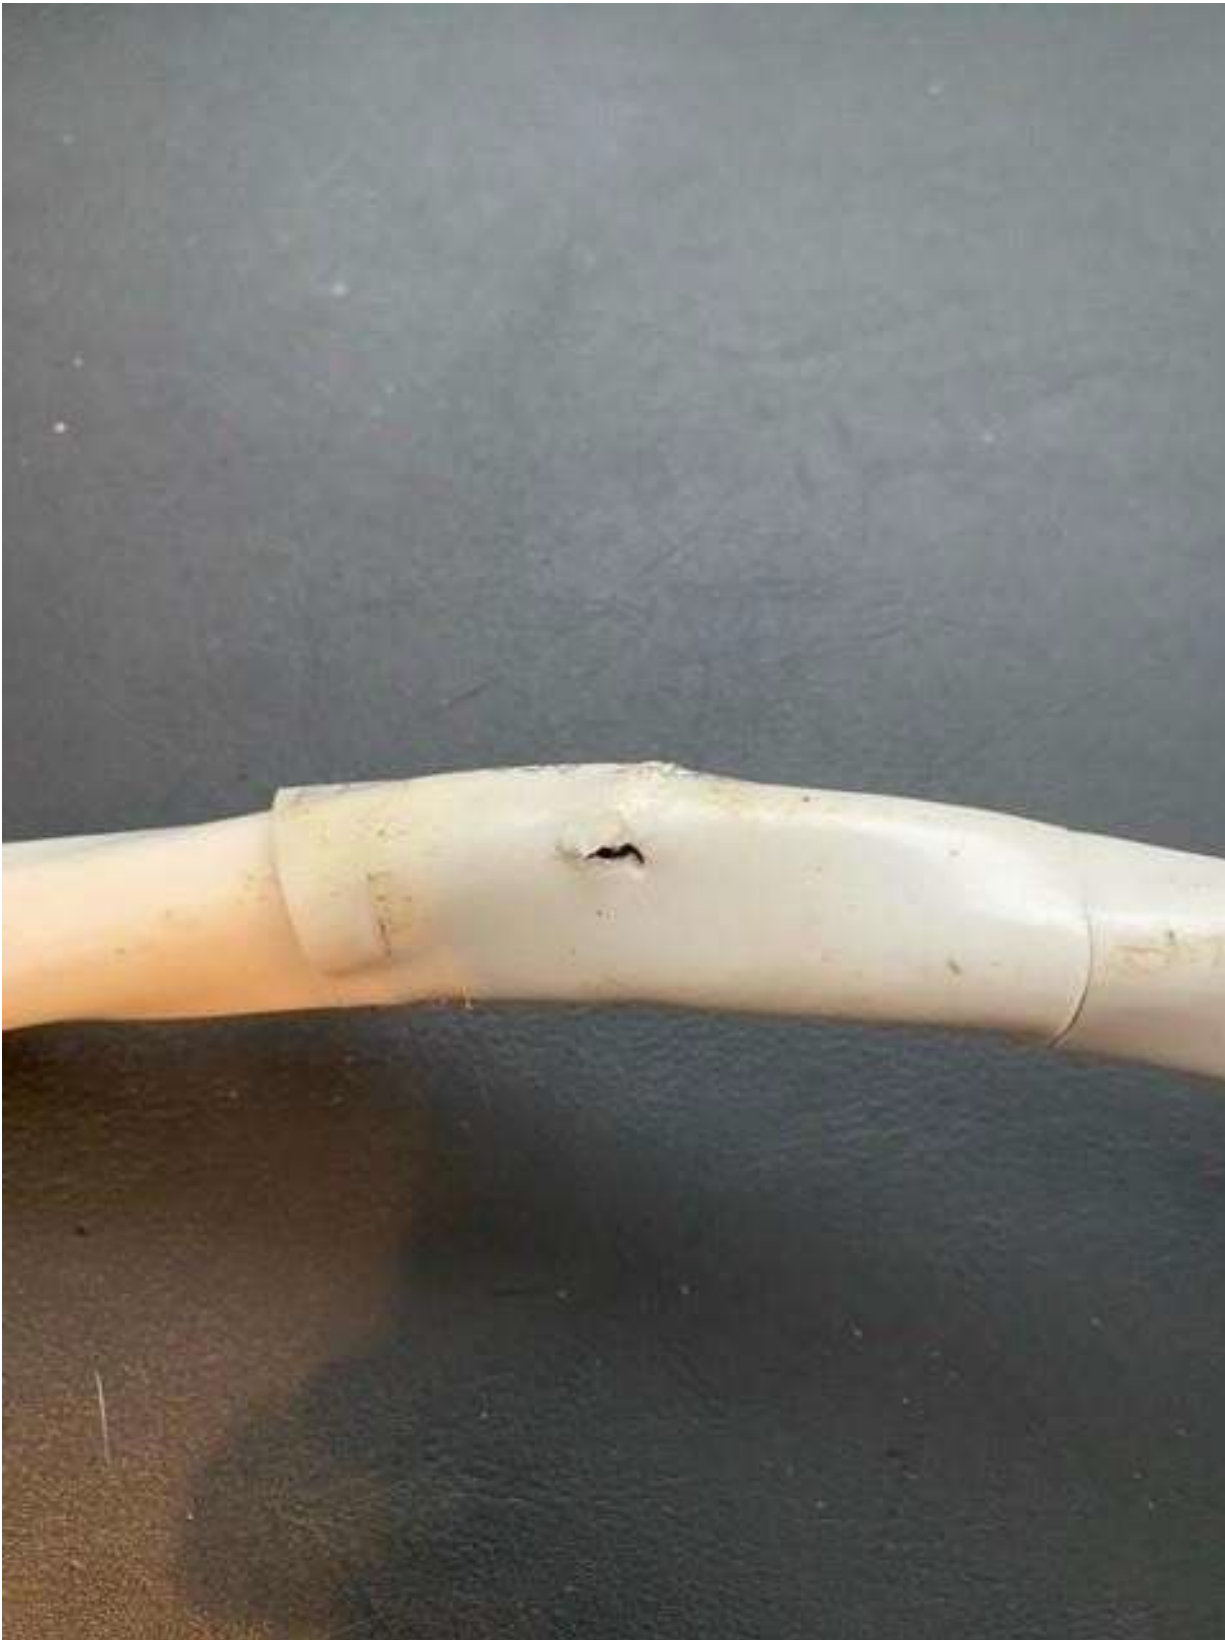
The nail penetrated the cable's outer jacket as well as the insulation of the B phase conductor. The nail appears to have made contact with the B phase copper conductor. (See photo #6 and #7)

Photo #6 – Damage to outer jacket of feeder cable

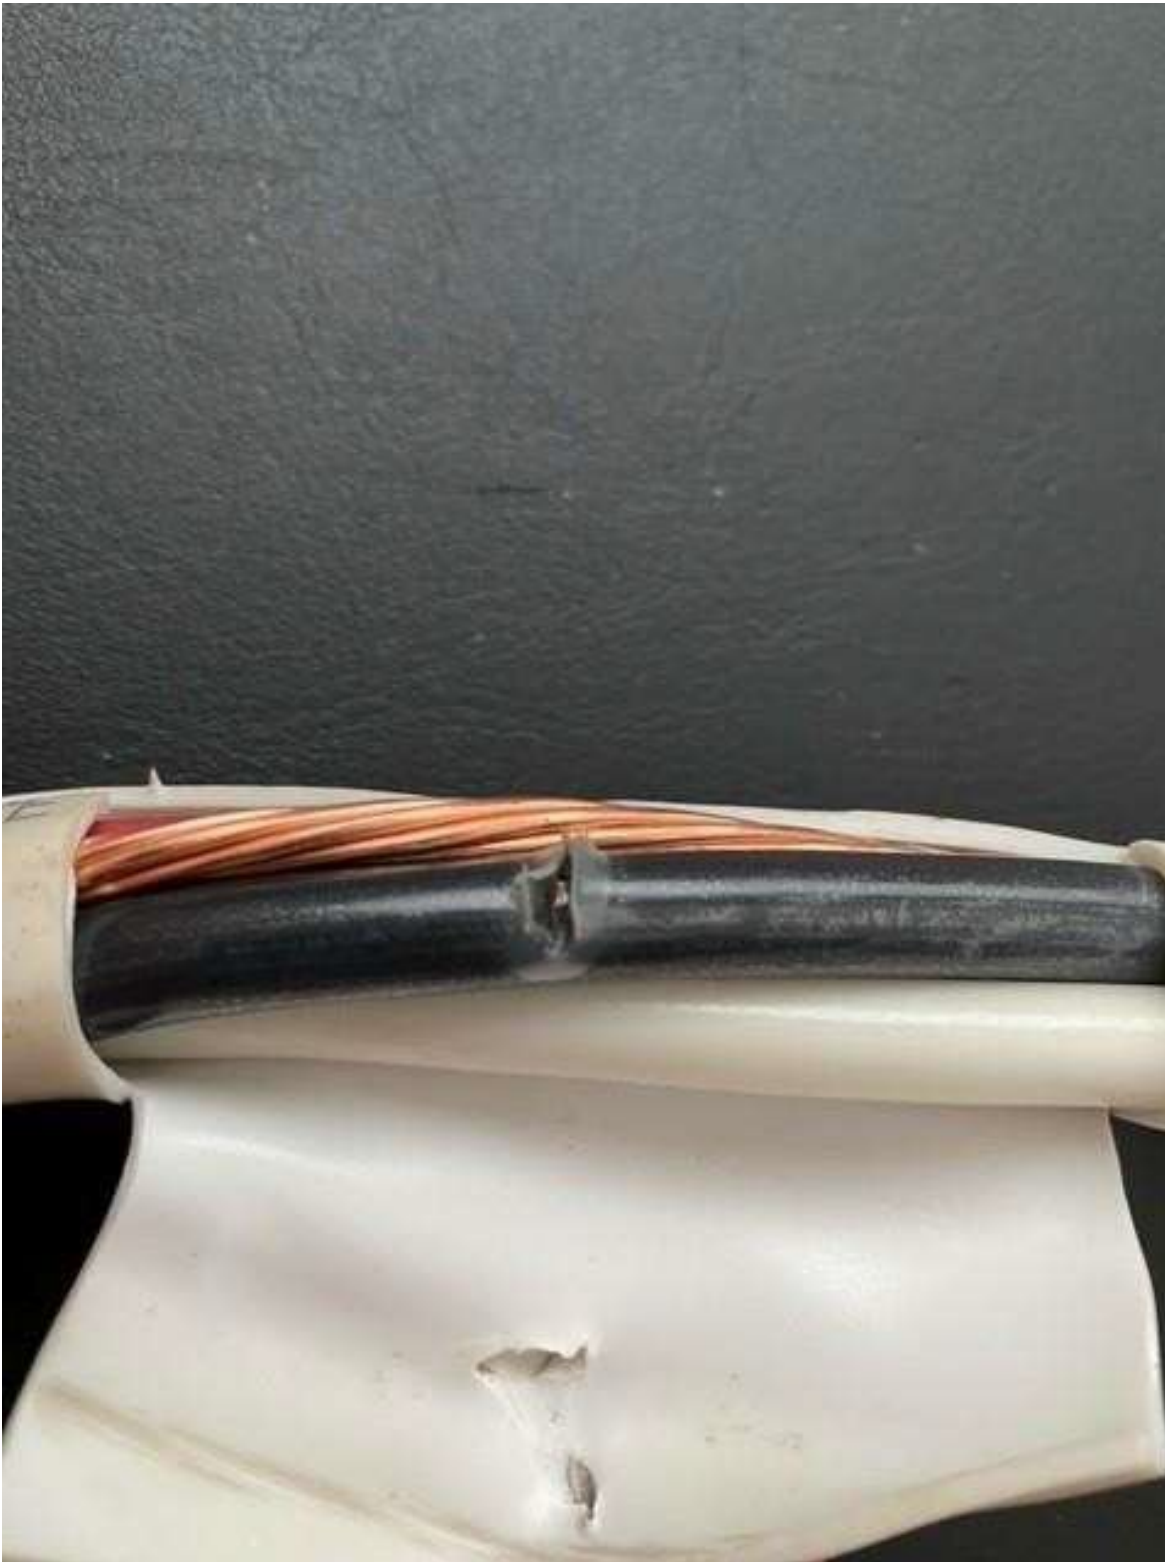
Photo #7 – Damage to conductor insulation of feeder cable.

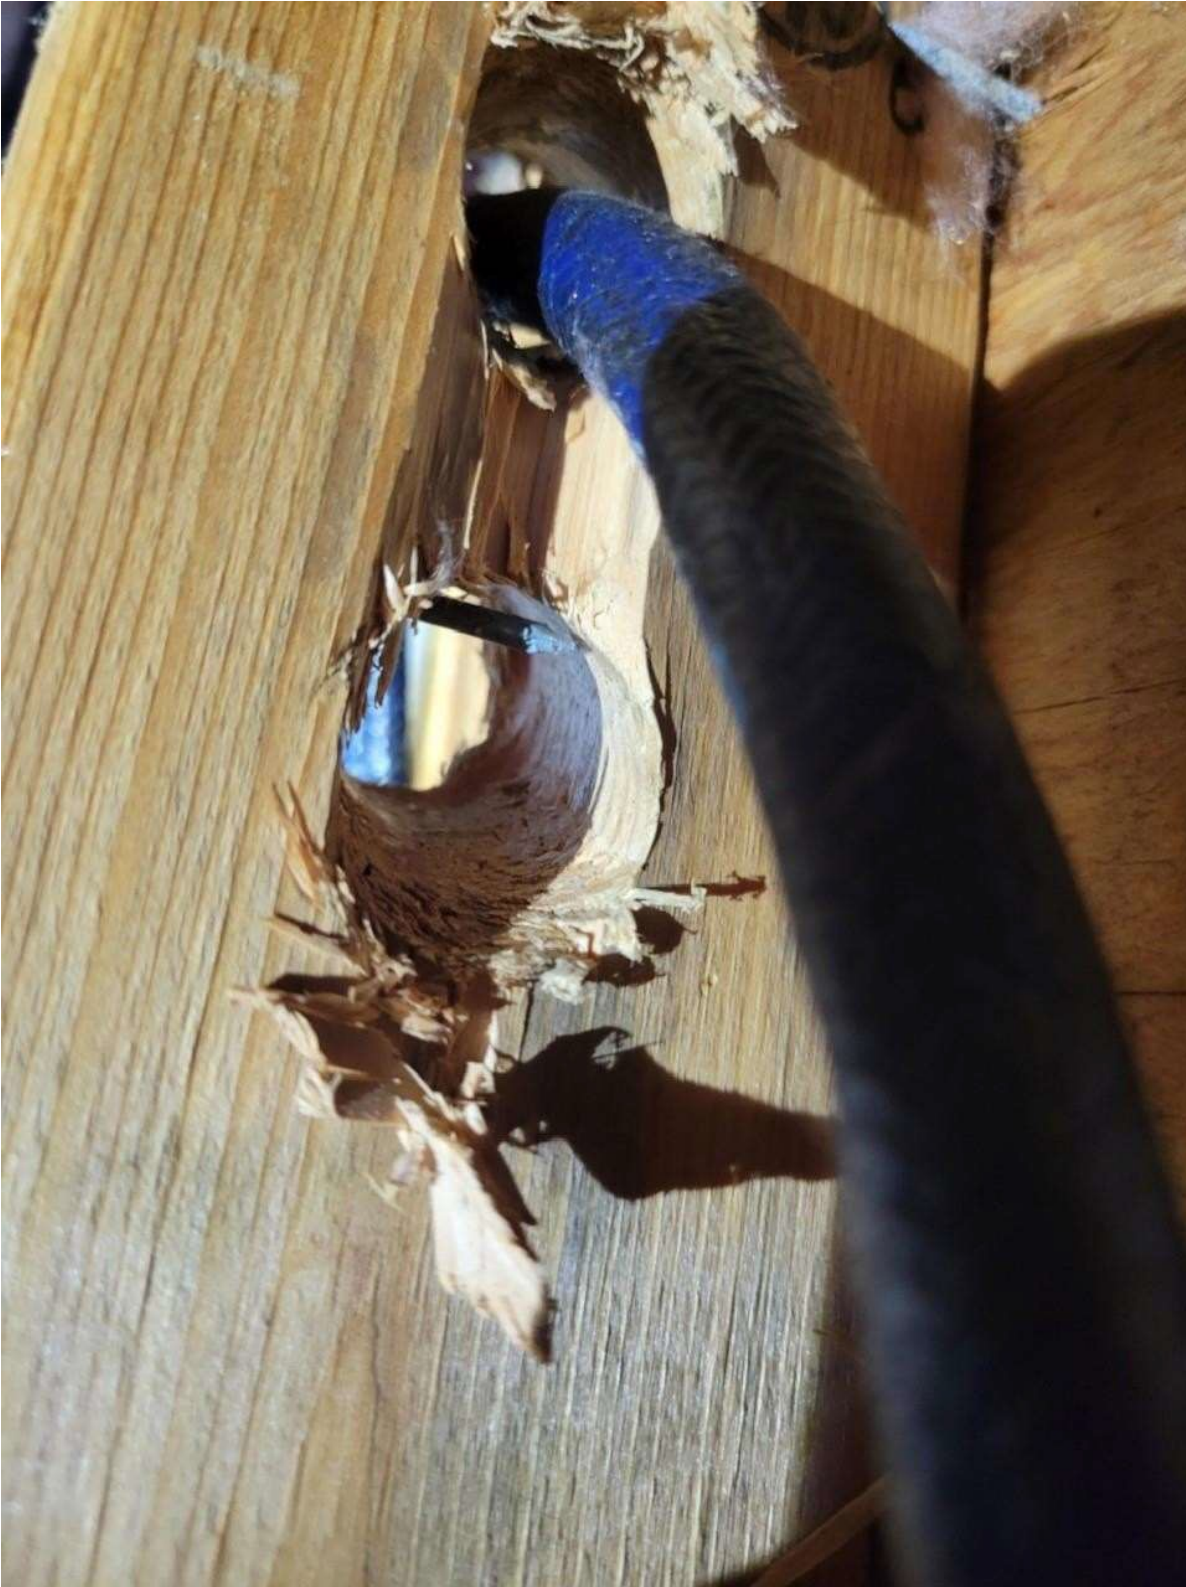
The on-site electrician stated that the damaged feeder cable had been struck by a nail driven from inside the house and into one of the studs through which the cable had been routed. The nail was observed to be projecting into the hole through which the feeder cable had been ran. (See photo #8)

Due to the length of the nail driven from inside the house, it reached far enough into the stud to strike and damage the feeder cable, which was run through the middle of the stud.

Photo #8 – Hole in 2x4 stud showing the nail that caused the damage to the feeder cable.
