Incident Summary #II-1447197-2022 (#30043) (FINAL)

SUPPORTING INFORMATION	Incident Date	October 3, 2022	
	Location	New Westminster	
	Regulated industry sector	Elevating devices - Elevator	
	Impact	Qty injuries	0
		Injury description	None
		Injury rating	None
	Damage	Damage description	Burn damage to the elevator braking resistor bank, wires, toggle switches, and metal enclosure. Extended downtime for one of the two elevators.
		Damage rating	Moderate
	Incident rating	Moderate	
Incident overview	An elevator braking resistor bank overheated when exposed to continuous power related to a motor control drive transistor failure.		
INVESTIGATION CONCLUSIONS	Site, system and components	<p>The site is a 14-floor high rise apartment building with two separate passenger elevators of the electric traction type. The elevator power equipment, motors, drives, and resistor banks are located in the upper floor elevator machine room. Each elevator motor has a controller cabinet (Image 1) which houses a variable frequency drive (VFD) and the braking resistor components.</p> <p>The VFD takes the 480-volt alternating current (AC) power supply and inverts it to roughly 680-volts direct current (DC) wit

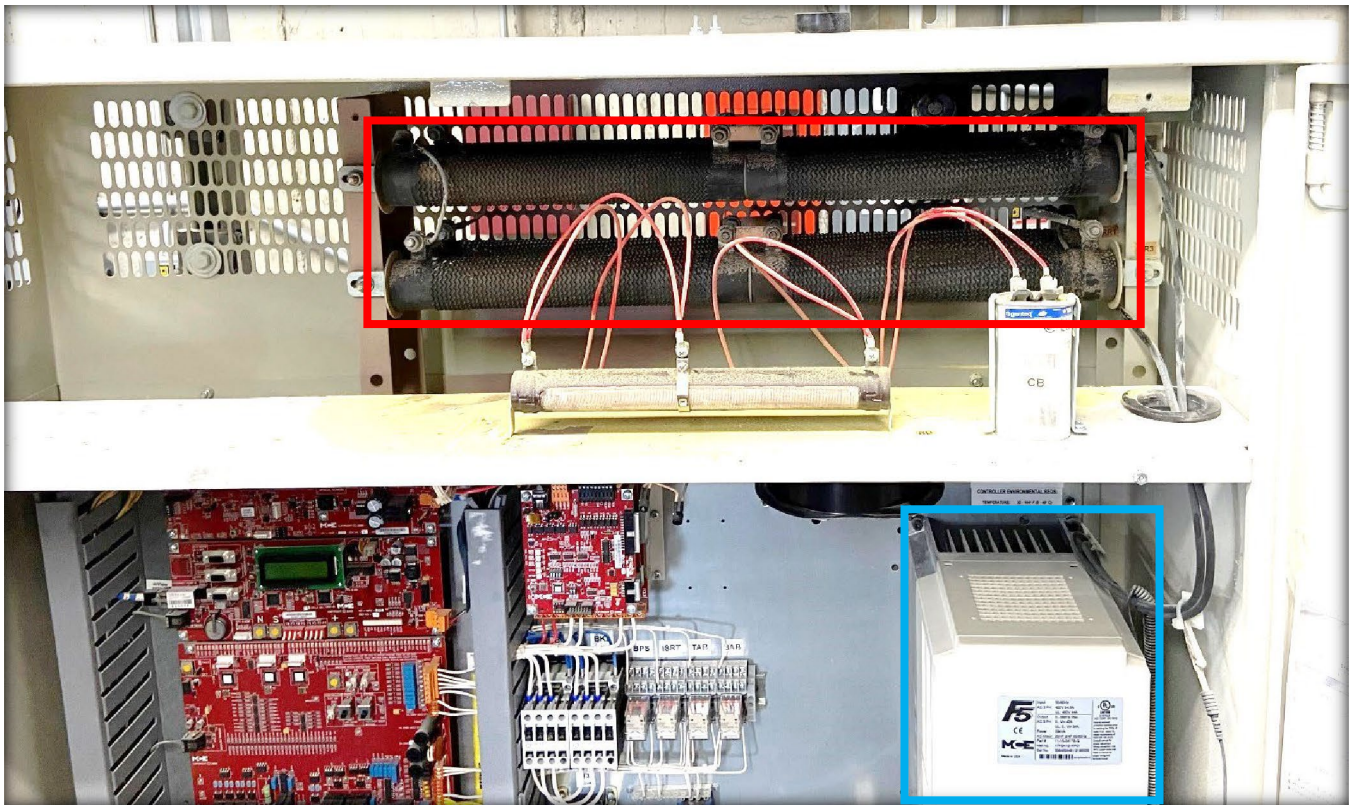
<p>Facts and evidence</p>	<p>TSBC investigator site findings</p> <ul style="list-style-type: none"> • Elevator controller #1 had fire damage to the resistors, controller cabinet paint, rubber isolation pads, capacitor, wires, and toggle switches. • Based on the specifics of the part number, the VFD was not issued with a monitoring circuit for the braking resistors (Image 2). • The heat sink and fan for the braking transistor were in place (Image 11 & Image 12). There was no evidence that they were not operating effectively to cool the transistor. <p>VFD testing by independent contractor (Refer to Appendix A for full report)</p> <ul style="list-style-type: none"> • Testing was performed on site on the unpowered VFD with a digital multimeter in the diode setting. • The testing used a process outlined to ensure the function of the transistors in the manufacturer's installation manual. • Resistance levels of the braking transistor were outside the ranges specified in the manual. This indicated the transistor had experienced a failure (Image 8). • The transistors that control the motor had resistance levels within the ranges specified in the manual. <p>Drive manufacturer statements</p> <ul style="list-style-type: none"> • The source of the resistor bank overheating was identified as a faulty brake transistor manufactured by IXYS Corporation with part number VUB120-16NOX. • After the drive manufacturer performed internal quality analysis and external third-party review of the damaged modules, it was concluded that the individual IGBT cells which make up the IGBT chip were breaking down. <ul style="list-style-type: none"> - X-ray review of new units displayed microscopic air pockets in some units, resulting in inadequate heat transfer and thereby failure of the cell. - When cells begin to fail this creates an avalanche affect and eventually burns a hole in the IGBT chip creating a short. - The failures typically occurred within one to two years of the drive production date, which is generally six months to a year from commissioning of the elevator. • In response to the analysis, new "G" housing frame drives in production were redesigned and thereafter built with brake transistor and power modules from another manufacturer.

Image 3 – Elevator controller including fire damaged resistor bank (Red rectangle), VFD (blue square).

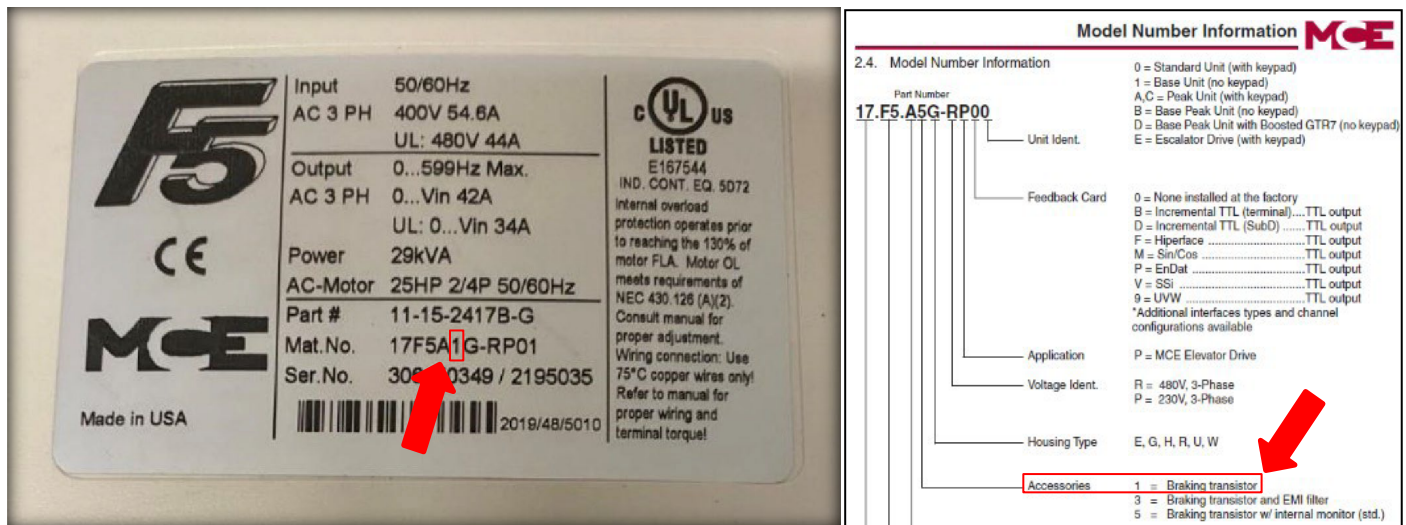
Image 4 – VFD label with braking transistor only indicated in part number, no internal monitor.

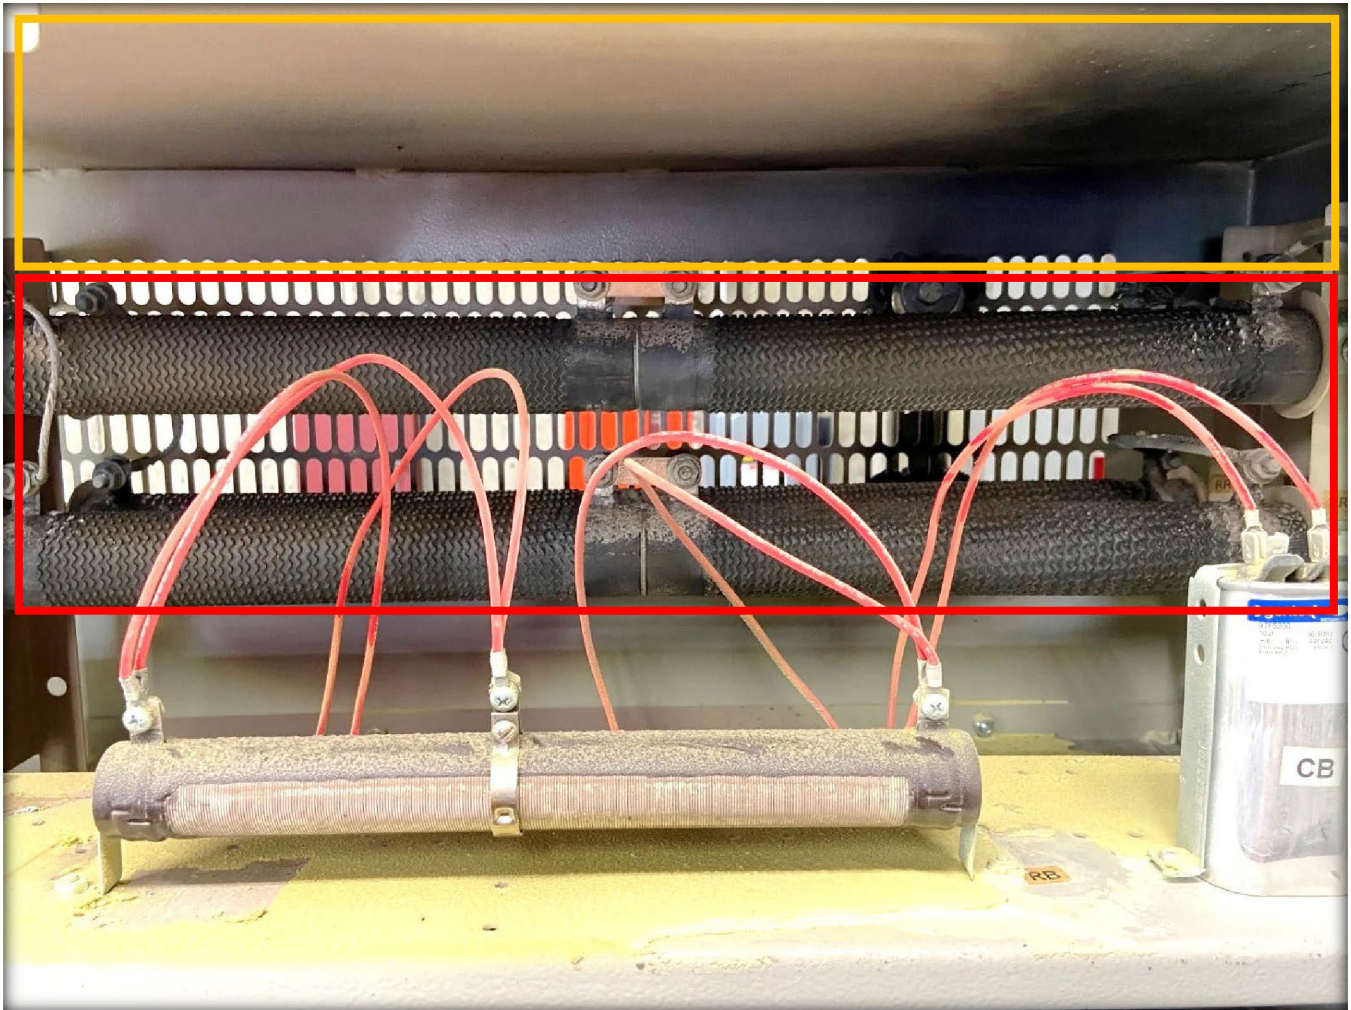
The cause of the incident was the transistor failing internally, during normal operating conditions, allowing continuous current to overheat the braking resistor bank until the fire occurred.

Image 5 – Resistor bank (red), fire damage (orange), yellow dry chemical fire extinguishing substance.

The incident most likely would have been prevented if a thermal monitoring circuit was installed and operating for the elevator controller.

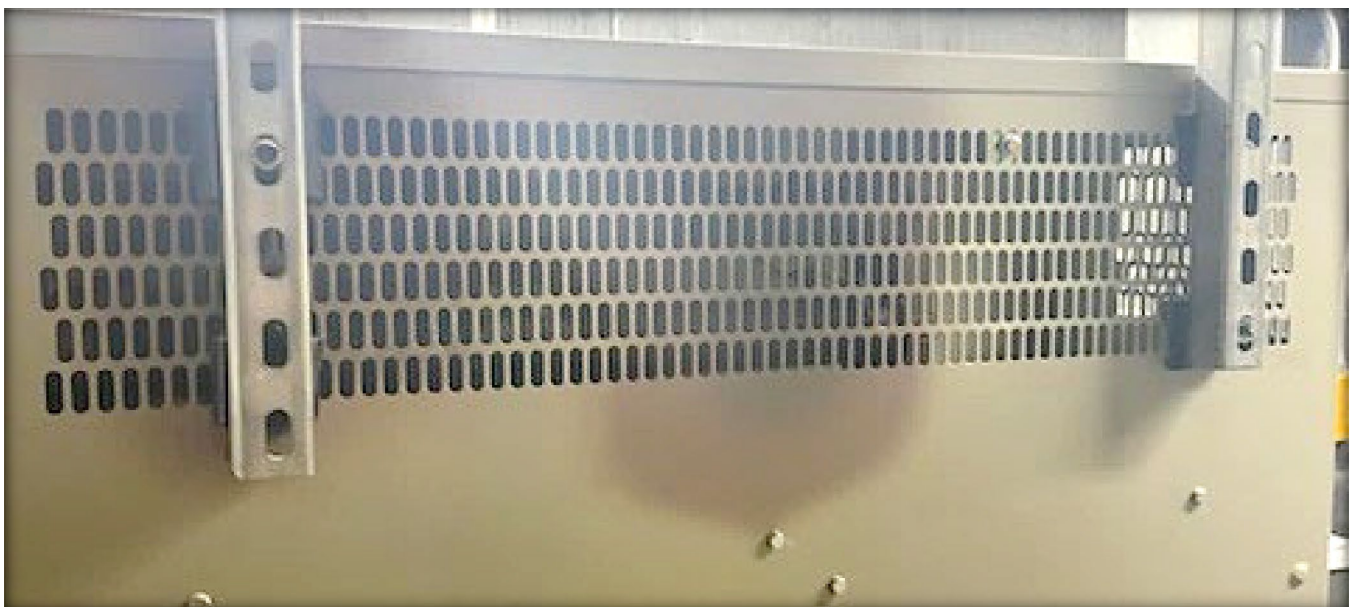
Image 6 – Heat damage to the back of the elevator controller cabinet.

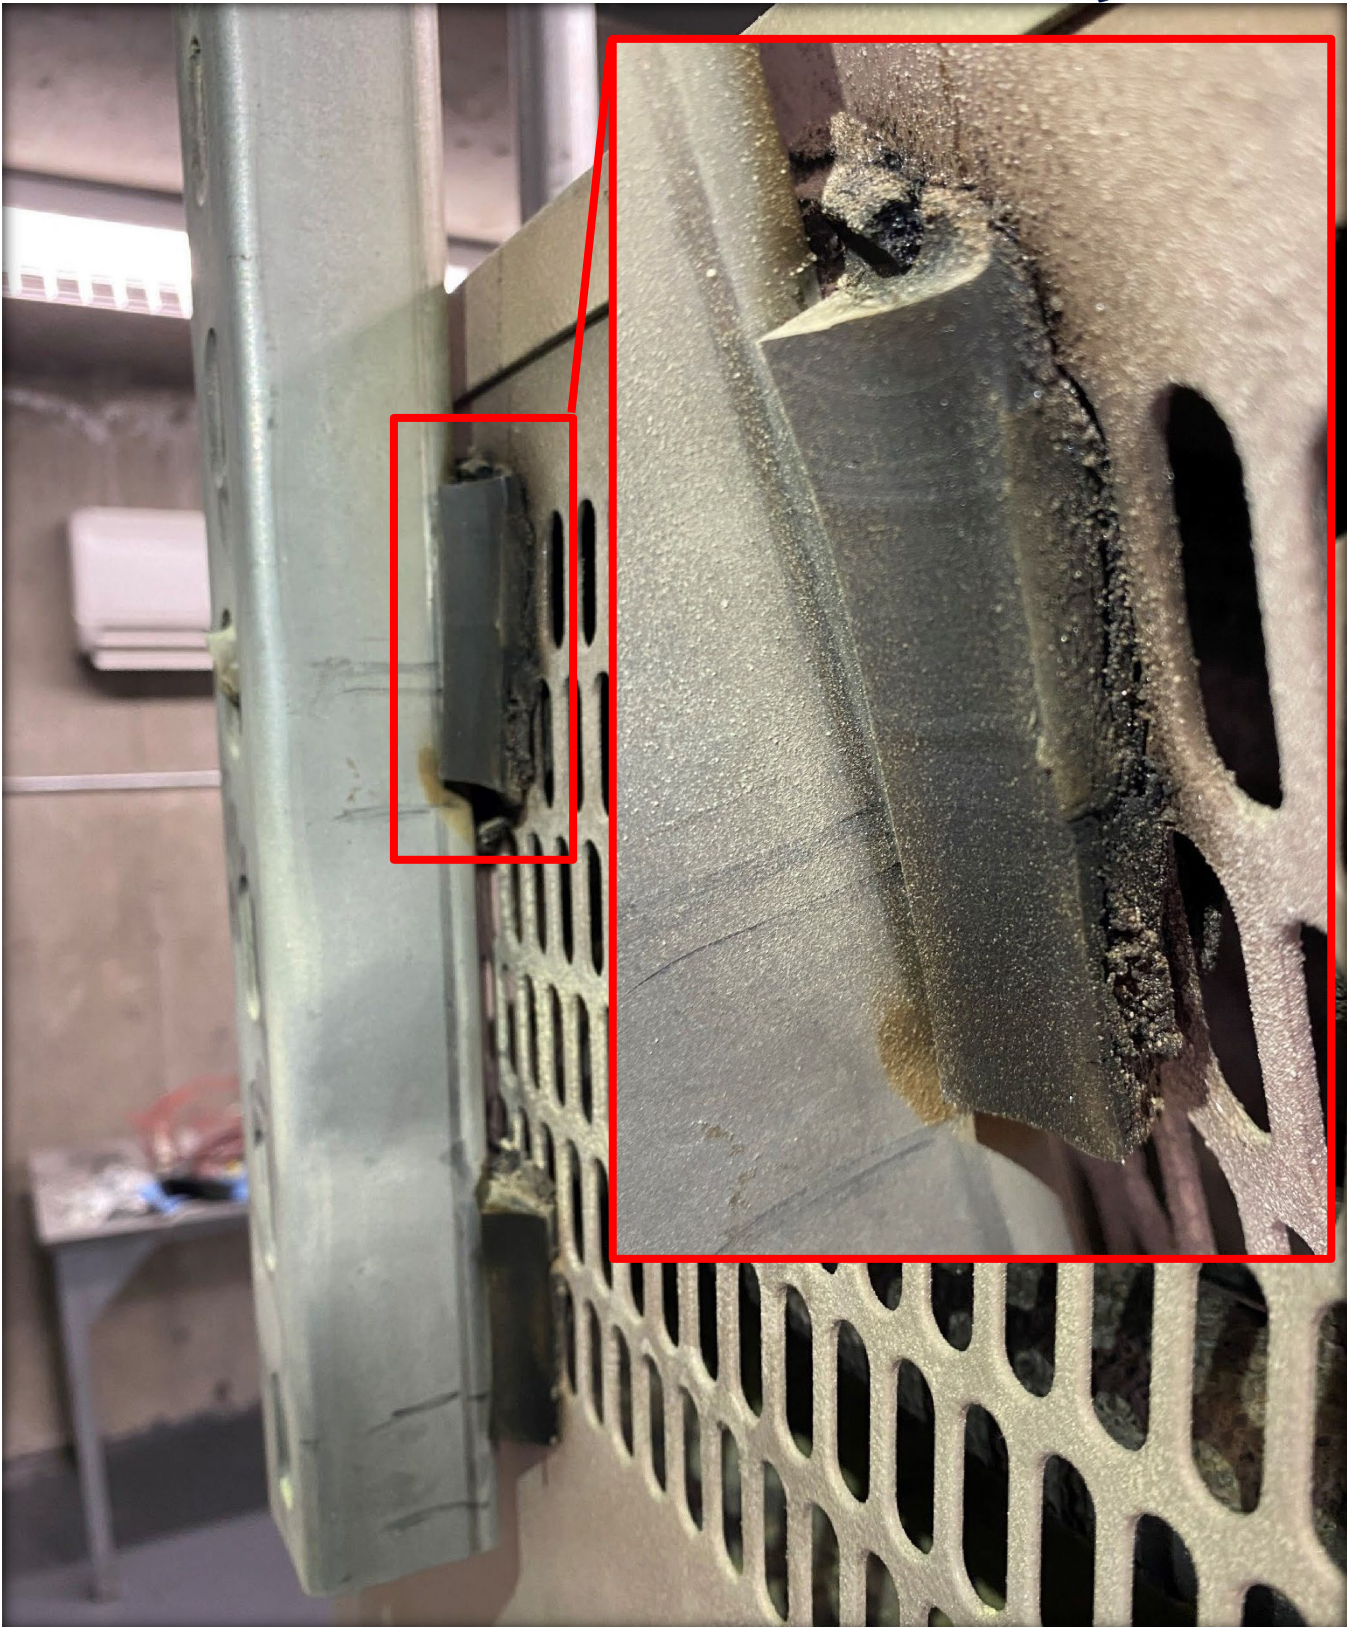
Image 7 – Heat damage to rubber insulators on back of elevator cabinet with close-up of insulator.

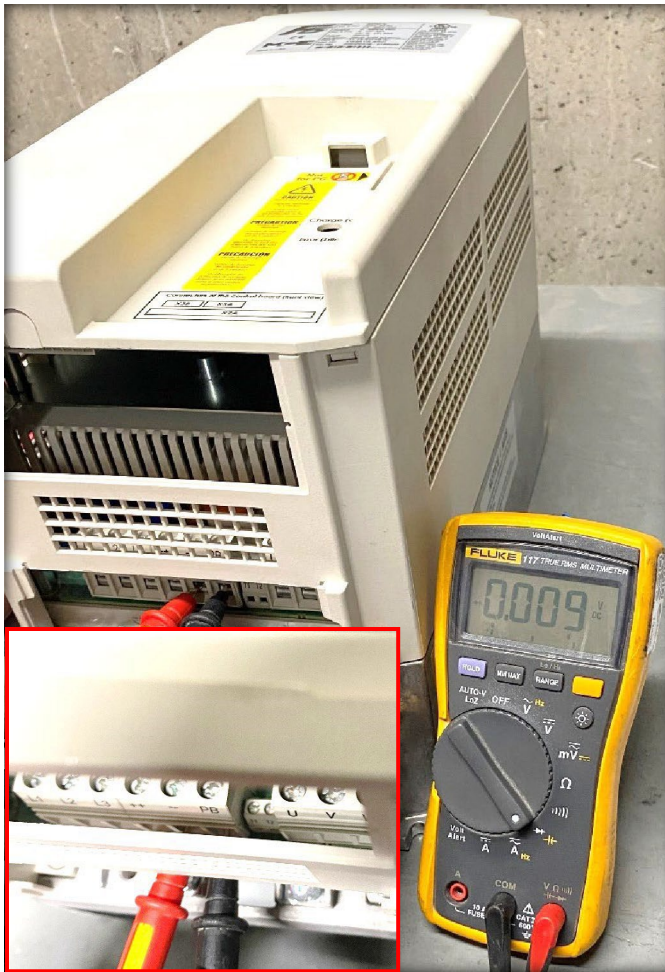
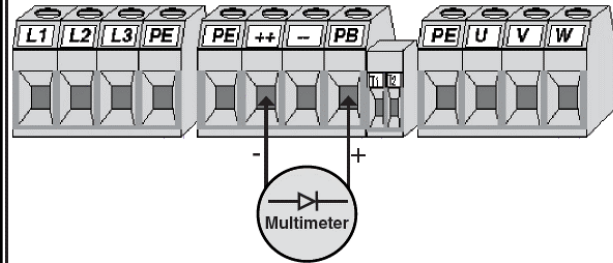
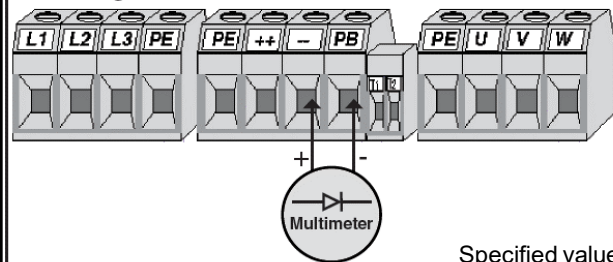
- An IGBT can fail in two ways, open or close. If the IGBT opens, the drive will fault on an over potential fault but no further harm than a shutdown until the drive is replaced or repaired.
- However, in the scope of this failure, the IGBT failed to a closed state, which created a continuous current path from the line voltage to the DC bus and then to the DBRs. There is no mechanical way to remedy this condition other than physically disconnecting the power source to the drive or until a component finally fails to an open state (e.g., wire melts creating a break in the circuit).

Image 8 – Testing results out of range from the “G” housing specification of 1.5 VDC at **-0.008 to -0.009 VDC**. The measurement taken from the negative terminal to the PB terminal for the braking circuit indicates the braking transistor had failed.

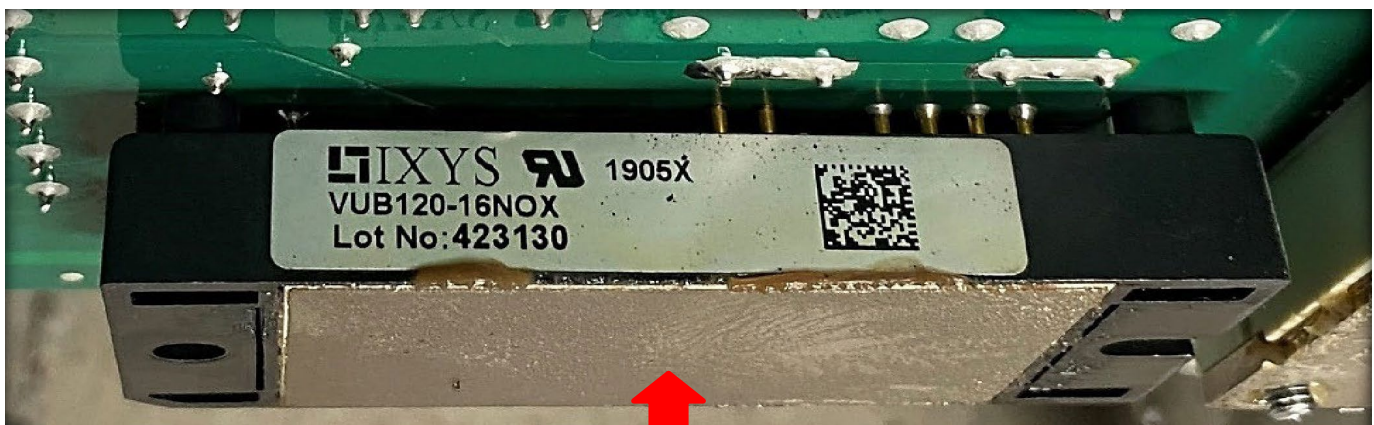
Image 11 – Braking transistor pack, heat sink used for transistor cooling attaches to the metal plate (red arrow).

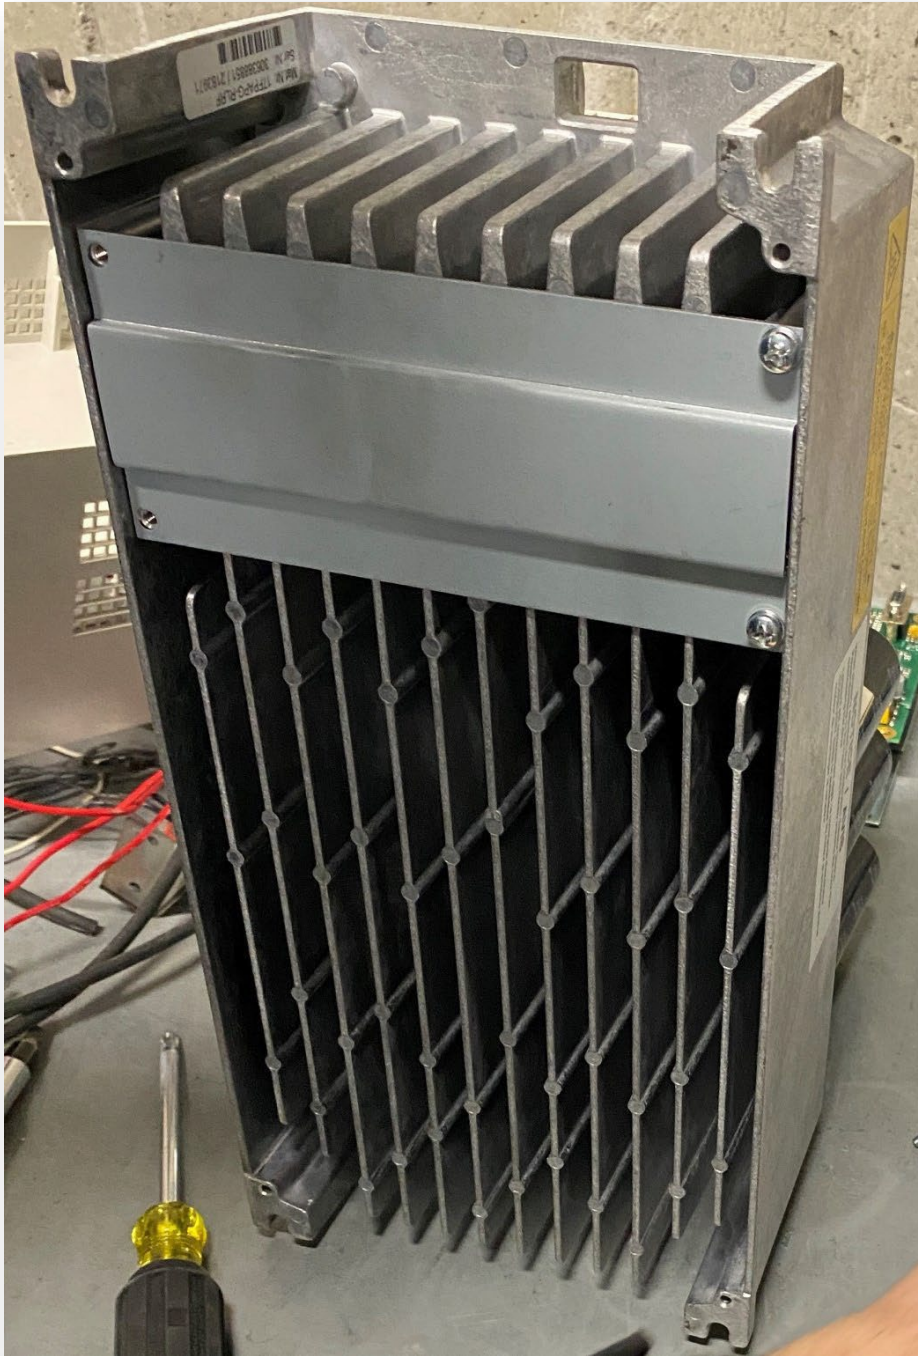
Image 12 – Heat sink with integral fan under cover to cool transistor pack.
