Incident Summary #II-1280613-2021 (#24889) (FINAL)

SUPPORTING INFORMATION	Incident Date	November 3, 2021	
	Location	Abbotsford, British Columbia	
	Regulated industry sector	Electrical - Low voltage electrical system (30V to 750V)	
	Impact	Qty injuries	0
		Injury description	N/A
		Injury rating	None
	Damage	Damage description	A receptacle and cord were melted in a fire that occurred in the bedroom on the lower level of a single-family dwelling. Fire and smoke damage to a small section of wall in the bedroom as well as a table and chair.
		Damage rating	Moderate
	Incident rating	Moderate	
Incident overview	A fire in a dwelling occurred where an extension cord was plugged into a bedroom receptacle. The cord was connected to a series of power bars that were connected to power various household electrical equipment.		
INVESTIGATION CONCLUSIONS	Site, system and components	<p>The incident occurred in a bedroom on the lower level of a single family dwelling. The bedroom had three 15-amp, 120 volt duplex receptacles located around the perimeter of the room. Only two receptacles were accessible for use due to the furniture layout in the room.</p> <p>The receptacles were supplied by a 15-amp

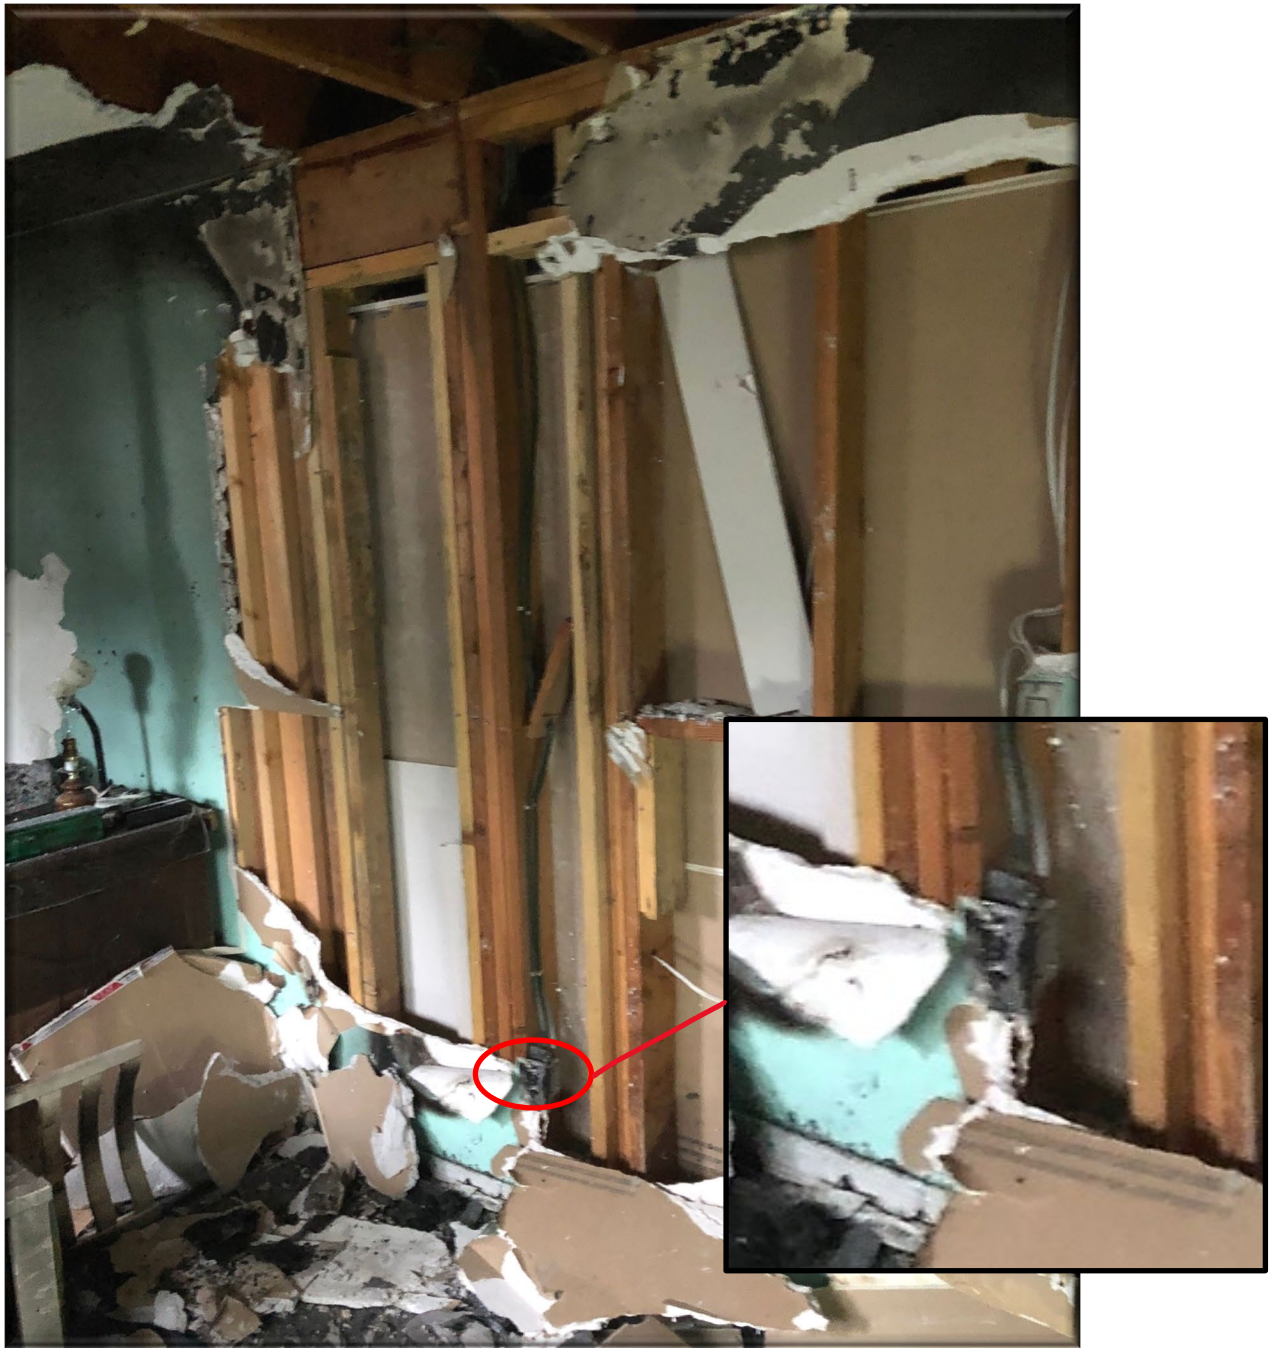
Photo 1 – Area of fire damage including point of origin of fire (red outline).

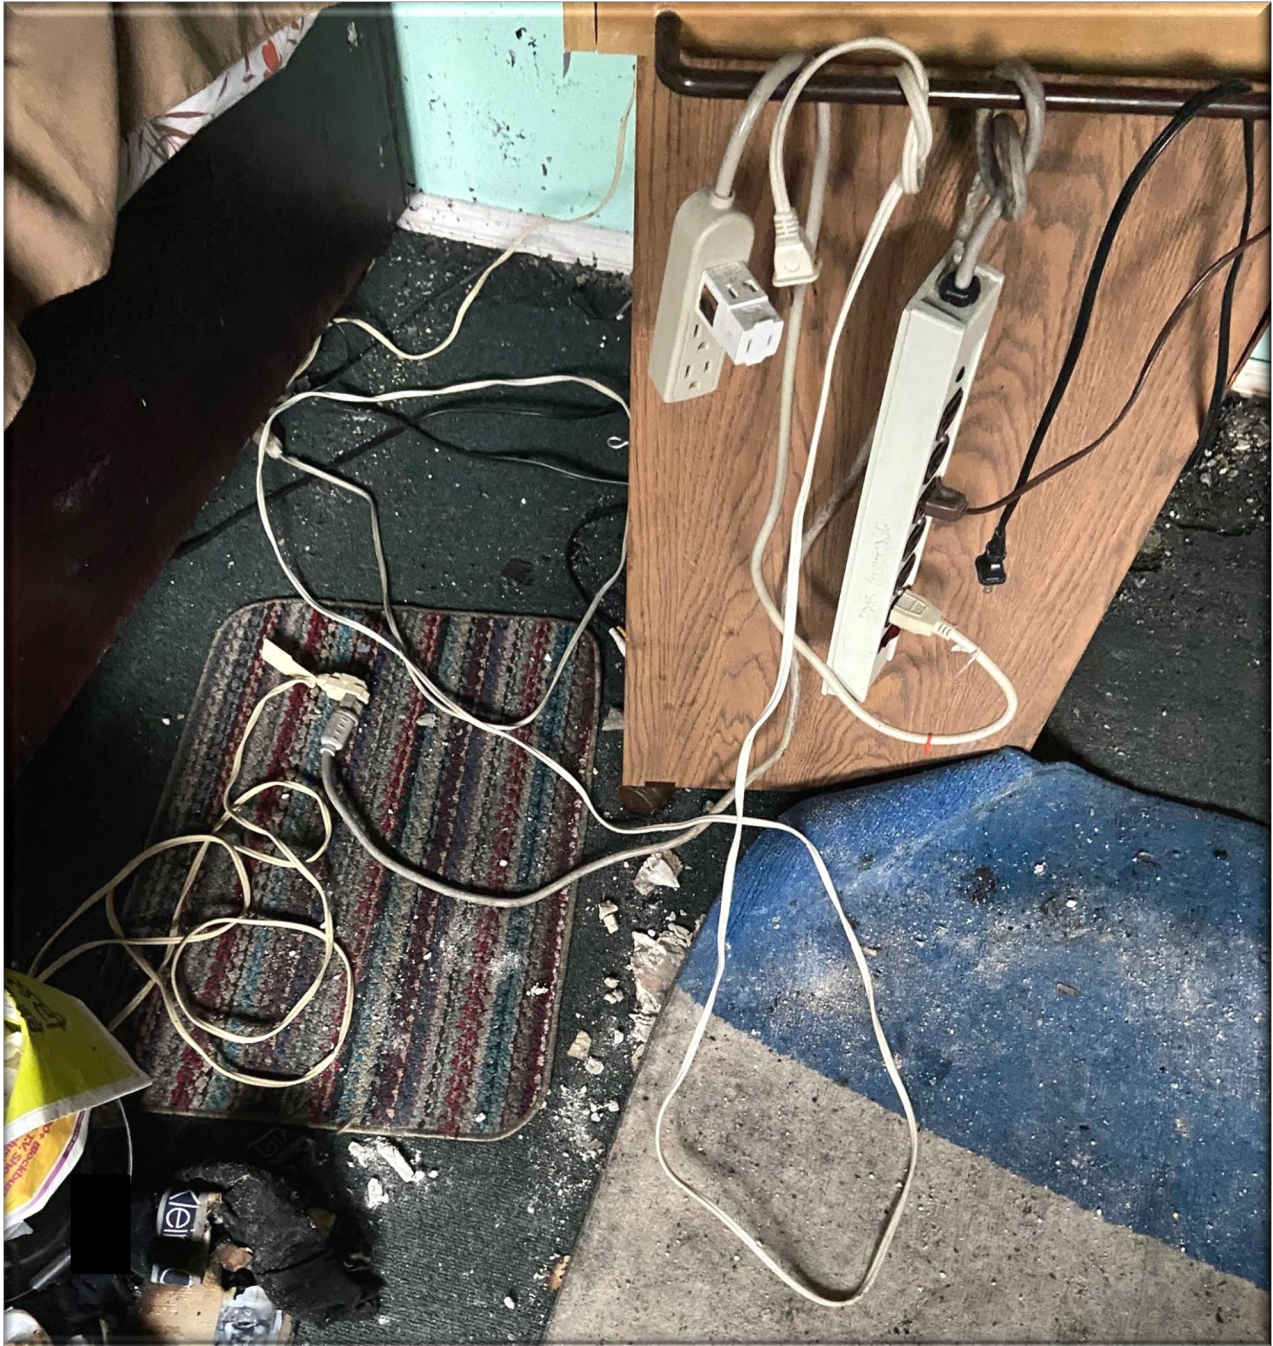
Photo 2 – Power bars and multi-outlet adapters that were connected to the overheated receptacle.

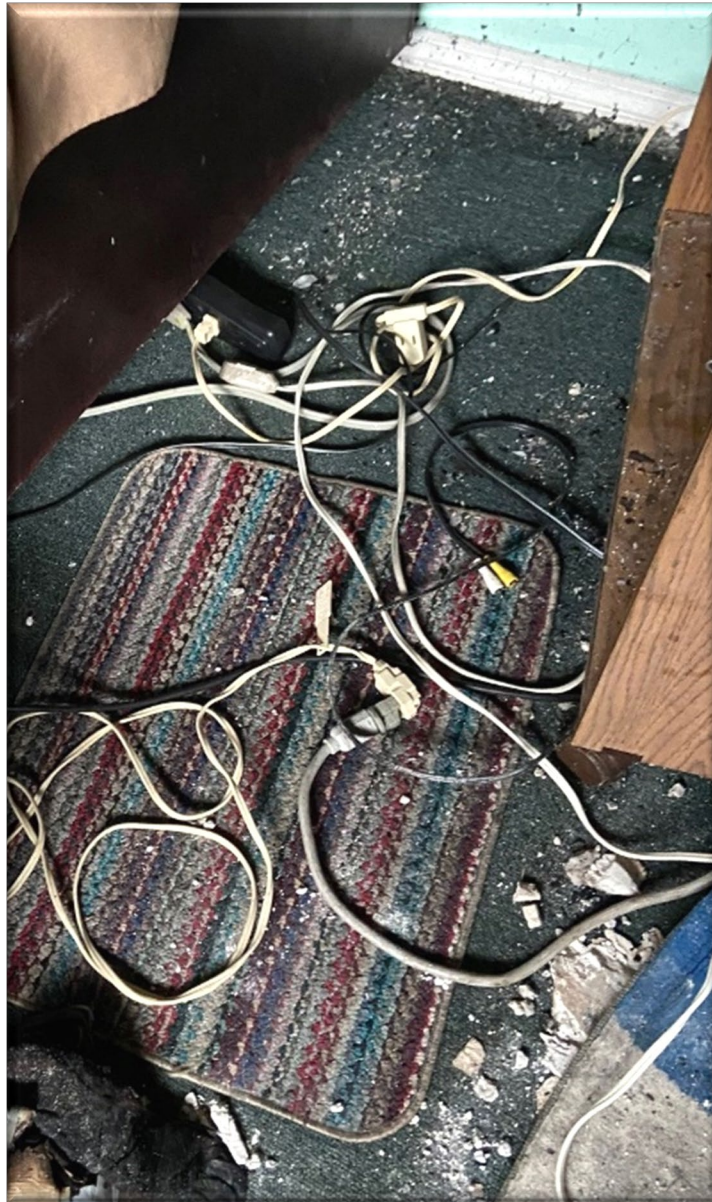
Photo 3 – Additional power bars connected downstream from power bars in [Photo 2](#).

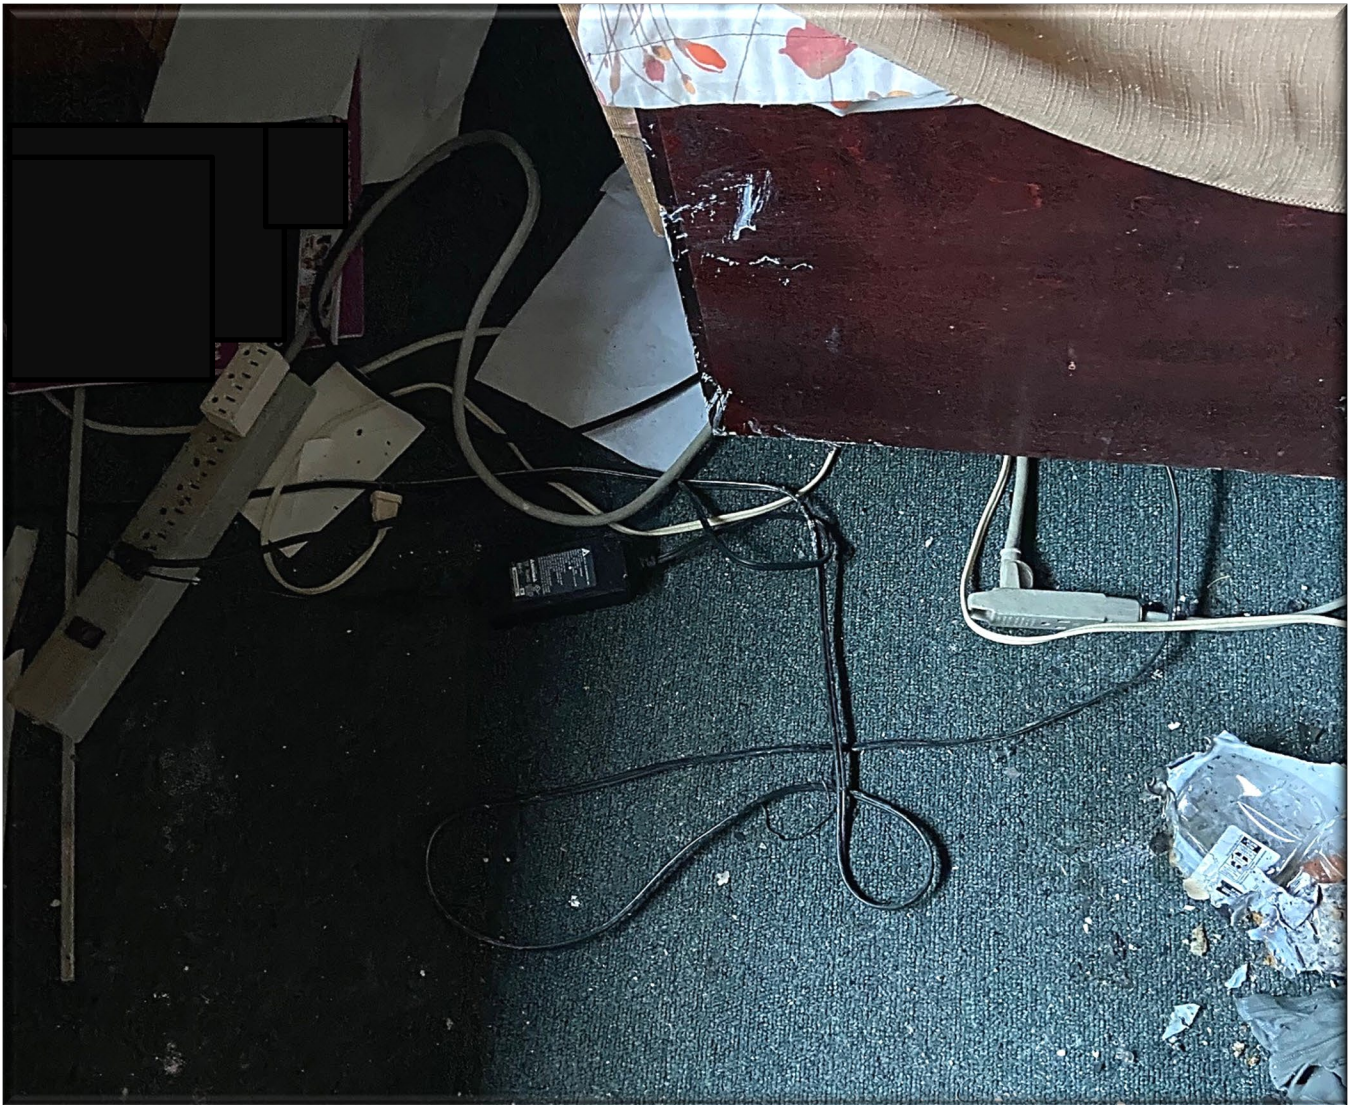
Photo 4 – Further power bars connected downstream from power bars in [Photo 3](#).

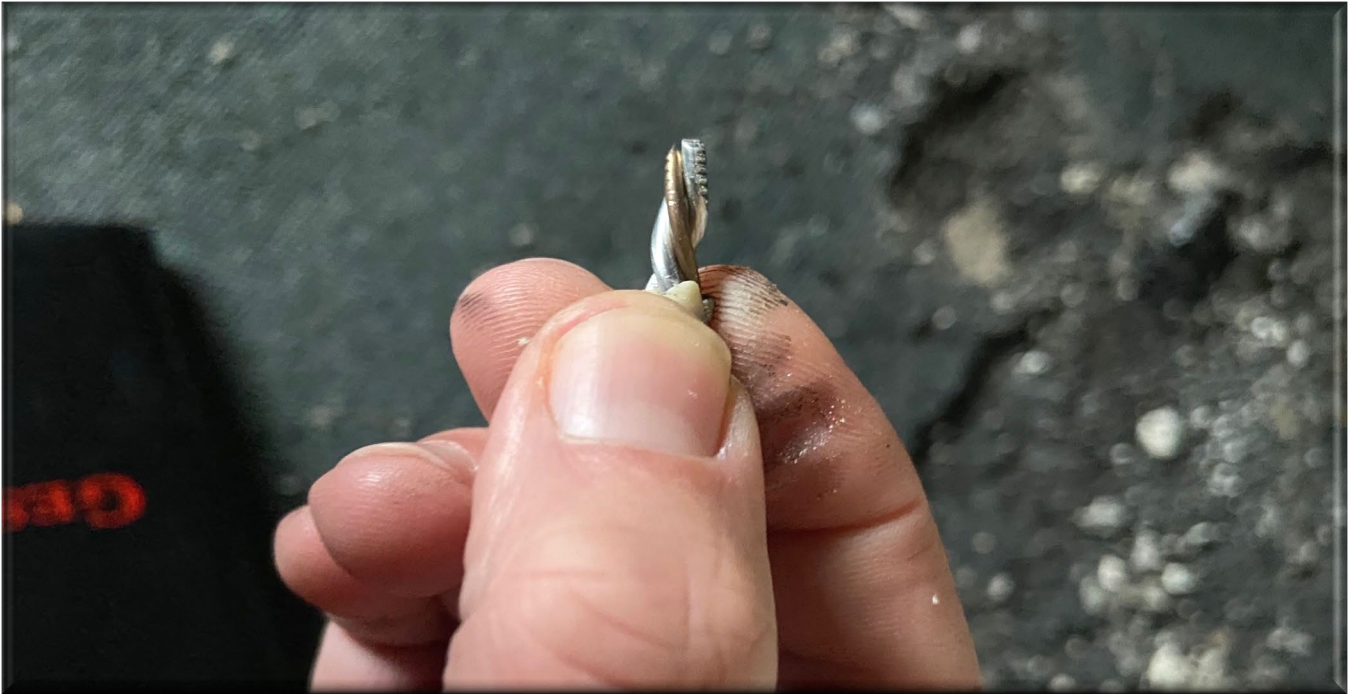
Photo 5 – Wiring connected to receptacle where fire originated shows no signs of overheating.

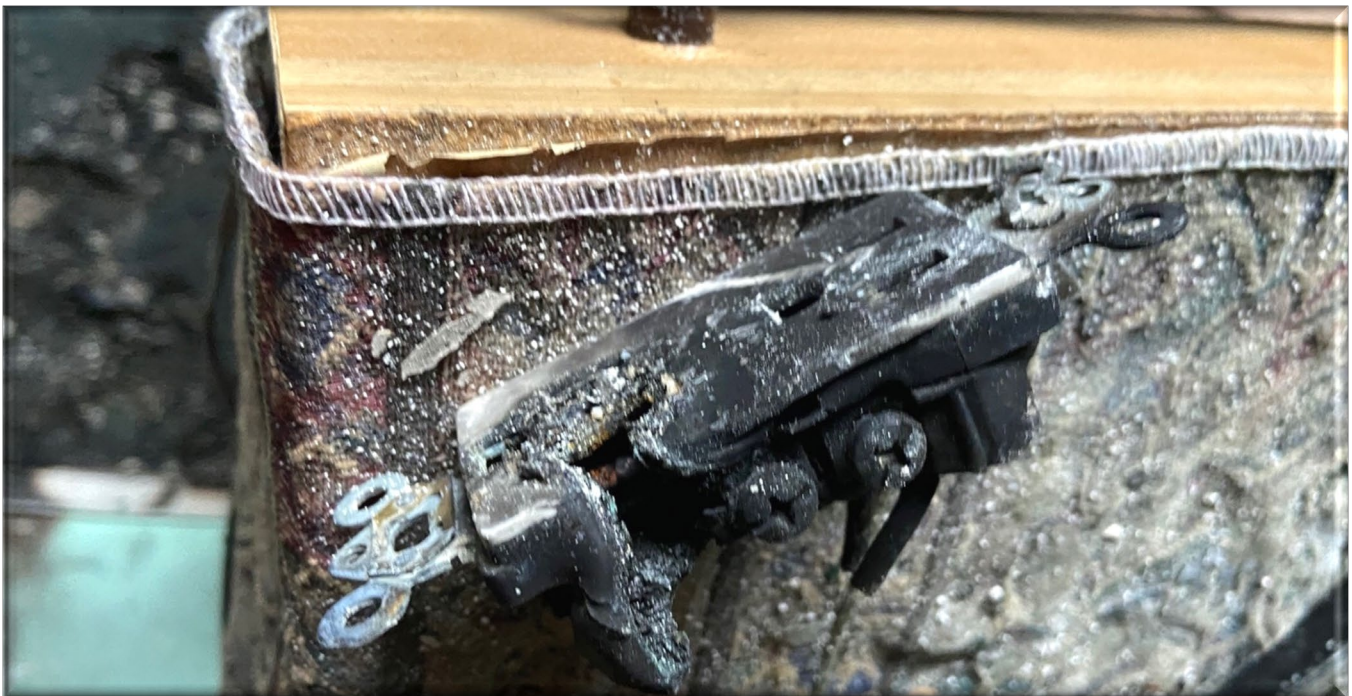
Facts and evidence	<ul style="list-style-type: none">• Statement from Abbotsford Fire Rescue Service (AFRS) said that a power bar was plugged into the outlet where the fire started.• Examination of the bedroom showed at least six power bars had been connected together using extension cords to power devices throughout the room. (Photo #2, 3 and 4).• The power bars were being used to provide power to cell phone chargers, lamps, a TV, a digital video recorder, and other household electrical equipment.• The branch circuit wiring connected to the receptacle where the fire started showed no signs of overheating or damage, which indicates that the fire was not caused by wiring issues. (Photo #5).• The permanent outlet that the power bars were plugged into had significant heat and fire damage, and the nature of the damage indicates that the damage started internal to the receptacle and propagated outwards. (Photo #6 and 7)

Causes and contributing factors	<p>The cause of the fire was very likely an overheated connection point between a receptacle and a power bar, where the power bar was used to feed several downstream power bars and overloaded the connection point for a prolonged time. The overloading of the connection likely generated excessive heat, which led to melting of the non-metallic components of the receptacle and ultimately a fire.</p>

Photo 6 – Melted receptacle was the point of origin of the fire.

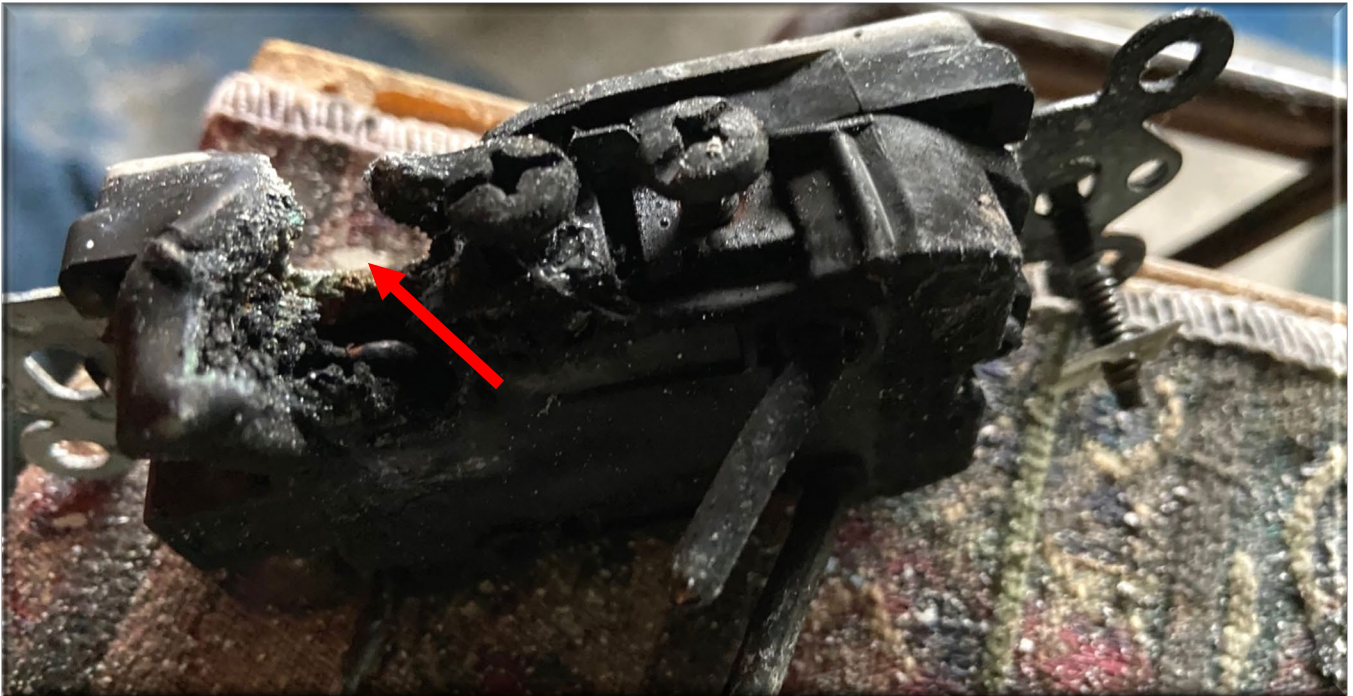
Photo 7 – Closeup of overheated receptacle showing that point of origin was the internal connection point for a cord end (red arrow).
