## Incident Summary #II-1676974-2024 (#44599) (FINAL)

SUPPORTING INFORMATION	Incident Date	February 23, 2024	
	Location	Abbotsford	
	Regulated industry sector	Electrical - Low voltage electrical system (30V to 1000V)	
	Impact	Qty injuries	0
		Injury description	N/A
		Injury rating	None
	Damage	Damage description	A main electrical distribution centre sustained distortion, melting and smoke damage to all three phases of bussing, the main breaker, and the walls of the cabinet.
		Damage rating	Moderate
Incident rating	Moderate		
Incident overview	An arc flash occurred in an energized 600 volt, 3 phase main distribution centre installed in a shipping container being used to provide temporary power to a building under construction. A mobile crane was used to attempt to remove the container before the underground utility lines had been disconnected and the internal bus bars twisted until contact between phases resulted in a line to line short.		
INVESTIGATION CONCLUSIONS	Site, system and components	<p>During construction of a new building, a portable service was rented to provide power to the building due to delays in the arrival of the permanent service equipment. The portable service c

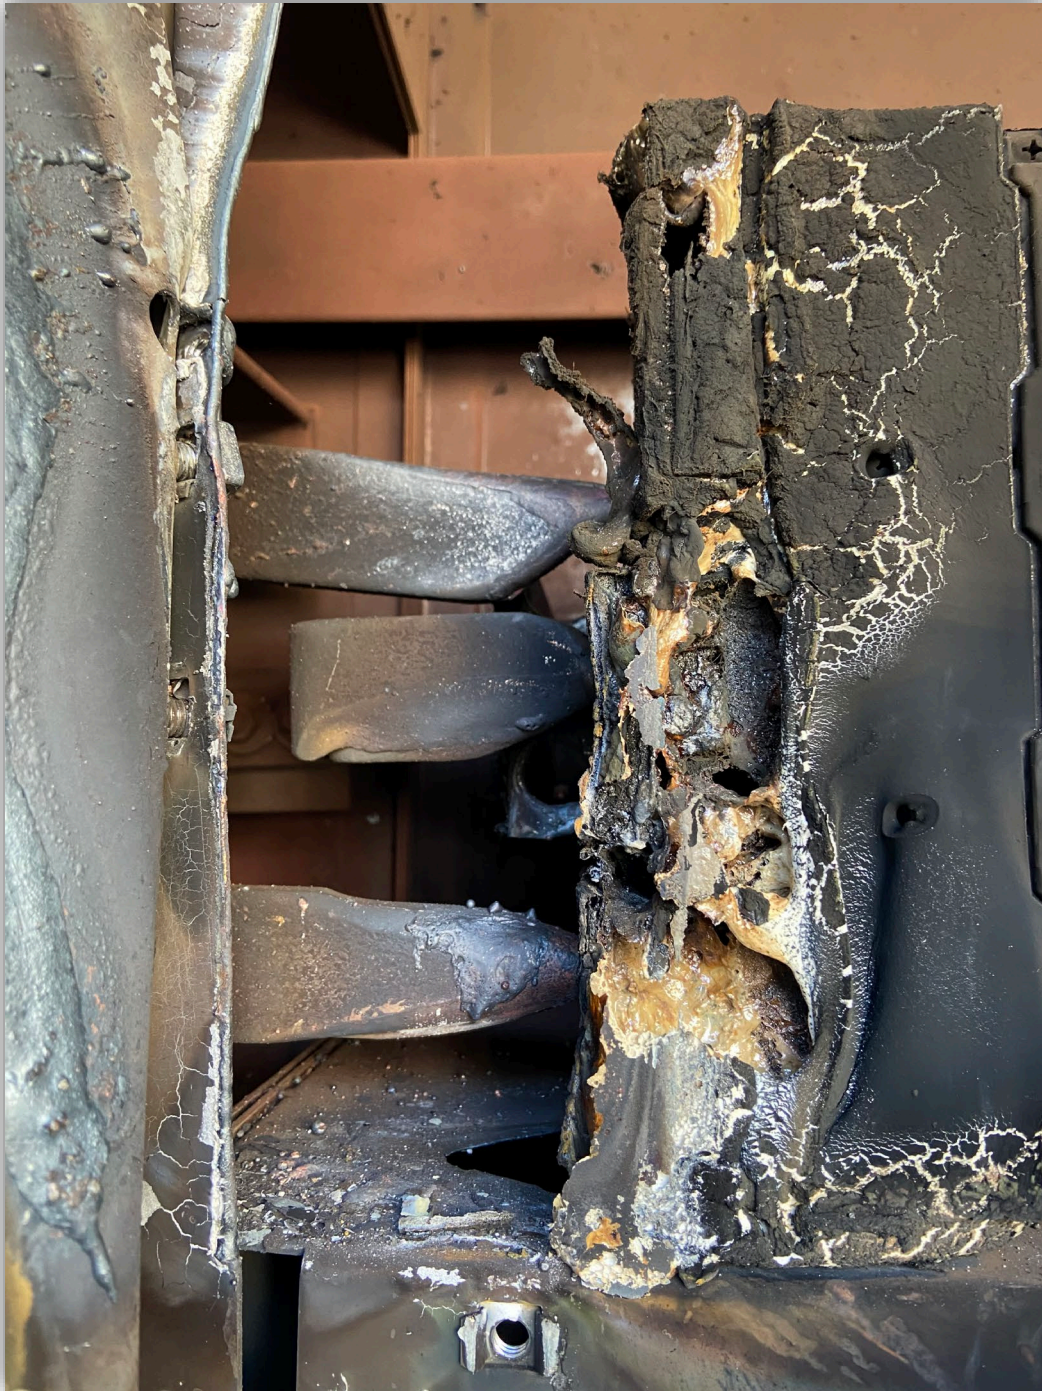
<p>separate, and line crew had never been tasked with attending site prior to incident.</p> <ul style="list-style-type: none"><li>• Observed melting of all three phase bus bars at connection to main breaker (<a href="#">Image 1</a>).</li><li>• Observed twisting of bus bars where they are connected to the utility conductors in MDC (<a href="#">Image 2</a>).</li><li>• Observed hole melted through front of MDC from arc flash (<a href="#">Image 3</a>).</li></ul>
Causes and contributing factors	<p>It is certain that the cause of the incident was that an attempt was made to remove a shipping container housing electrical service equipment while it was still energized by the utility power supply.</p> <p>The lack of clear communication between the parties involved in the disconnection and removal, as well as the failure to physically confirm disconnection of the utility supply before attempting to remove the equipment were contributing factors to the incident.</p>

Image 1 - Melting of bus bars due to arcing fault.

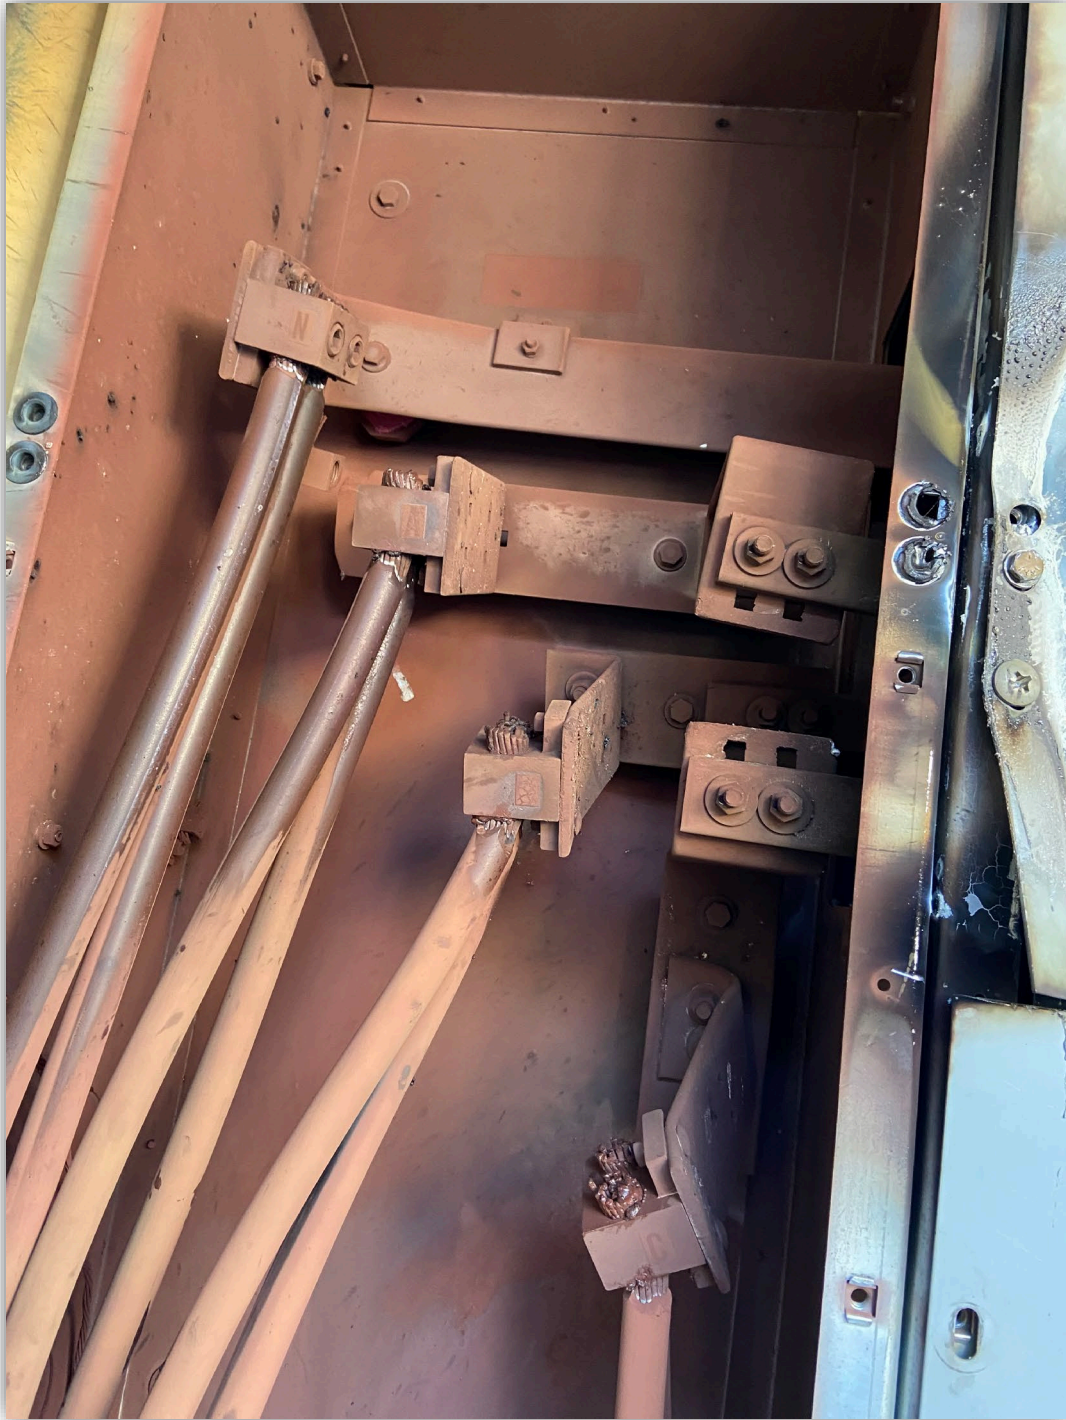
Image 2 – Twisting of bus bars due to tension from utility conductors.

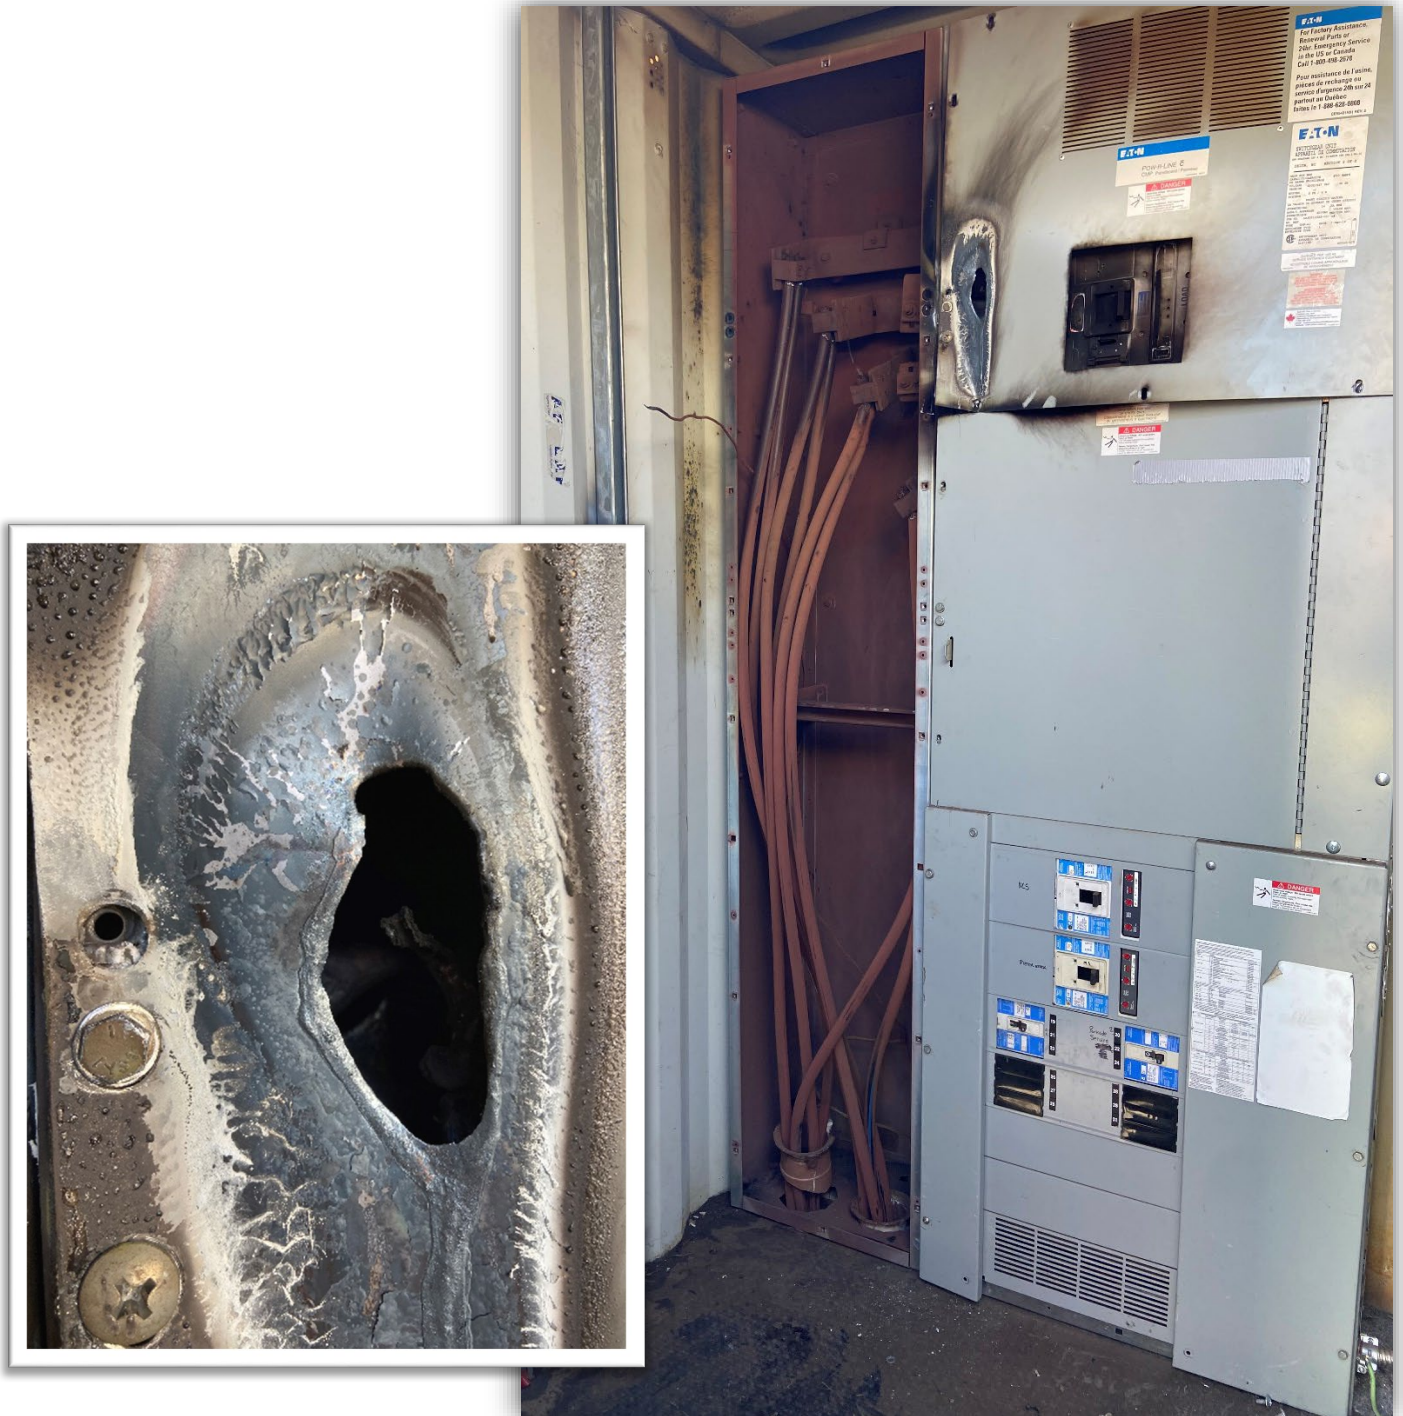
Image 3 – Overall damage to main distribution equipment. And close up of the hole melted through front of MDC due to arc flash.

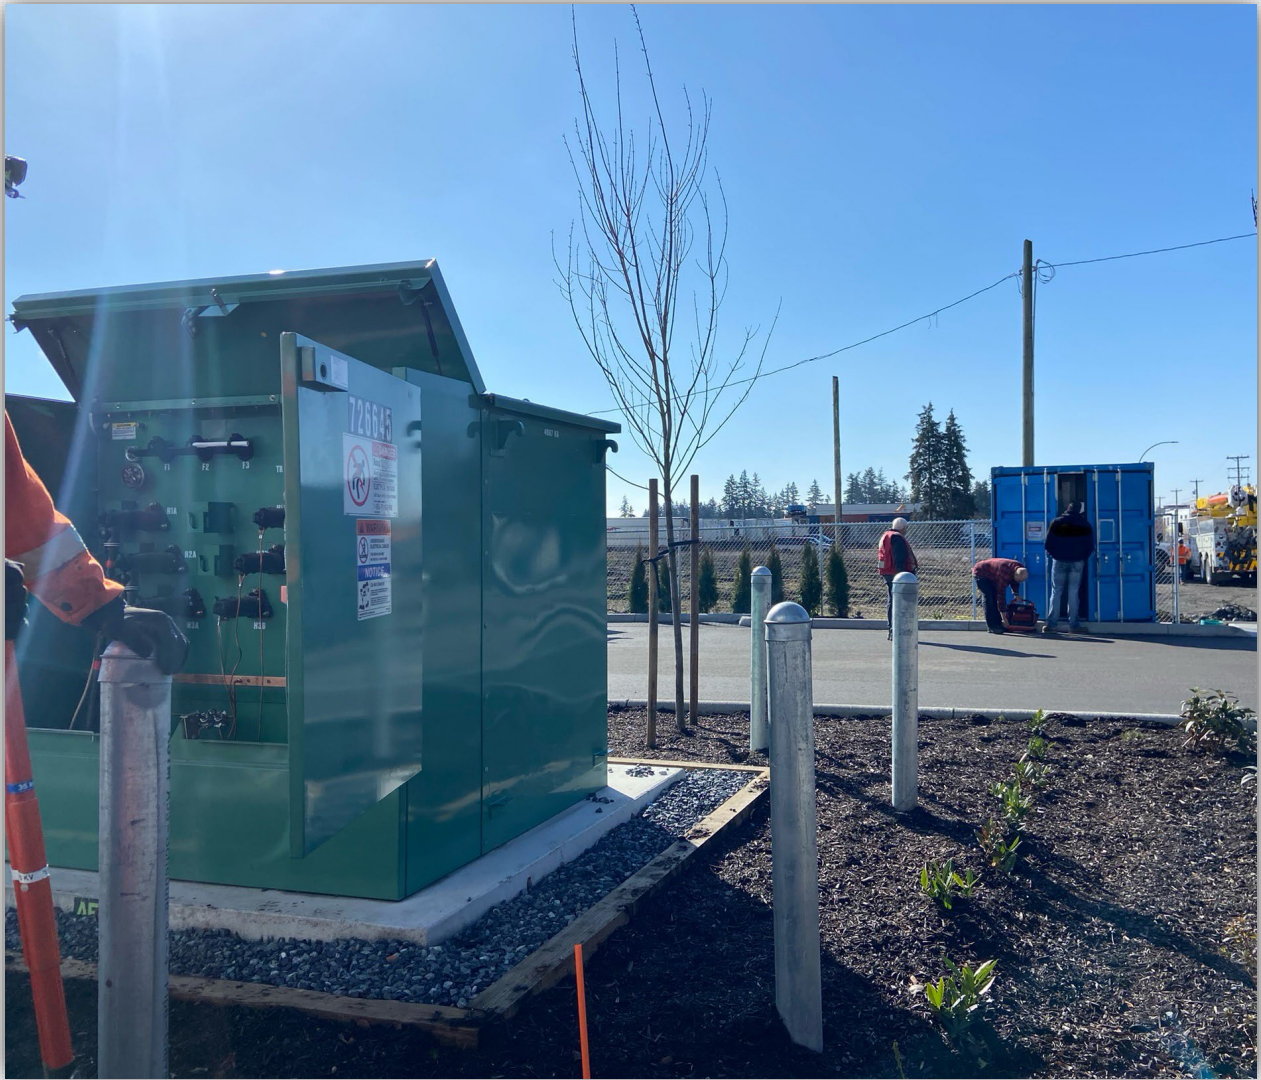
Image 4 – Overall site layout of temporary service equipment and utility transformer.
