Incident Summary #II-972306-2020 (#16462) (FINAL)

SUPPORTING INFORMATION	Incident Date	January 25, 2020	
	Location	Langley BC	
	Regulated industry sector	Boilers, PV & refrigeration - Refrigeration system	
	Impact Injury	Qty injuries	0
		Injury description	No Injuries
		Injury rating	None
	Damage	Damage description	Liquid feed solenoid valve O-ring was damaged causing ammonia to escape the valve body and release into the machine room.
		Damage rating	Minor
Incident rating	Minor		
Incident overview	A meat processing plant houses an anhydrous ammonia refrigerant plant as part of the plants process. A solenoid valve located in the refrigeration machine room had a damaged O-ring resulting in ammonia leaking outside the valve body. A licensed refrigeration contractor identified the leak and performed repairs including replacing the damaged O-ring.		
INVESTIGATION CONCLUSIONS	Site, system and components	<p>The liquid feed solenoid valve allows liquid ammonia at a high pressure (145psi) to pass through the valve and serves the ammonia liquid storage tank. The ammonia liquid storage vessel serves the compressor pumps with a constant supply of liquid ammonia. The solenoid valve control mod

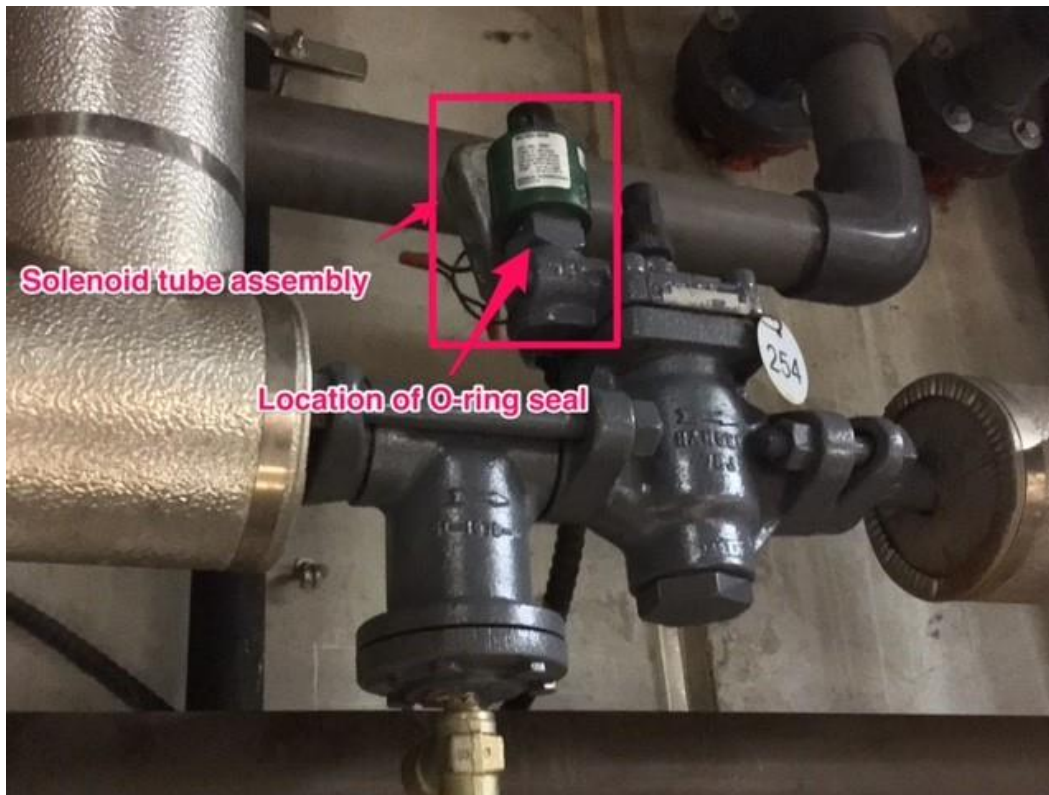
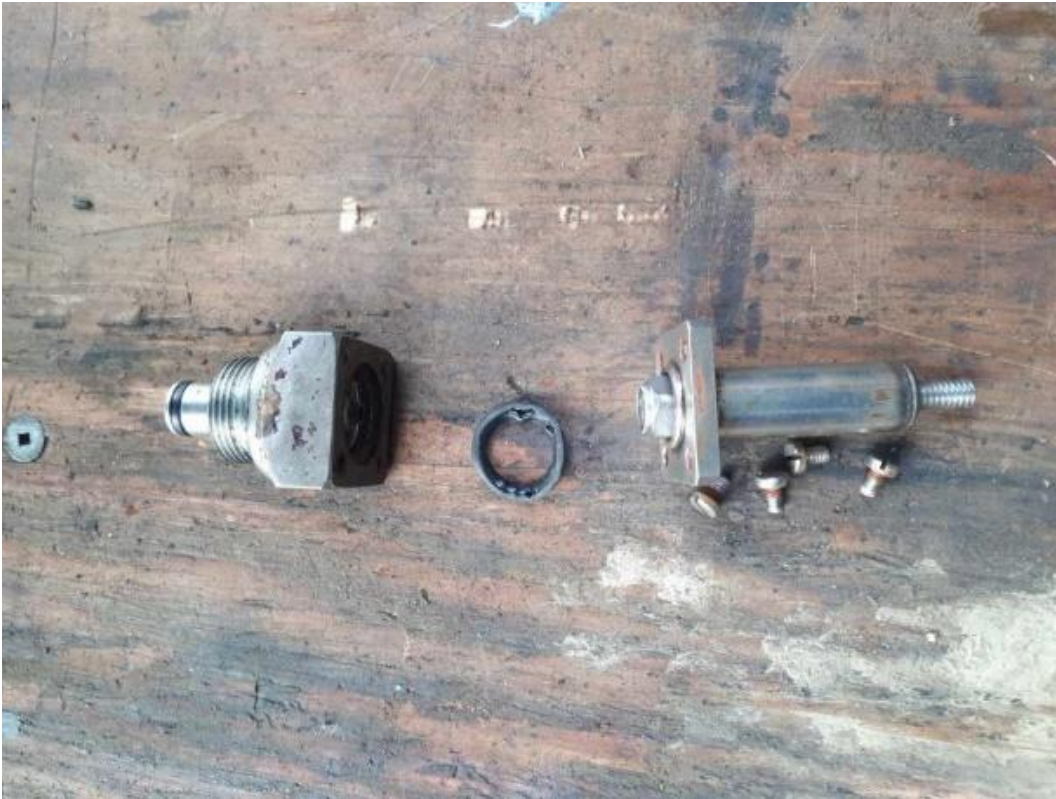
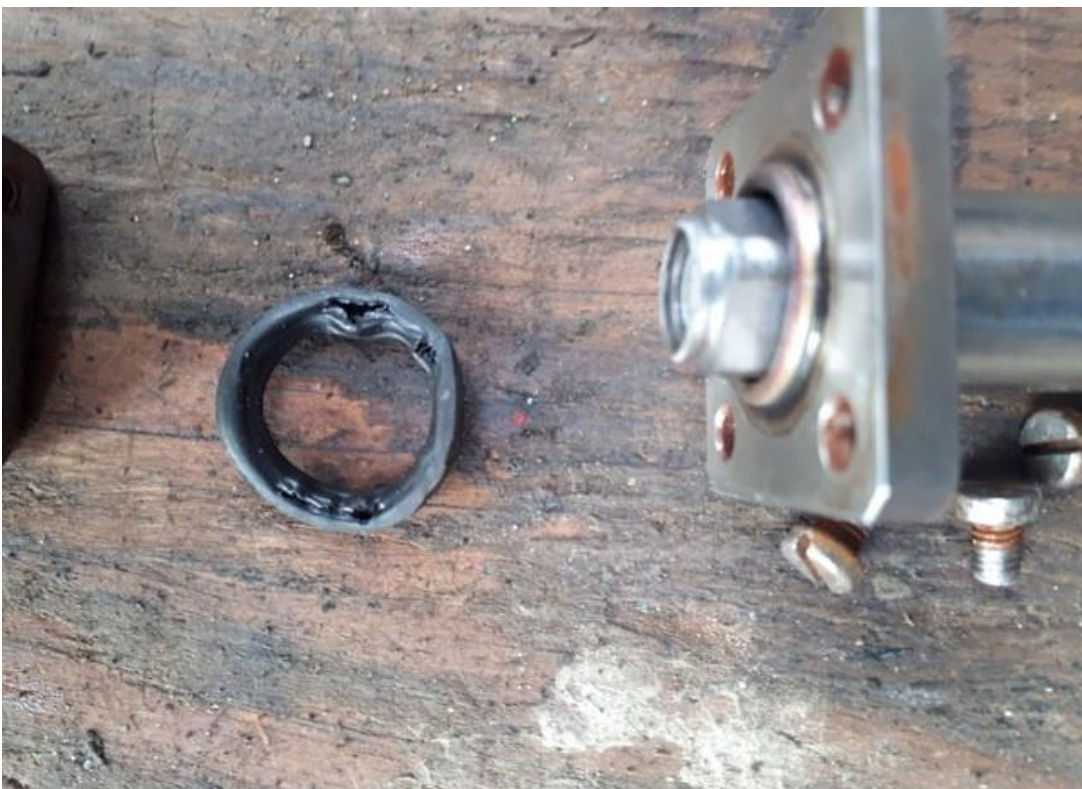
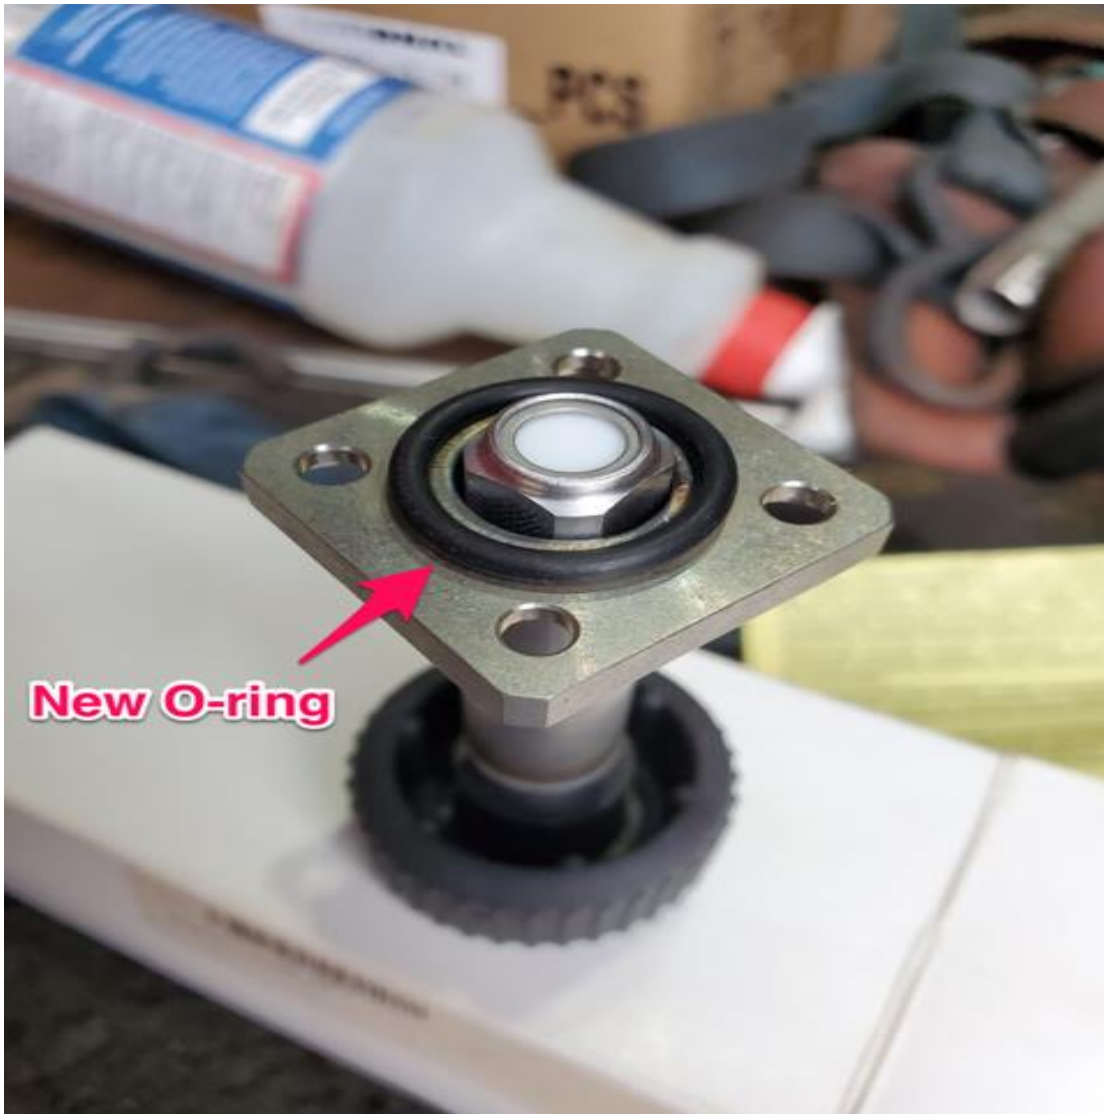
Failure scenario(s)	The liquid feed solenoid valve allows liquid ammonia to flow through it. The solenoid tube and control module assembly is held together by four screws and an O-ring is placed between the valve stem and body to create a seal between the connected body and stem. Constant temperature swings from ammonia passing through the solenoid valve from its open and closed position created an environment for the O-ring material to degrade overtime (approximately 20 years of service). The O-ring material failed and allowed ammonia to escape through the valve body from a lack of seal.	
	Facts and evidence	<ul style="list-style-type: none"> -Pictures of the solenoid tube assembly disassembled to show internal parts -Pictures of damaged O-ring with evidence of wear and tear in the material. -Contractor Service report dated Jan 25 describing tightening screws on valve to stop leak.. -Contractor service report dated Jan 27 describing servicing the valve and replacing damaged O-ring. -Duty holder email Jan 25 describing the sequence of events from the ammonia release.

<ul style="list-style-type: none">-Picture of what a new O-ring would look like in the valve assembly-Contractor witness statement indicating temperature fluctuations of (20F-100F) between liquid ammonia passing through the valve in the open position and back to the closed position as a likely scenario for the O-ring degradation.-Contractor witness statement indicating the liquid ammonia storage vessel was installed in the year 2000 and that the solenoid valve was a component for the vessel installation to give an approximate age of the valve.
Causes and contributing factors	<p>-It is highly likely the O-ring did not create a positive seal to prevent ammonia from escaping the valve assembly. The O-ring prevents ammonia from escaping a small gap between the connected sections of the valve stem and body. The age and temperature swings from cyclic fatigue of the valve constantly opening and closing caused the O-ring material to degrade over an approximate 20 year service life and eventual fail.</p>
