Incident Summary #II-1187393-2021 (#21850) (FINAL)

SUPPORTING INFORMATION	Incident Date	April 13, 2021	
	Location	Peace River Region	
	Regulated industry sector	Boilers, PV & refrigeration - Refrigeration system	
	Impact	Qty injuries	0
		Injury description	No Injuries
		Injury rating	None
	Damage	Damage description	Failure of multiple cassettes of a semi-welded plate heat exchanger released ammonia into the brine cycle of a refrigeration plant, rendering the cassettes unusable and contaminating the brine. Significant plant down time occurred as replacement cassettes were not readily available.
		Damage rating	Major
	Incident rating	Major	
	Incident overview	<p>In the fall of 2009, an indoor ice surface facility's refrigeration plant, was placed into operation and successfully operated without significant failure until the spring of 2021. When brine samples were taken in April 2021, the brine analysis reports came back indicating ammonia in the brine.</p> <p>The discovery of ammonia in the brine represented a hazard in the refrigeration plant and risk to plant staff. So, the operator shutdown and locked out the plant, and a second set of samples were taken to confirm that there was

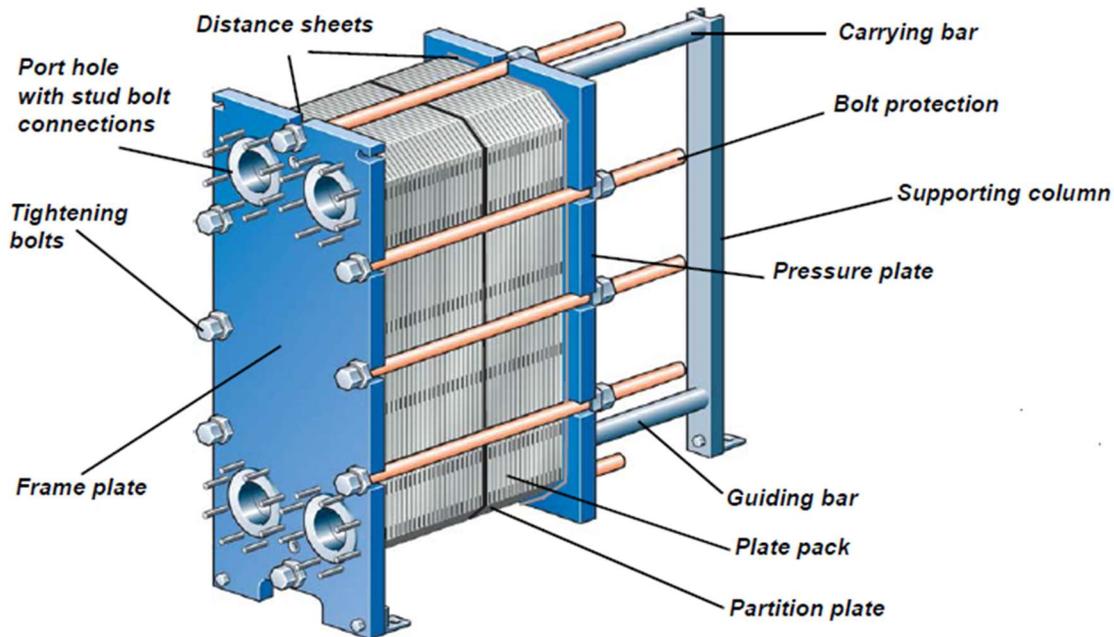
Figure 1: Semi-Welded Plate Heat Exchanger

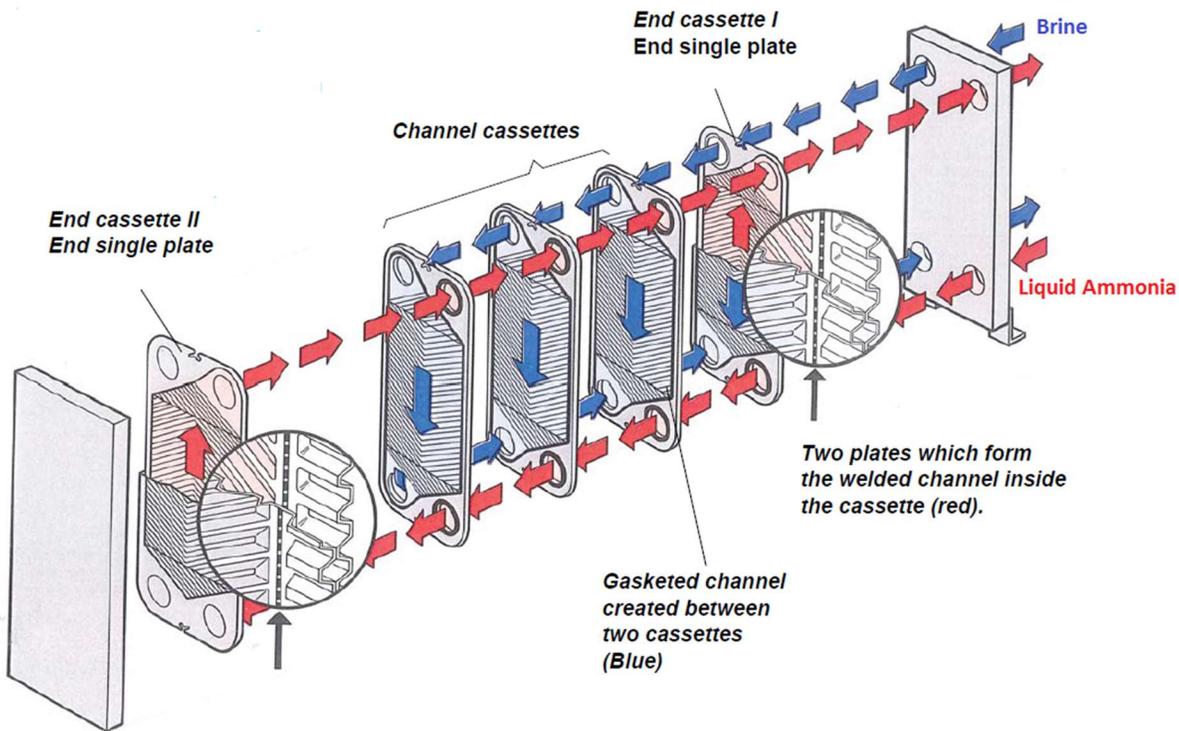
Figure 2: Cassette arrangement forming the Semi-Welded Plate Heat Exchanger

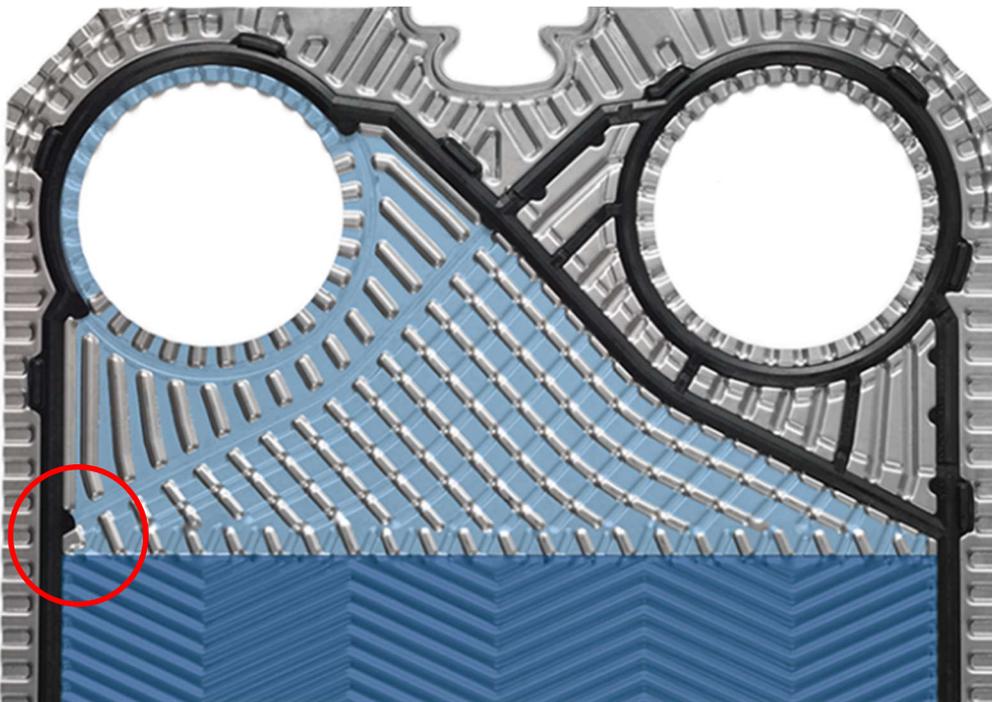
The heat exchanger plate failure was very likely initiated by weld defects created during the manufacturing process and accelerated by contact with the brine solution, resulting in a leak path. This allowed ammonia to pass from the welded channel into the gasket channel of the semi-welded plate heat exchanger, contaminating the brine.

Figure 3: Cassette and gasket identifying location of both weld defects.

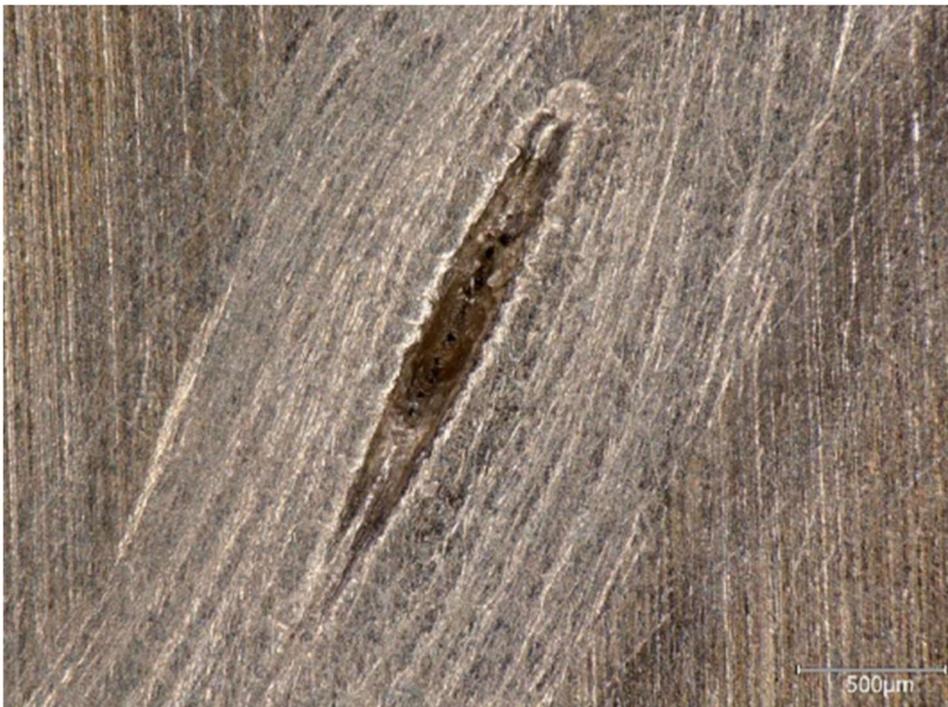
Figure 5: Electron microscope view of weld defect. Cassette 7B

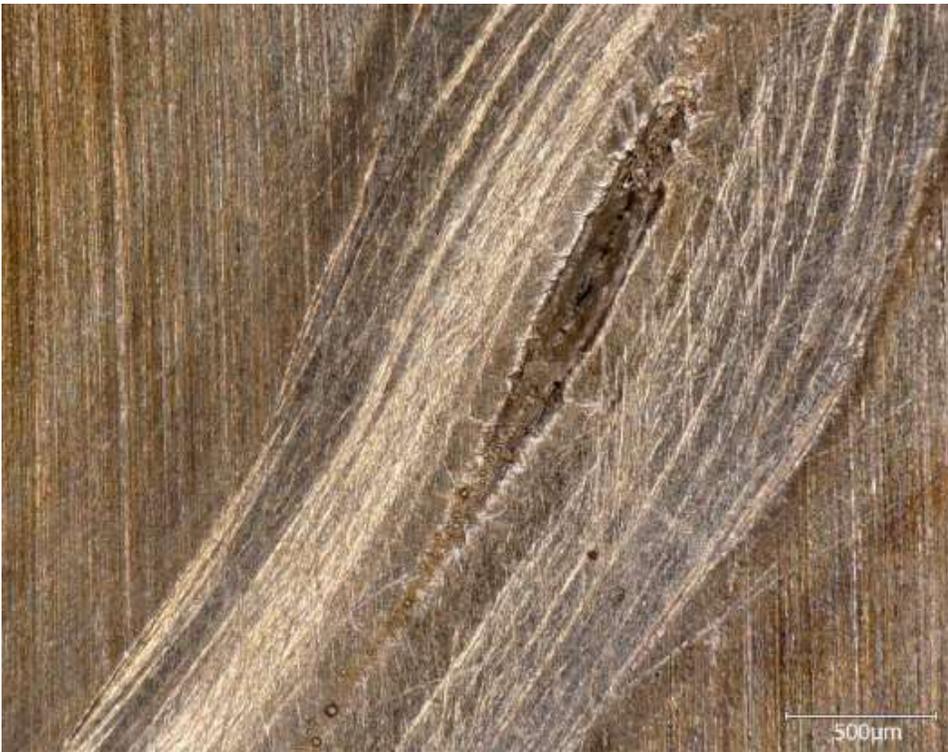
Figure 6: Electron microscope view of weld defect. Cassette 8B
Tests performed by an independent test facility.

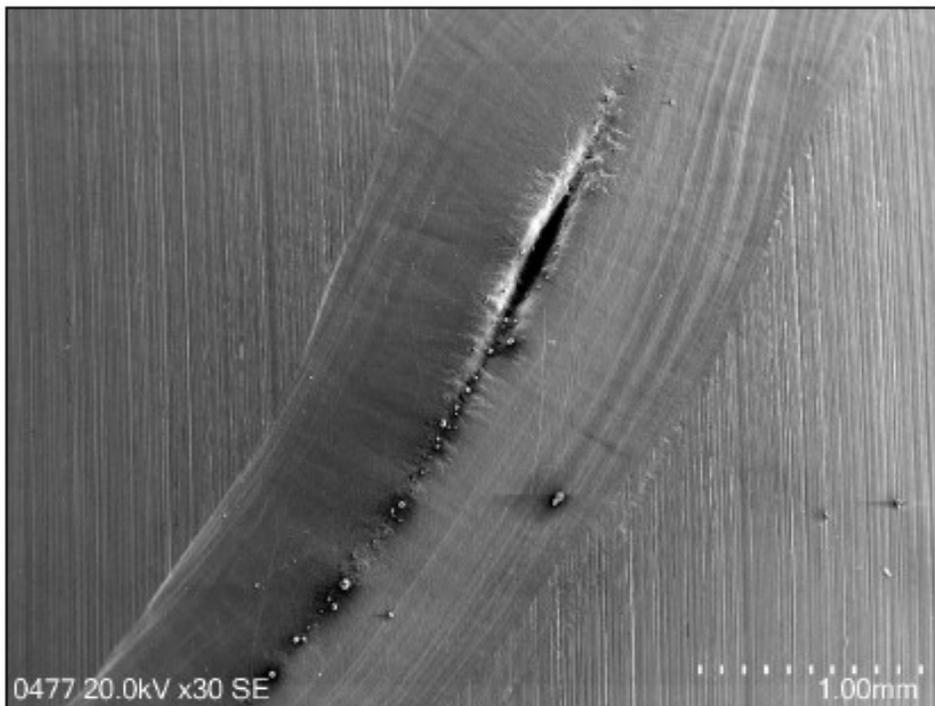
Figure 7: SEM image of the weld anomaly (plate 8B, corner D)
Tests performed by an independent test facility.

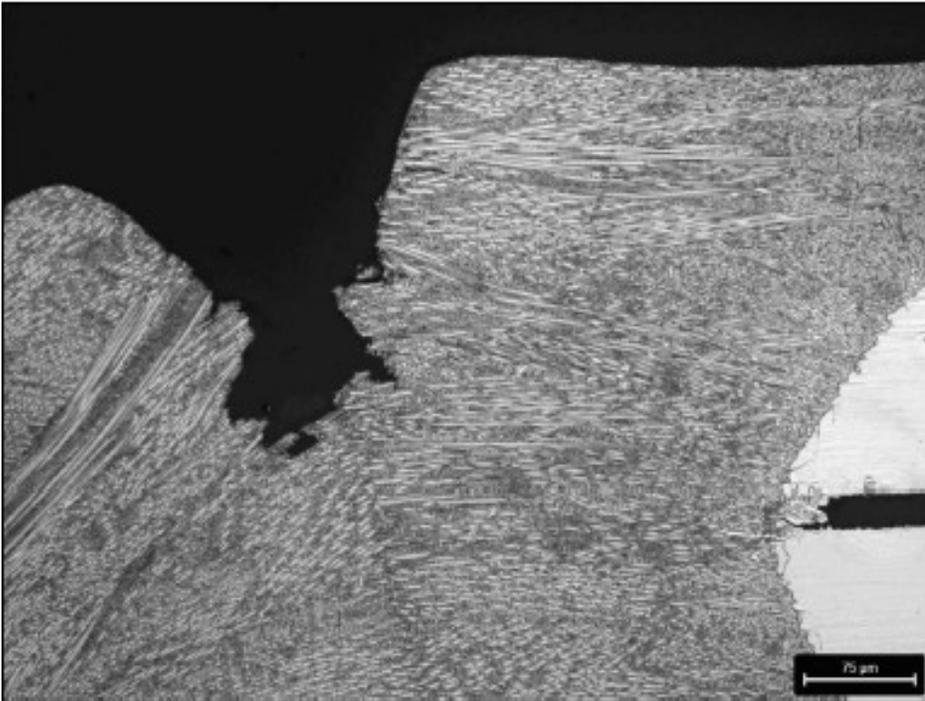
Figure 8: Defective weld after etching
