## Incident Summary #II-1413698-2022 (#28974) (FINAL)

SUPPORTING INFORMATION	Incident Date	July 29, 2022	
	Location	Port Coquitlam	
	Regulated industry sector	Electrical - Low voltage electrical system (30V to 750V)	
	Impact	Qty injuries	0
		Injury description	No Injuries
		Injury rating	None
	Damage	Damage description	Arcing and fire damage to an exterior electrical receptacle which was beyond repair, there was also smoke and fire damage to the vinyl siding around the receptacle located on the exterior second floor deck of a single-family dwelling.
		Damage rating	Minor
	Incident rating	Minor	
Incident overview	While pressure washing the exterior of a single-family dwelling, water entered into an exterior receptacle which was provided with a dry location cover. The high-pressure spray of water created shorting between the energized components and grounded components of the receptacle leading to overheating and/or arcing causing the fire which damaged the receptacle and exterior siding.

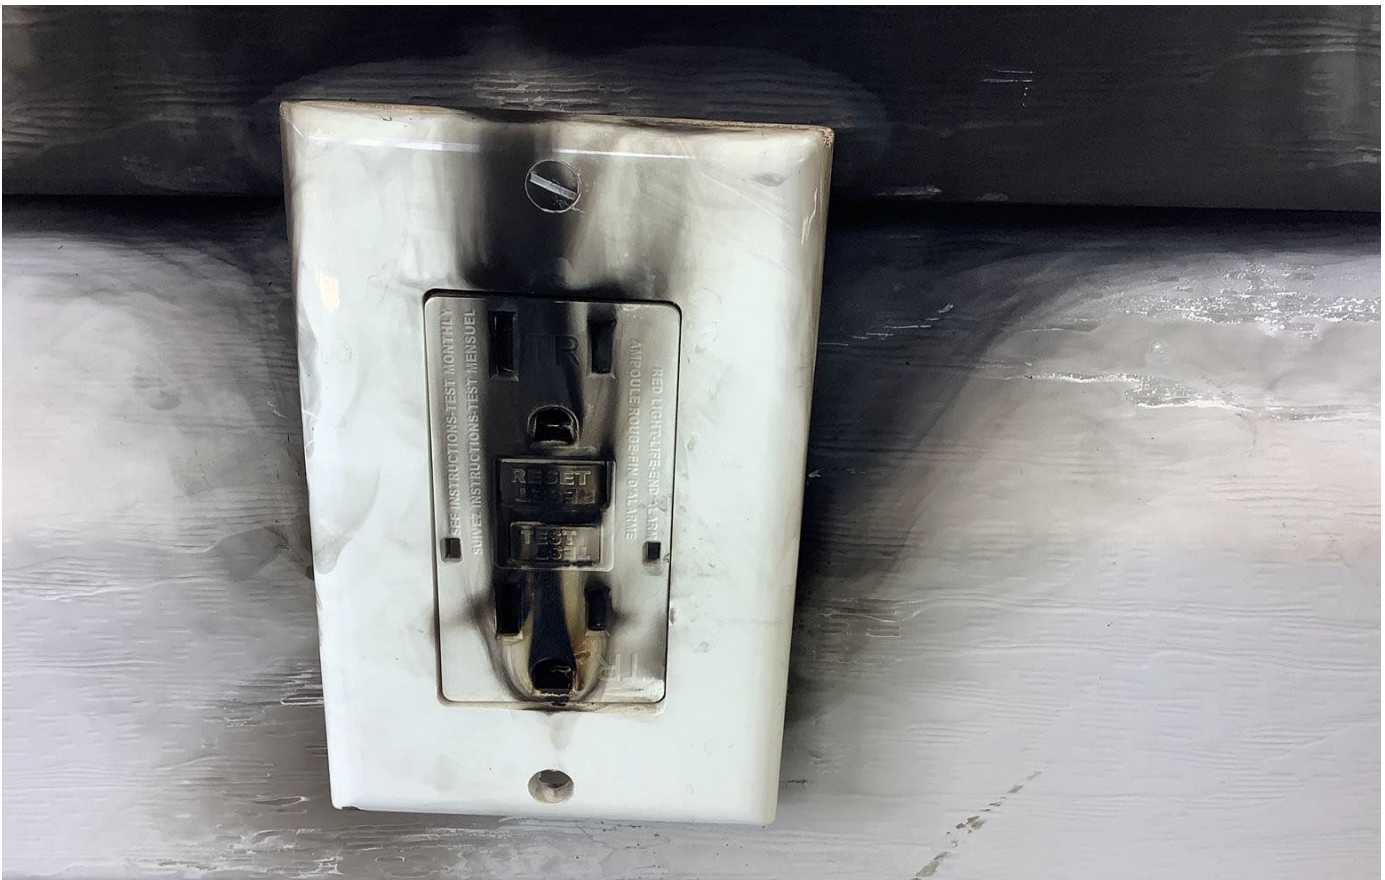
<ul style="list-style-type: none"><li>-The tenant stated the next day after the pressure washing, they noticed a larger area on the siding above the receptacle was burnt and black and called 911</li><li>-Nothing was plugged into the exterior receptacle at the time of the incident</li><li>-The fire department indicated the circuit breaker feeding the receptacle was still in the on position and then was turned off by their crew</li></ul>
Causes and contributing factors	It is highly probable that the incident was caused by water being sprayed from the pressure washer towards the receptacle. The provided dry type receptacle cover plate, which is not designed to prevent moisture ingress was a contributing factor.

Image 1 – Exterior deck receptacle with dry location cover.

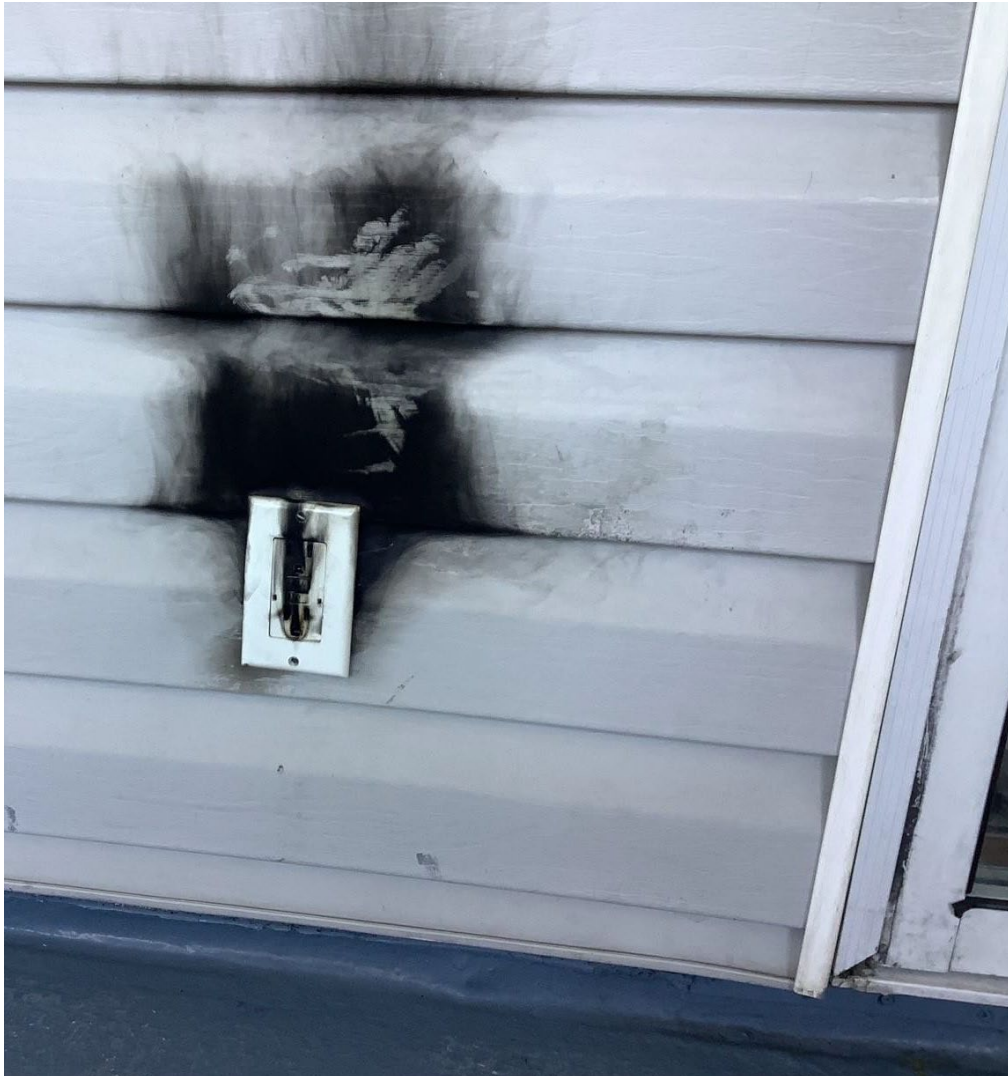
Failure scenario(s)	While the exterior of the building was being cleaned with a pressure washer which utilizes a high-pressure water spray to remove dirt and grime; water was able to enter an exterior receptacle in an area being pressure washed. The exterior receptacle was provided a dry location cover which does not prevent the ingress of water, this caused water to enter the receptacle and device box, making contact between the energized and grounded parts resulting in shorting, arcing, overheating and subsequent fire.	
	Facts and evidence	-The tenant stated they had pressure washing performed on the exterior of the building and that same day noticed black marks on the siding above the receptacle and a burning smell

Image 2 – Damage to exterior siding and receptacle
