Incident Summary #II-877333-2019 (#14184) (FINAL)

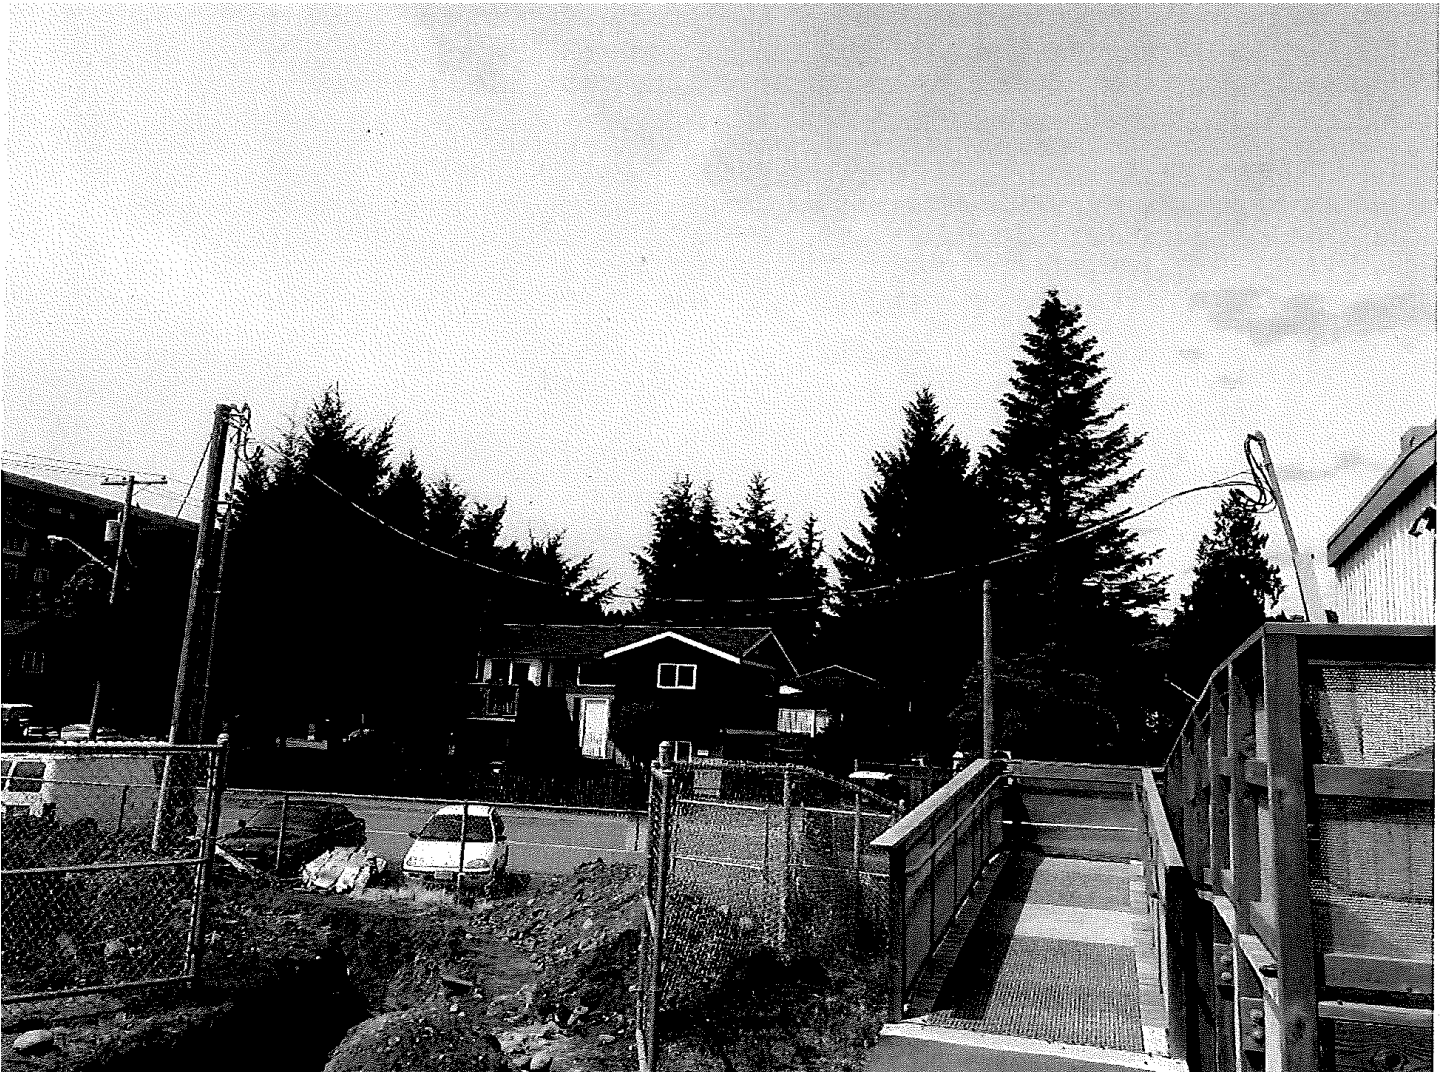
SUPPORTING INFORMATION	Incident Date	July 8, 2019	
	Location	Langford	
	Regulated industry sector	Electrical - Low voltage electrical system (30V to 750V)	
	Impact	Qty injuries	0
		Injury description	N/A
		Injury rating	None
	Damage	Damage description	Mechanical strain imposed on overhead feeder cabling resulting in deformation of mast conduit
		Damage rating	Minor
Incident rating	Minor		
Incident overview	Mechanical strain was imposed on overhead feeder cabling by raised boom of mobile excavation equipment resulting in deformation of mast conduit. Thermoplastic jacketing of overhead cabling and cabling in raceway system was not damaged to point of compromising integrity of insulating properties. Overcurrent protection equipment for this portion of the installation was not activated as a result of this incident.		
INVESTIGATION CONCLUSIONS	Site, system and components	The equipment involved in this incident is comprised of the following: overhead service to private pole; combination meter base installed on private pole; overhead, supported cabling from pole to detached structure; mast conduit on detached structure to raceway; raceway entering detached structure to sub-distribution equipment.

Failure scenario(s)	Crew operating excavation equipment in close proximity to overhead feeder cabling did not accurately gauge the limits of approach to overhead feeder cabling. The raised boom of excavation equipment in transit contacted and imposed mechanical strain on overhead feeder cabling. Mechanical strain imposed on overhead feeder cabling caused deformation to lower portion of mast conduit.	
	Facts and evidence	<ul style="list-style-type: none"> - Overhead supply cabling installed in accordance with minimum clearance requirements as put forth in Canadian Electrical Code (CEC 6-112 [2] [d]). - Overhead supply cabling in work area was not demarcated with warning flags at time that work was occurring. - Equipment operator moved equipment through area containing overhead supply cabling with boom raised. - Raised boom of equipment made contact with overhead supply cabling. - Strain imposed by boom contact with overhead supply cabling caused deformation to lower portion of mast conduit. - Thermoplastic jacketing of cabling was not damaged to the point of compromising insulation, over current protection was not activated.

Causes and contributing factors	<ul style="list-style-type: none"> - Equipment operator was moving equipment within limits of approach of overhead feeder cabling and allowed the crane boom to hit the suspended electrical cable - A contributing factor was the overhead feeder cabling in work area was not being properly demarcated with warning flags prior to commencing work.

Photo 1: View of the suspended overhead electrical cable and bent vertical mast (right). Photo shows the equipment after partial repairs had been conducted, (provided by FSR).

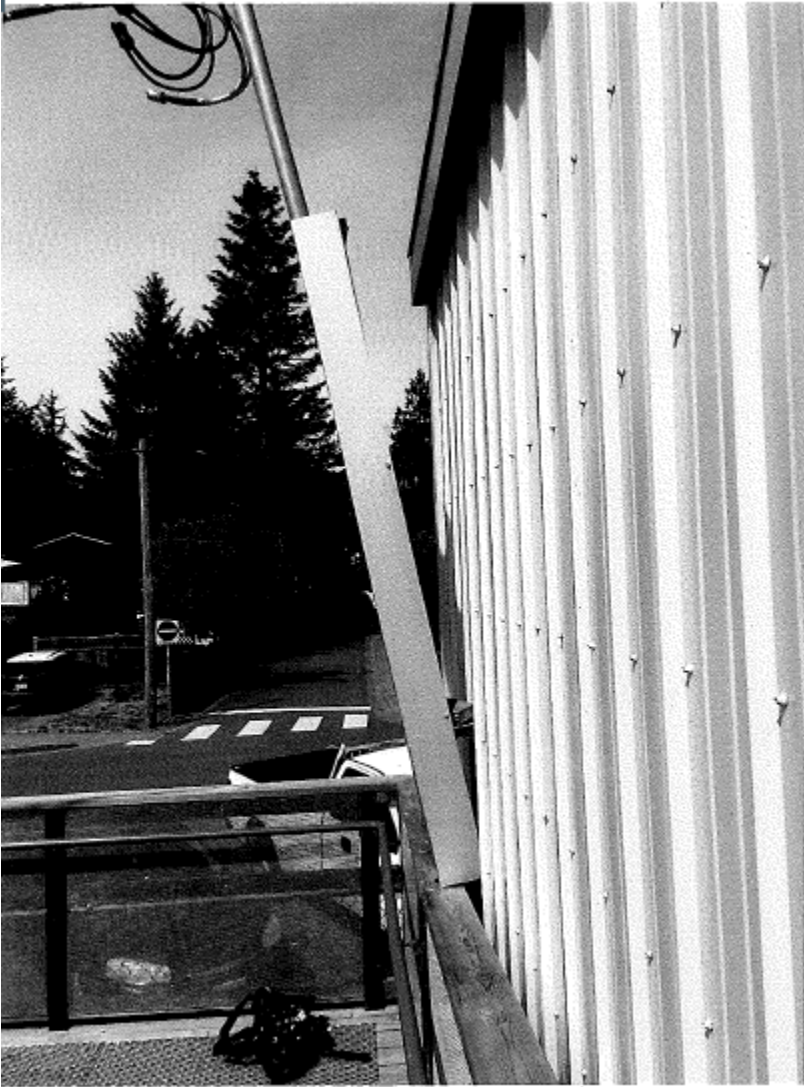
Photo 2: Close up of mast after repairs had occurred and been completed. (provided by FSR).
