# Appendix M: Leak Check Report

Technical Safety BC investigated an ammonia release from a partially disassembled refrigeration system. The Technical Safety BC investigation found that ammonia was released from a high-pressure receiver (Receiver #4). The receiver was part of a larger system and was contained within a skid that included a compressor, motor, and oil separator. (Figure 1).

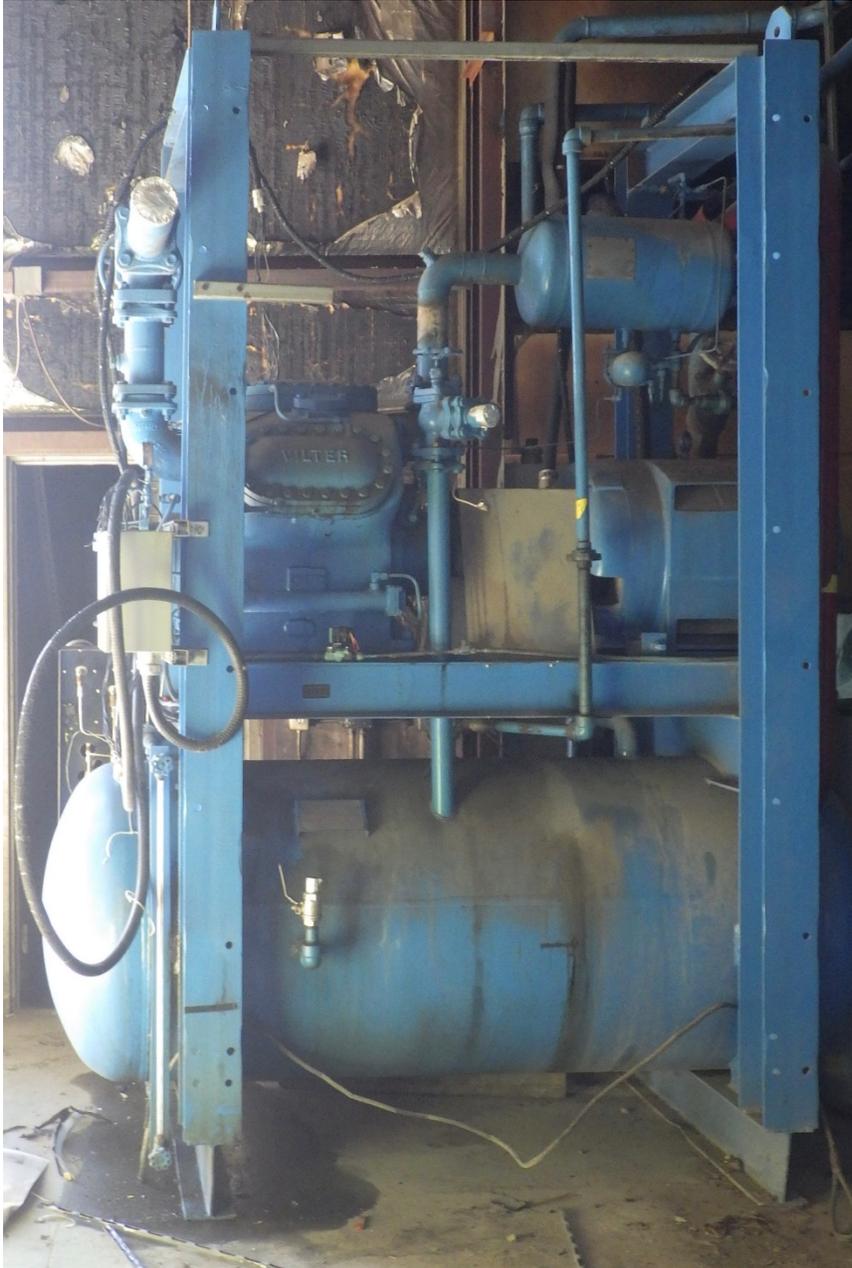
Figure 1: Refrigeration skid containing receiver, compressor, compressor motor, and oil separator

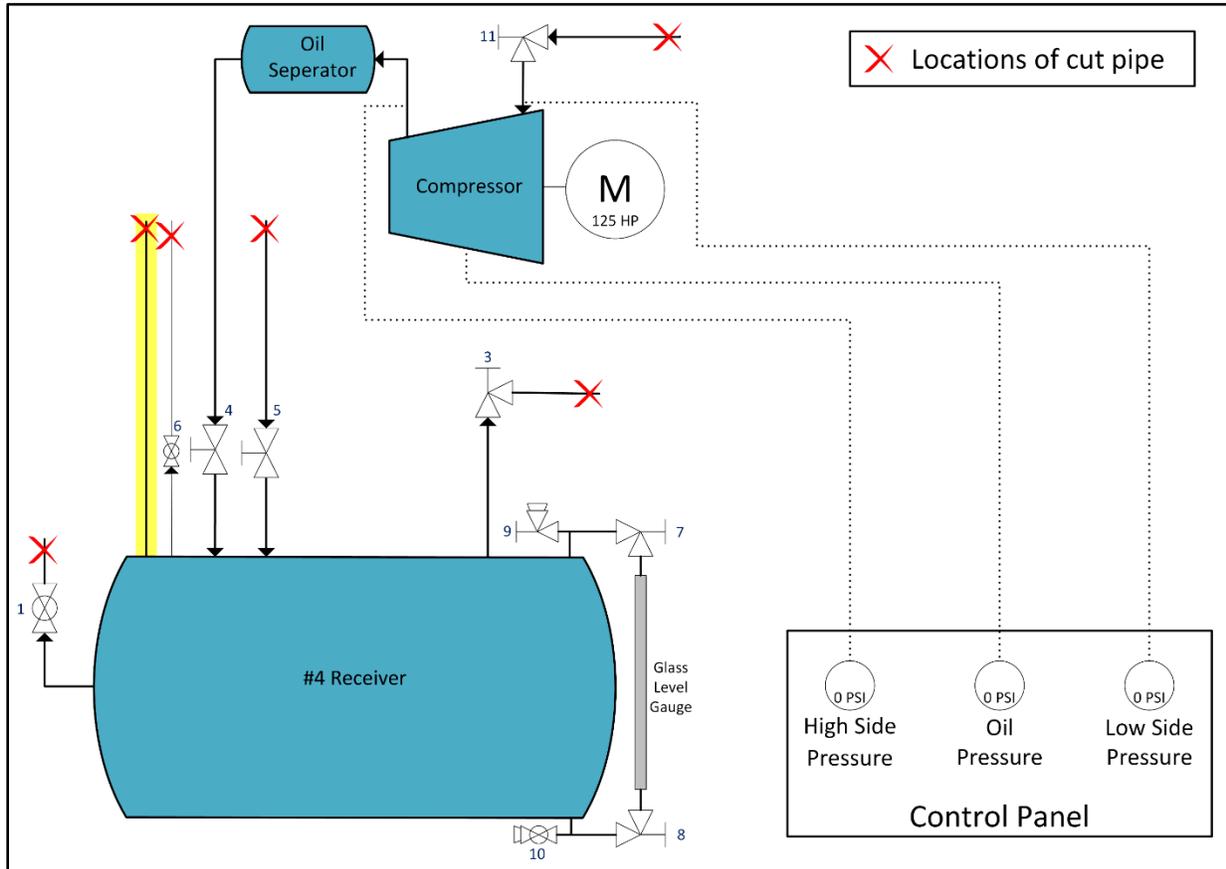
The refrigerant pipes connecting the skid to the rest of the refrigeration system had all been cut to allow for the skid to be transported off site. Figure 2 depicts the as found configuration of the system.

Figure 2: Configuration of refrigeration skid. Red "X" represents locations where the pipe was cut.

A pipe welded to the receiver was cut, with no valves between the open end and the receiver as depicted by the highlighted pipe in Figure 2. From an external visual inspection, this made it appear as though the receiver should not have been capable of holding pressure however, the process flow diagram from the manufacturer indicated that this pipe flowed through the receiver as a heat exchanger rather than being connected to it. The position of the valves and the integrity of the vessel was not known at the time. The scenario presented was that the ball valve (1) was opened, resulting in the ammonia release. To verify the scenario presented with all valves (except valve 1) left in their as found positions, a leak test was performed on the high-pressure receiver.

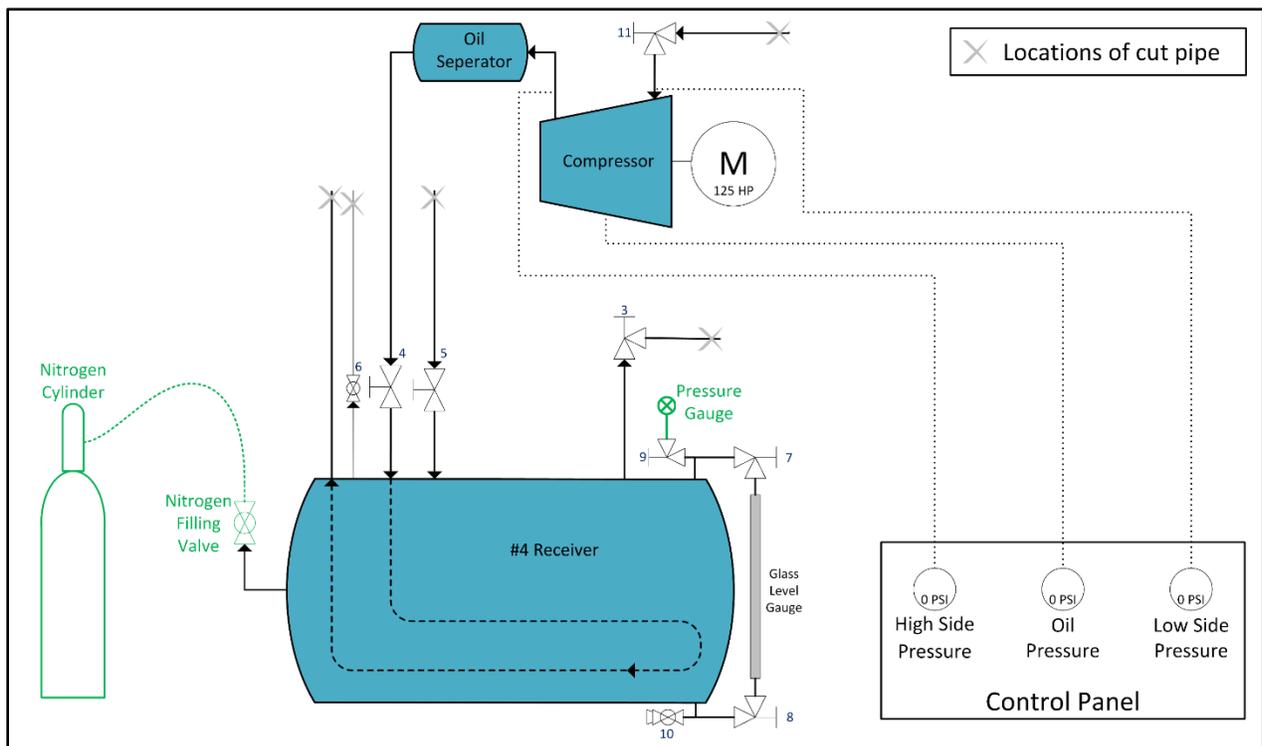
To perform the leak test, a 2-inch ball valve (valve #1) was removed and sent to a lab for separate analysis. The nitrogen tank was connected to the 2-inch pipe where the valve had been removed. This 2-inch pipe was chosen as the fill point because it is the location where ammonia was released. By adding pressure at this point, the pressure boundary of the chamber that previously held ammonia was being directly tested.

A pressure gauge was then connected to the vent valve (Valve #9) located above the glass level gauge. This gauge was used to monitor pressure during the test.

Figure 3: Leak check configuration with nitrogen cylinder connected to 2-inch liquid feed line.

The high-pressure receiver was brought up to a test pressure of 15PSI. The Nitrogen cylinder was isolated from the receiver and the receiver pressure was monitored for a duration of 10 minutes. During this time, no changes in pressure were observed. After 10 minutes the pressure had not changed and a final pressure of 15PSI was recorded (Table 1). It was also noted the gauges on the system control panel did not register pressure during the duration of this test. The refrigeration mechanic safely released the pressure from the receiver and disconnected the pressure gauge.

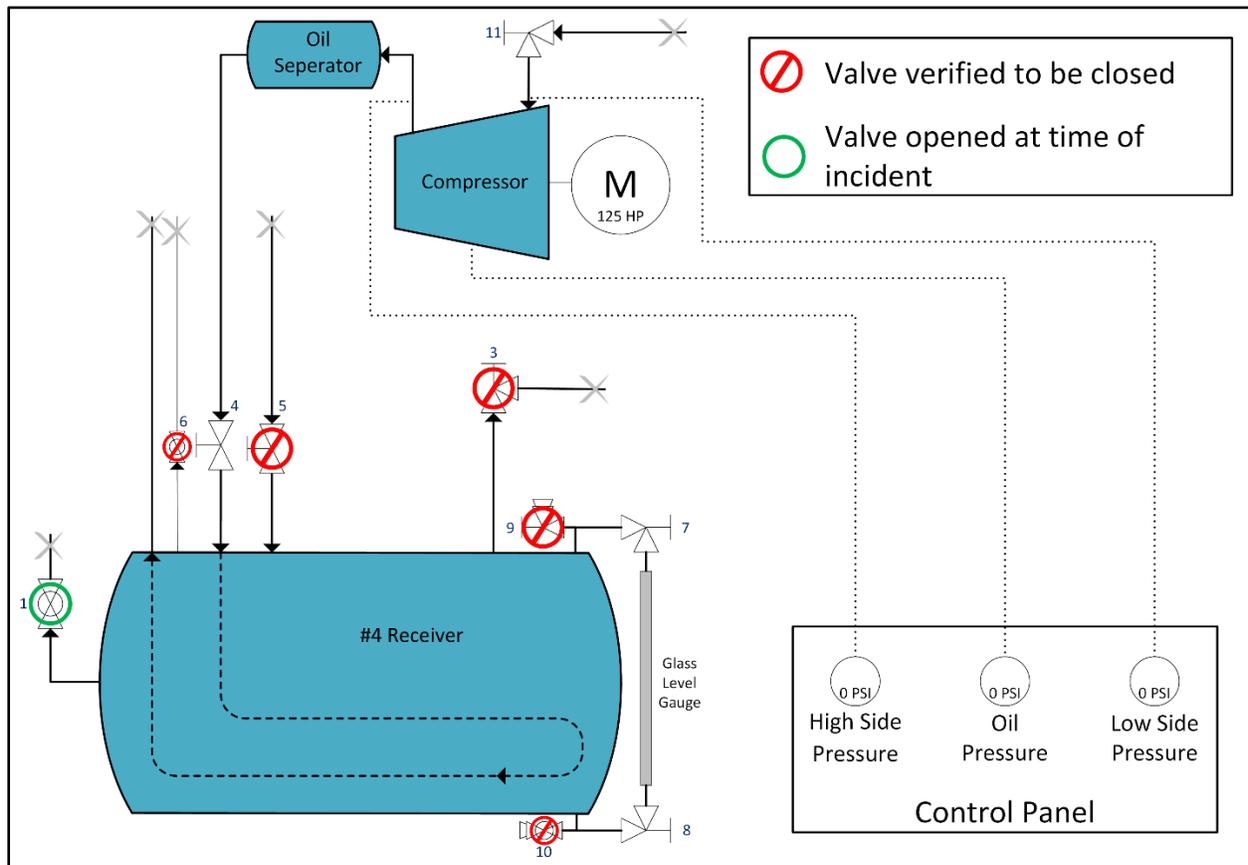
The high-pressure receiver was able to hold a pressure of 15PSI for 10 minutes. This indicates that:

1. Valves #3, #5, #6, #9, and #10 were all closed.
2. The pipe with no valve was part of an internal cooling loop independent of the receiver's primary volume and did not release pressure.
3. The gauges on the control panel were not reading the pressure inside the high-pressure receiver.

Figure 4: Known valve positions on the high-pressure receiver (Receiver #4) based on leak check findings.
