Incident Summary #II-1588168-2023 (#37421) (FINAL)

SUPPORTING INFORMATION	Incident Date	August 4, 2023	
	Location	Christina Lake	
	Regulated industry sector	Electrical - Low voltage electrical system (30V to 1000V)	
	Injury	Qty injuries	0
		Injury description	N/A
		Injury rating	None
	Impact Damage	Damage description	A conductor junction failed resulting in a short circuit between the conductor junction component and the bonded-to-ground junction box enclosure. The short circuit arcing and heating condition created localized conductor insulation damage, junction box enclosure damage, and fire damage to the ground cover layer directly below the junction box.
		Damage rating	Minor
Incident rating	Minor		
Incident overview	A recreation vehicle park electrical installation featured copper conductors and aluminum conductors that were connected by mechanical terminal lugs housed in an aluminum junction box. The terminal lugs were wrapped with insulating material. One of the conductor junctions failed, creating an electrical arcing condition within the junction box enclosure. The arcing condition created a hole in the junction box which allowed molten metal to drop down through the hole

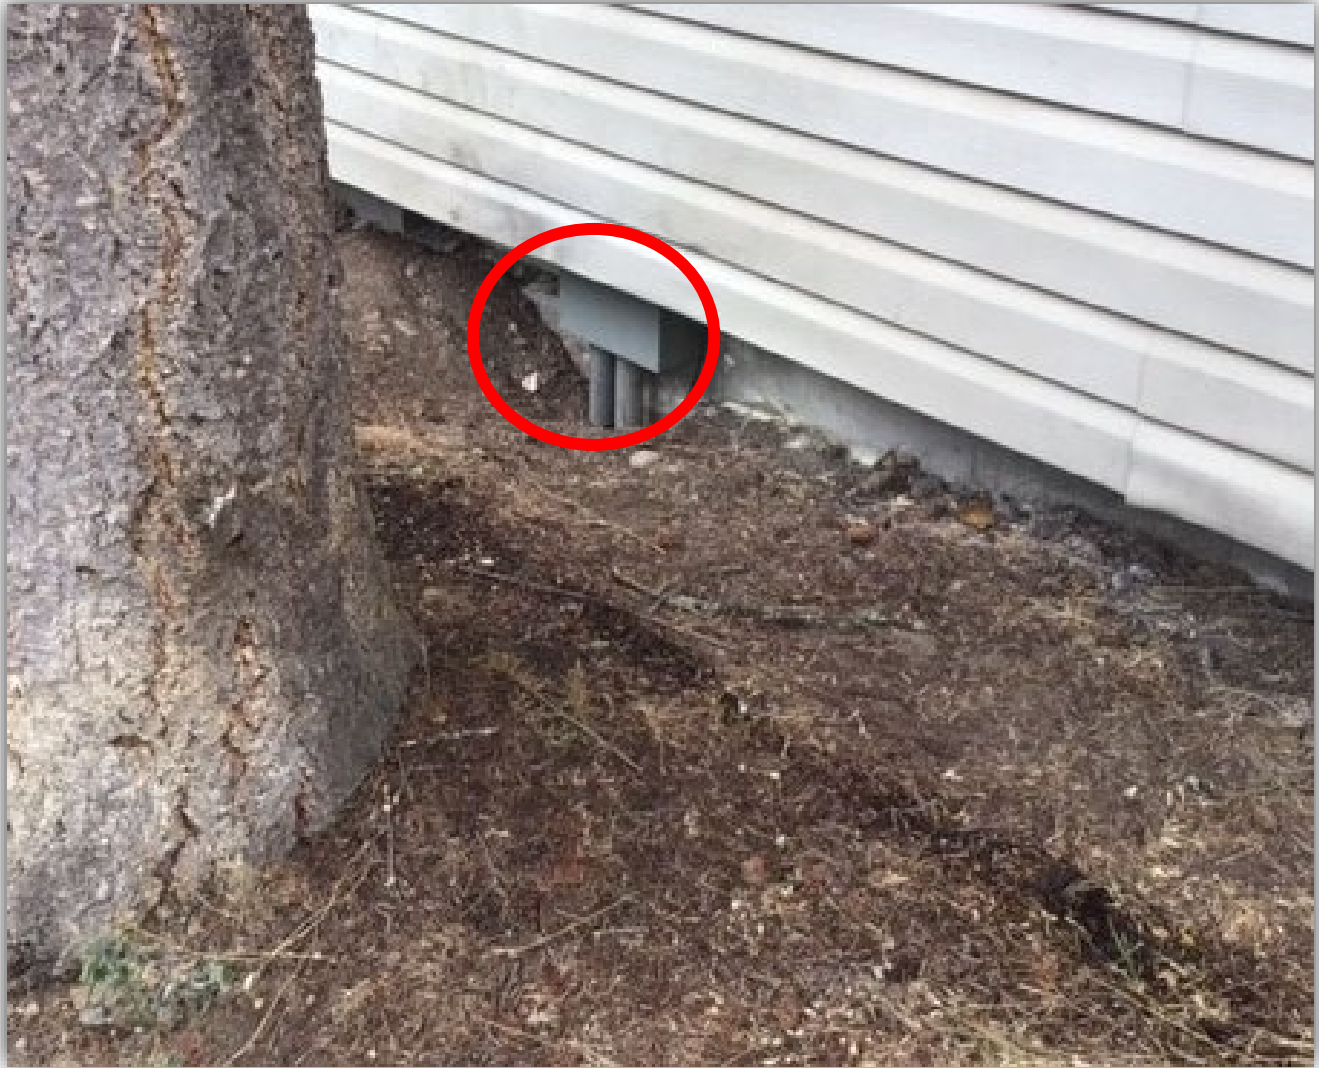
Image 2 – Southeast corner of power shed - grass fire occurred below exterior junction box.

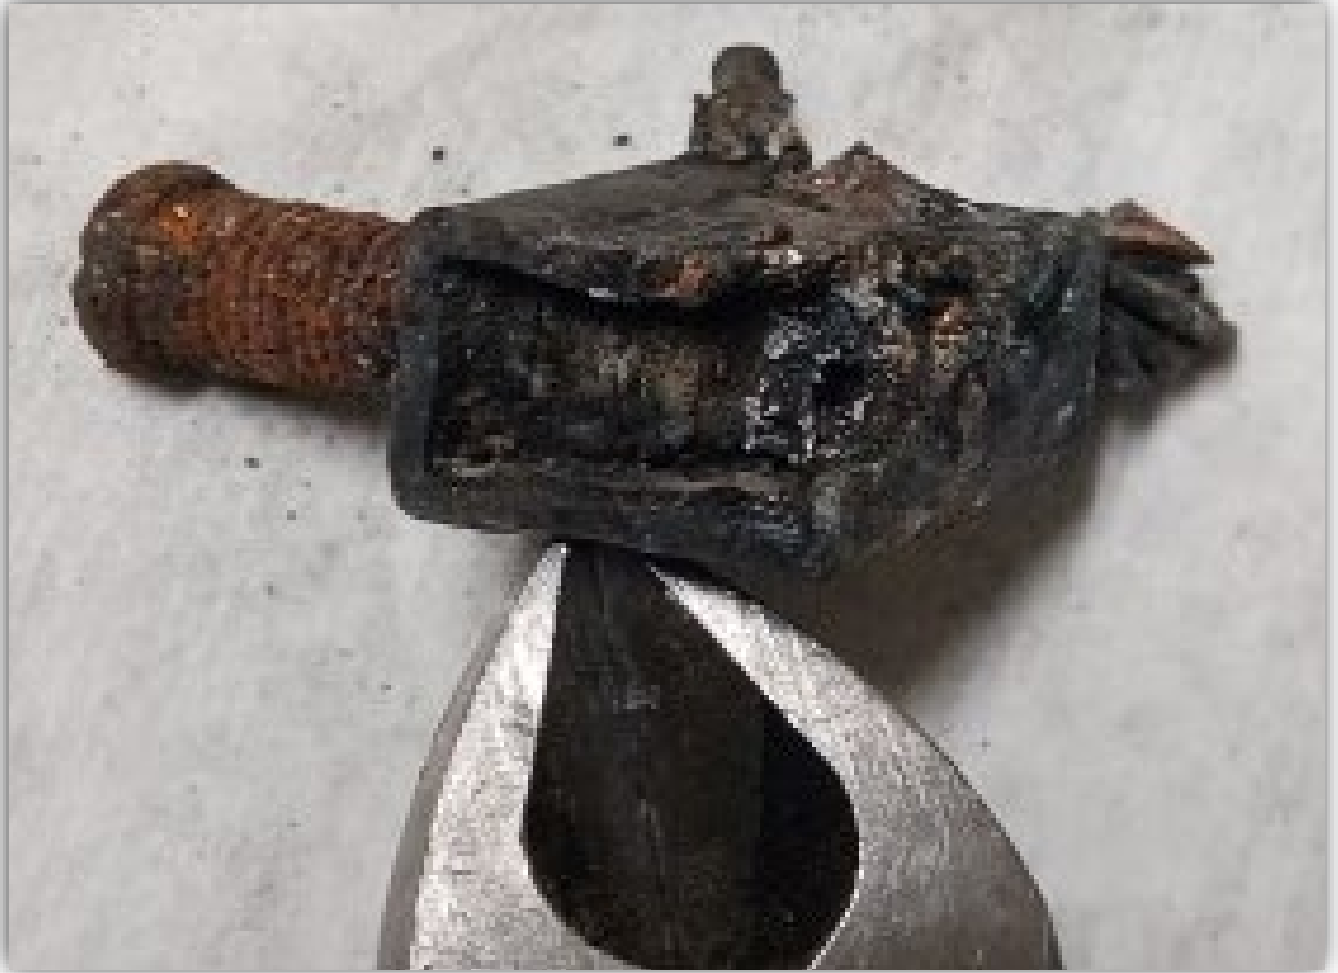
<p>Causes and contributing factors</p>	<p>The cause of the incident was a degraded aluminum to copper connection which overheated under electrical load.</p> <p>Contributing factors to the incident were:</p> <ol style="list-style-type: none"> 1. The use of unapproved mechanical connectors 2. Insufficient non-oxidizing compound used on aluminum connections. 3. The high current load draw from cooling equipment in the RV.

Image 3 – Termination lug involved in arcing incident.
