Incident Summary #II-1173055-2021 (#21513) (FINAL)

SUPPORTING INFORMATION	Incident Date	April 6, 2021	
	Location	Chilliwack- Residential home	
	Regulated industry sector	Gas - Natural gas system	
	Impact	Qty injuries	0
		Injury description	N/A
		Injury rating	None
	Damage	Damage description	Heat damage to insulation on inside of furnace and burnt acoustic insulation inside furnace ducting.
		Damage rating	Minor
	Incident rating	Minor	
	Incident overview	A homeowner noticed a burning smell coming from the vents in the home. He quickly turned the furnace off and realized something was burning inside the ducting near the furnace.	
INVESTIGATION CONCLUSIONS	Site, system and components	Furnaces are commonly used to heat residential homes. In normal circumstances they are a safe and effective way of warming the home, however clearances to combustibles need to be maintained (as per manufacturers instructions and Gas installation code). Supply and return ducts are sealed to the furnace cabinets so that foreign objects etc. do not make their way into the furnace.

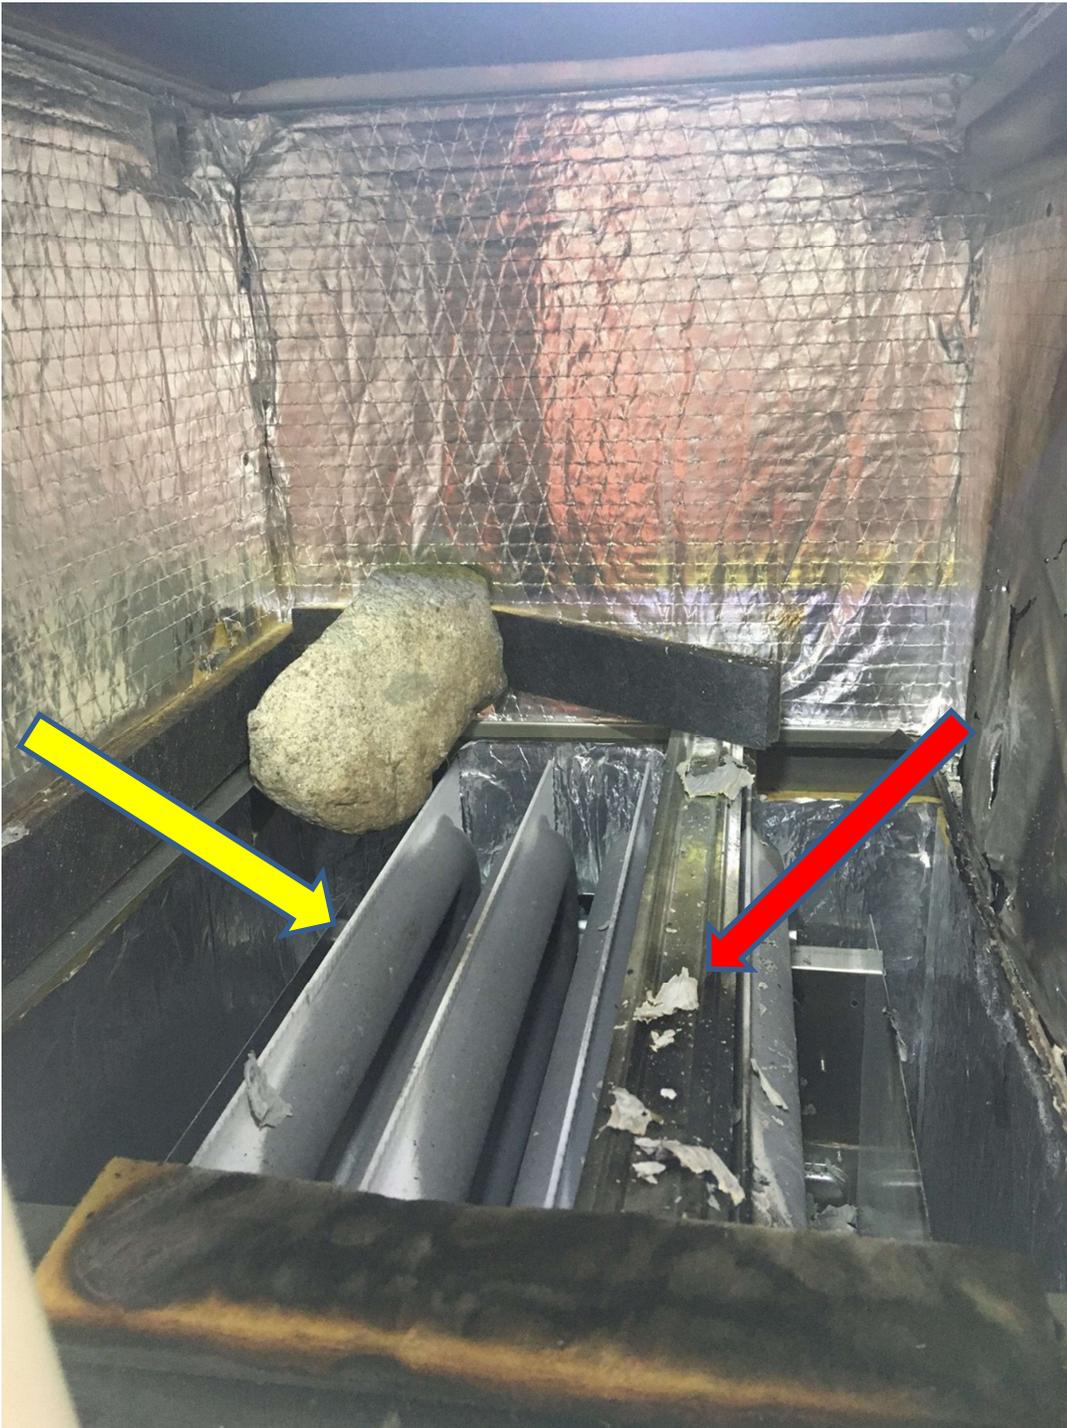
Failure scenario(s)	A piece of cardboard inside the ducting resting on the heat exchanger of the furnace became hot enough to catch fire and spread to the furnace cabinet and acoustic duct insulation.	
	Facts and evidence	<p>-2 weeks prior to the incident, a duct cleaning was completed by a company who provides the service.</p> <p>-cardboard ash and a large rock were found on top of the furnace heat exchanger after the incident</p> <p>-the duct cleaning company has stated that they often cut an access hole in the ducting above the furnace and place a piece of cardboard and weighted object on top of the furnace heat exchanger during duct cleaning. This is done to prevent debris from falling into the furnace. After the cleaning process, the cardboard and weight are removed, and access hole covered with a patch. Compressed air and vacuums are used to clean the ducts.</p>	
	Causes and contributing factors	After the ducts were cleaned, the duct cleaner forgot to remove the piece of cardboard and rock and closed the access hole. During the two weeks after the duct cleaning and up to the incident, the area was experiencing mild temperatures. This likely resulted in the furnace only cycling on periodically and taking time to fully dry and overheat the cardboard till it eventually caught fire and began damaging the insulation.

The rock left side of the picture.

Yellow arrow points to the heat exchanger

Red arrow points to the bits of cardboard ash.

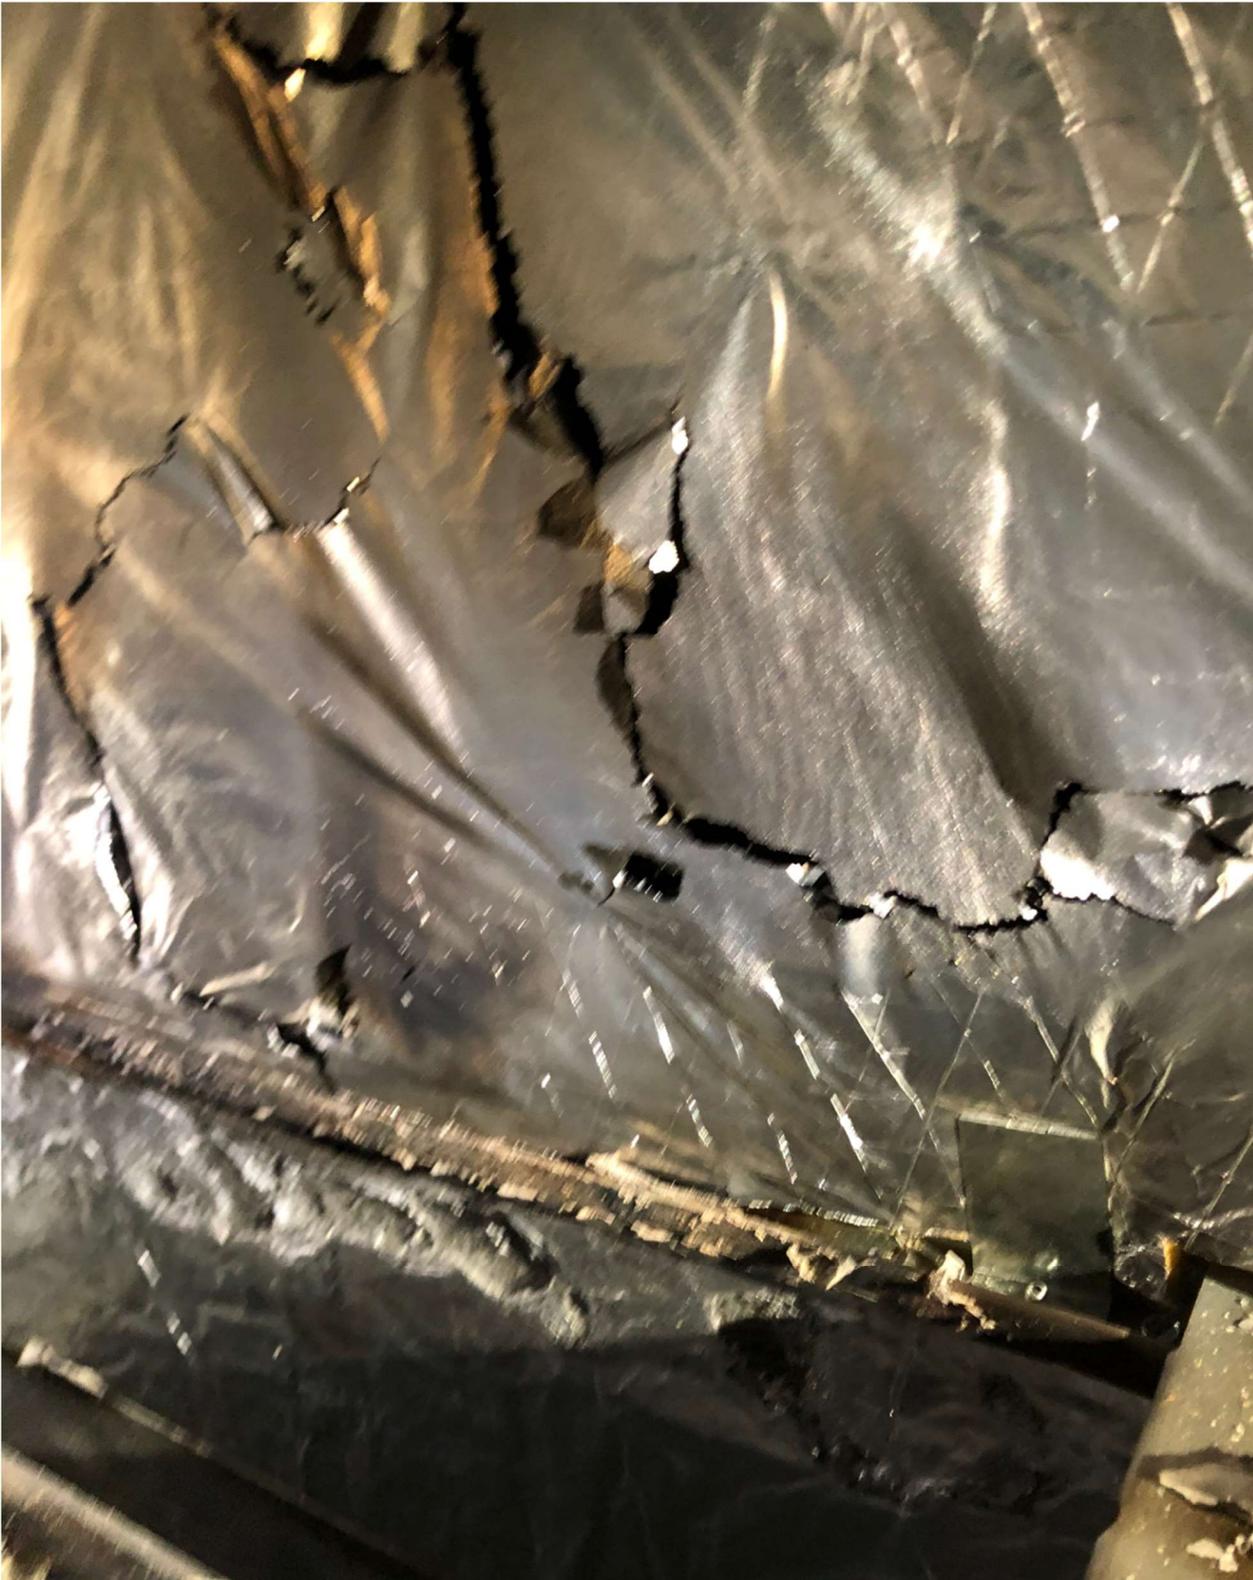
Picture above shows charred insulation
