Incident Summary #II-1194712-2021 (#22041) (FINAL)

SUPPORTING INFORMATION	Incident Date	May 14, 2021	
	Location	Victoria	
	Regulated industry sector	Electrical - High voltage electrical system (greater than 750V)	
	Impact	Qty injuries	0
		Injury description	Not Applicable
		Injury rating	None
	Damage	Damage description	Catastrophic phase to phase fault on high voltage equipment, as well as water damage to subsequent low voltage (600 volt) equipment and distribution systems
		Damage rating	Major
	Incident rating	Major	
Incident overview	Failure of a pressurized, underground irrigation pipe on a timed system caused water to infiltrate an underground conduit system leading to an electrical room ceiling junction box. This box pressurized, causing the water to force past cover, pour onto 600 Volt bus duct and distribution centre resulting in short circuit of main transformer.		
INVESTIGATION CONCLUSIONS	Site, system and components	<p>The site is a public facility, fed by a utility 3phase, 25KV high voltage service to an electrical room. The high voltage feeder then passes through 3, high voltage fuses (1 per phase), and then to a transformer which converts the 25KV to 347/600V for cust

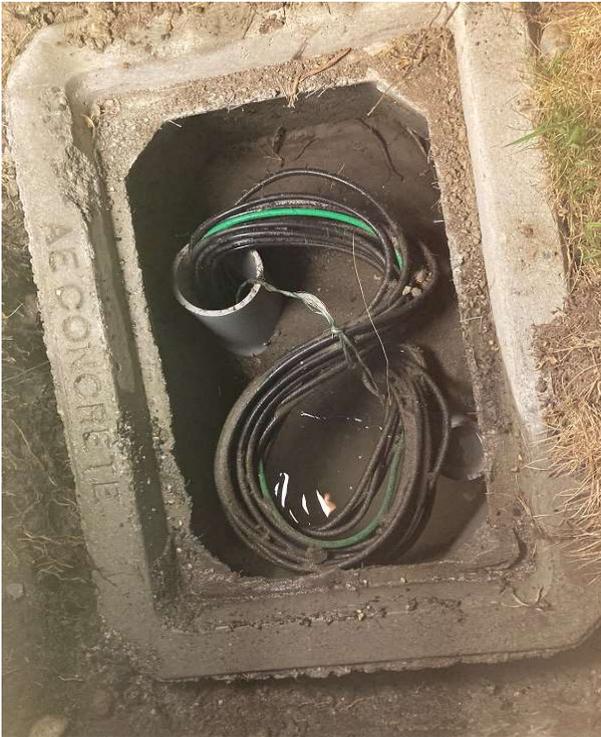
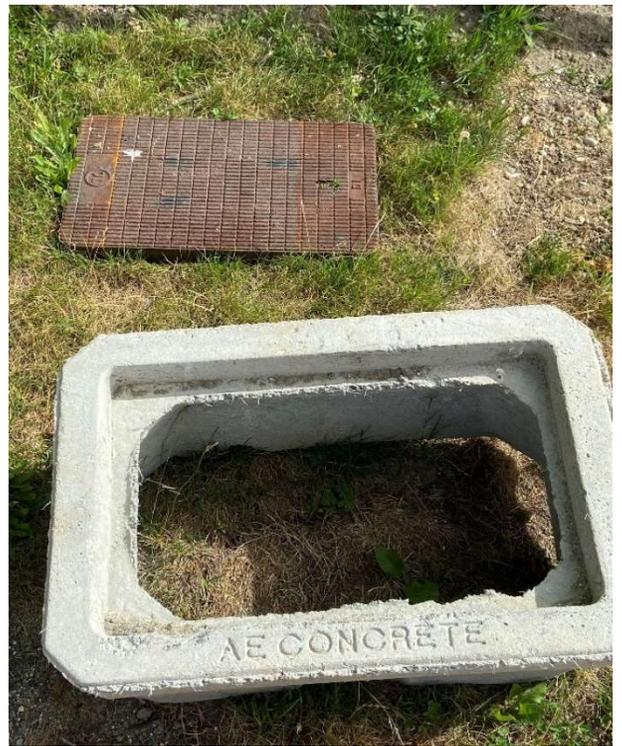
Photo group 1 – in ground EV charger junction box

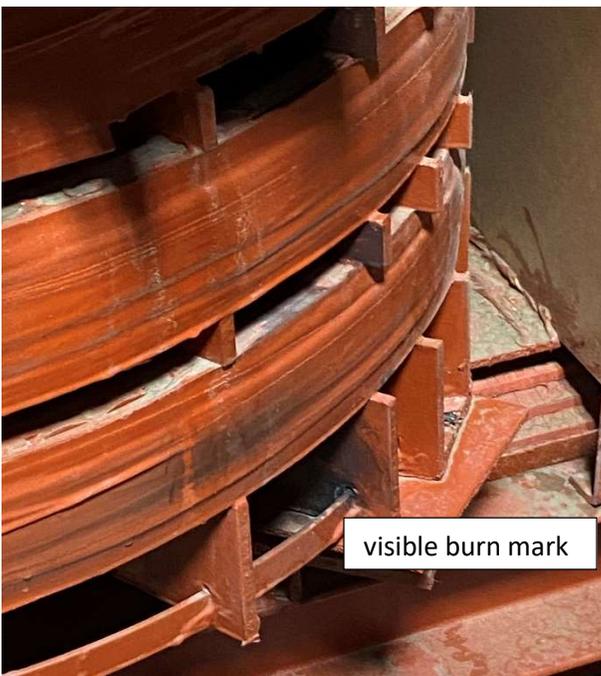
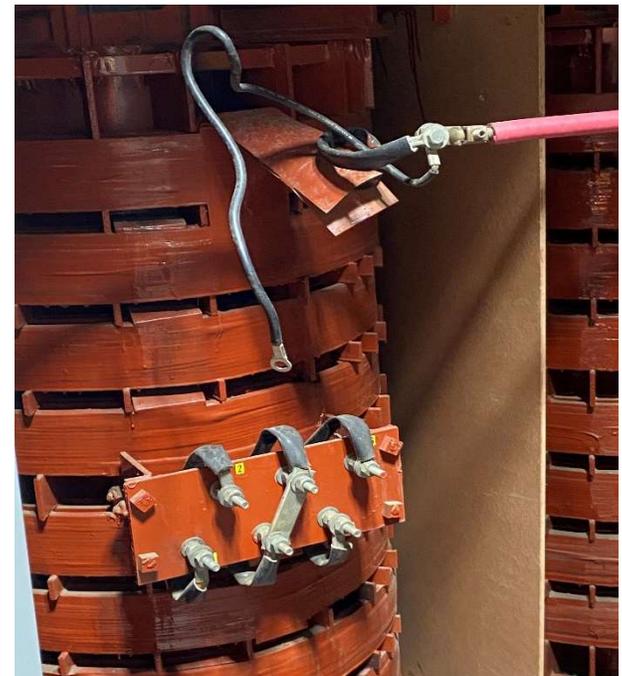
Photo group 2 – 25KV transformer

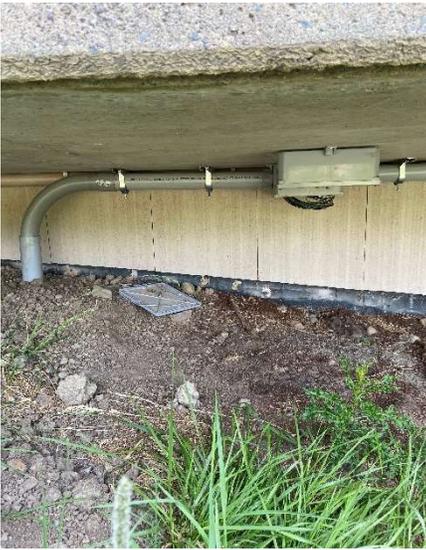
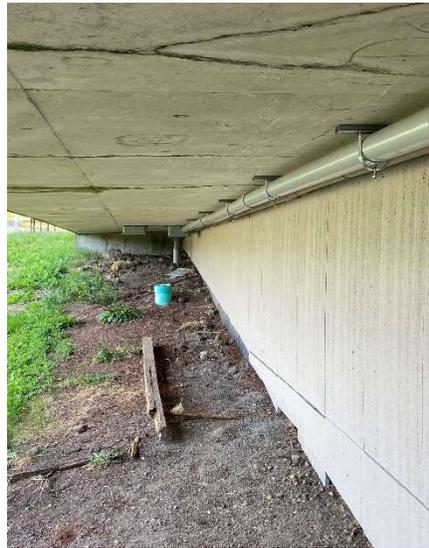
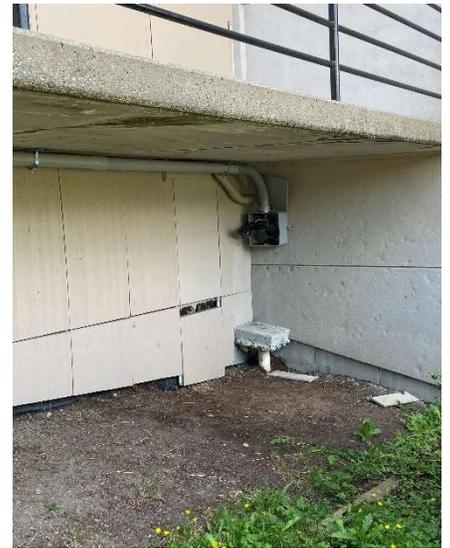
Photo group 3 – EV charger conduit system

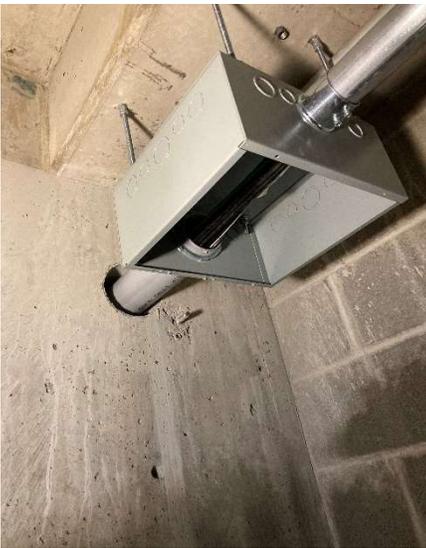
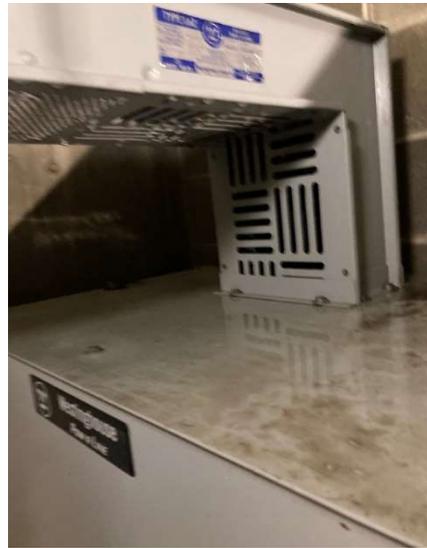
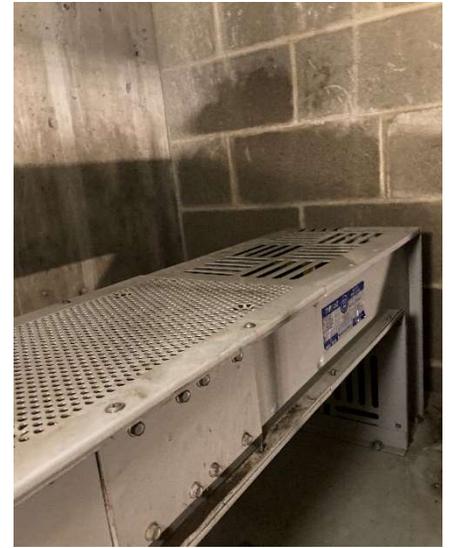
Photo 4 – EV electrical rm box
above bus duct

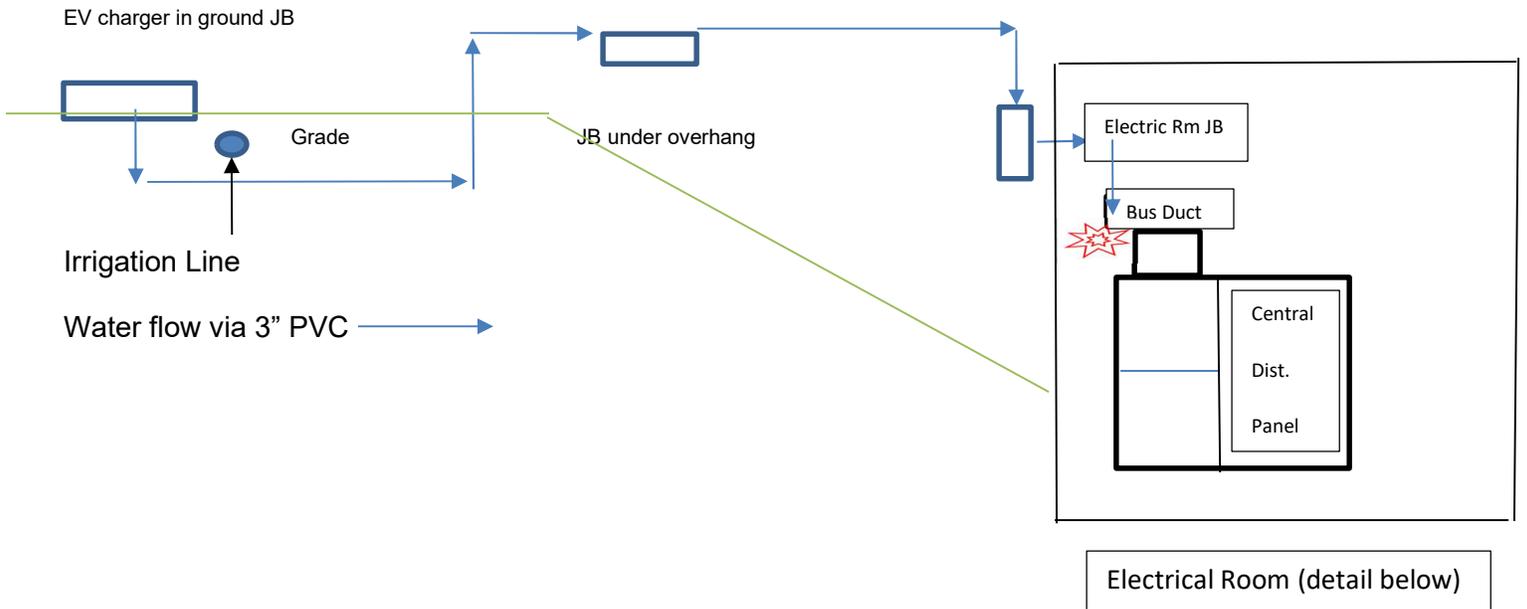
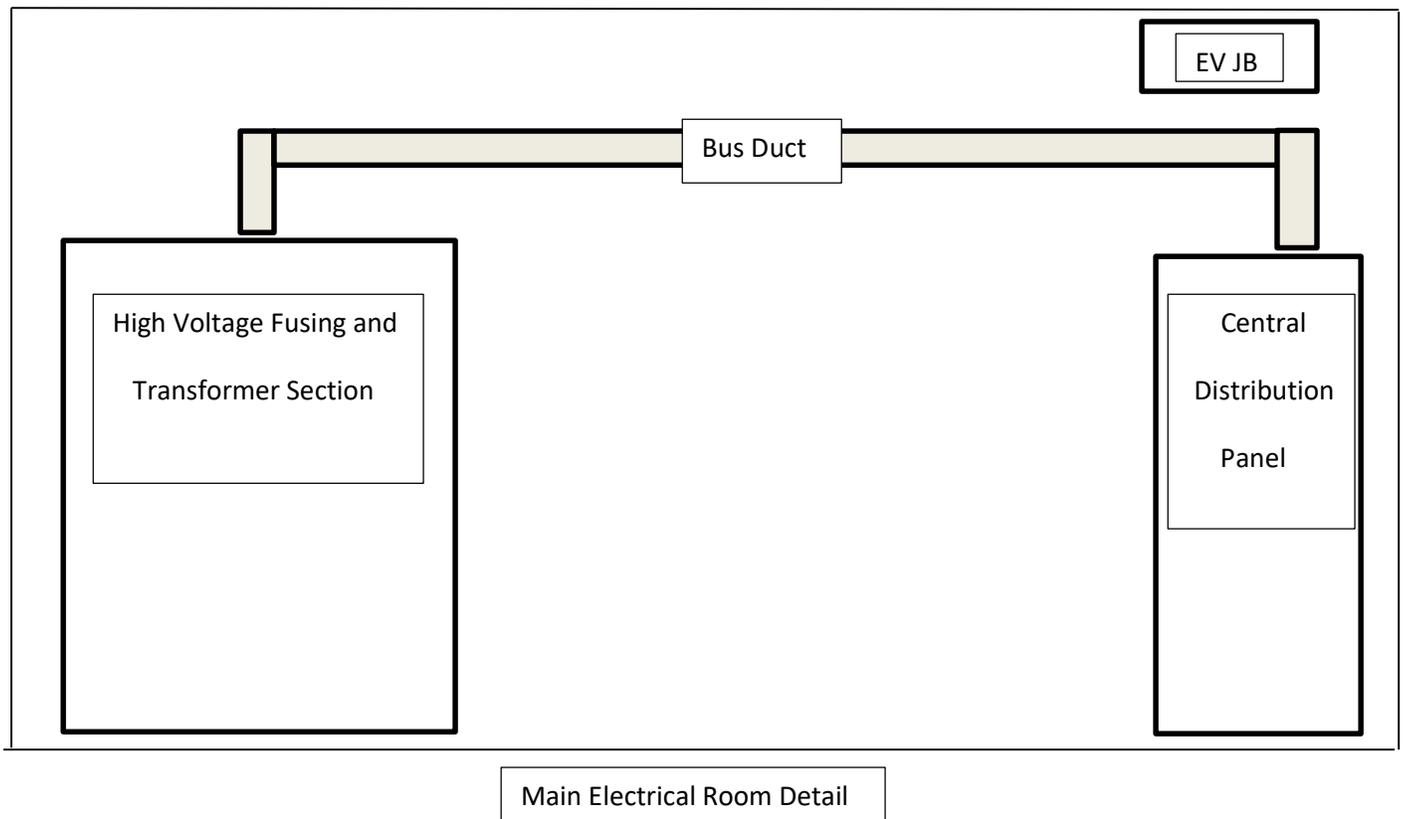
Photo group 5 – bus duct entering central distribution panel below
bus duct
