## Incident Summary (Reference 5574511)

| | Regulated industry sector | | Boilers, PV and Refrigeration | |
| DESCRIPTION | Incident overview | | A leak was identified in the lower furnace of a Recovery Boiler. The tube leak discharged directly into the smelt bed. An emergency shut down of Recovery Boiler was employed. The potential for a smelt water explosion was created. | |

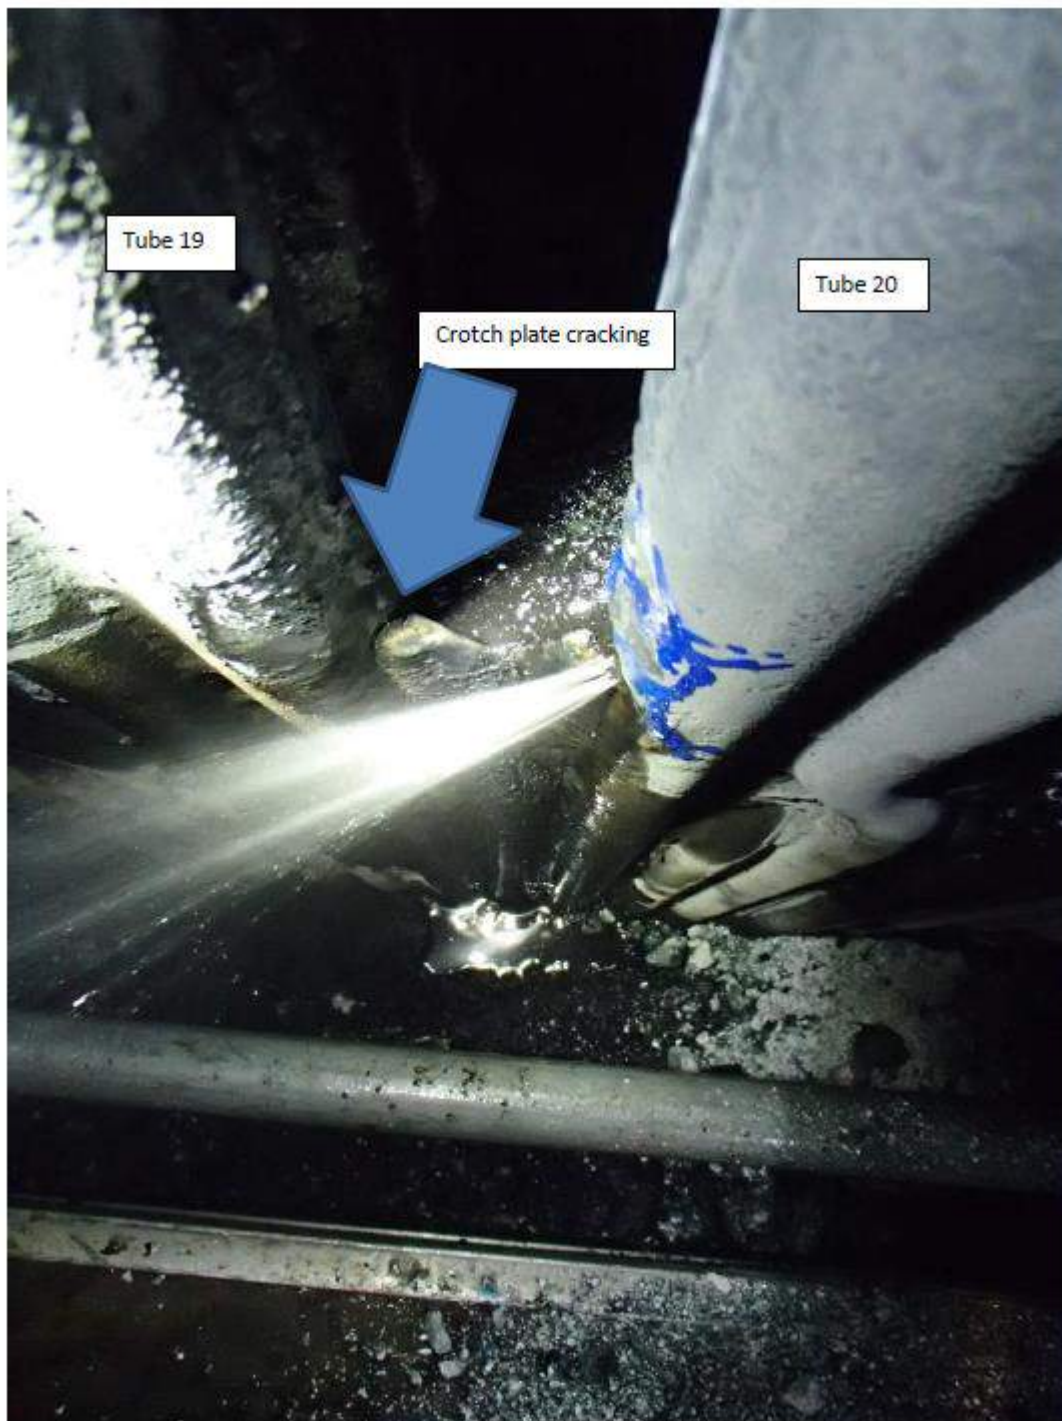
| CONCLUSIONS | Failure scenario(s) | | The failure occurred at the junction of an opening in the boiler wall, which is comprised of a series of vertical tubes welded to one another. The crack was located at the convergence of 2 tubes in a wall opening, it propagated from the connecting membrane into the wall of a boiler tube.<br>The operating conditions, age of the equipment and design of the boiler contributed to development of a crack. | |
| | Facts and Evidence | | This failure has previously occurred at this site as well as with other boilers of a similar construction. It has been recognized by owners operators and the manufacturer that the inherent design of the tube wall openings contribute to the likelihood of failures. During operation the area is also exposed to high temperatures and a method of cleaning and maintenance known as “port rodding”, which contributes to corrosion/erosion. | |
| | Causes and Contributing Factors | | It is probable that the operating conditions, age of the equipment and design of the boiler contributed to this failure. | |
