Incident Summary #II-752719-2018 (#8908) (FINAL)

SUPPORTING INFORMATION	Incident Date	September 28, 2018	
	Location	Abbotsford BC	
	Regulated industry sector	Gas - Natural gas system	
	Impact	Qty injuries	0
		Injury description	None
		Injury rating	None
	Damage	Damage description	Small hole in a copper gas line
		Damage rating	Moderate
	Incident rating	Moderate	
Incident overview	Since moving into their new home in 2010, occupants of the home could smell what they thought was natural gas in different parts of the home.		
INVESTIGATION CONCLUSIONS	Site, system and components	<p>Natural gas is brought into houses through gas lines which can be copper, corrugated stainless steel tubing or black iron pipe. Natural gas has an added odorant called methyl mercaptan so that it can be detected by sense of smell in case of a leak.</p> <p>These gas lines are commonly run inside the walls so that they are out of sight and protected from physical impact.</p> <p>When running copper tubing through these walls, provisions need to be made so that nails and screws do not penetrate the copper tubing when the walls are covered up with drywall, plywood, or other materials.</p> <p>The gas installation

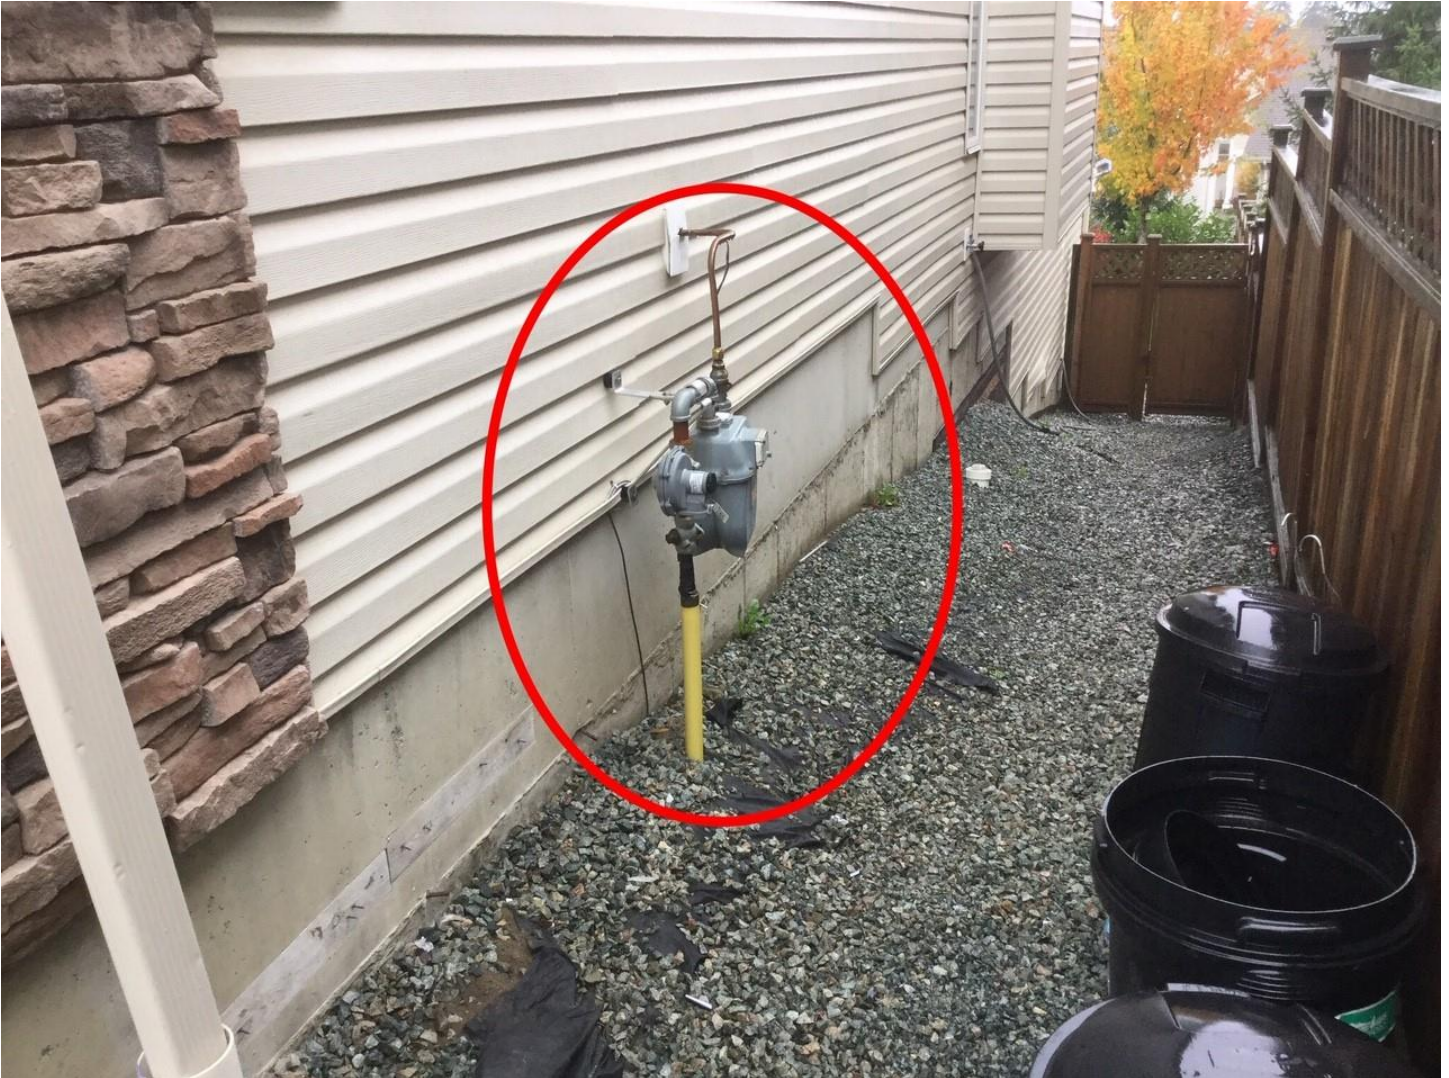
Picture #1

-Red oval circles the natural gas meter where gas is supplied to the home (copper is already repaired in this picture).

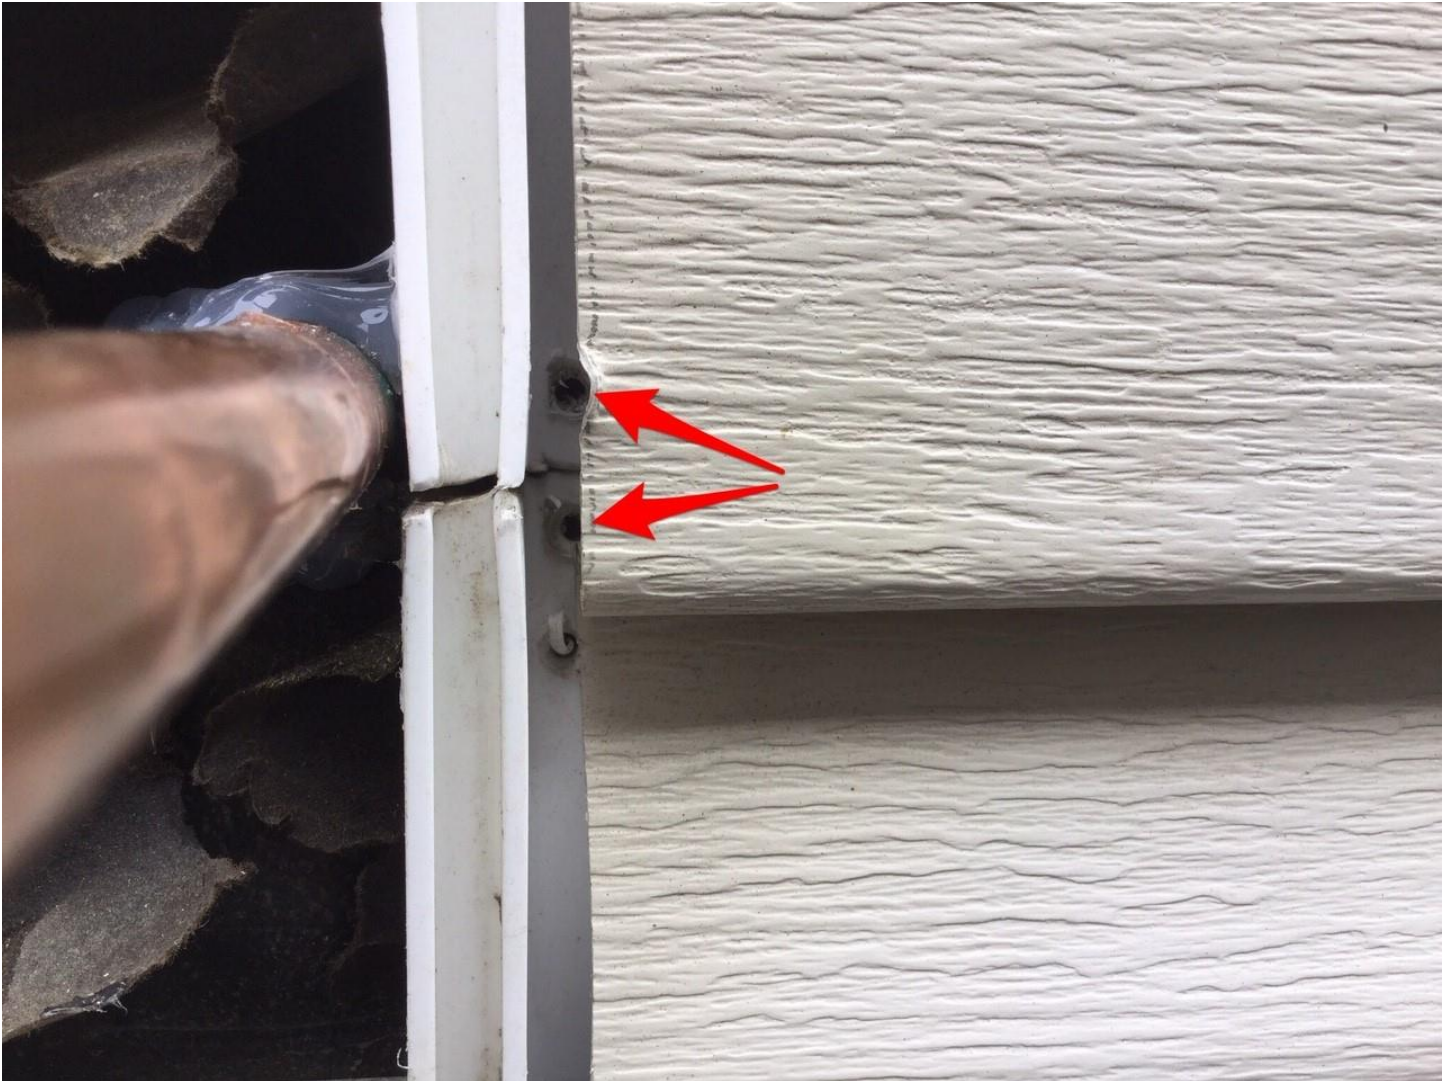
Picture # 2

Causes and contributing factors	<p>During the installation of the vinyl exterior siding and trim pieces, screws were driven into the exterior piercing the copper tubing and causing a leak. A metal protection plate installed where the copper tubing was less than 1.75" from the exterior plywood surface would have likely prevented this.</p>

-Red arrows point to where screws were driven into the exterior, puncturing the copper tubing

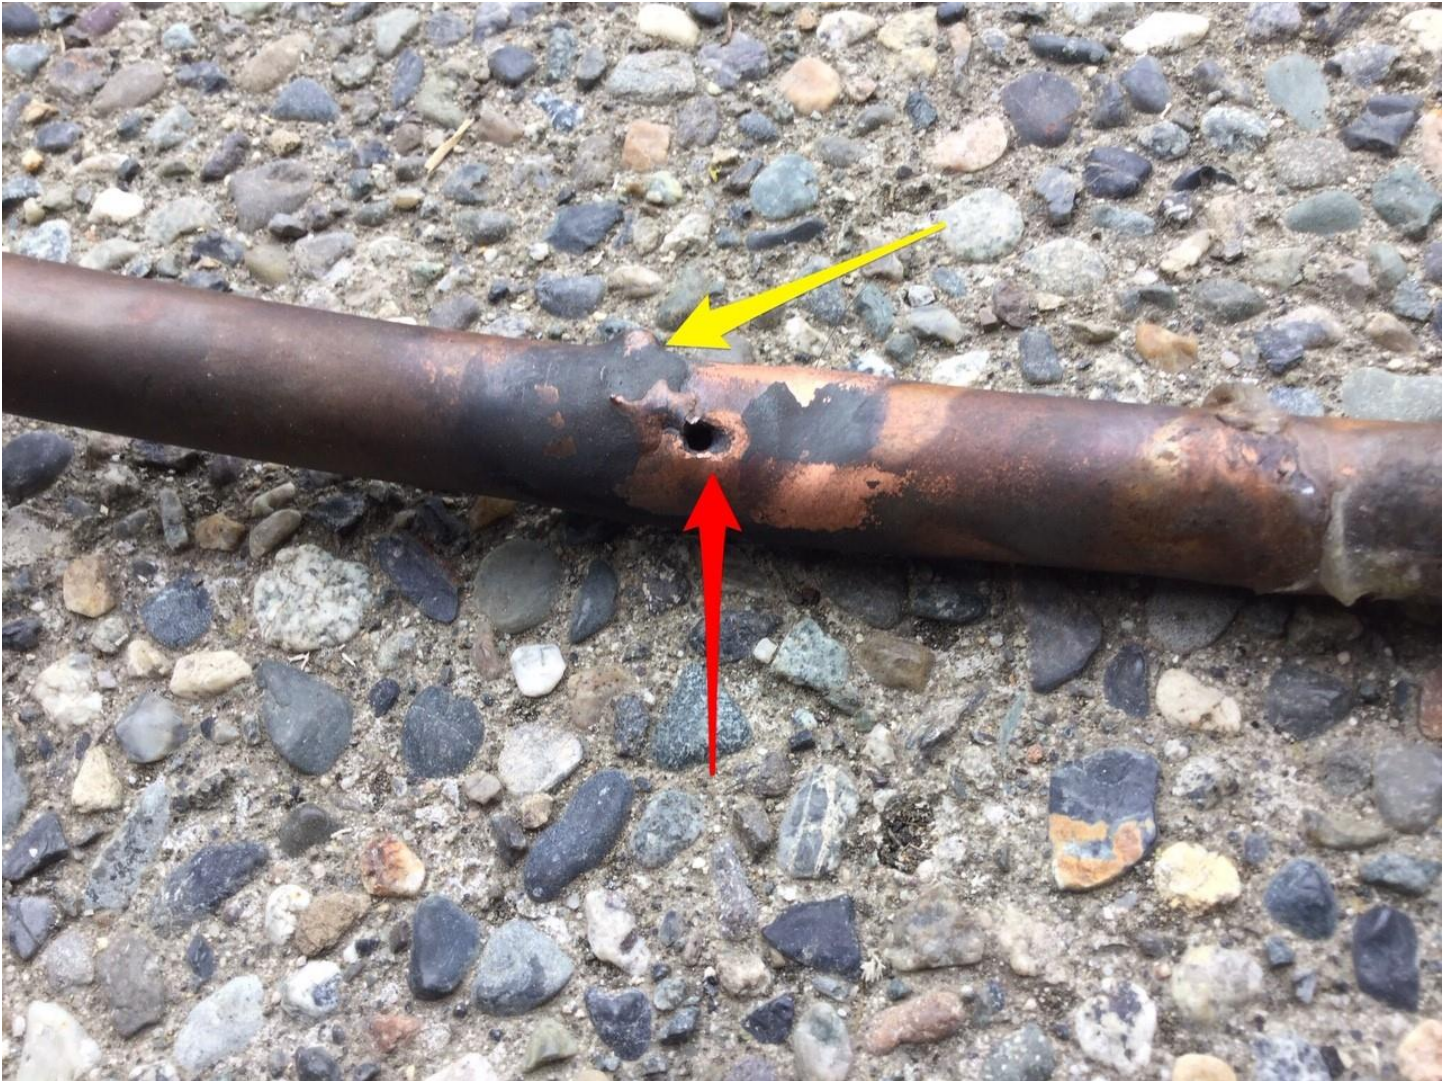
Picture #3

<p>into the exterior and copper tubing but went unnoticed. (see picture #3 of brazed repair and second hole next to the repair)</p> <ul style="list-style-type: none"> - The screw that punctured the copper tubing slowed down the release of gas and because it was in an insulated and sealed wall, it was difficult to determine where the gas odor was coming from. -During a recent renovation, drywall was removed in the garage and the leak was discovered. The home owner stated that the screw was found piercing the copper tubing. -The screw punctured the copper where the tubing passed through the wall on an angle from outside to inside. -Two screw holes can be seen on the exterior siding that align with the hole in the copper tubing and the solder repair. (see picture #2) -No installation permit could be located for this installation. Worker qualification/ experience could not be determined. It is also unknown if correct pressure testing procedures were followed.

-Yellow arrow points to brazed repair

-Red arrow points to the hole caused by the 2nd screw
