Incident Summary #II-1765674-2024 (#52211) (FINAL)

SUPPORTING INFORMATION	Incident Date	September 24, 2024	
	Location	Prince George	
	Regulated industry sector	Electrical - Low voltage electrical system (30V to 1000V)	
	Impact	Qty injuries	0
		Injury description	No injuries
		Injury rating	None
	Damage	Damage description	A Motor Control Center (MCC) bucket arc-flashed causing damage to the breaker, wiring and small dust fire occurred causing charring and soot on the door.
		Damage rating	Moderate
Incident rating	Moderate		
Incident overview	At a sawmill, a pull-out pump motor control bucket in the 27-inch barker (powering machinery used for de-barking logs) Motor Control Center (MCC) had an arc-flash. The phase "A" TEW 600volt conductor that ran from the breaker to the starter contactor arced to the metal enclosure of the MCC bucket.		
INVESTIGATION CONCLUSIONS	Site, system and components	<p>The incident happened at an "L" shaped Sawmill where logs come in one side, are processed, sorted and travel through the facility and continue out the other side before travelling to the kiln and planer mill areas. This is an automated Mill where production starts at 0700 with 2 electricians o

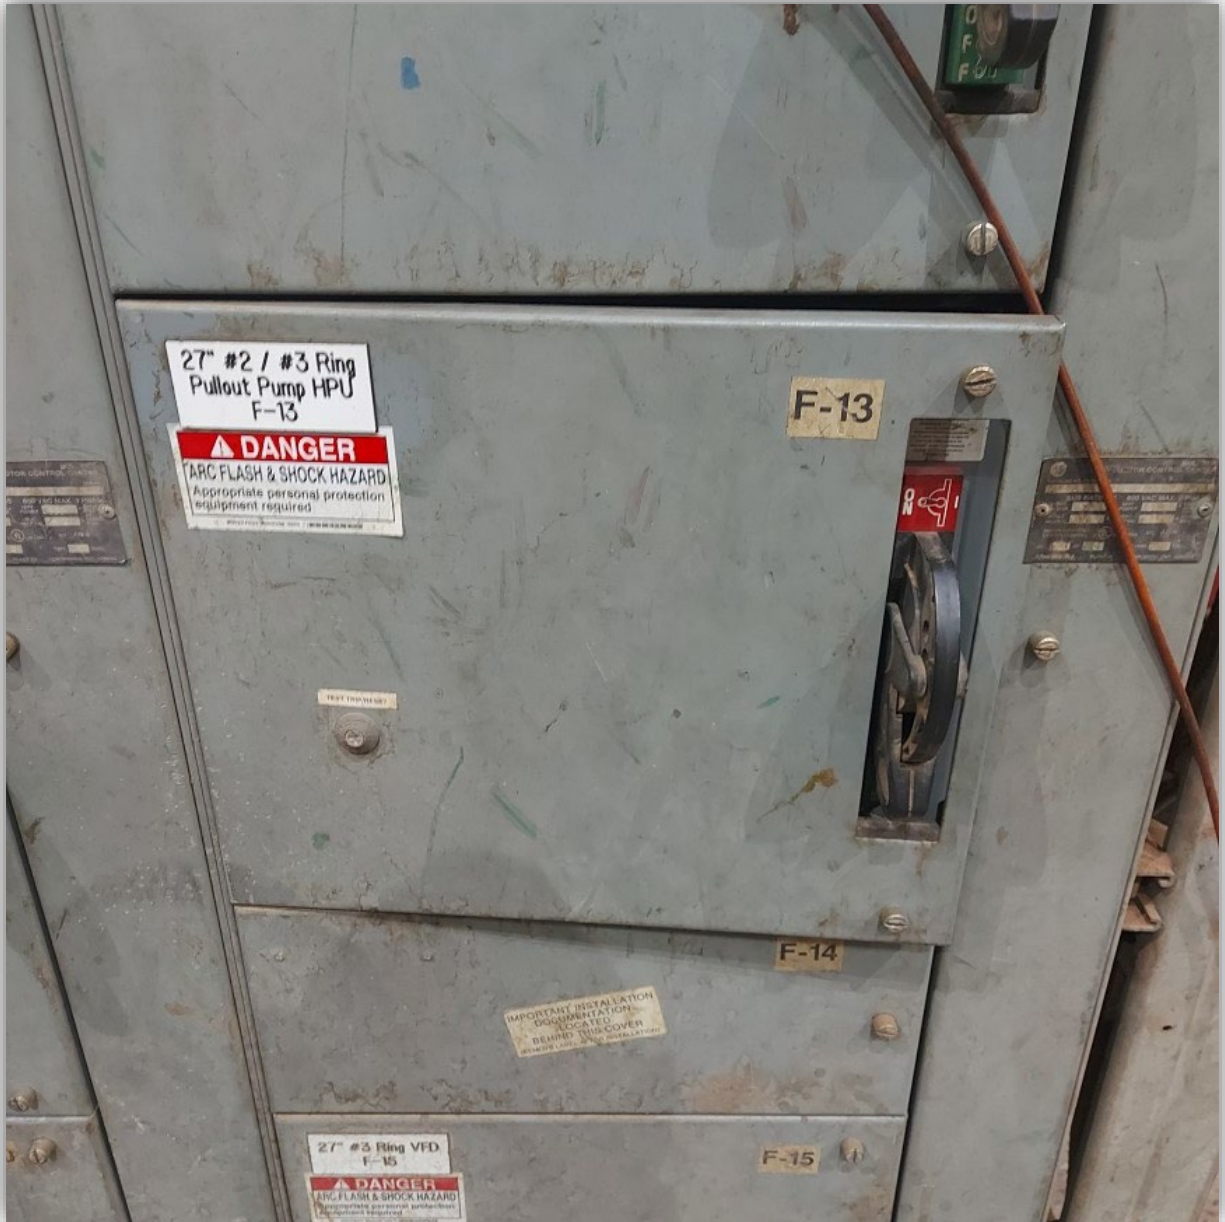
Image 1 - Front of Motor Control Centre (MCC) Bucket.

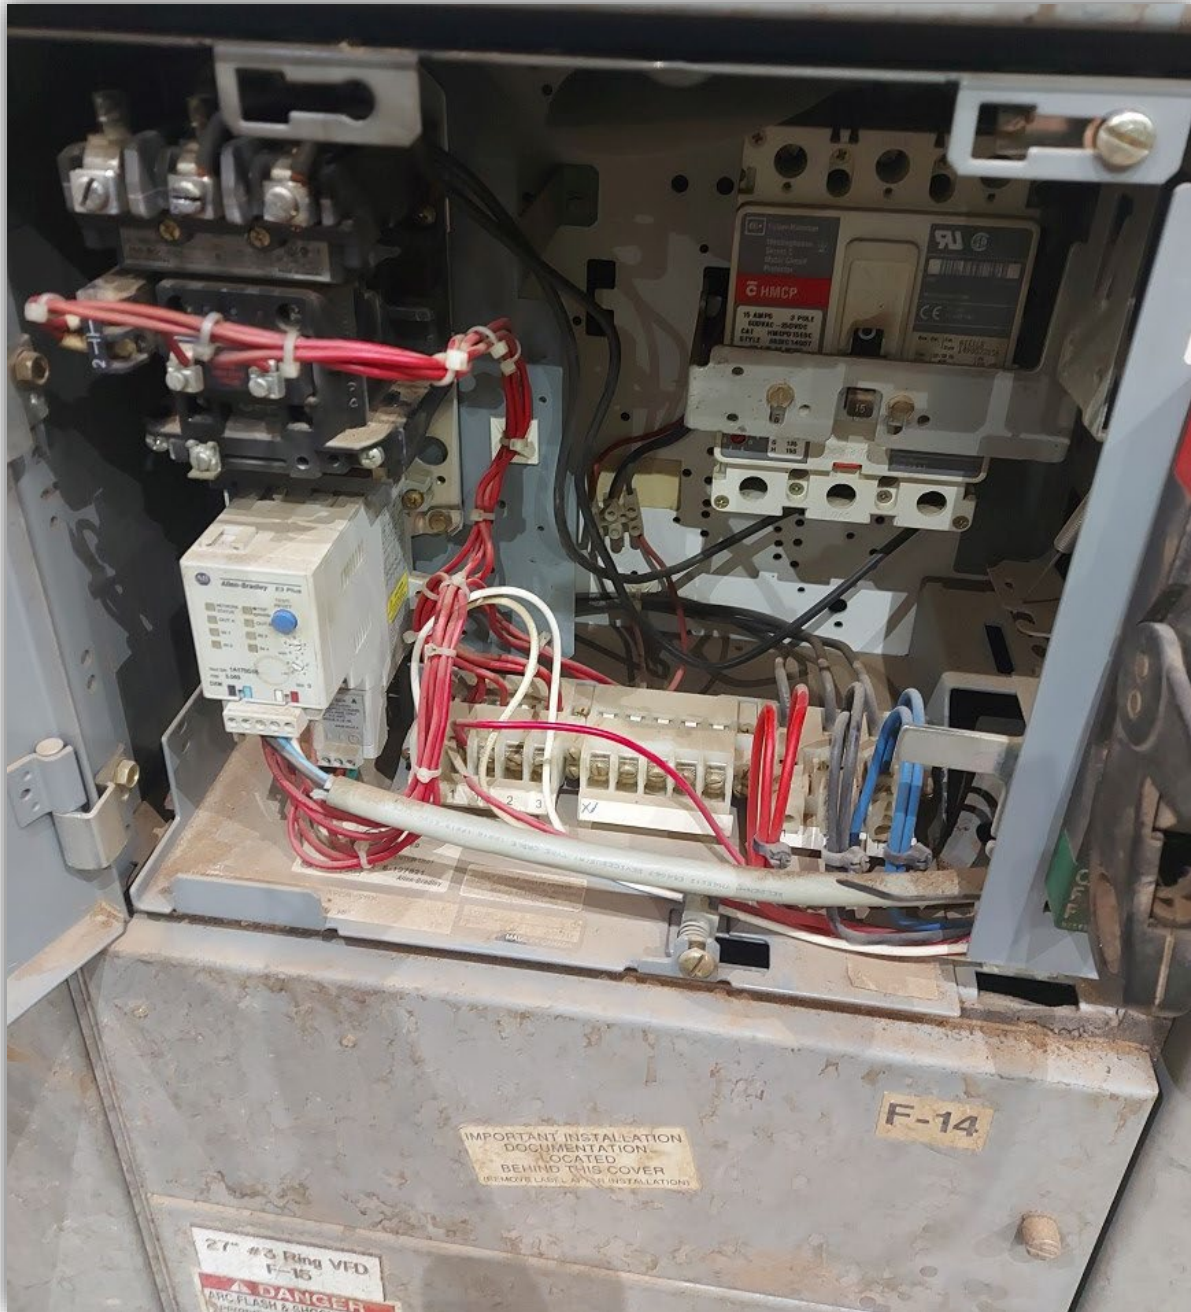
Image 2 - Inside Motor Control Centre (MCC) Bucket the phase "A" TEW conductor has been removed. If the picture is enlarged, you can see the starter mounting plate.

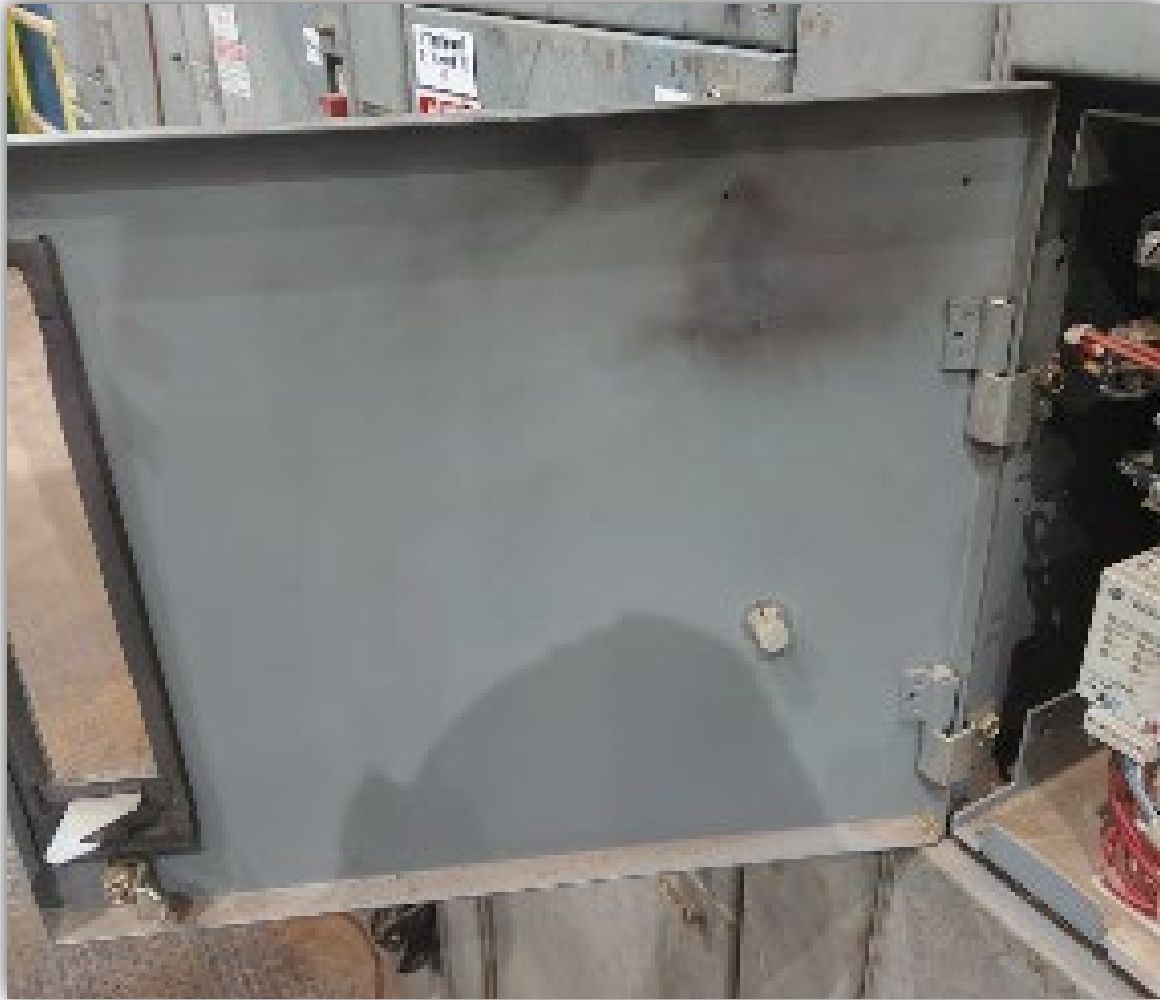
Image 3 - Door of Motor Control Centre (MCC) Bucket showing some charring and soot from the arc-flash incident.

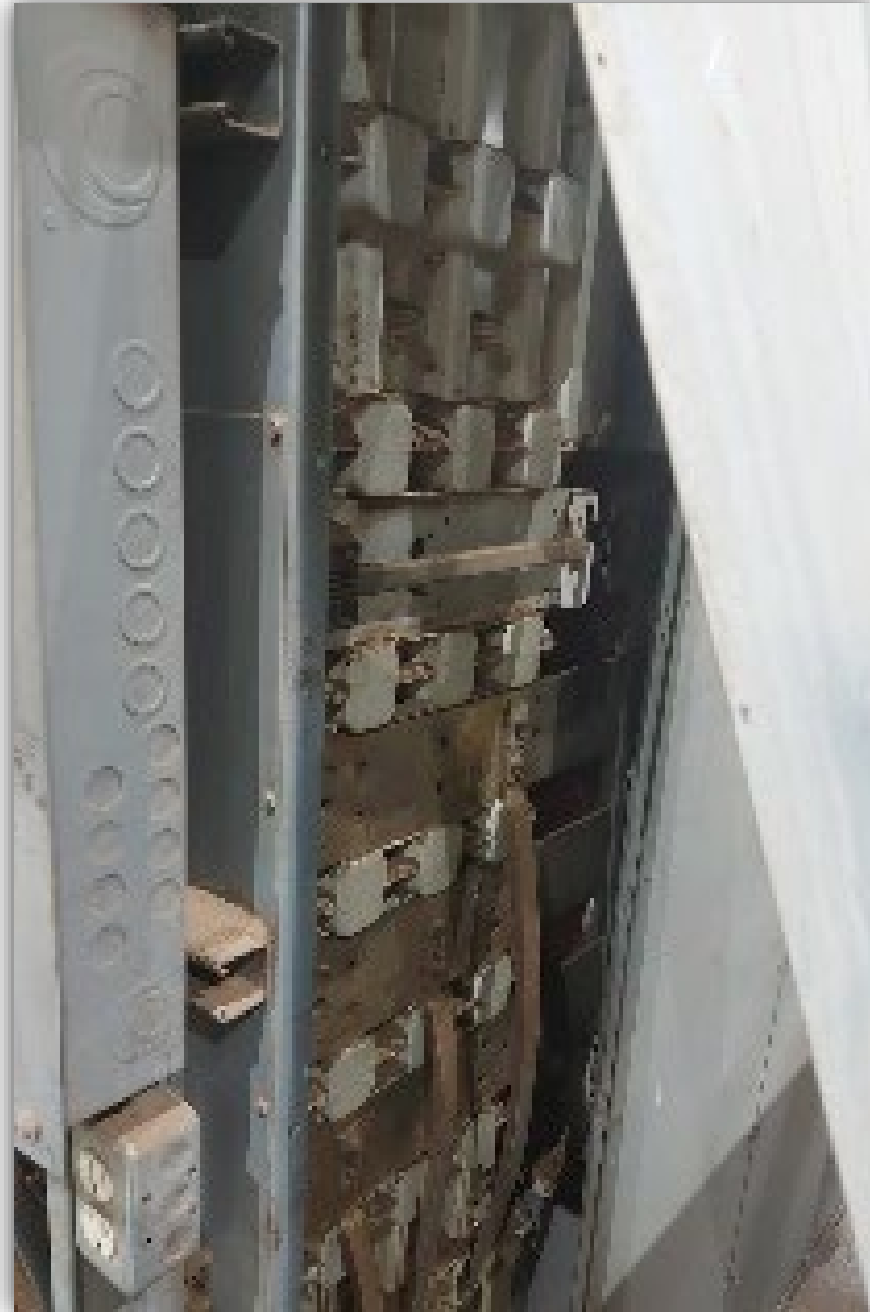
Image 4 - Rear of Motor Control Centre (MCC) with cover removed to inspect for any damage from the arc-flash incident (Image supplied by Mill Manager).

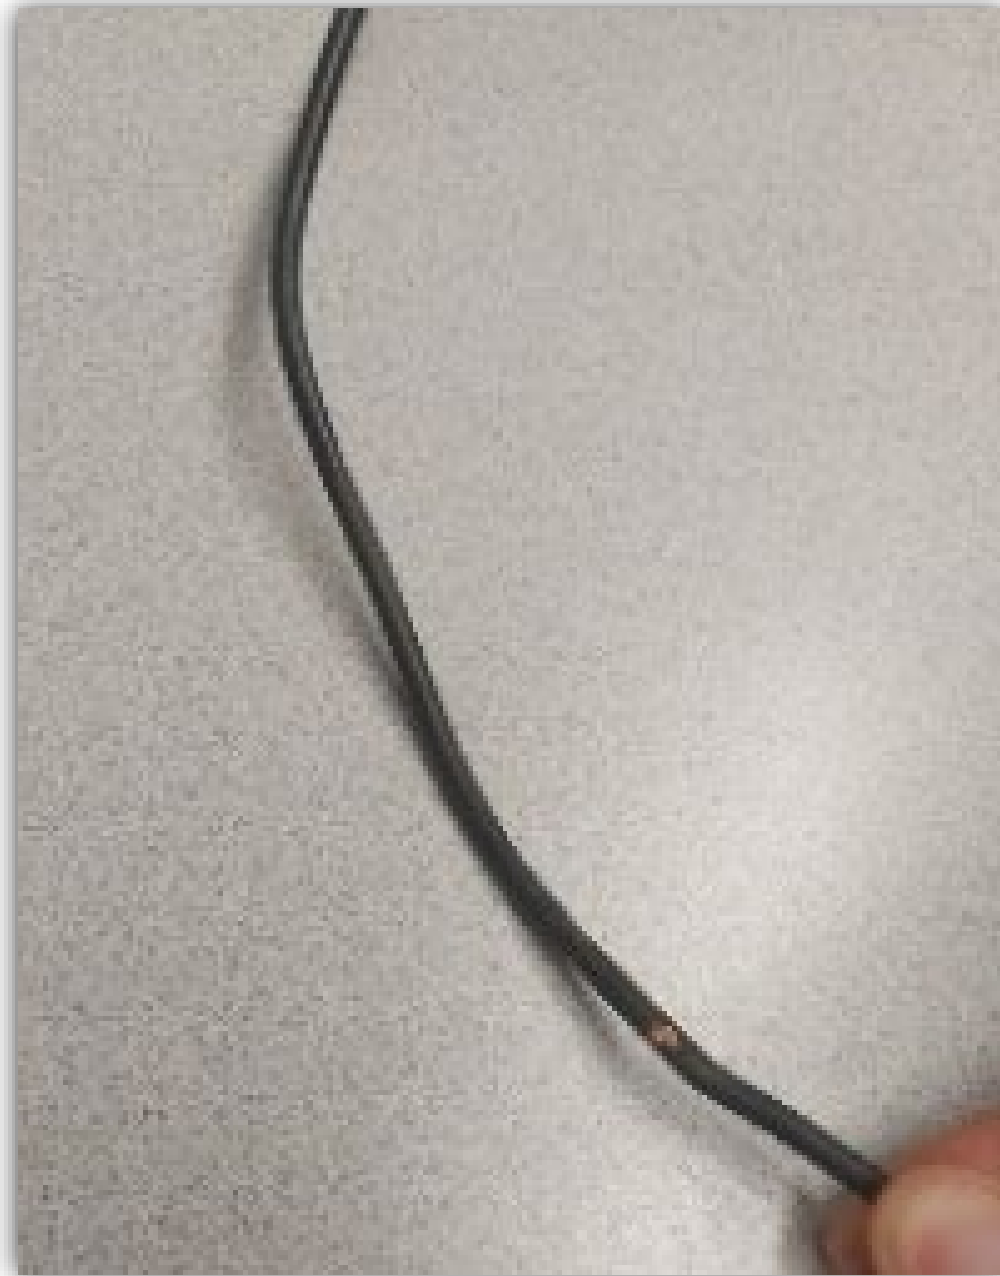
<p>Causes and contributing factors</p>	<p>It is likely that the arc flash was caused by higher than normal voltages due to an existing ground fault conditions which exceeded the insulating capacity of a 600v TEW conductor.</p> <p>It is likely the location of the arc flash was due to the insulation of the conductor in that location being degraded over time due to abrasion against the MCC bucket wall.</p> <p>One of the contributing factors was likely that the sawmill was operating with a visual only monitoring system. An audible monitoring system was not required by the CEC. The ground fault alert lights mounted on the MCC needed to be specifically looked at directly to alert employees of a fault when they may not have been able to view the fault lights for periods of time and there is no dedicated person monitoring this. When the original fault happened, it was not immediately discovered, as the foreman had been somewhere else on the floor.</p>

Image 5 - TEW 600volt wire from phase "A" that arced. Worn to copper where it arced due to friction on mounting bracket components in the MCC.

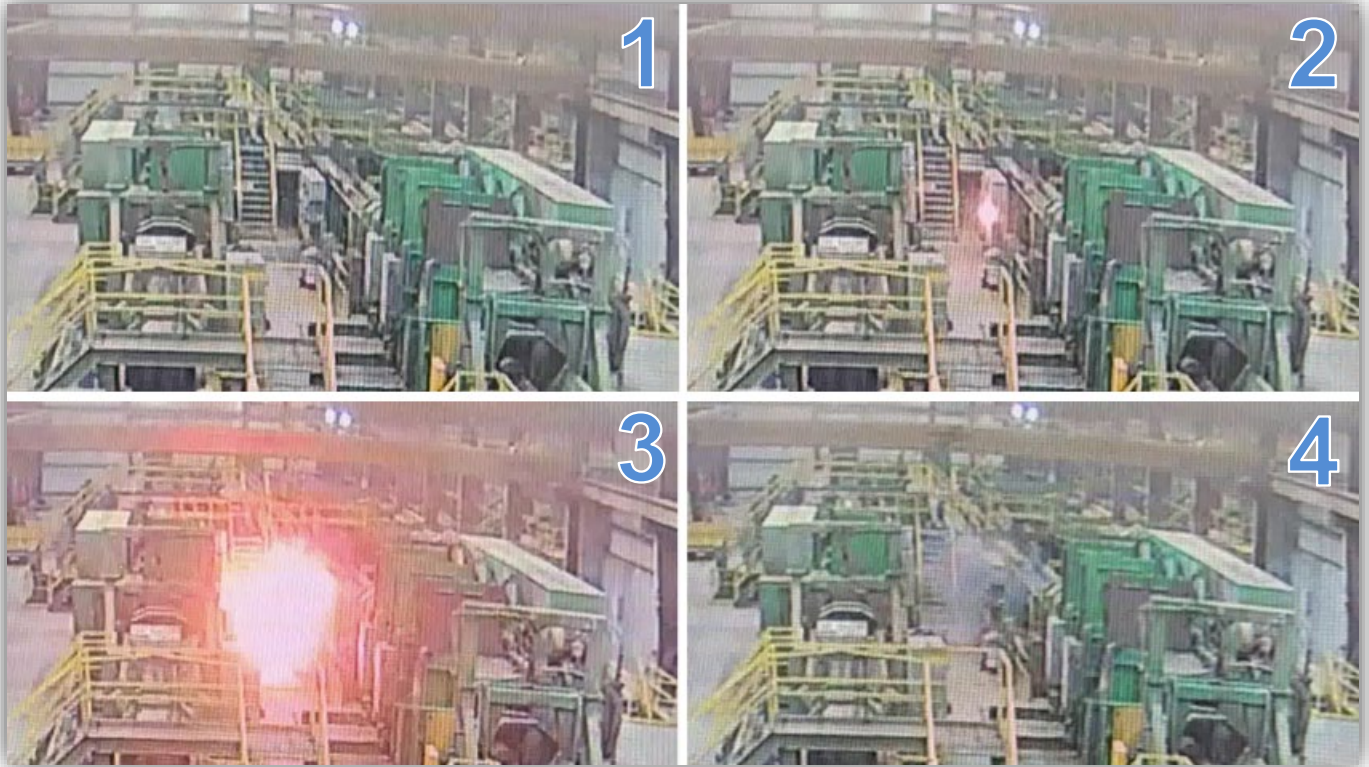
Image 6 – Screenshots of arc incident from the surveillance camera.
