## Incident Summary #II-809561-2019 (#10925) (FINAL)

SUPPORTING INFORMATION	Incident Date	February 10, 2019	
	Location	Whistler	
	Regulated industry sector	Passenger ropeways - Above surface ropeway	
	Injury	Qty injuries	0
		Injury description	NA
		Injury rating	None
	Impact Damage	Damage description	Occurring on February 9 the initial motor: Damage was reported as blown (arc damage) compensating windings, blown armature windings (reported as a “big blow hole) and blown field windings.
			Occurring on February 10 the replacement motor: Damage is reported as blown compensating windings (reported as “has a very large hole ”), and shorted field windings.
		Damage rating	Major
	Incident rating	Major	
Incident overview	The main drive DC motor had the windings fault (short) to ground. This occurred again to a similar replacement motor.		
INVESTIGATION CONCLUSIONS	Site, system and components	<p>A detachable grip chair lift with a DC motor as the normal prime mover (a device which converts energy from an energy source into mechanical energy).</p> <p>The DC motor utilizes (see <b>Drawing#1</b> of cross section of DC motor):</p> <ul style="list-style-type: none"> <li>• An internal set of ca

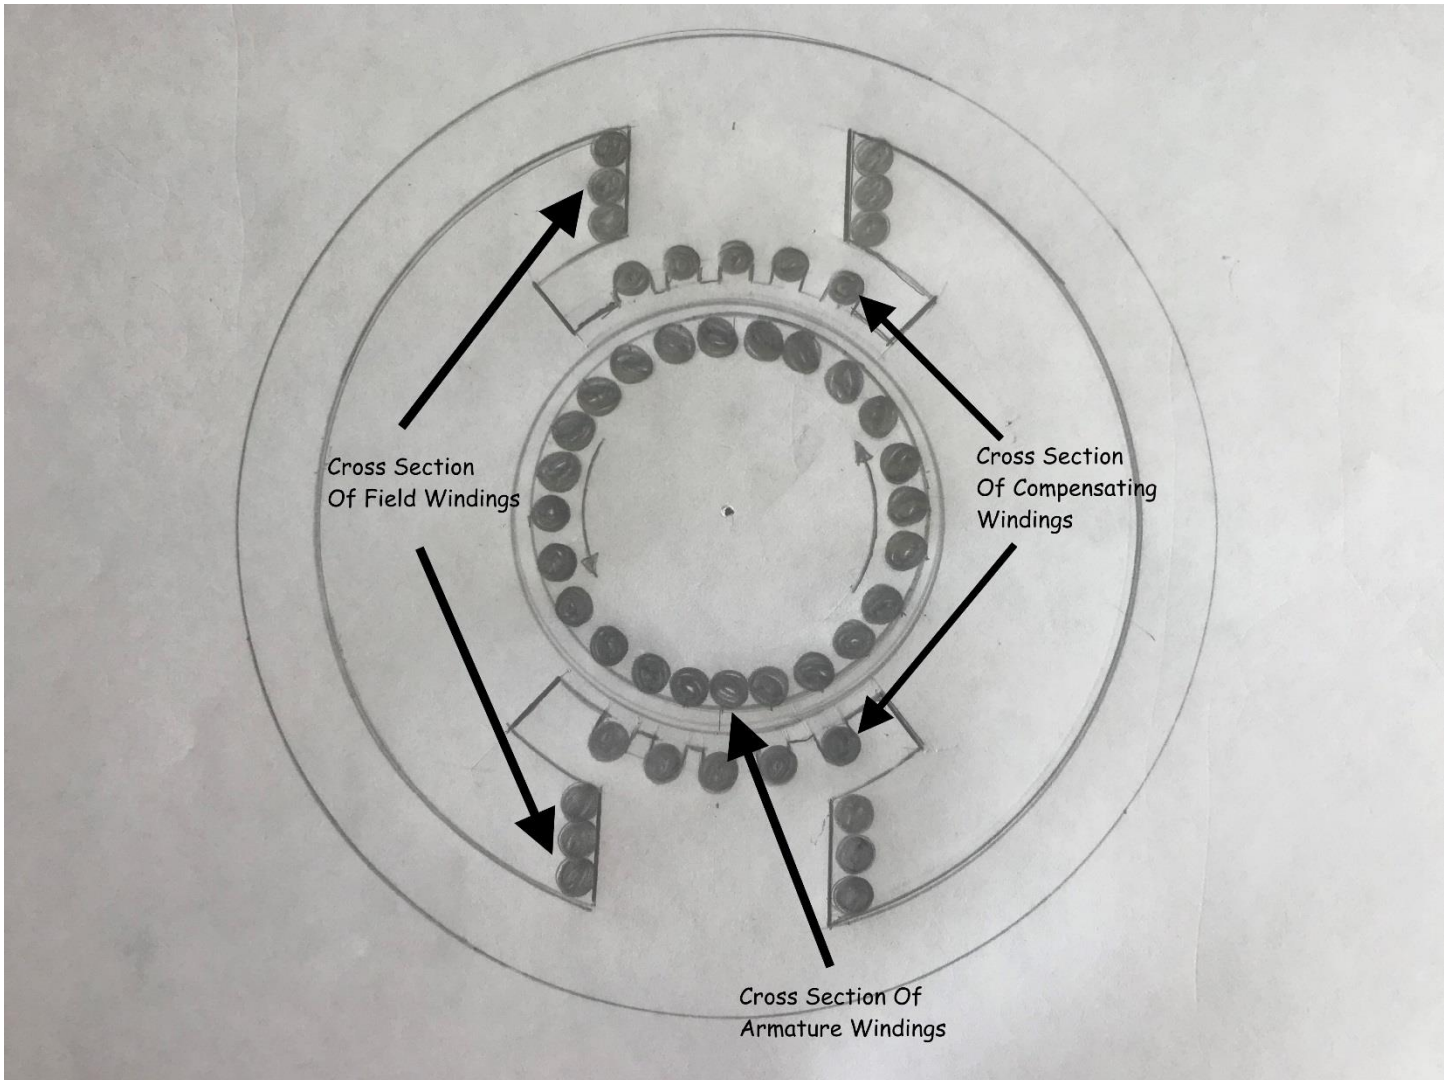
**Drawing #1**

Example of the Cross Section of a DC Motor
