Incident Summary (Posse file 5623158)

SUPPORTING INFORMATION	Incident Date		<i>August 24, 2017</i>	
	Location		<i>Revelstoke</i>	
	Regulated industry sector		<i>Electrical- Low Voltage Electrical System (30-750 volts)</i>	
	Impact	Injury	Qty injuries	<i>none</i>
			Injury description	<i>none</i>
			Injury rating	<i>None</i>
	Damage	Damage description	<i>Damage to the internal buss as well as charring to the base of the enclosure and the internal side of the exterior cover</i>	
			Damage rating	<i>Moderate</i>
Incident rating		<i>Moderate</i>		
Incident overview		<i>Individual was installing a metal fish tape to pull new conductors/ cabling through and into the wrong 'empty' conduit when it entered into the bottom of an energized 600 volt 3-phase 4-wire (200 amp fed) Main Distribution unit and shorted from ground to 1 phase of the buss. Minor damage to the buss was noted.</i>		
INVESTIGATION CONCLUSIONS	Site, system and components		<ul style="list-style-type: none"> - <i>A 400 amp 347/600 volt site service provides power to the buildings industrial equipment, power and lighting system.</i> - <i>The fish tape is a very commonly used tool to assist contractors in the installation of

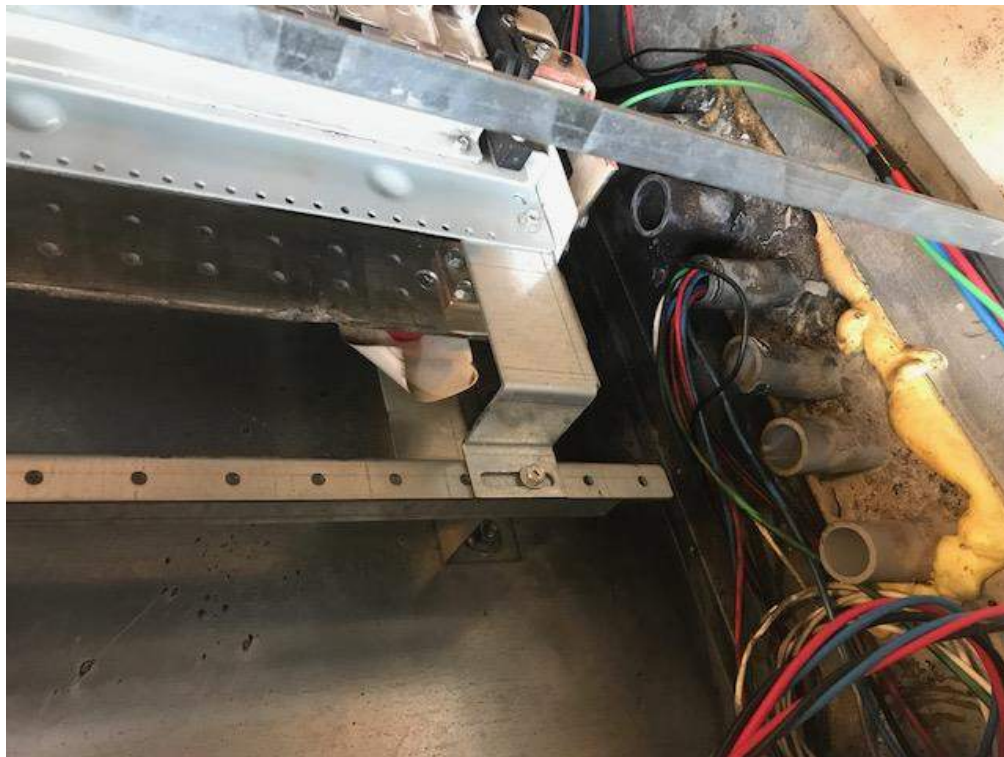
Initial burn damage at time of incident within enclosure

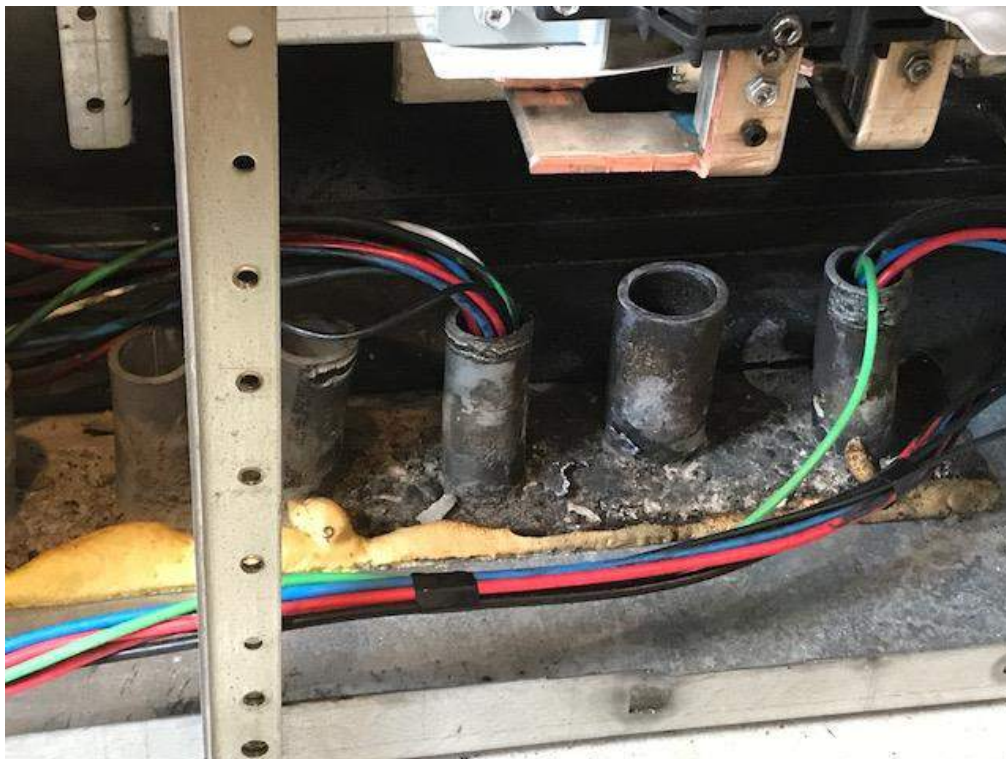
Initial burn damage within enclosure

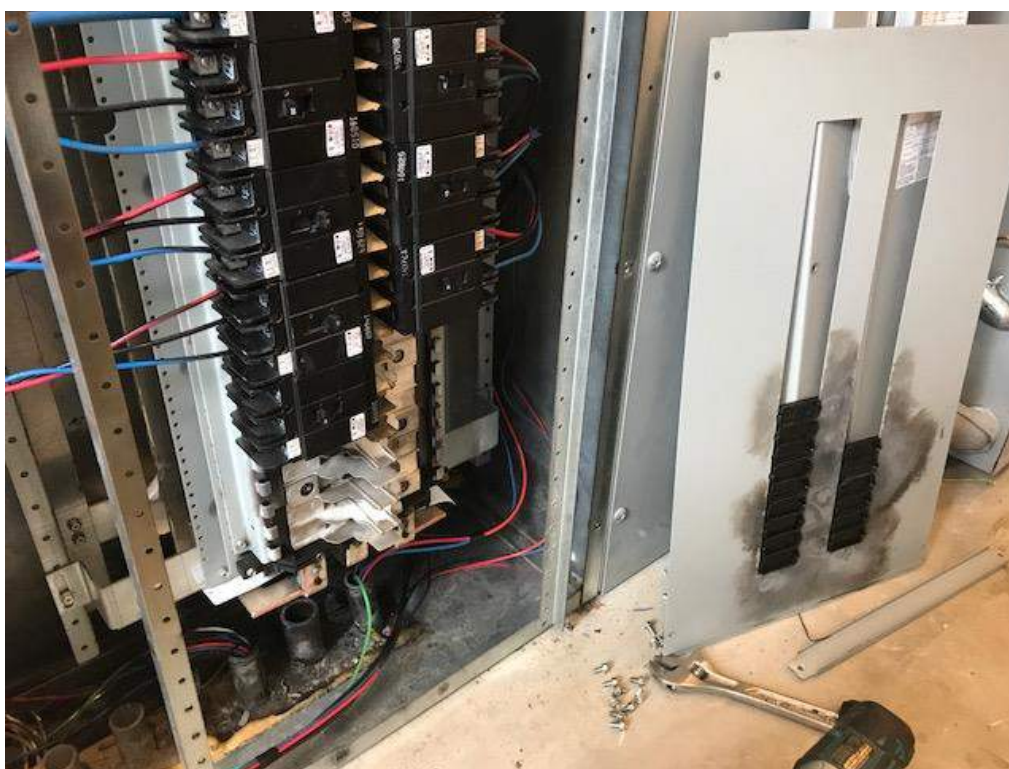
Opened MDC at time of incident

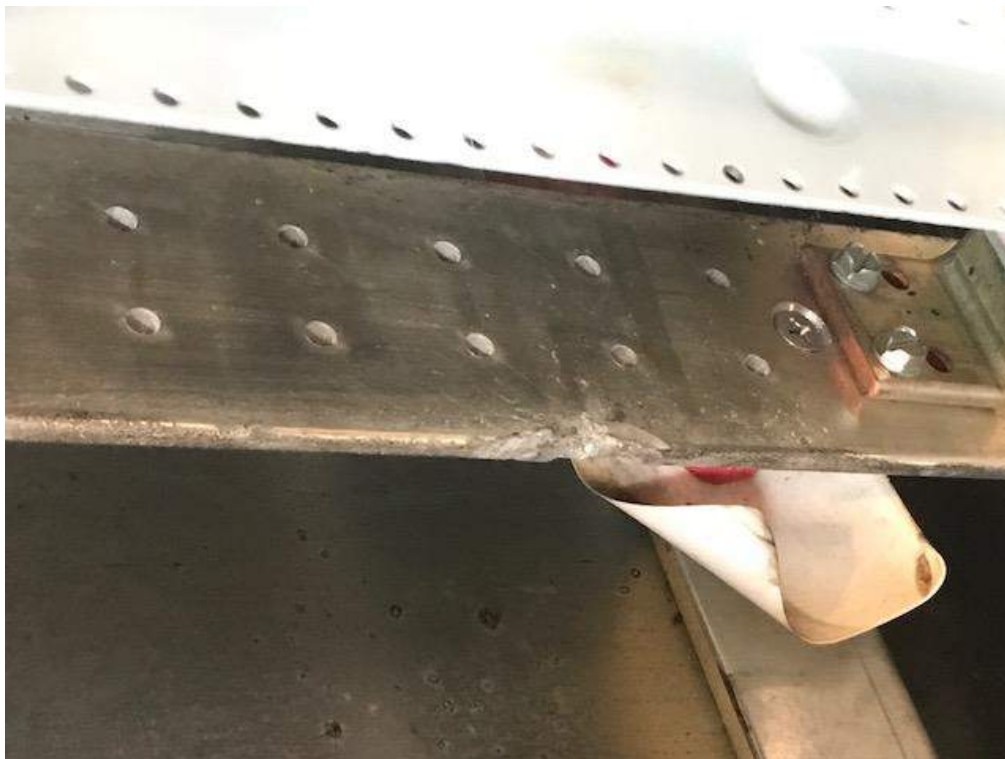
Extent of Buss damage- at load end of enclosure

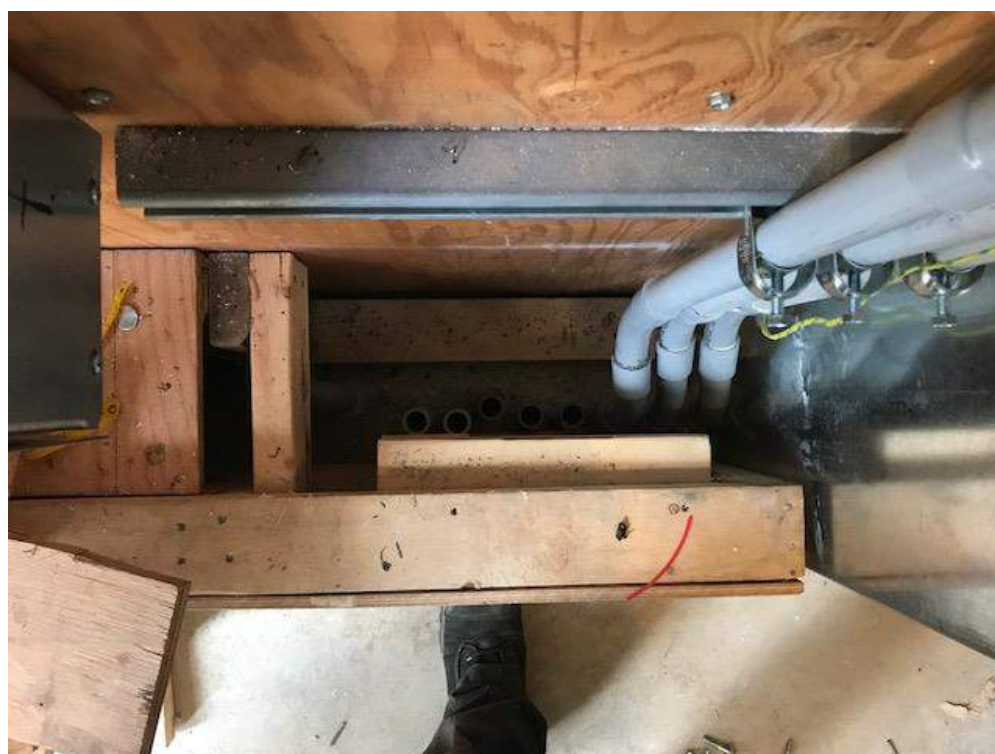
Empty conduit system ORIGINAL TARGET

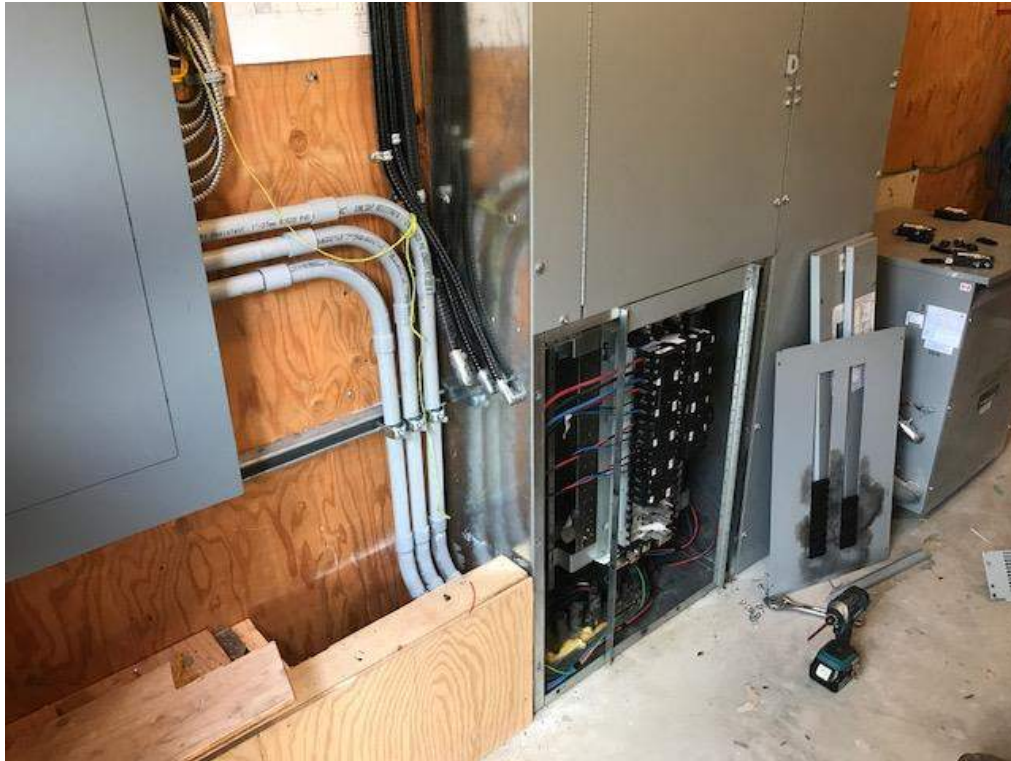
MDC after incident
